Arboricultural Appraisal Report

Subsidence Damage Investigation at:

1 Daleham Gardens
London
NW3 5BY

CLIENT:	Crawford & Company
CLIENT REF:	SU1701605
MWA REF:	SUB170822-1684
MWA CONSULTANT:	Andy Clark
REPORT DATE:	11-09-2017

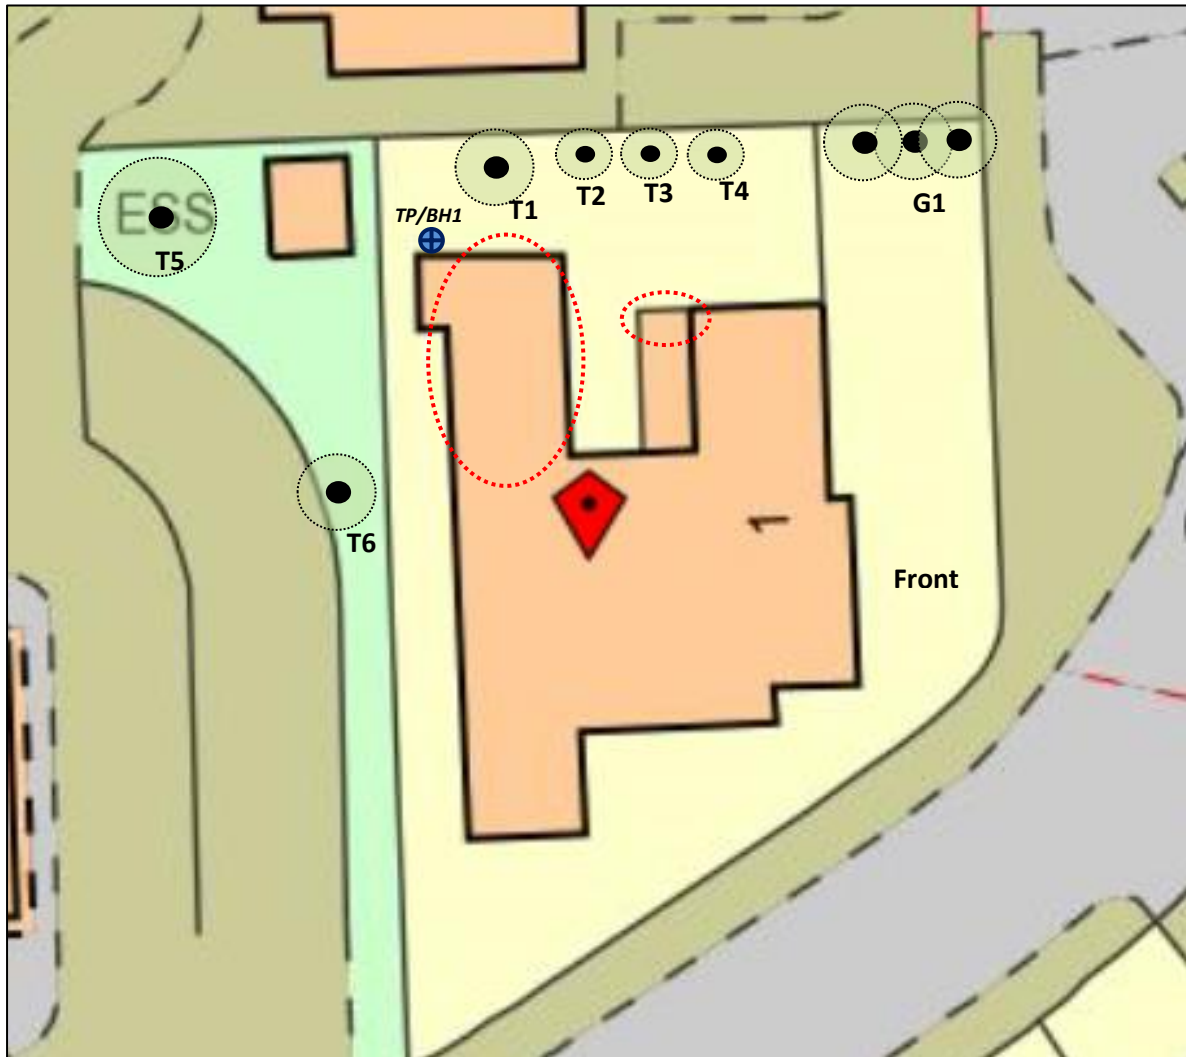
SITE PLAN

Approximate areas of damage

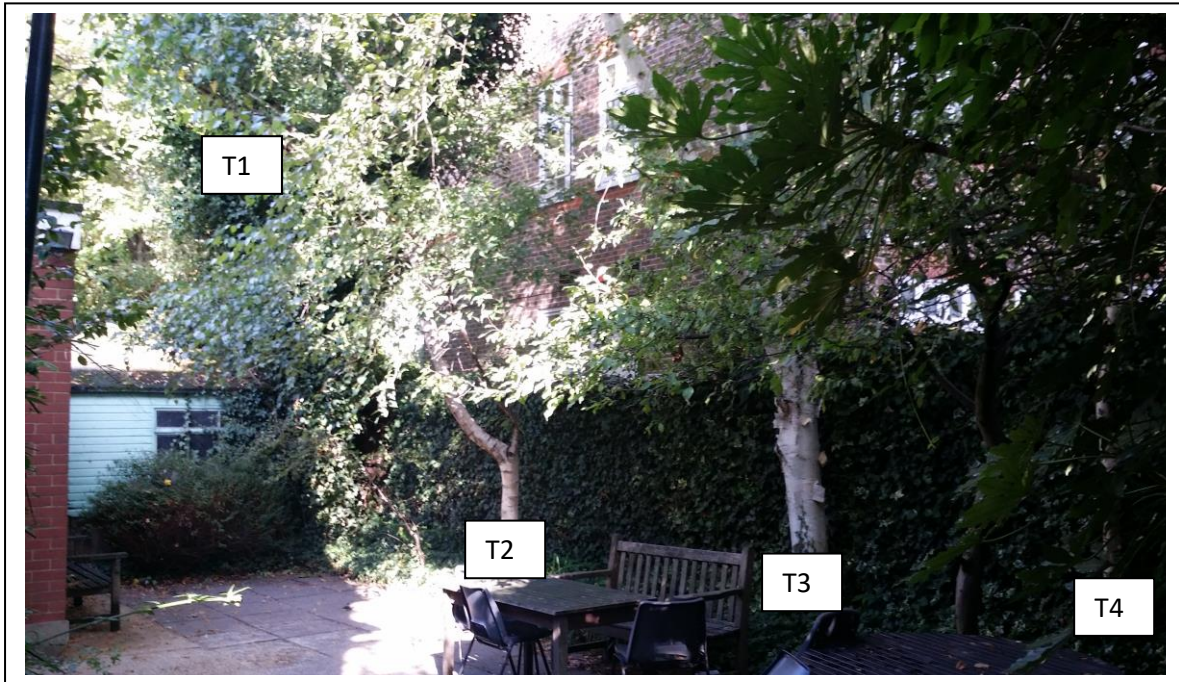
View of T1 Hawthorn with T2 – T4 White Birch

Based on the technical reports currently available, engineering opinion and our own site assessment we conclude the damage is consistent with shrinkage of the clay subsoil related to moisture abstraction by vegetation. Having considered the available information, it is our opinion that T1 Hawthorn is the principal cause of the current subsidence damage with T2 to T4, White Birch, also being contributory. If an arboricultural solution is to be implemented to mitigate the current damage and allow the soils beneath the property to recover to a position such that an effective repair solution can be implemented we recommend that T1, T2, T3 and T4 are removed.

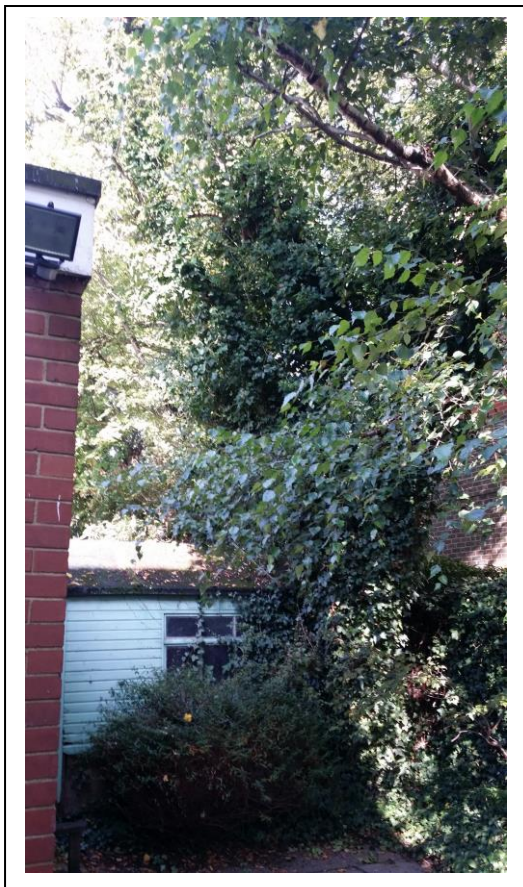
Roots were observed to a depth of 1.3m bgl in TP/BH1 and recovered samples have been positively identified (using anatomical analysis) as Pomoideae sp.; the origin of which will be T1 Hawthorn confirming the influence of T1 on the soils below the foundations. Irrespective of the root identification, given the size and relative proximity to the property of T2 to T4, the roots of these trees will also be present below the foundations and influencing the soil moisture content.

View of T1 Hawthorn

Tree No.	Species	Ht (m)	Dia (mm)	Crown Spread (m)	Dist. to building (m)	Age Classification	Ownership
T1	Hawthorn	12.0	350*	8.0	3.4	Younger than property	Policy Holder
Management history		No signs of significant past management Extensive Ivy growth to main stem and throughout crown					
Recommendation		Fell to ground level and treat stump to inhibit regrowth					
T2	Himalayan White Birch	9.5	150	7.0	3.3	Younger than property	Policy Holder
Management history		No signs of significant past management Asymmetric crown growth habit					
Recommendation		Fell to ground level and treat stump to inhibit regrowth					
T3	Himalayan White Birch	12.5	260	9.0	5.1	Younger than property	Policy Holder
Management history		No signs of significant past management					
Recommendation		Fell to ground level and treat stump to inhibit regrowth					
T4	Himalayan White Birch	6.0	110	3.0	7.0	Younger than property	Policy Holder

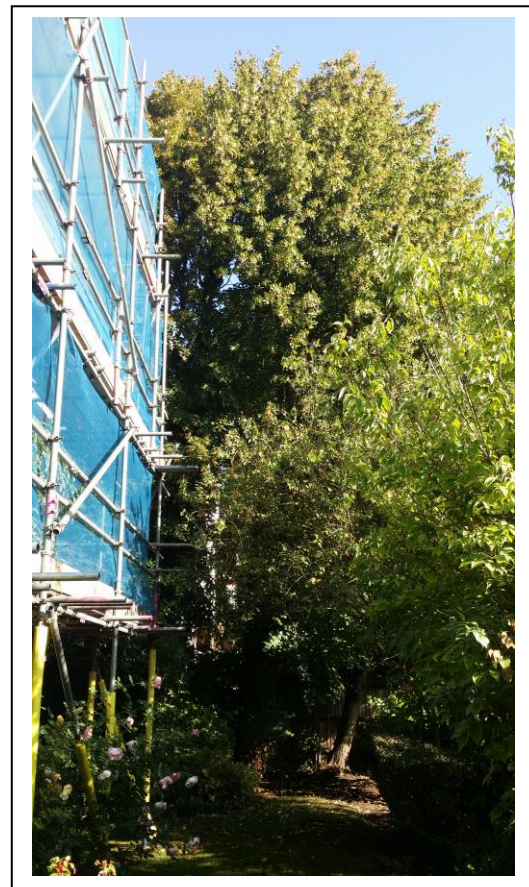
View of G1 Lime

Tree No.	Species	Ht (m)	Dia (mm)	Crown Spread (m)	Dist. to building (m)	Age Classification	Ownership
T5	Lime	15.0*	500*	10.0*	10.0	Younger than property	3rd Party:- Tavistock Centre, Belsize Lane, NW3
Management history		No signs of significant past management					
Recommendation		Do not allow to exceed current dimensions					
T6	Cherry	13.0*	250*	6.0*	10.0*	Younger than property	3rd Party:- Tavistock Centre, Belsize Lane, NW3
Management history		No signs of significant past management					
Recommendation		Do not allow to exceed current dimensions					
G1	Lime [x3]	16.5	500	10.0	6.0*	Younger than property	Policy Holder
Management history		Pollarded in past – regrowth appears <10yrs					
Recommendation		Re-pollard to previous points and retain at new dimension by a program of regular [triennial] re-pollarding
