### 3.4 Existing Building

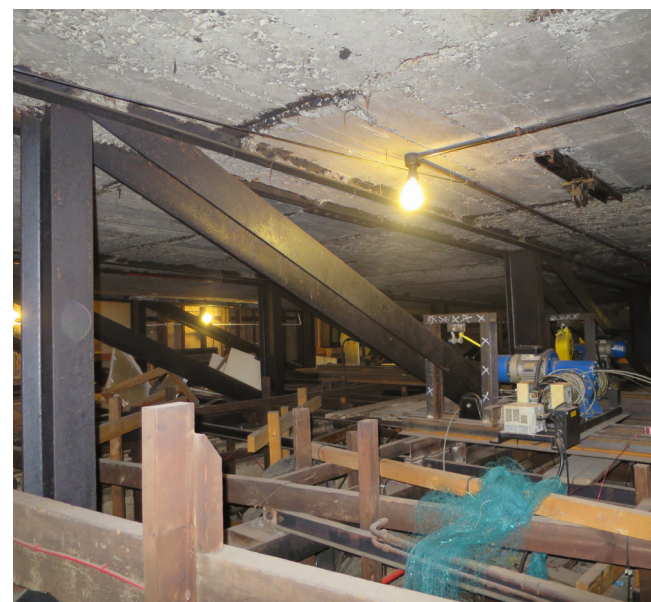
The roof structure over the main auditorium consists of a series of steel trusses spanning north-south and supported on loadbearing masonry walls. A concrete filler joist slab spans between the trusses and is concealed by the existing roof finishes. The existing decorative ceiling to the auditorium is supported by joinery fixed to the underside of the steel trusses. There is a fall in the existing roof from the Crowndale Road elevation towards Bayham Place. The roof also pitches at the Bayham Place elevation matching the profile of the existing roof trusses.

Existing roof structure over KOKO auditorium

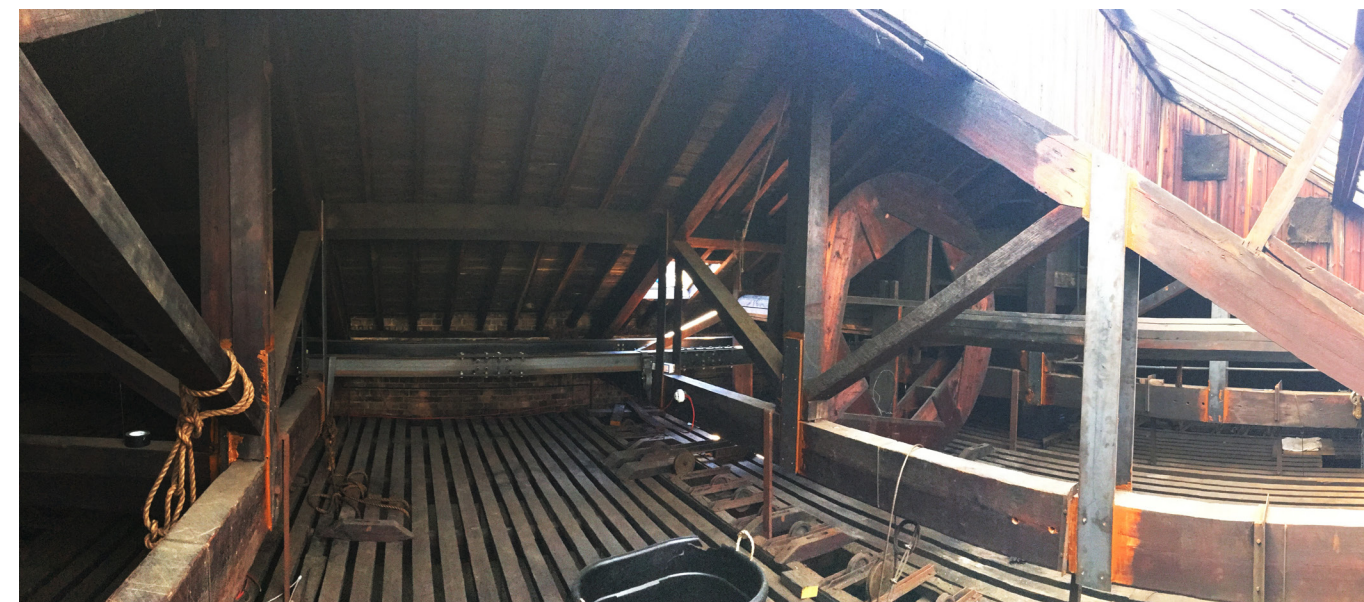
The fly tower galleries, located approximately 6 m above the main stage, consist of timber framed floors supported on timber trusses spanning between the masonry walls on the east and west elevations. An additional truss spanning between the two east-west trusses, supports another high level timber crossover gallery at the rear of the stage. Two steel framed galleries with checker plate floors also exist at approximately 3.5 m above the north and south side of the stage. The construction of these stage galleries indicates they are not original.

Photo of existing flytower roof structure

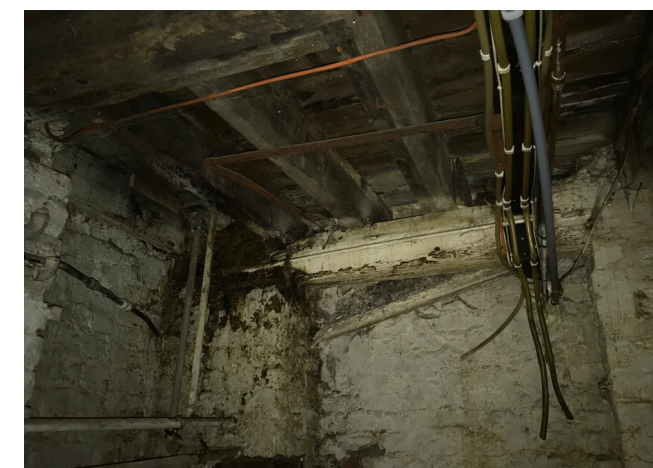
- Ceilings and wall finishes were removed in several locations to confirm the superstructure construction. The works confirmed that the upper floors are constructed from timber floor boards on timber joists supported by loadbearing walls. The timber floor boards were typically not level and observed to be in poor condition on all floors.

Poor condition timber beam in The Hope & Anchor

- The existing timber floors do not have the capacity to support the required loads for the proposed function space and private members club. Extensive and intrusive structural works would be required to upgrade the capacity to meet the loading demands required by the design standards. The timber joists would require furring and floor boards would require replacement to obtain level and complete floors. Rotting timber was also noted beneath the ground floor and it is suspected that the proposed works would expose further defects in the existing structure.

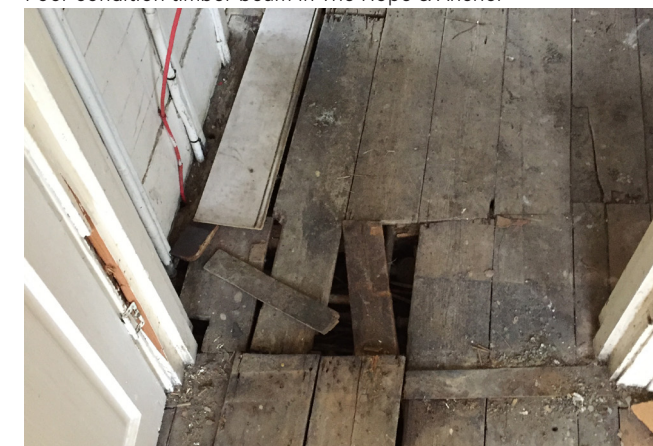
Poor condition timber floor boards in The Hope & Anchor

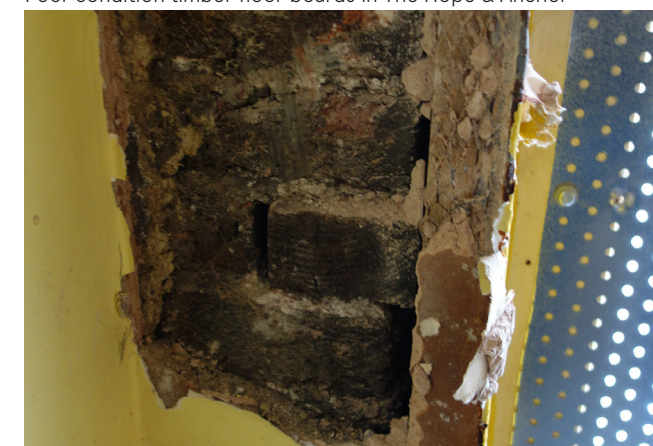
- Bricks were extracted in various locations and levels to test for compressive strength and to gain an understanding of the mortar in various locations. Sandberg issued results of the material testing in report 60082/S/1 dated 17 August 2017. The mortar was typically found to be a hydraulic, semi-hydraulic or non-hydraulic lime with a few exceptions where Portland cement and sand mix or a cement, lime and sand mix was found. The loadbearing masonry façade was observed to be in poor condition, with the brick testing returning weaker and more variable strengths than those in KOKO. Decaying embedded timber was also noted in the loadbearing brick walls in several locations.

Poor condition brickwork in The Hope & Anchor

- The existing façade would require extensive repairs to be retained and re-used. Likely repairs would include removing all decayed embedded timber, replacing decayed timber lintels and repointing.

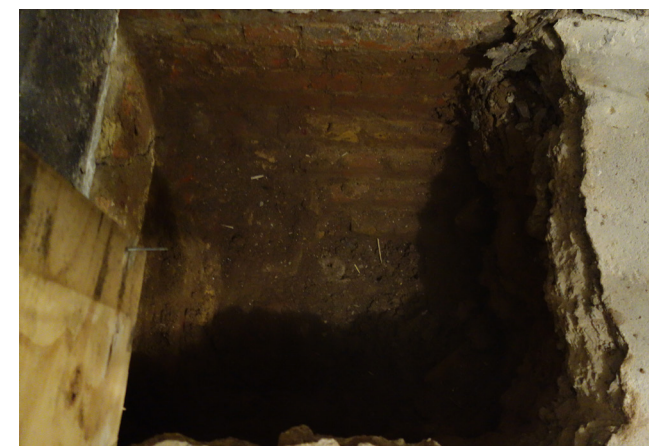
- Four trial pits were carried out in the basement of KOKO. The trial pits typically exposed corbelled brick supported on concrete strip footings of dimensions and build-ups similar to the trial pits carried out by RSK. One area of the sub-basement has not yet been able to be accessed for foundation investigations due to the presence of asbestos containing materials. The trial pits are proposed to be carried out following removal of the asbestos containing materials.

Trial pit in KOKO

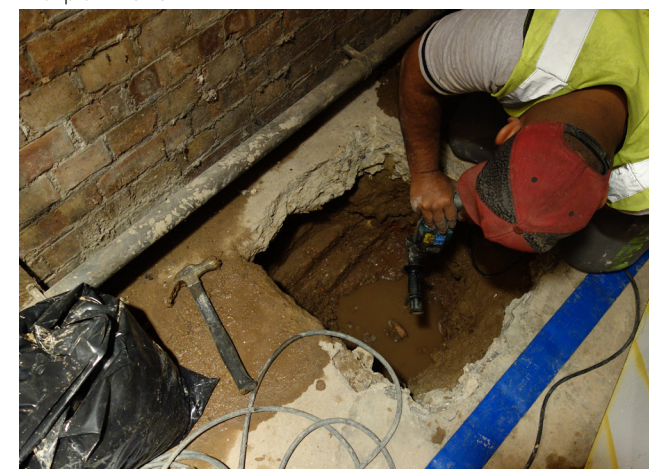
Trial pit in KOKO

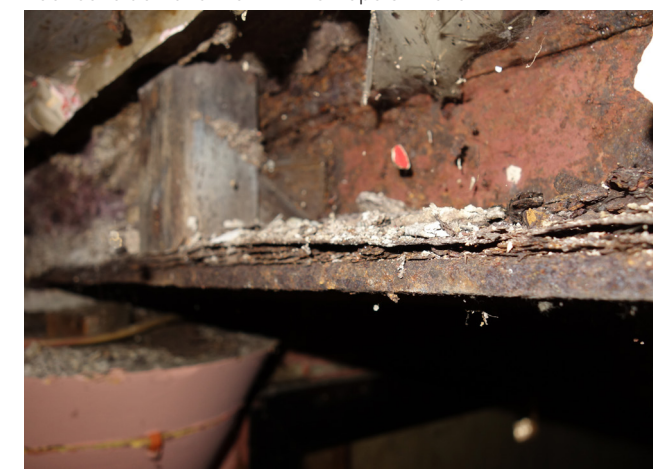
- Ceiling finishes were removed to expose the steel beams supporting the single story flat roof at the south side of the pub. Extensive corrosion was noted to the bottom flange of the steel beams at the Crowndale Road elevation.

Corroded steel roof beams in The Hope & Anchor

- The existing transfer structures at high level ground would need to be strengthened/replaced to resist the increased loads due to the proposed use and additional storey.
