Appendix H6 - CCTV Drainage Survey

Site Details
THE HOPE PROJECT
CAMDEN HIGH STREET
LONDON
NW1 7JE

CCTV SURVEY REPORT

Project name: 45059 Project Number: Contact: Date: 06/07/2016

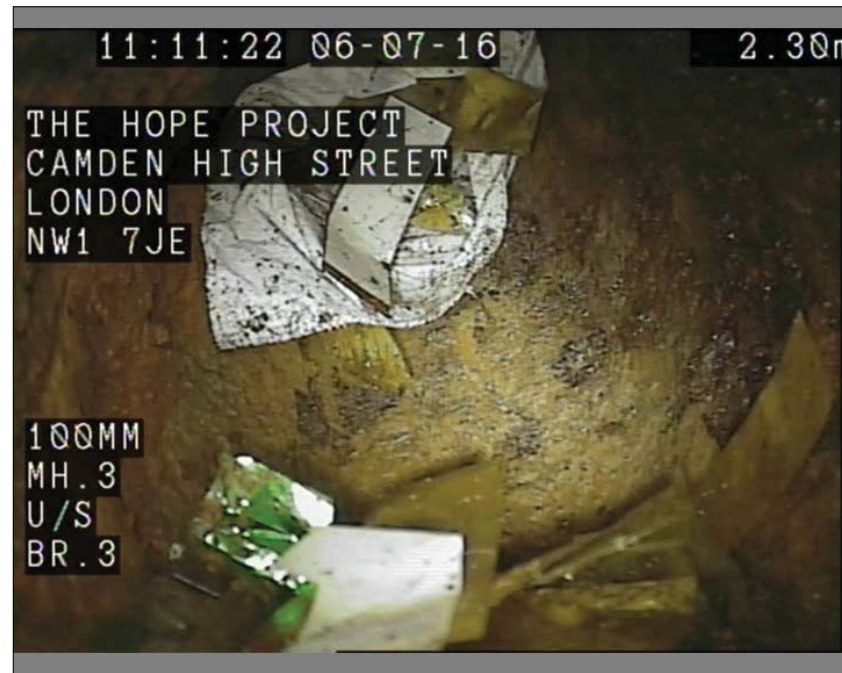
Photo: 9_9_44_A.JPG
2.3m, Settled deposits, coarse, 80% cross-sectional area loss

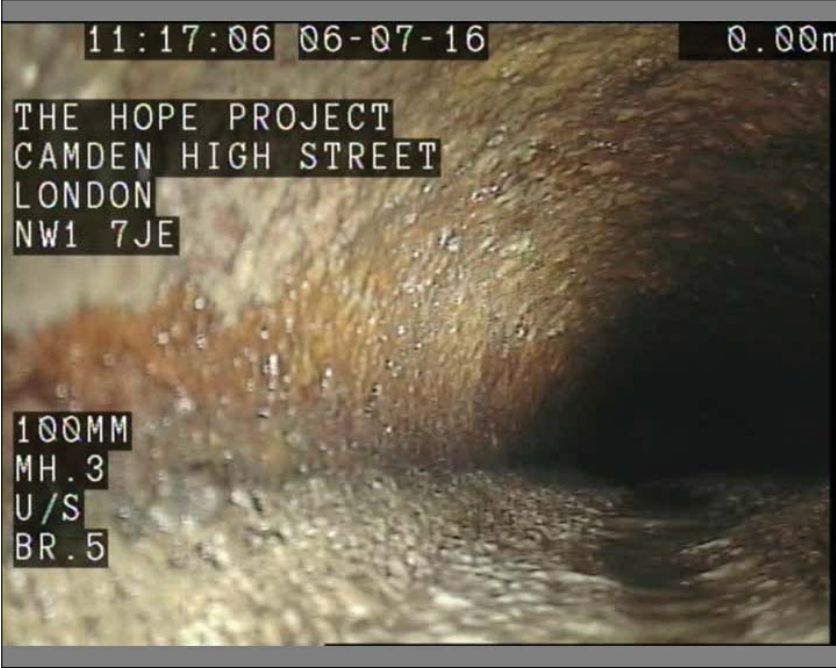
Photo: 11_11_52_A.JPG
0m, Attached deposits, encrustation, from 3 to 8 o'clock, 30% cross-sectional area loss

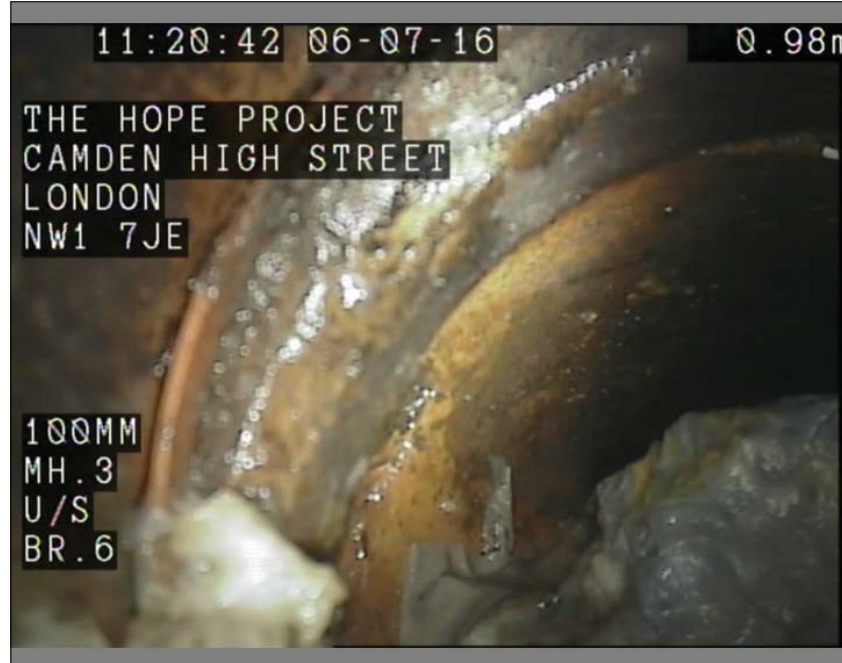
Photo: 11_1_5_18072016_124455_A.jpg
0.98m, Joint displaced, medium

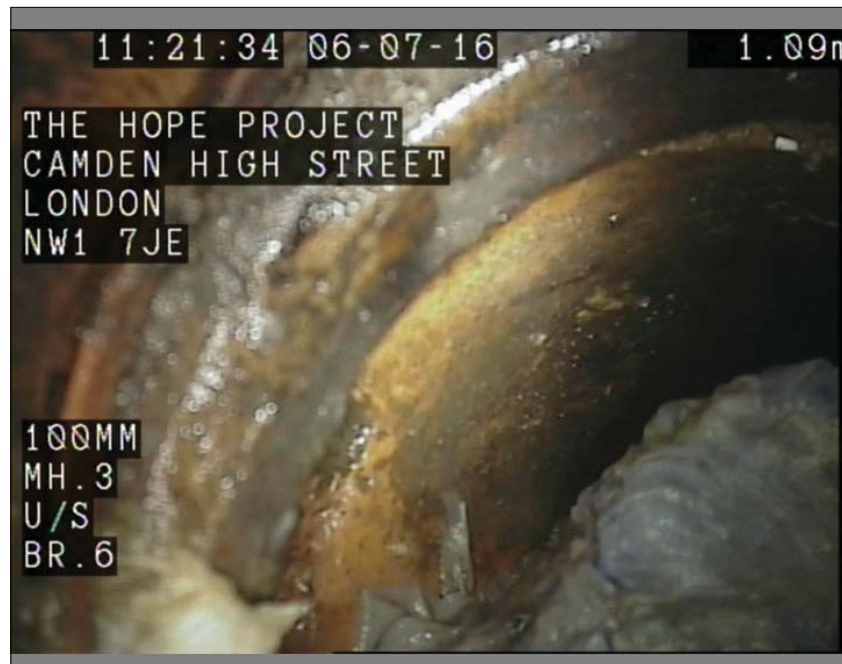
Photo: 12_12_59_A.JPG
1.09m, Settled deposits, coarse, 60% cross-sectional area loss

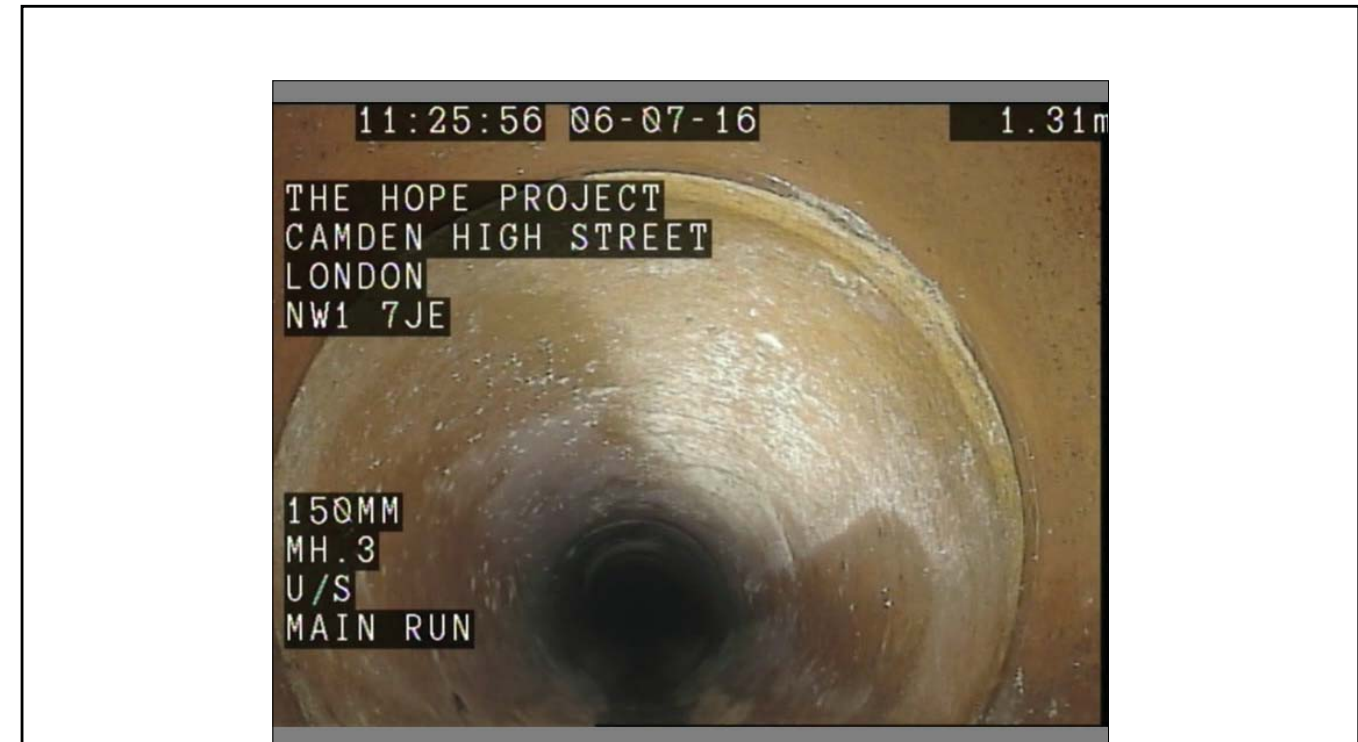
Photo: 12_1_6_18072016_124539_A.jpg
 1.31m, Crack, circumferential at joint, from 1 to 4 o'clock

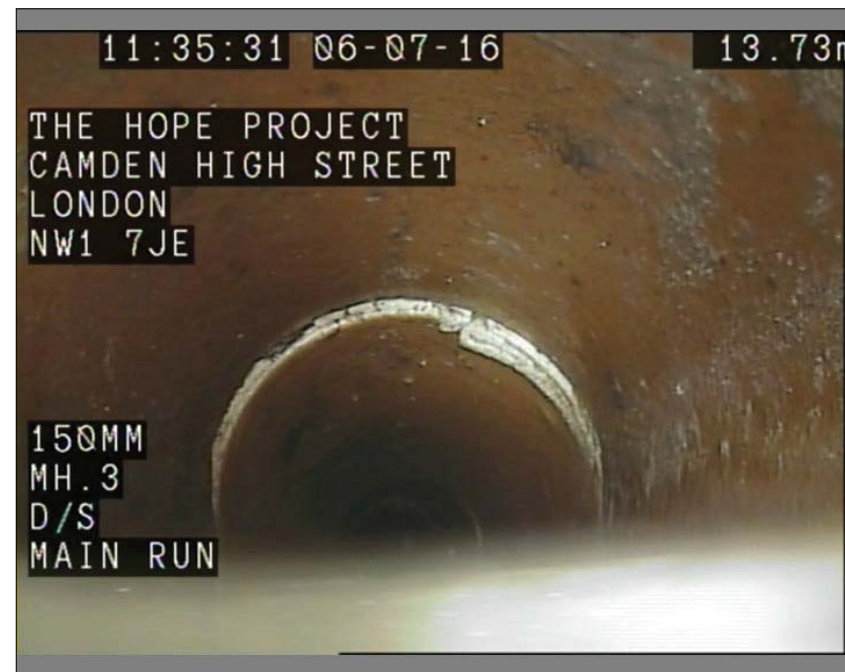
Structural defects			
Section	PLR	Grade	Fault description
13	MH3 X	4	Broken pipe at joint, from 1 to 3 o'clock
19	BR2 X	4	Broken pipe, from 10 to 12 o'clock

Photo: 14_14_82_A.JPG
13.84m, Broken pipe at joint, from 1 to 3 o'clock

Grade 4; Best practice suggests consideration be given to a repair to avoid potential collapse

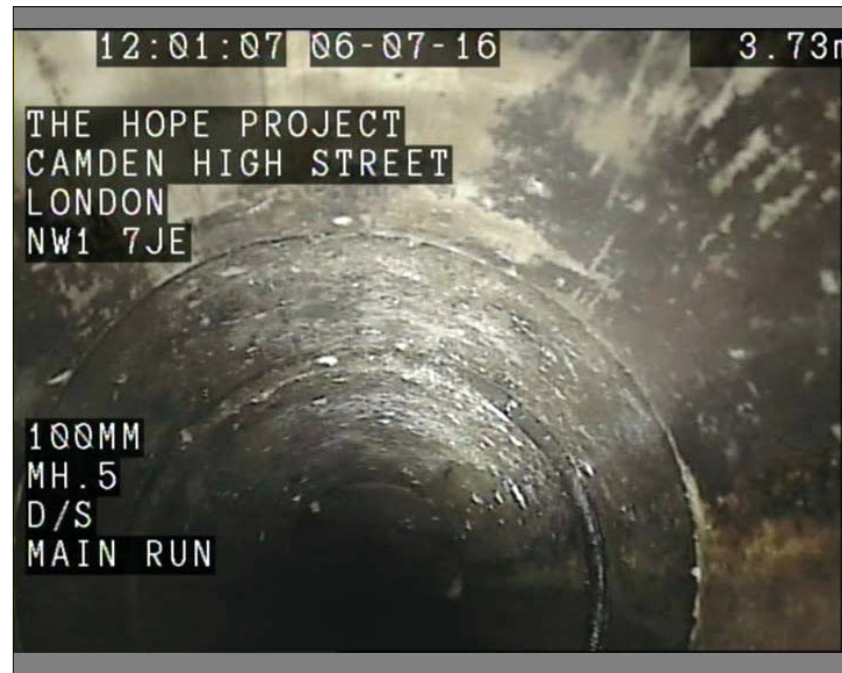
Photo: 17_17_107_A.JPG
 3.73m, Crack, circumferential, from 7 to 4 o'clock
