Place :	LONDON	Location details:	U/S MH :	BR1
Road :	CAMDEN HIGH STREET	Catchment:	U/S Depth :	
Location	Difficult access	Tape number : 1	D/S MH :	MH7
Inspection	MH7 (U/S) BR1	Pipe Length 1.00 m	D/S Depth :	0.52
Direction Use:	Combined	Pipe shape :	Circular	
Year laid :	Z	Pipe size :	150 mm	
Purpose :	Sample survey to determine asset condition	Pipe material :	Vitrified clay	
Total length :	2.41 m	Lining :

THE HOPE PROJECT
CAMDEN HIGH STREET
LONDON
NW1 7JE

STRUCTURAL ENGINEER'S REPORT**ON:****DATING OF TRUSSES OVER MAIN AUDITORIUM****OF:****KOKO (NEE CAMDEN PALACE THEATRE), CAMDEN****FOR:****JASMEER PATTI**

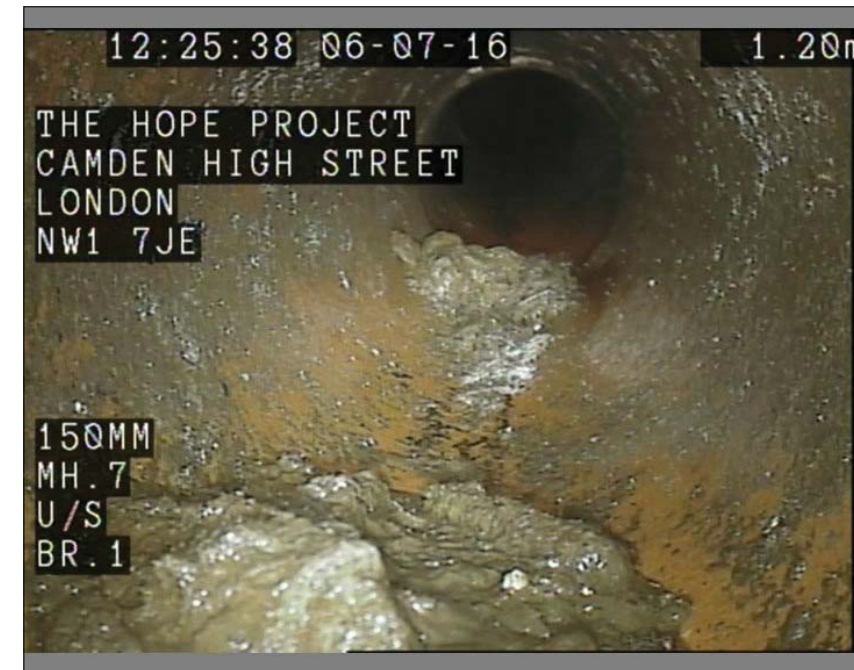
Photo: 19_19_120_A.JPG
1.2m, Settled deposits, coarse, 10% cross-sectional area loss

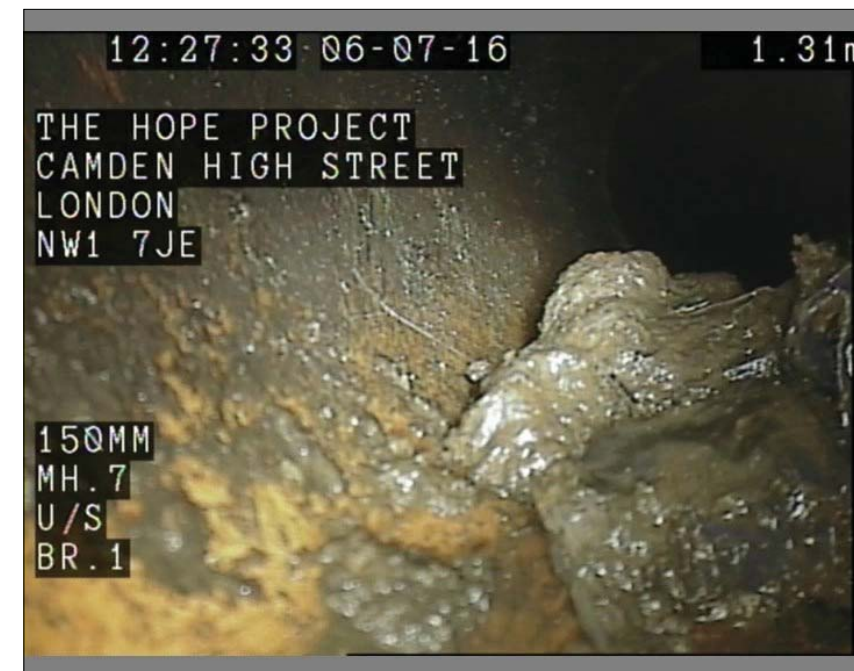
Photo: 19_19_121_A.JPG
1.31m, Settled deposits, coarse, 10% cross-sectional area loss

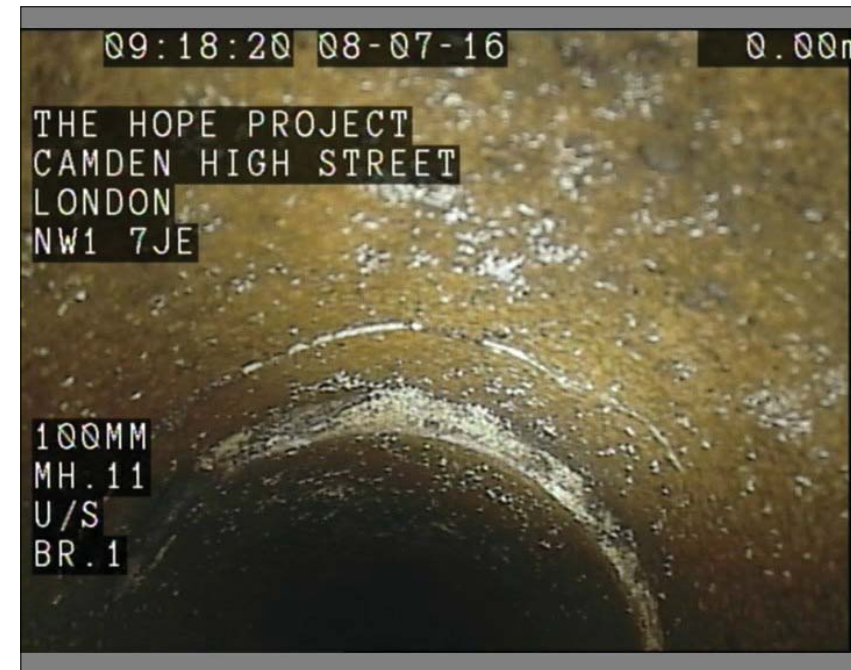
Photo: 25_25_155_A.JPG
0m, Crack, circumferential, from 10 to 2 o'clock

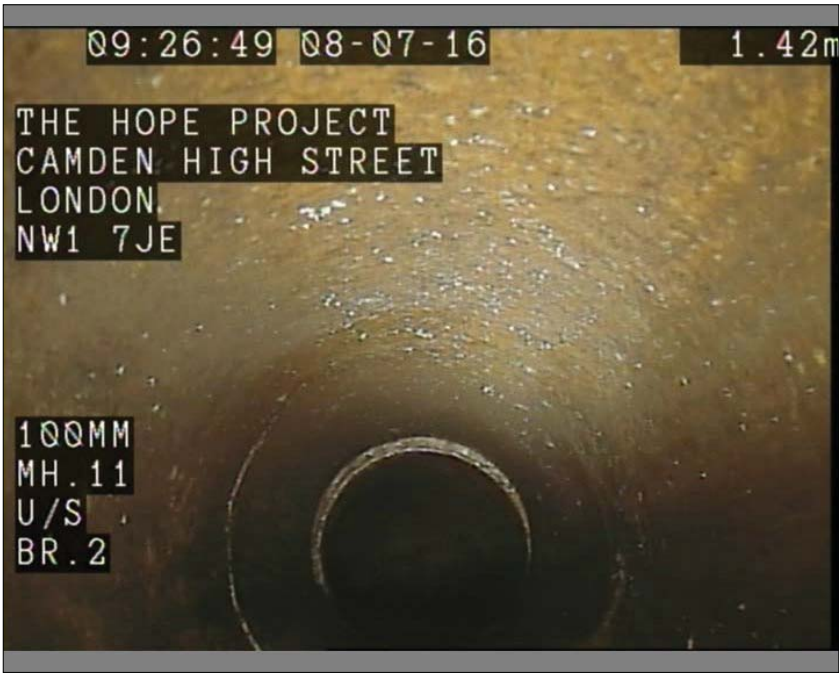
Photo: 26_26_163_A.JPG
1.42m, Crack, circumferential, from 7 to 5 o'clock

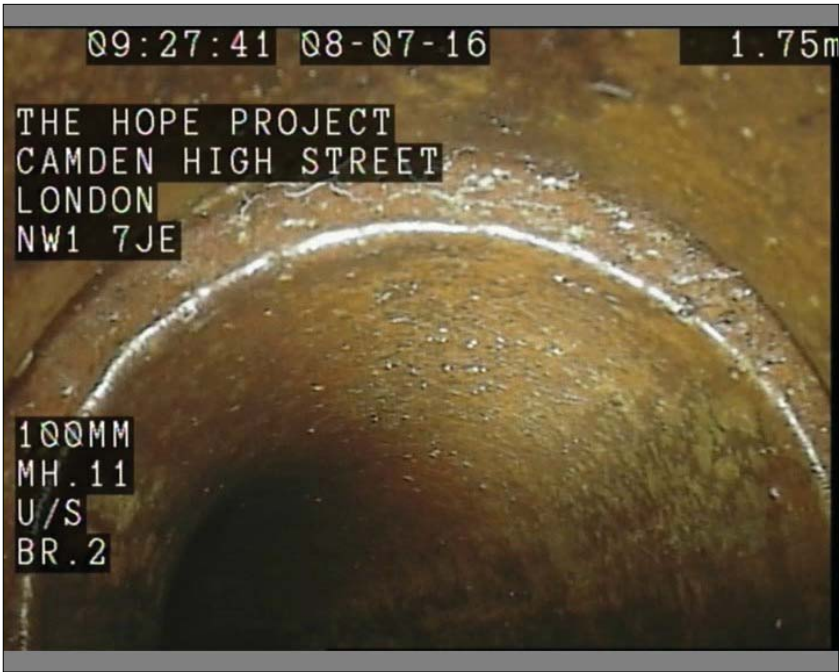
Photo: 26_26_164_A.JPG
1.75m, Crack, circumferential at joint, from 7 to 3 o'clock

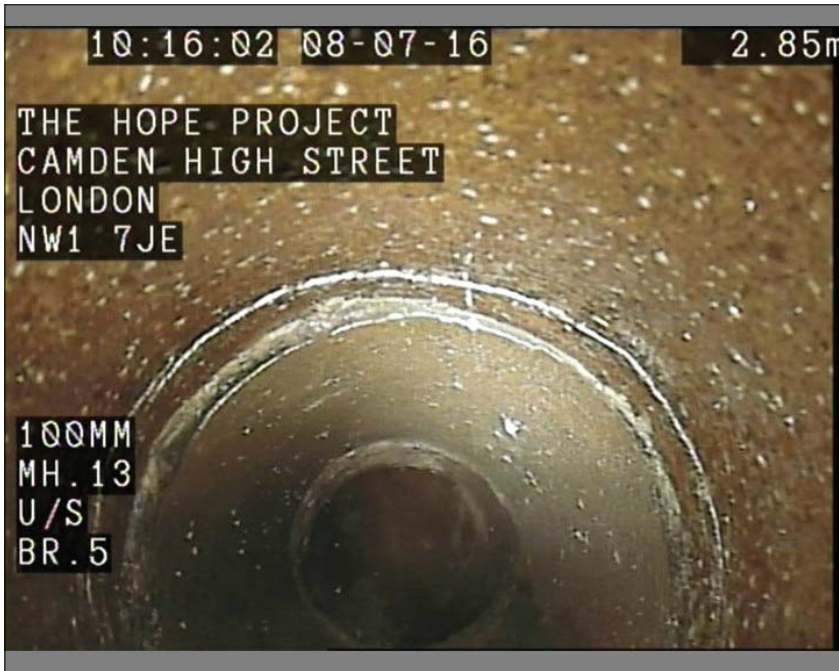
</div> <div>Photo: 32_32_211_A.JPG 2.85m, Crack, circumferential, from 9 to 3 o'clock</div>

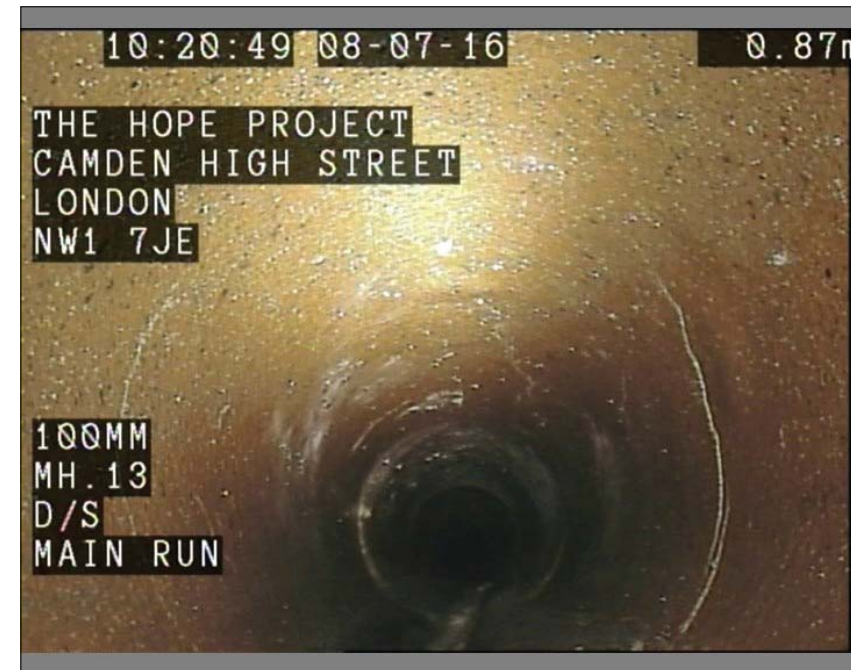
Photo: 33_33_218_A.JPG
0.87m, Crack, circumferential, from 7 to 10 o'clock

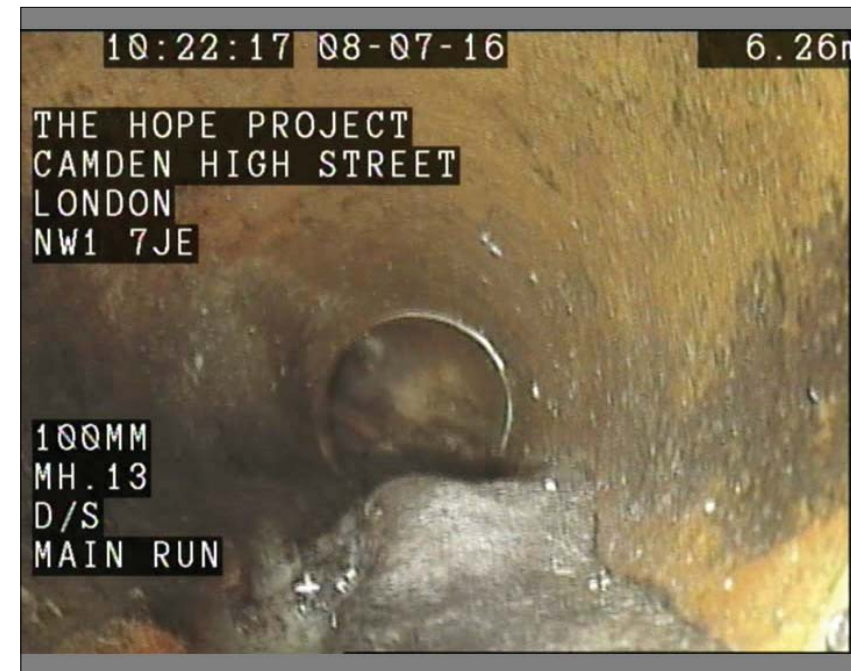
Photo: 33_33_227_A.jpg
6.26m, Attached deposits, encrustation, from 4 to 6 o'clock, 20% cross-sectional area loss
