KOKO (NEE CAMDEN PALACE THEATRE)

Appendix J

Intrusive Structural Investigation Site Reports

The Hope Project – Site Visit Report No.2

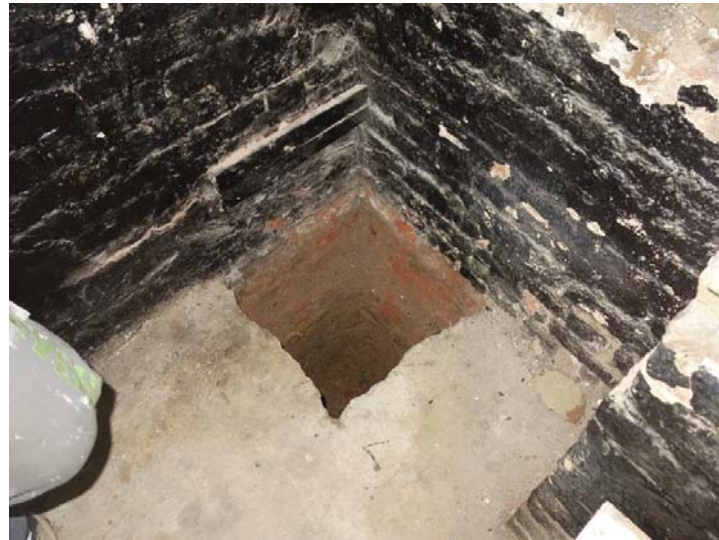
1.1 Trial pit exposed load bearing masonry bearing directly on clay approximately 400 mm below existing slab level (location B23)

Basement floor is a 140–150 mm thick concrete slab on a brick and concrete base on clay.

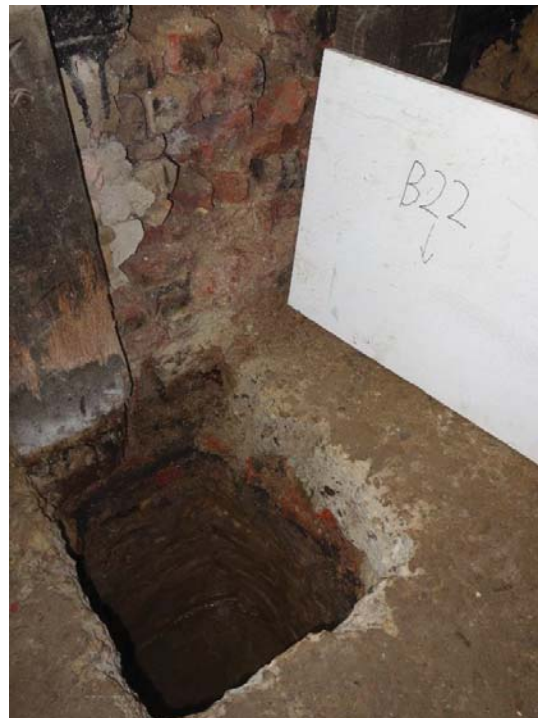
1.2 Trial pit exposed load bearing masonry arch wall bearing directly on clay approximately 350 mm below existing slab level (location B22).

Basement construction is a 160 mm thick concrete slab on a brick and concrete base on clay.

Water was observed in the base of the trial pit approximately 900 mm below existing slab level.

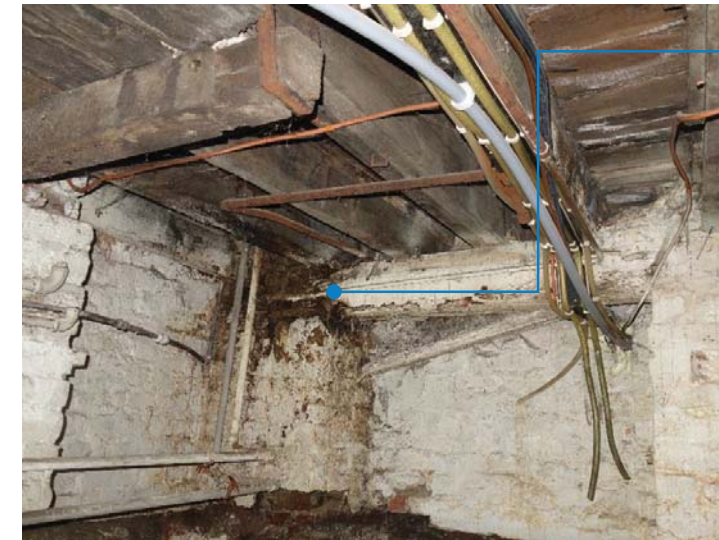
1.3 Water damage and rotting ground floor timber joists and supporting timber lintel (location B21).

Ground floor construction:
180–200d x 65w timber joists at 300–400crs.

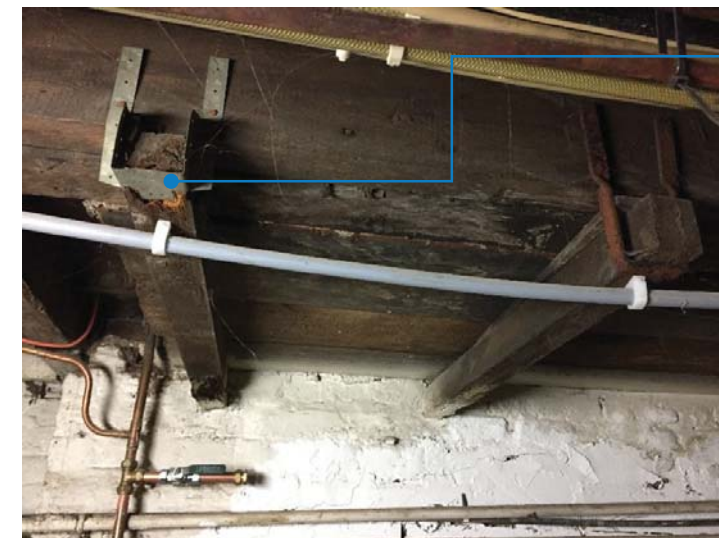
1.4 Existing timber beams supporting ground floor hearth in poor condition, with timber crushing at the joist hanger (location B21).

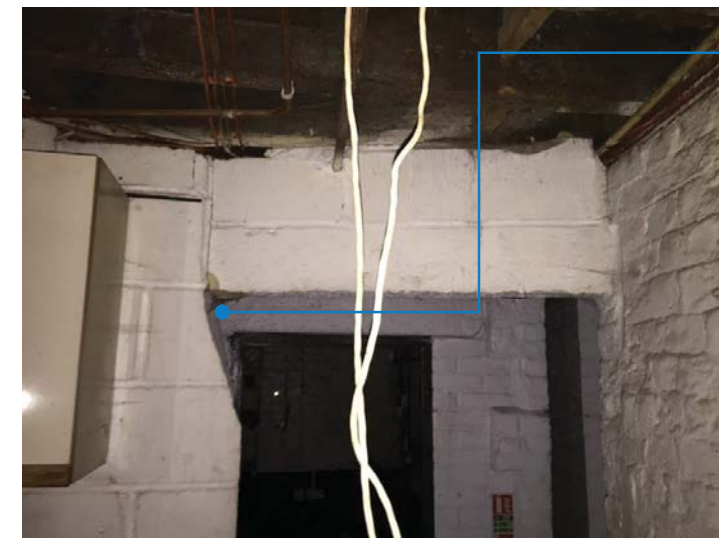
1.5 Loss of support to existing block lintel.

Prop to be installed to prevent local collapse.

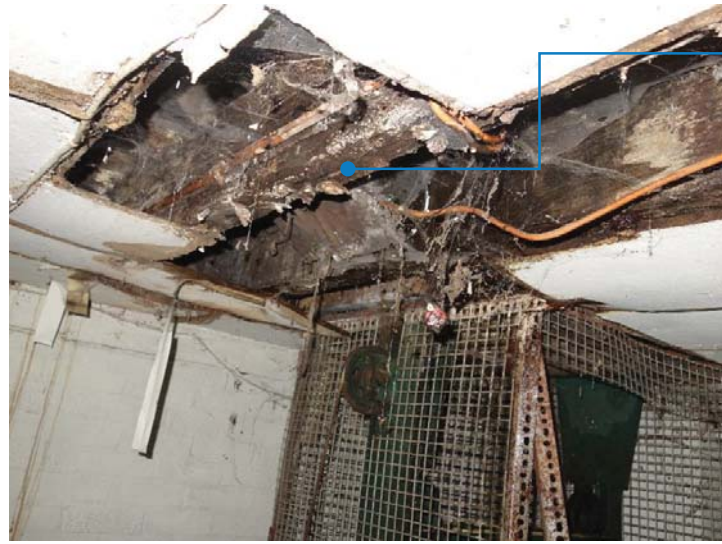
1.6 Water damage and rotting ground floor joists (location B24).

Ground floor construction:
180d x 50w timber joists at 300-350crs.

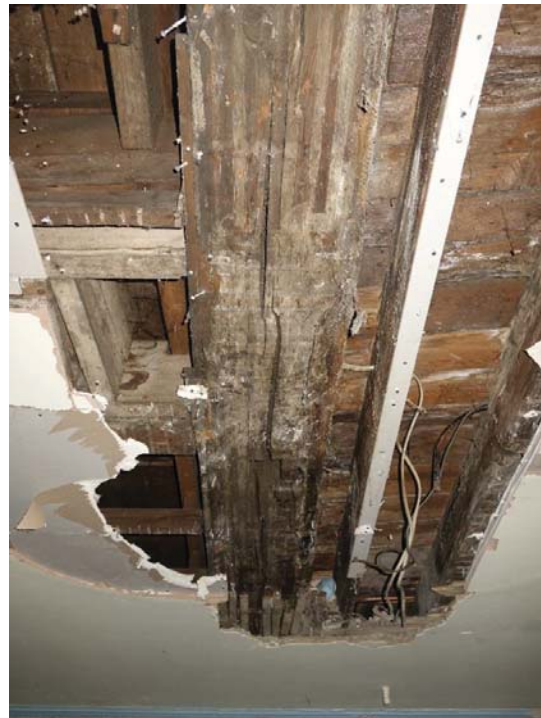
2.1 320d x 330w timber beam supporting brick façade above exposed above ceiling. Beam has several longitudinal cracks (location G14)

First floor construction:
180d x 60w timber joists at approx. 300crs.

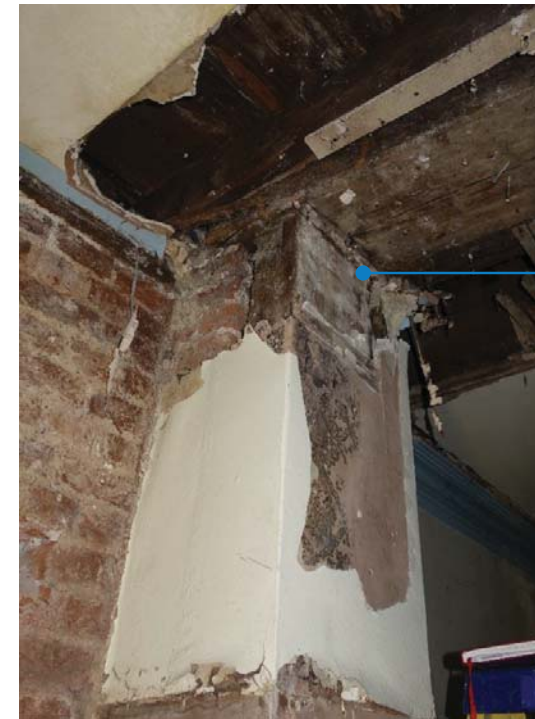
2.2 300d x 125w timber post support for timber beam (location G15).

Timber appears to be crushing at head of post.

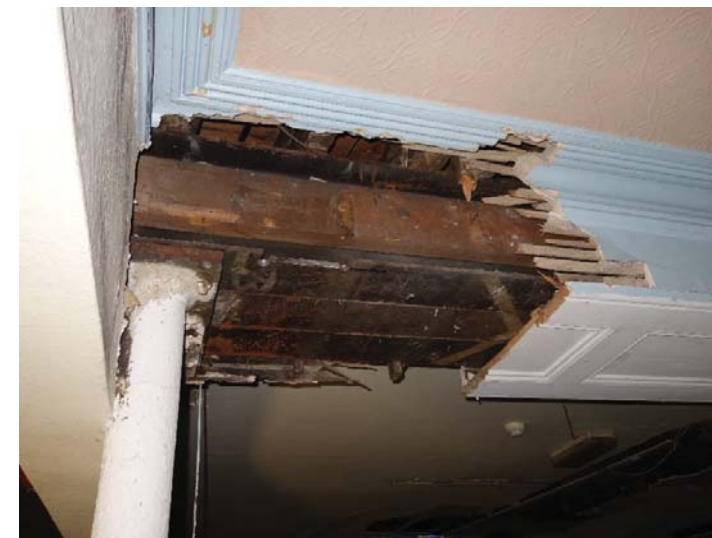
2.3 Triple steel beams measured to be 300d x 155w each (location G16). Comparison of the measured dimensions with the rolled beam sizes by Dorman Long & Co (1887) indicates the beam may be an imperial size 12x6x57.

Sandbergs have taken a steel sample at this location for steel testing.

Double cast steel posts, approximately 130 mm diameter support the triple beams.

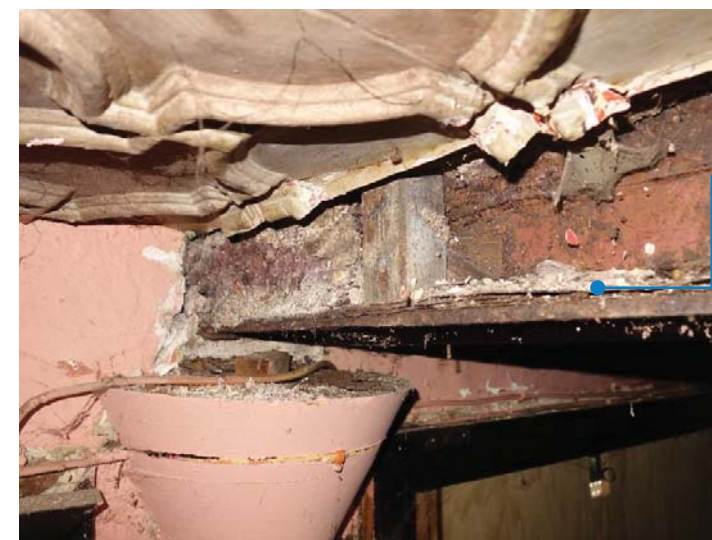
2.4 Steel beams supporting flat roof (location G19). Steel angles connected to the beam flange supports a concrete slab (filler joist concrete slab assumed).

Beam bottom flange has suffered significant corrosion.

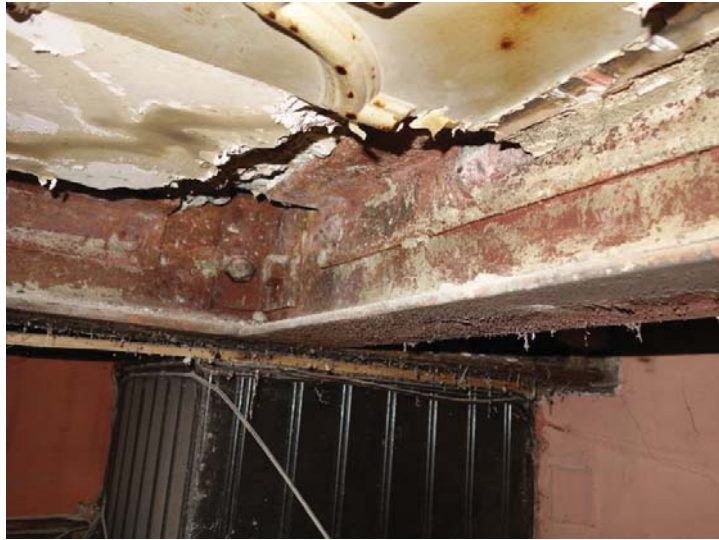
2.5 Steel beams supporting flat roof. Steel angles connected to the beam flange supports a concrete slab (filler joist concrete slab assumed). Beam bottom flange has suffered significant corrosion.

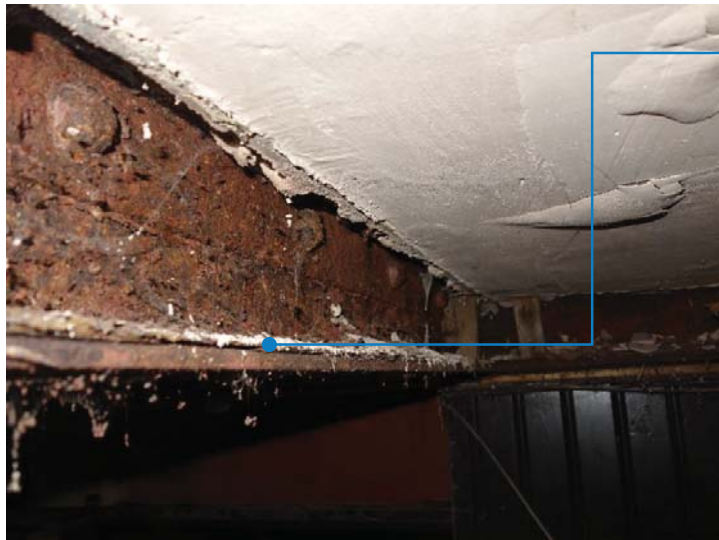
2.6 Corrosion of flat roof beam bottom flange.

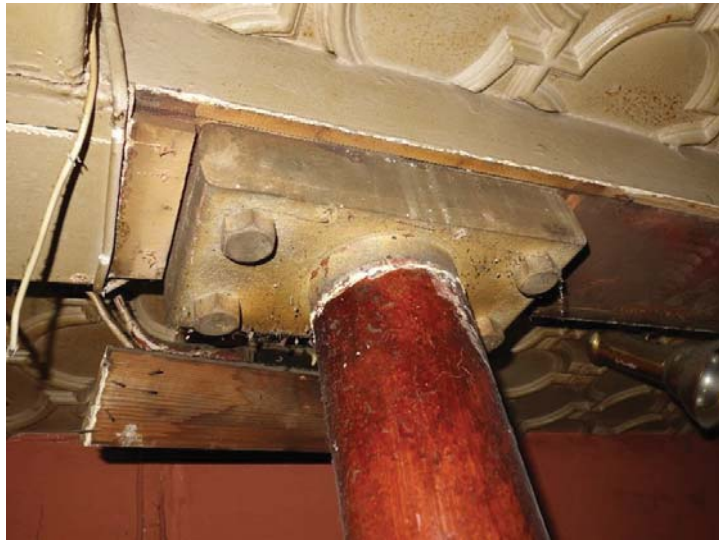
2.7 Thick top plate connection of cast steel post to steel roof beam (location G20).

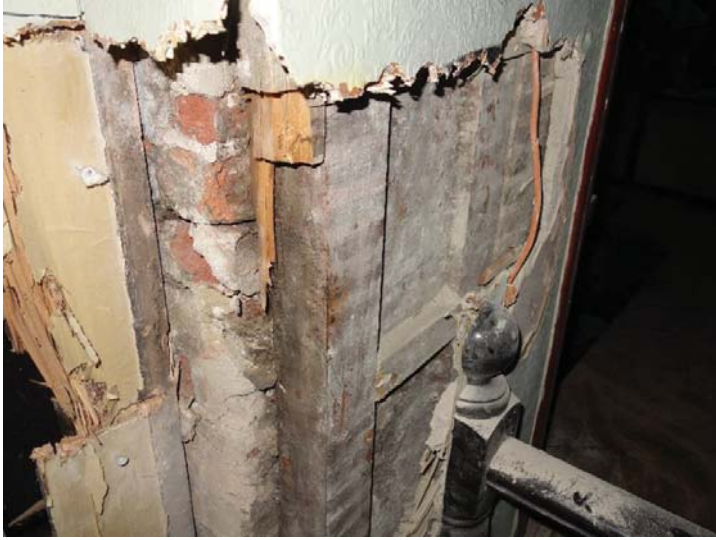
Cast steel or iron post uncovered in front of brick pier (location G17).

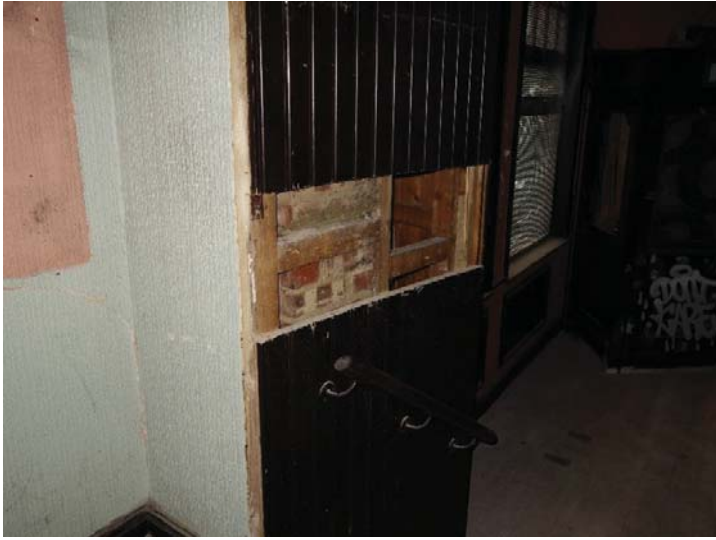
Brick piers exposed behind wall finishes (location G18).

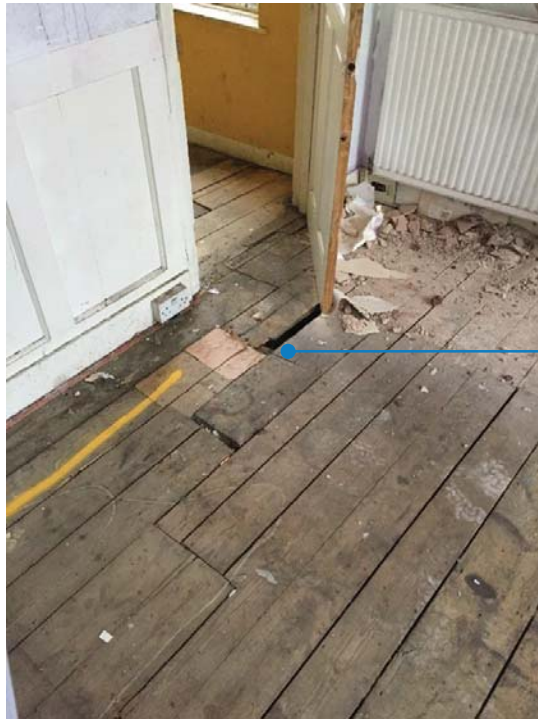
3.1 Upper level floor boards are not level, and are split/broken in several locations.

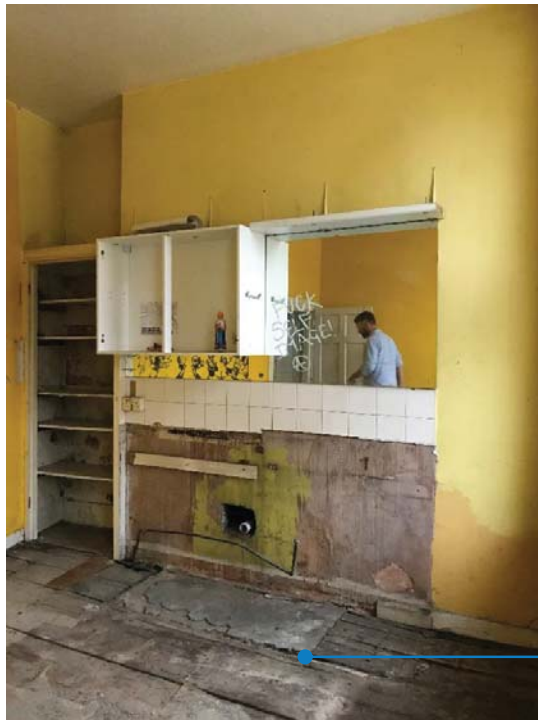
3.2 Upper level floor boards are not level, and are split/broken in several locations.

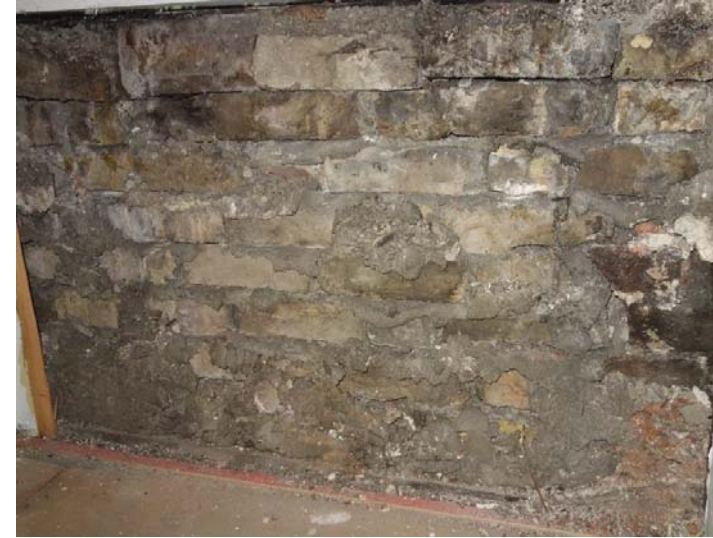
3.3 Poor quality brick and mortar in existing façade walls, particularly in spandrel panels.

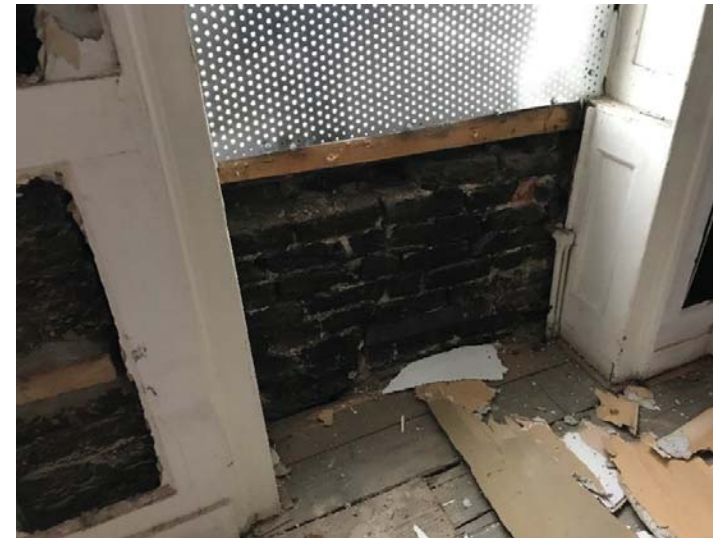
3.4 Poor quality brick and mortar in existing façade walls, particularly in spandrel panels.

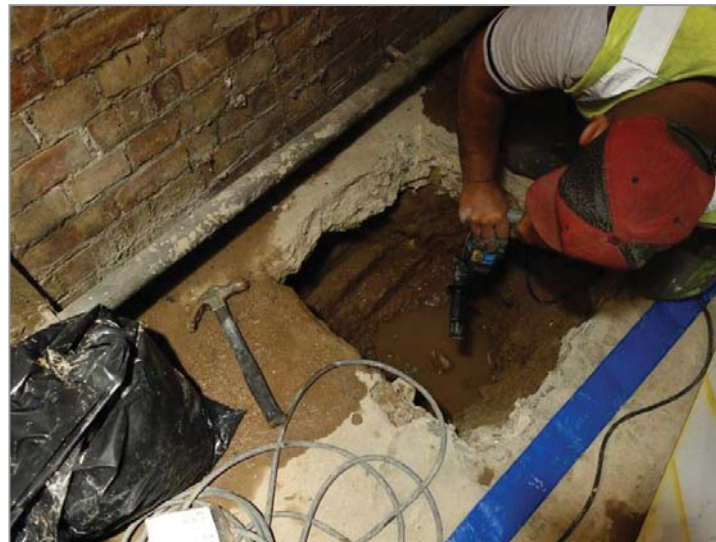
2.1 Trial Pit B1 exposed corbelled brick supported on a 400 mm thick concrete footing.

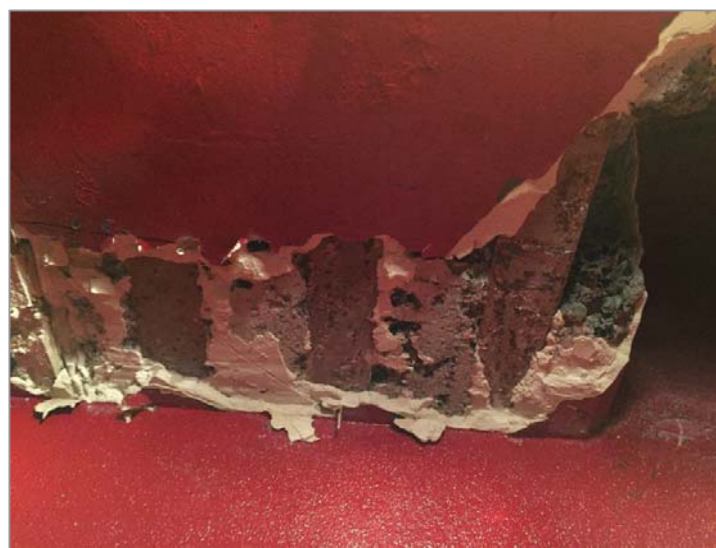
2.2 Investigation location B2 exposed a concrete encased triple steel I beam lintel (basement high level).

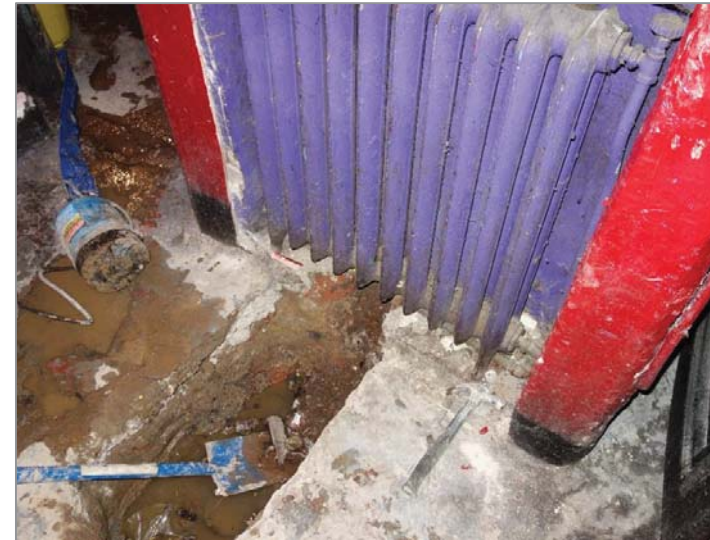
2.3 The existing wall at location B3 was found to have a radiator within the wall thickness. The corbelled brick was inconclusive; however, a concrete footing approximately 300 mm thick was exposed.

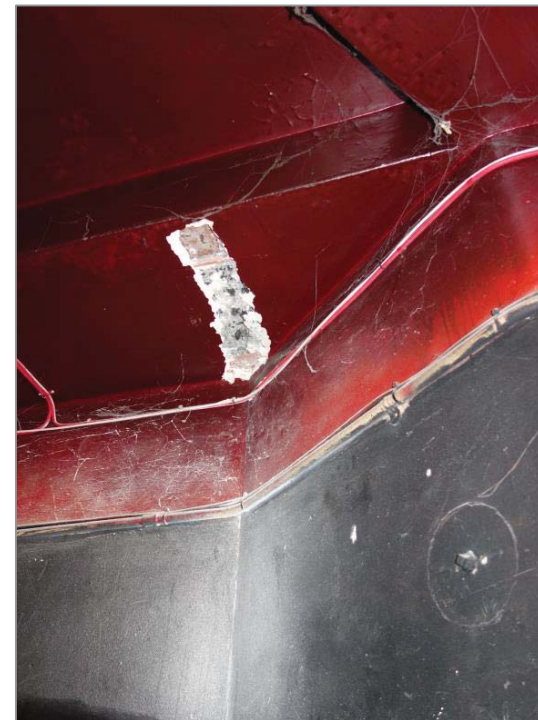
2.4 Investigation location B4 exposed a concrete encased double steel I beam lintel (basement high level).

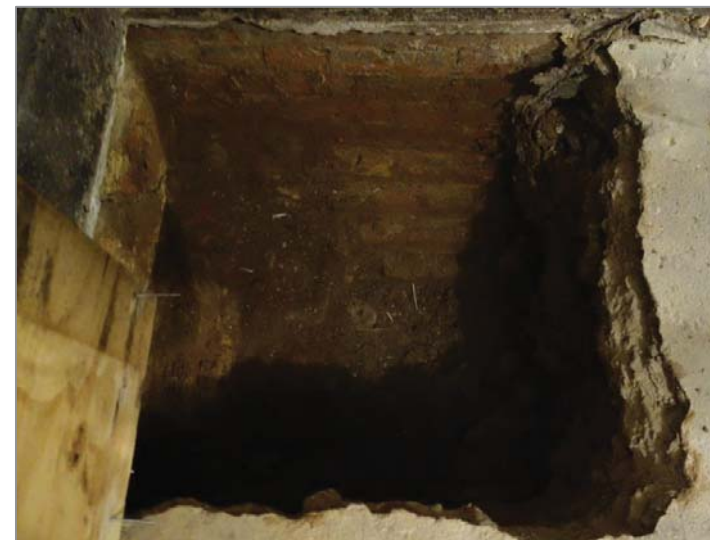
2.5 Trial Pit B5 exposed corbelled brick supported on a 350 - 400 mm thick concrete footing.

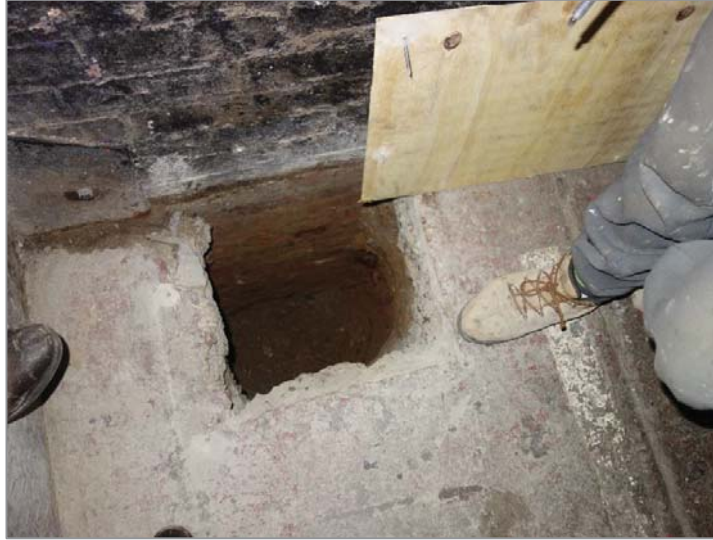
2.7 Trial pit B10 was dug to a depth of 1000 mm without finding corbelled brick or a concrete foundation. It is thought that the wall is likely to be found at the same level as the sub-basement walls.

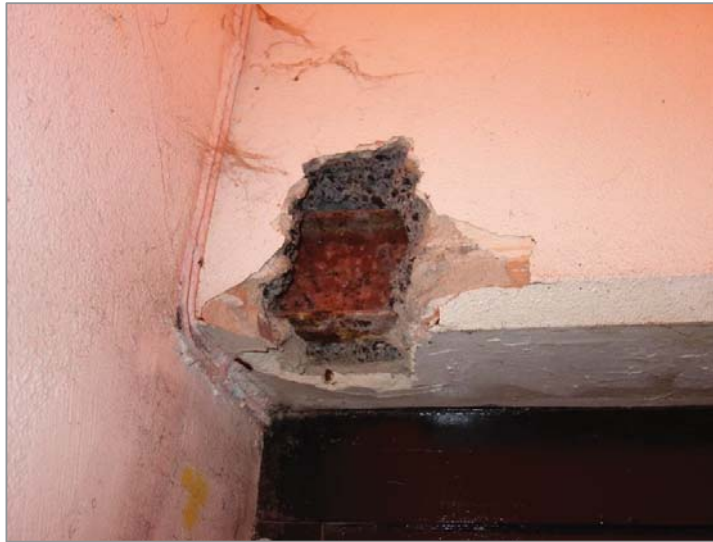
2.8 Investigation location B19 exposed a concrete encased triple steel I beam lintel (basement high level).

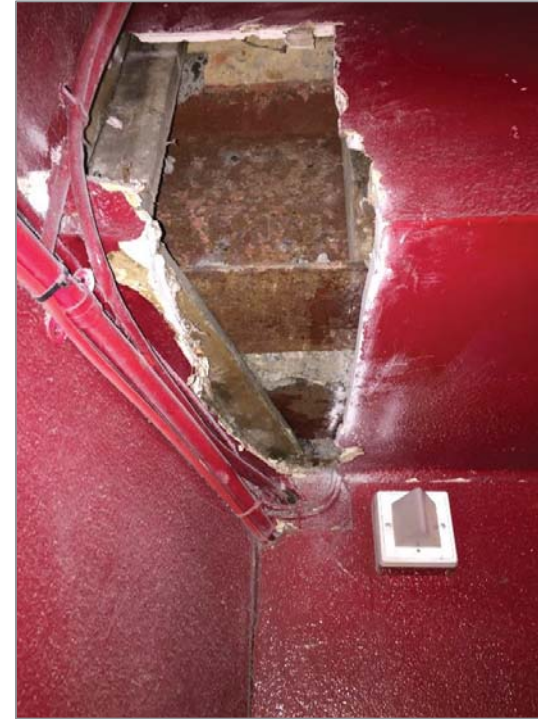
3.1 Investigation location G1 exposed a concrete encased triple steel I beam lintel (ground floor high level).

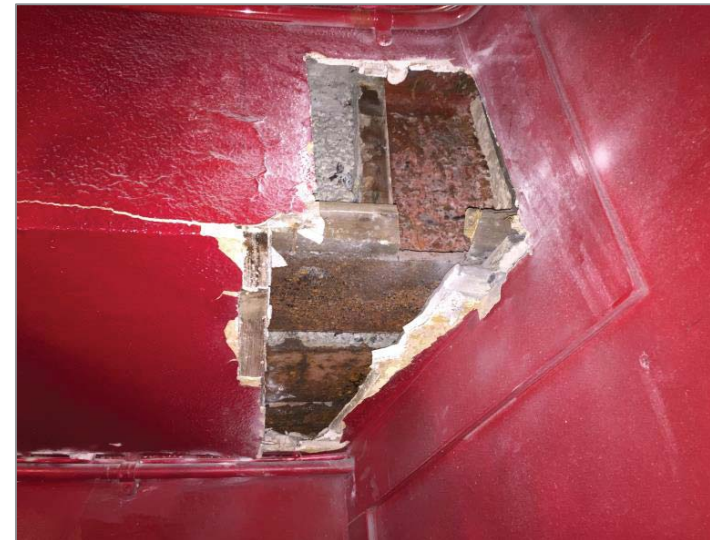
3.3 Investigation location G9 exposed a concrete encased triple steel I beam lintel (ground floor high level).

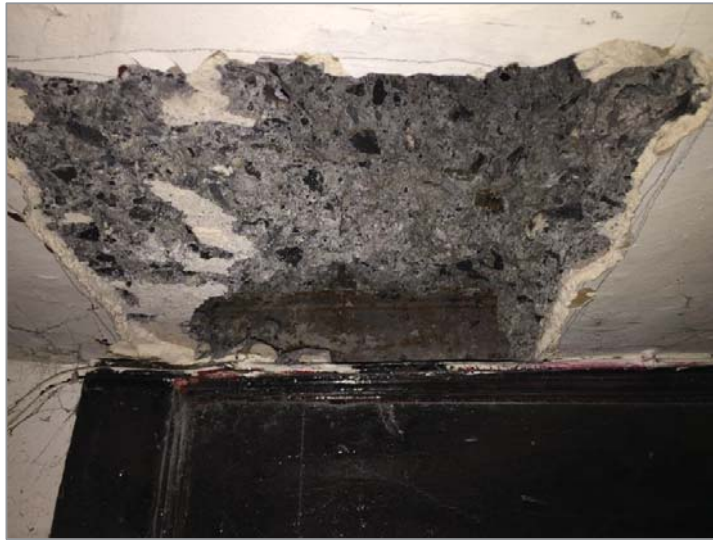
4.1 Investigation location S1 exposed a concrete encased steel I beam lintel (second floor high level).

The steel I section is approximately 100 mm high. Likely section: BSB3 (4x1.75" i.e. 102 x 44 mm).

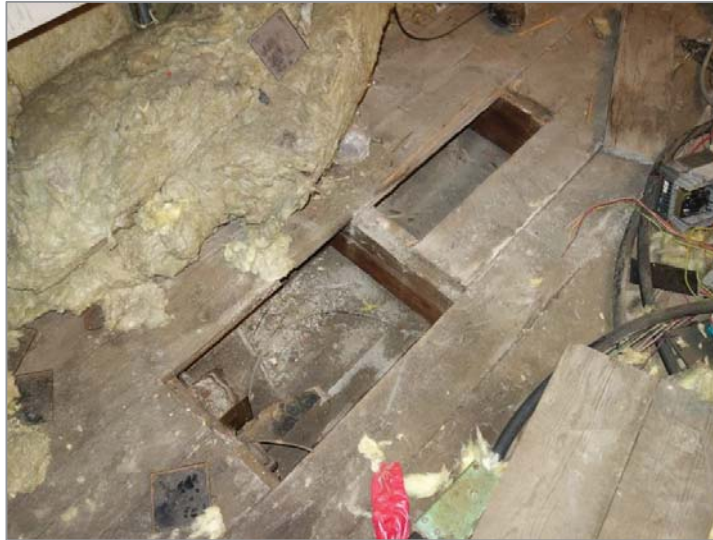
4.2 Investigation location S2 showed approximately 30 mm thick timber tongue and groove boards supported on 180x80 timber joists at approximately 640 mm centres.

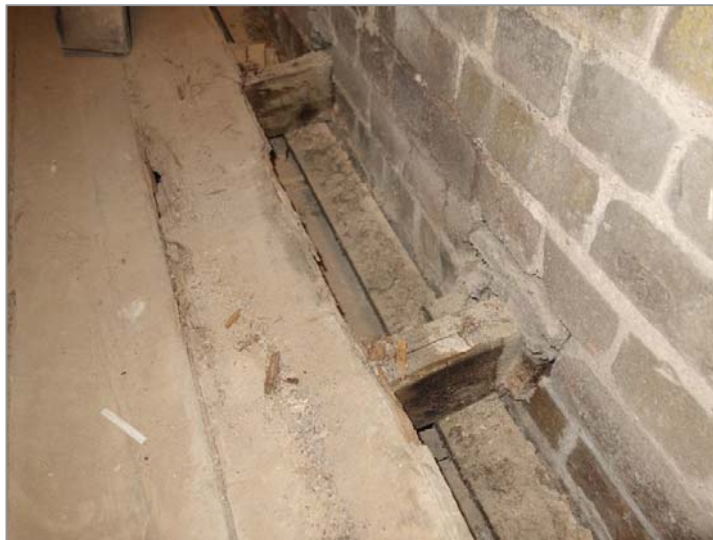
4.3 Investigation location S3 showed the gallery construction to be 30 mm timber boards on 100x50 timber joists at approximately 600 mm centres.

The joists are supported on the existing timber truss and the masonry wall at the rear of the stage. The joists extend approximately 120 mm into the wall and bear directly on the masonry.

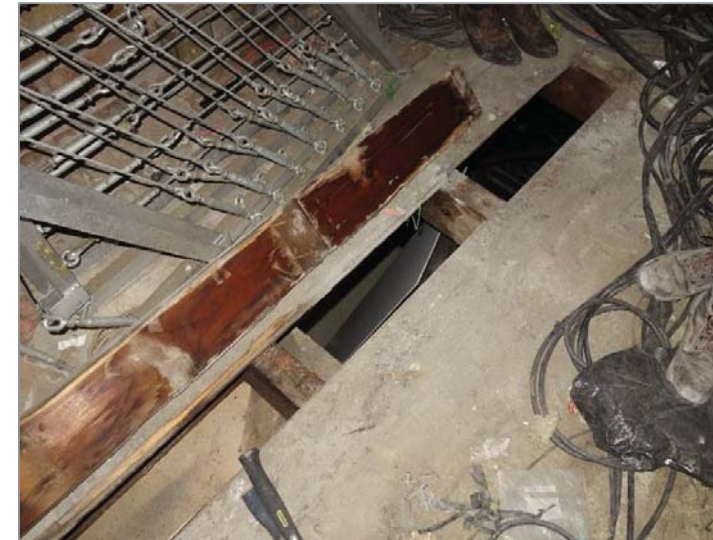
4.4 Investigation location S4 showed approximately 30 mm thick timber tongue and groove boards supported on 180x80 timber joists at approximately 640 mm centres.

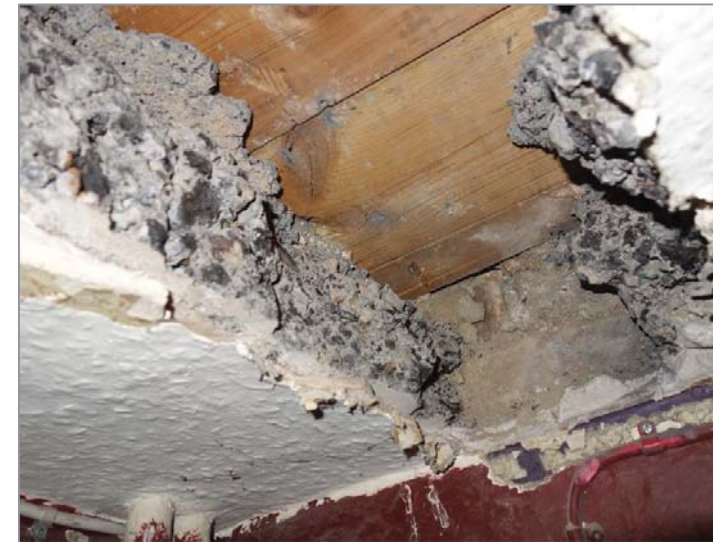
4.5 Investigation location S5 exposed an approximately 115mm thick concrete slab with timber floor boards over.

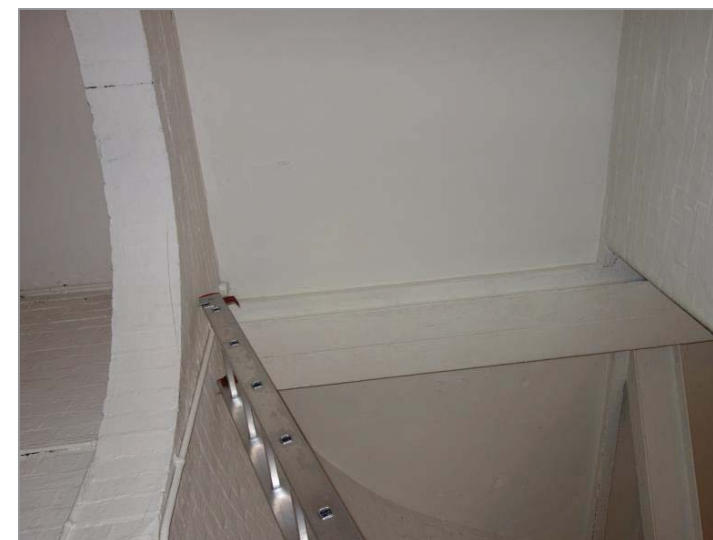
5.1 Access to location T1 confirmed the size of the double steel I beams at high level.

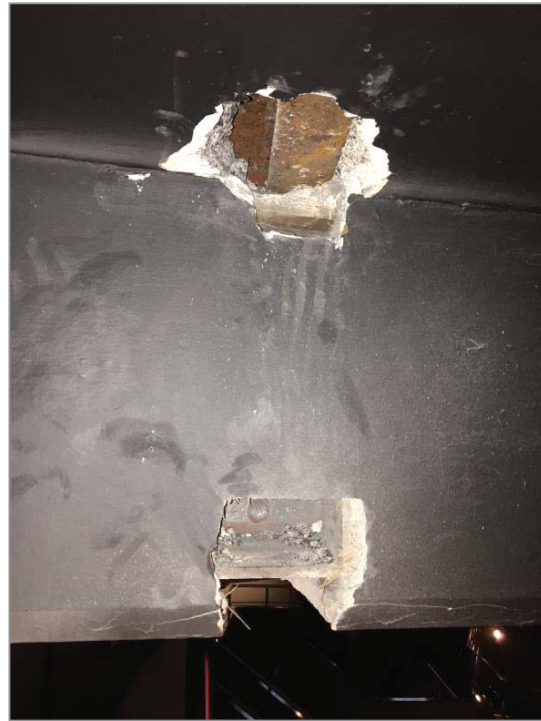
6.1 The finishes were removed at location R1 (third floor high level) to expose a concrete filler joist floor supported by existing steel plate girder beams.

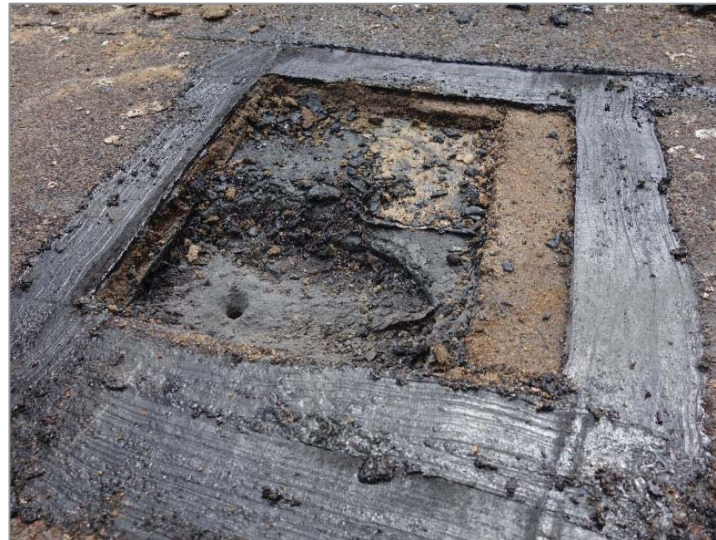
6.2 Investigations were carried out by removing the finishes on the roof at locations R2 – R7. In each case the slab thickness varied between approximately 135 mm and 230 mm.
