BREEAM Ecology Report

KOKO

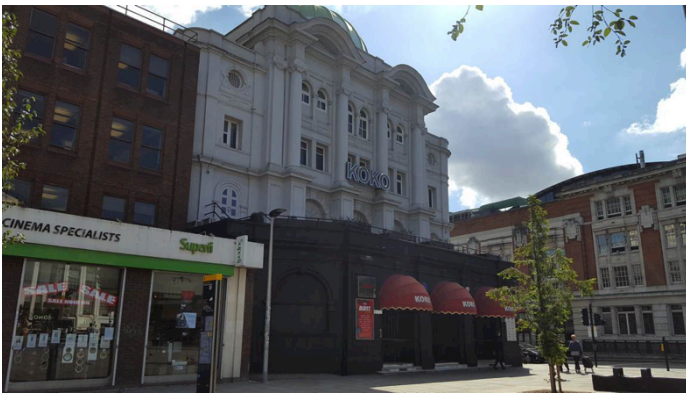
Western façade of the building

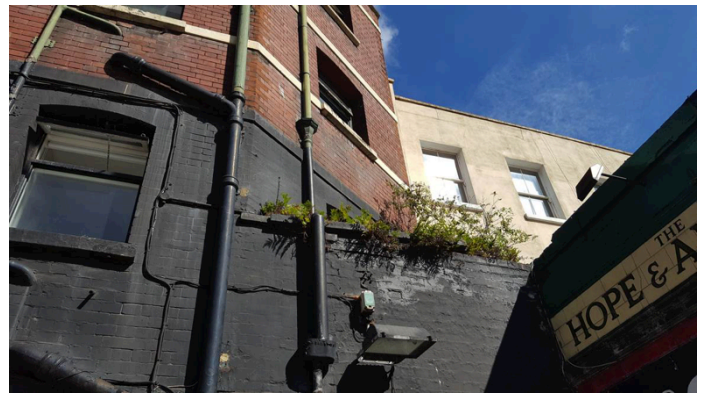
Area of ruderal plants

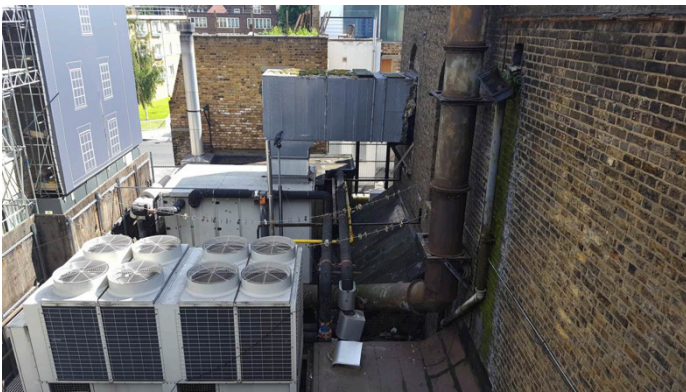
Service pipes with pigeon deterrents

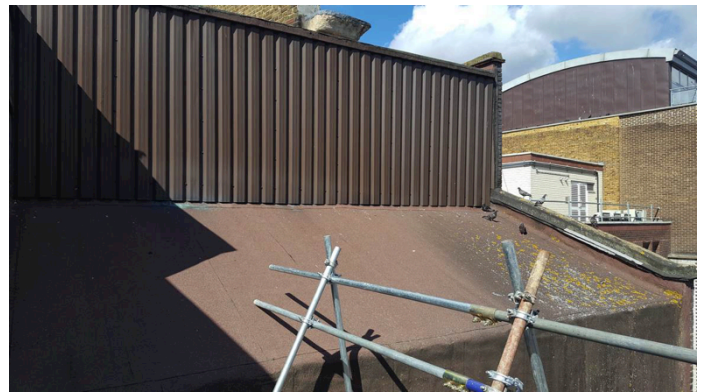
Pigeons on the roof

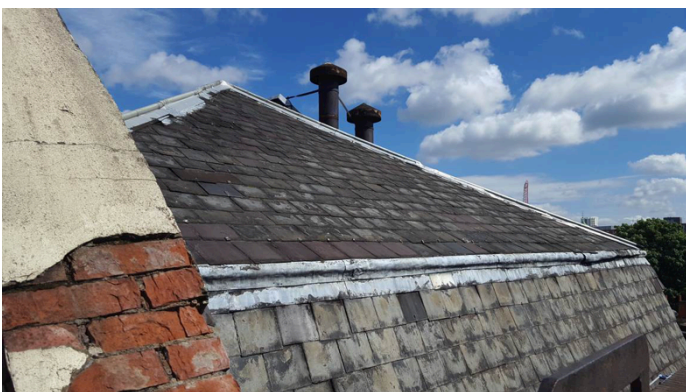
Slate tiled roof in good condition

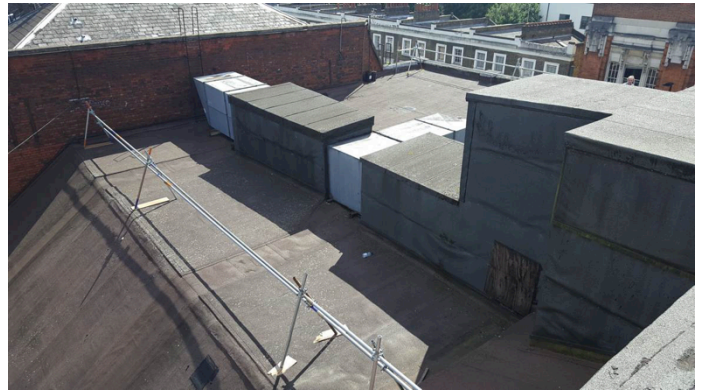
Flat asphalt roof in good condition
