40716-R06/SGG

08<sup>th</sup> June 2017

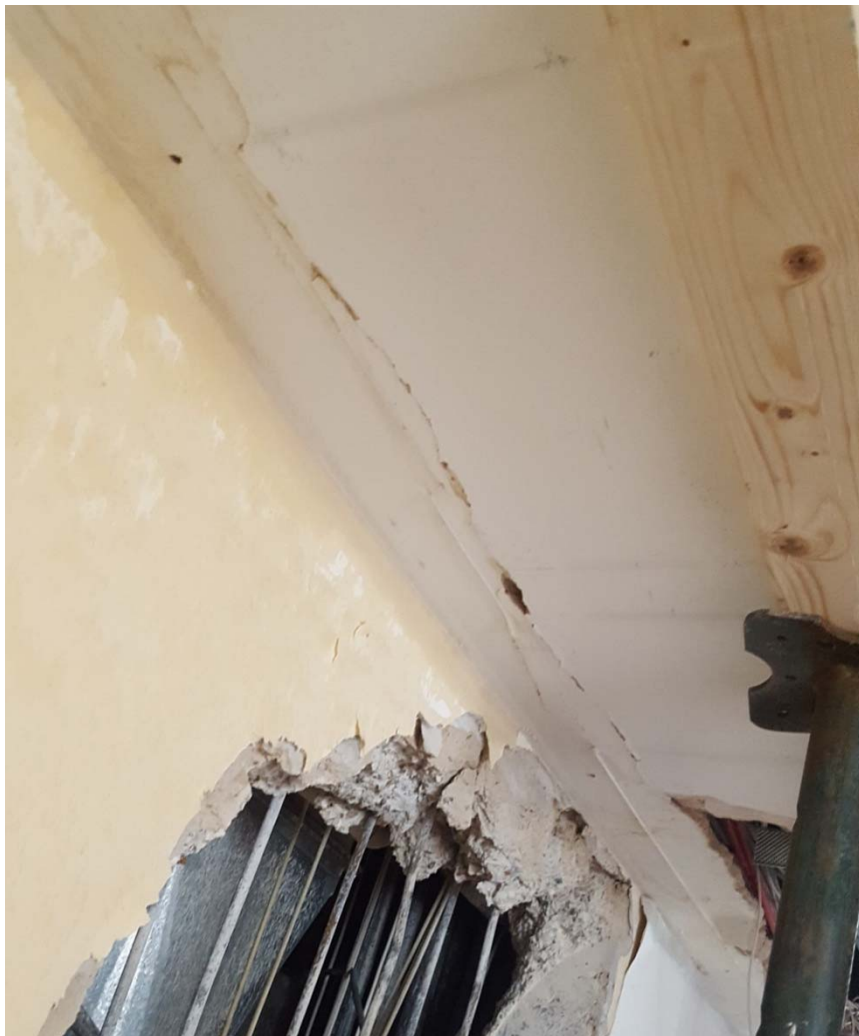
Plate 2 – View onto underside plenum slab showing parallel crack

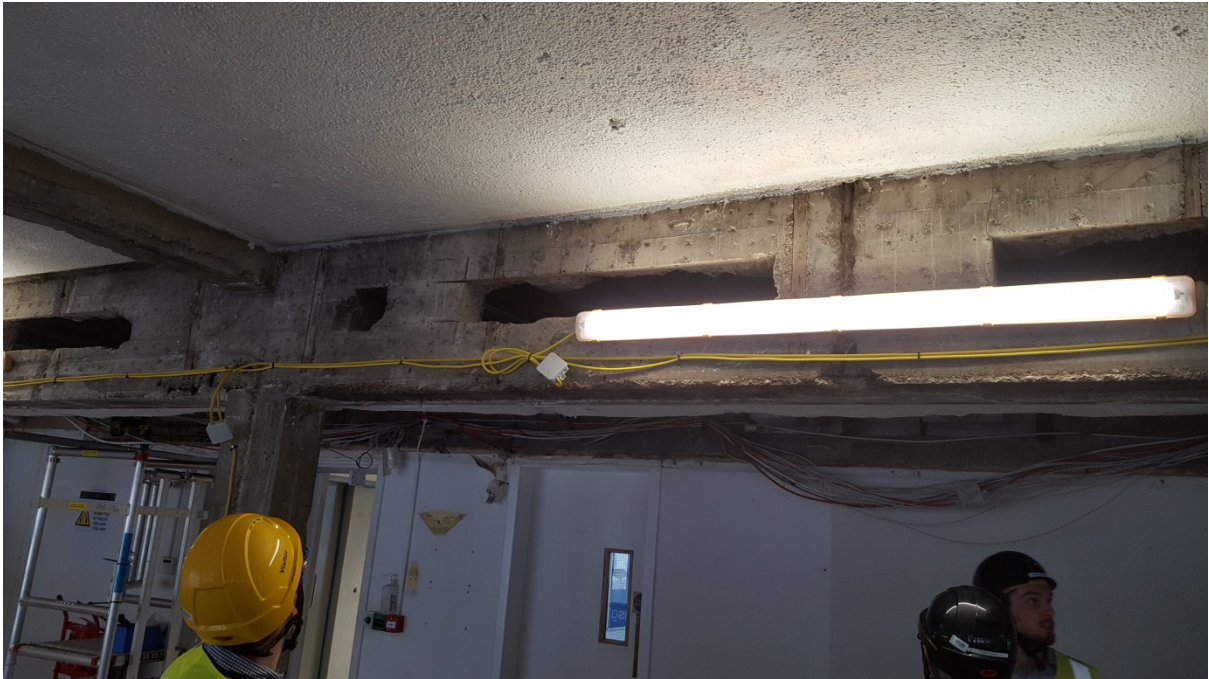
Plate 3 – View onto service holes in down stand beam (1)

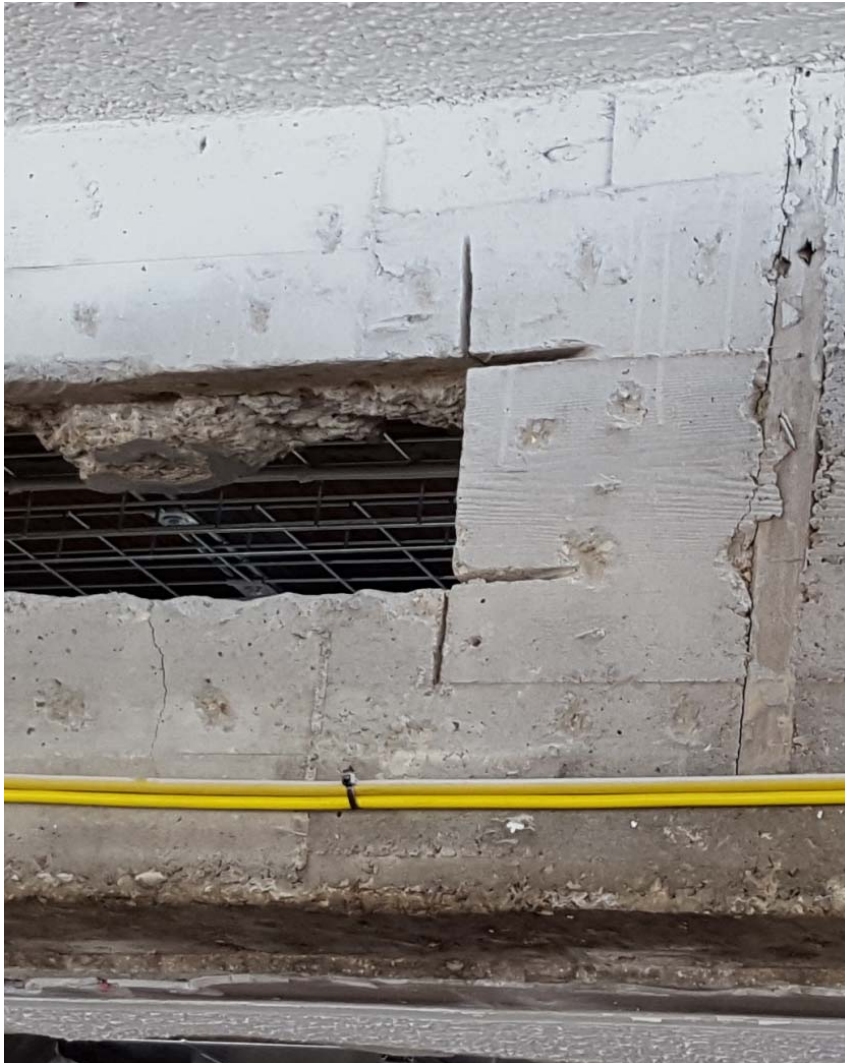
Plate 5 – Typical overcutting of large service hole

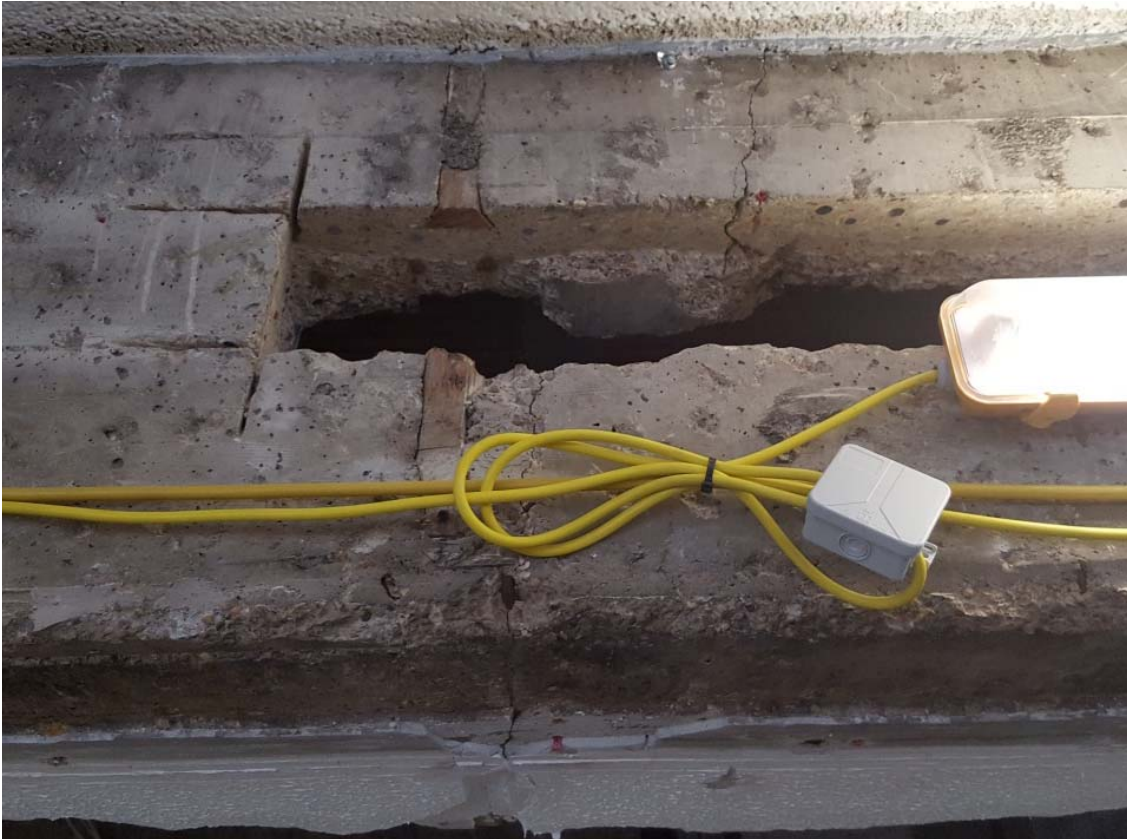
Plate 6 – View onto large service hole depicting vertical cracks in the remaining concrete (1)

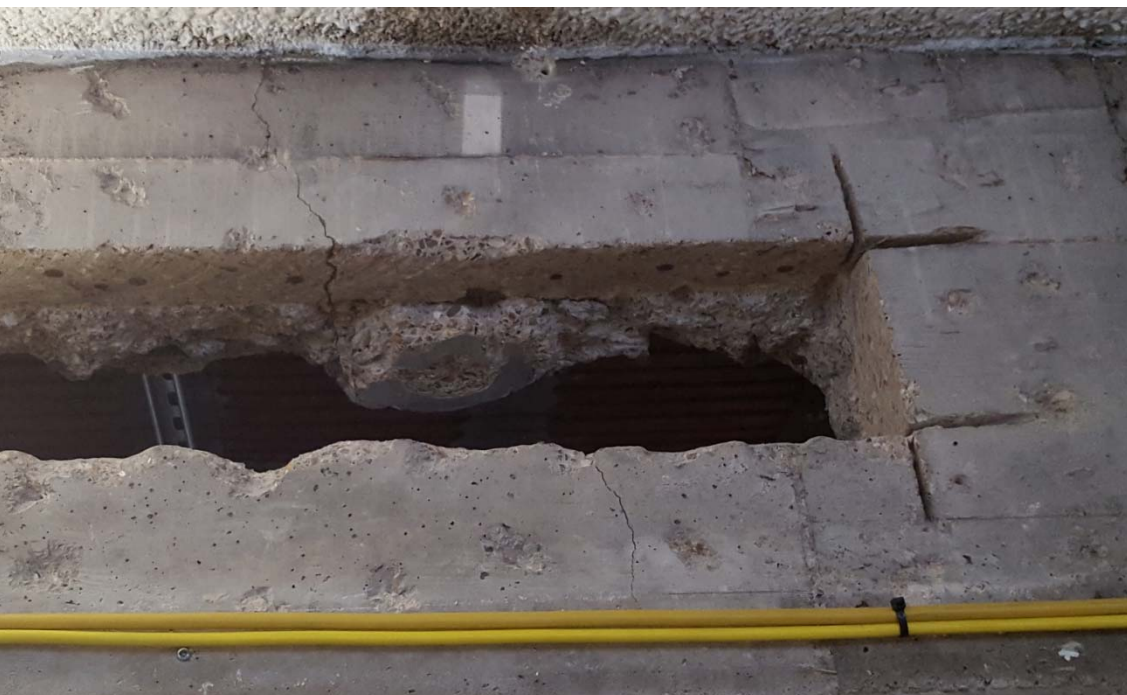
Plate 7 – View onto large service hole depicting vertical cracks in the remaining concrete (2)
