**STRUCTURAL REPORT ON THE CONDITION OF THE EXTERNAL WALLS TO NO.99 CAMDEN
MEWS LONDON NW1 9XA**

3.0 Summary

The inspection was carried out by Michael Eatherley on Tuesday 13 January 2015 accompanied and assisted by Mr Stephen Weiss and Michael Brundle, the Architect.

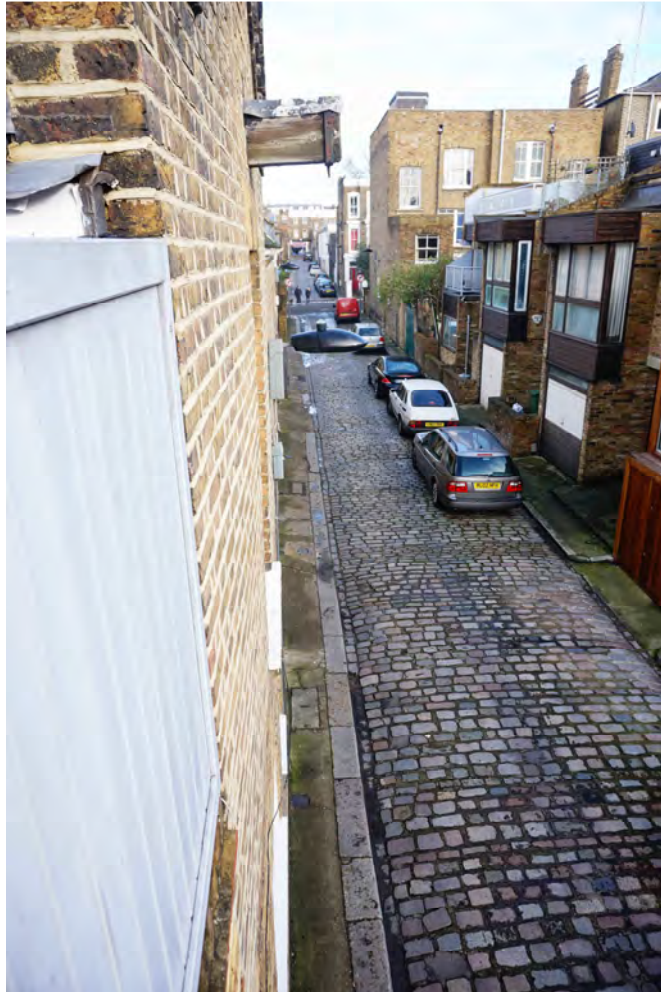
Front elevation showing bowing

The upper part of the wall bows out around the first floor window up to 75mm. Again the wall is in single brick Flemish bond stock in lime mortar, repaired with cement mortar. The construction is currently stable, although there is a risk that the presence of the tall central window and lack of ties to the internal structure could lead to progressive further bowing from the effects of moisture and thermal change. If this wall has to be retained, it would be advisable to consider incorporating ties back to the roof and floors and inside walls. In areas where cement mortar has been introduced, the mortar should be raked out and made good with lime mortar in order to allow more flexibility in adjusting to thermal effects.

The present foundation arrangement is not known, but likely to be similar to the rear wall where the brickwork extends down to a depth of about 750mm bearing onto a clay formation. The proposed new construction behind will have deeper, or possibly piled foundations similar to the adjoining property. If this part of the façade wall has to be preserved, it is advisable that some form of underpinning should be adopted to maintain the integrity of the building.

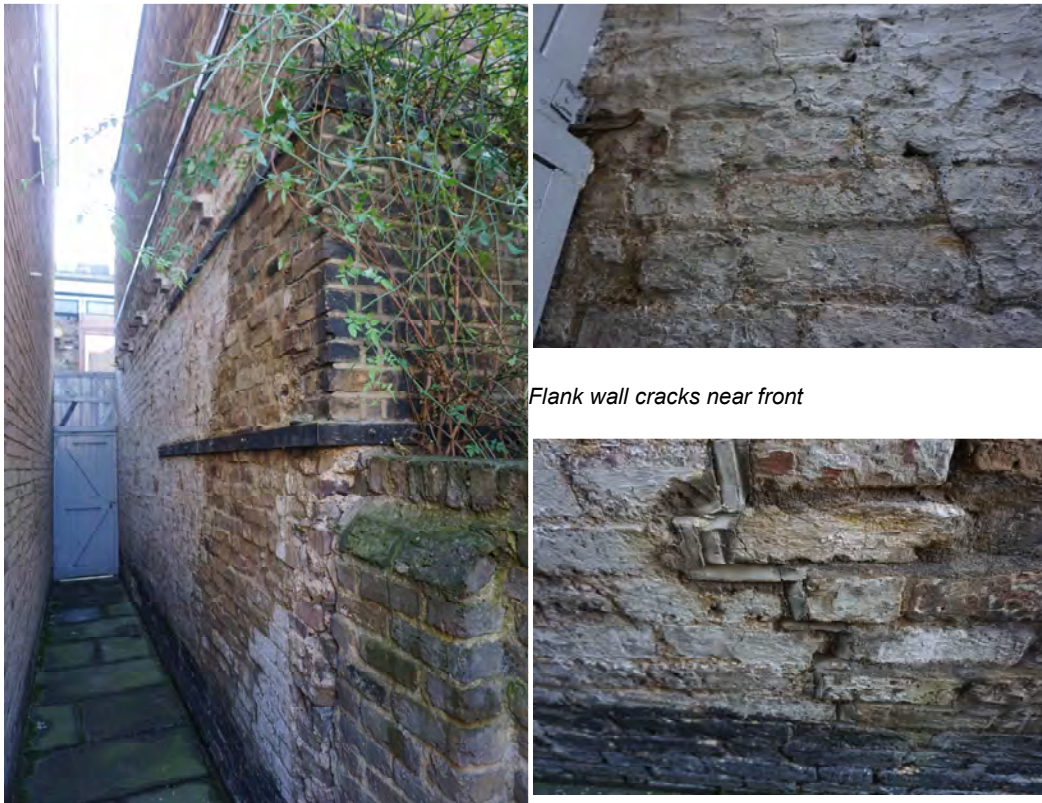
The single stock brick wall in Flemish bond of rather poor quality has been much altered since its original construction. The unstable upper part and a lower area loosened by subsidence at the northeast corner were rebuilt in 2007. The horizontal dividing line between the original wall and the new wall above has a line of flashing covering a step in the brickwork. The step is the result of 60 -70 mm bowing out in the middle of the lower wall and the straight modern part above. External steel ties have been installed at three levels as a means of reinforcing the corner brickwork at the back.

Flank wall cracks near front

Photos from the Party Wall Agreement of 1991 indicate that at some time the front wall continued to the northeast and the presence of corbels at mid height along the flank wall suggest that in the past there must have been a single storey store to the north. The lower part of the wall is very damp that is apparent both outside and inside. The wall has cracks at both ends and poorly repaired in inappropriate cement mortar. The form of the cracks suggests that there may have been slight continuing subsidence since the repairs were carried out.

This wall has large areas of modern intervention and is in poor condition. As it stands it has a limited long term future requiring constant remedial work. In order to provide a “sustainable future”, we consider that, for the proposed redeveloped house, it would be appropriate to demolish the wall, as far as possible saving and cleaning the bricks, and to rebuild on new foundations compatible with the proposed new construction behind. If required, the bricks may be reused and the wall rebuilt with the more accommodating lime mortar.

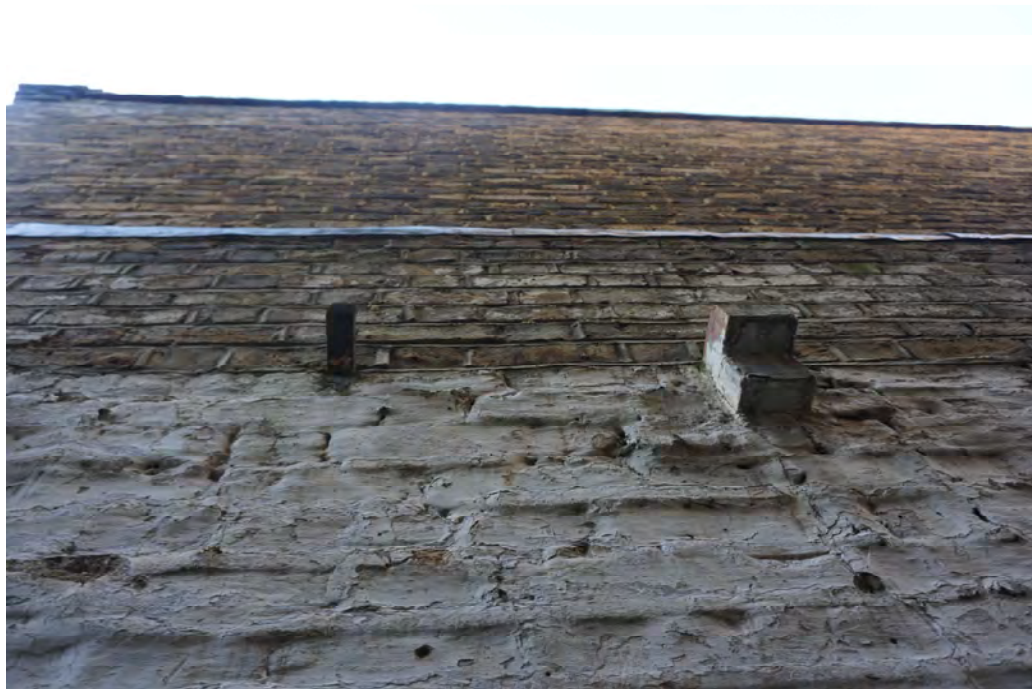
Flank wall showing flashing and old corbels

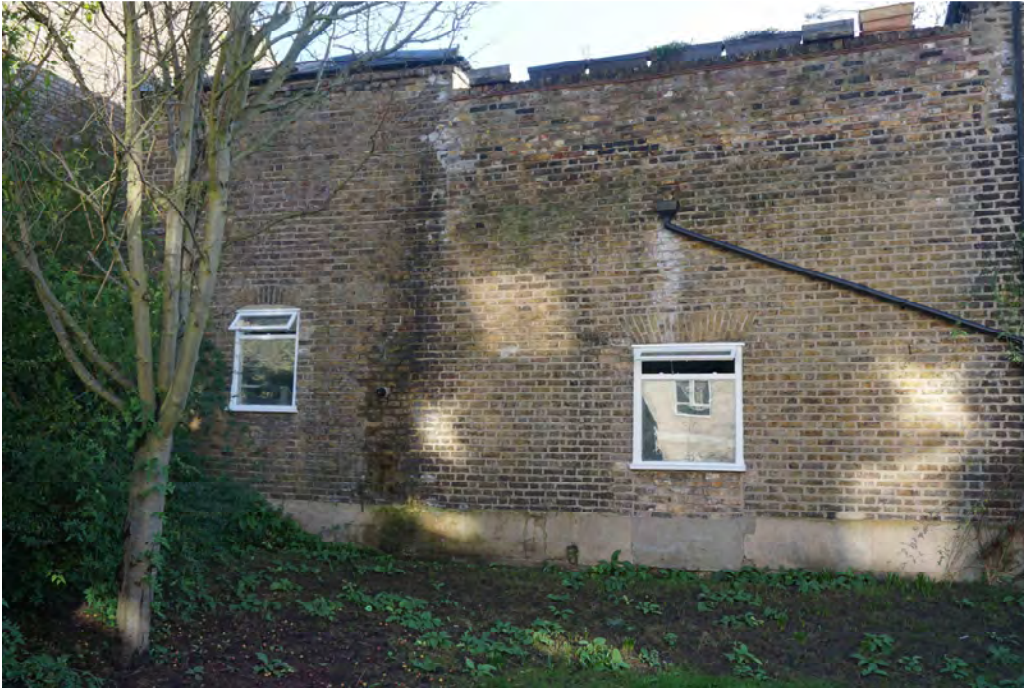
Again the wall is constructed in stock bricks, one brick thick in Flemish bond, with the central upper part extended to form a parapet to the roof terrace. The brickwork is not of good quality and suffers from a bowing out of about 60mm in the middle and also from a noticeably incline in the coursing, no doubt a result of the very soft formation material identified in the soil report. New windows were inserted in 1977.

Rear wall

For the same reasons as the flank wall coupled with the proposed changes in window locations, we consider that it would be inappropriate to retain this wall in the proposed new construction and recommend that it is demolished and rebuilt on appropriate foundations, again re-using the old bricks as may be required.

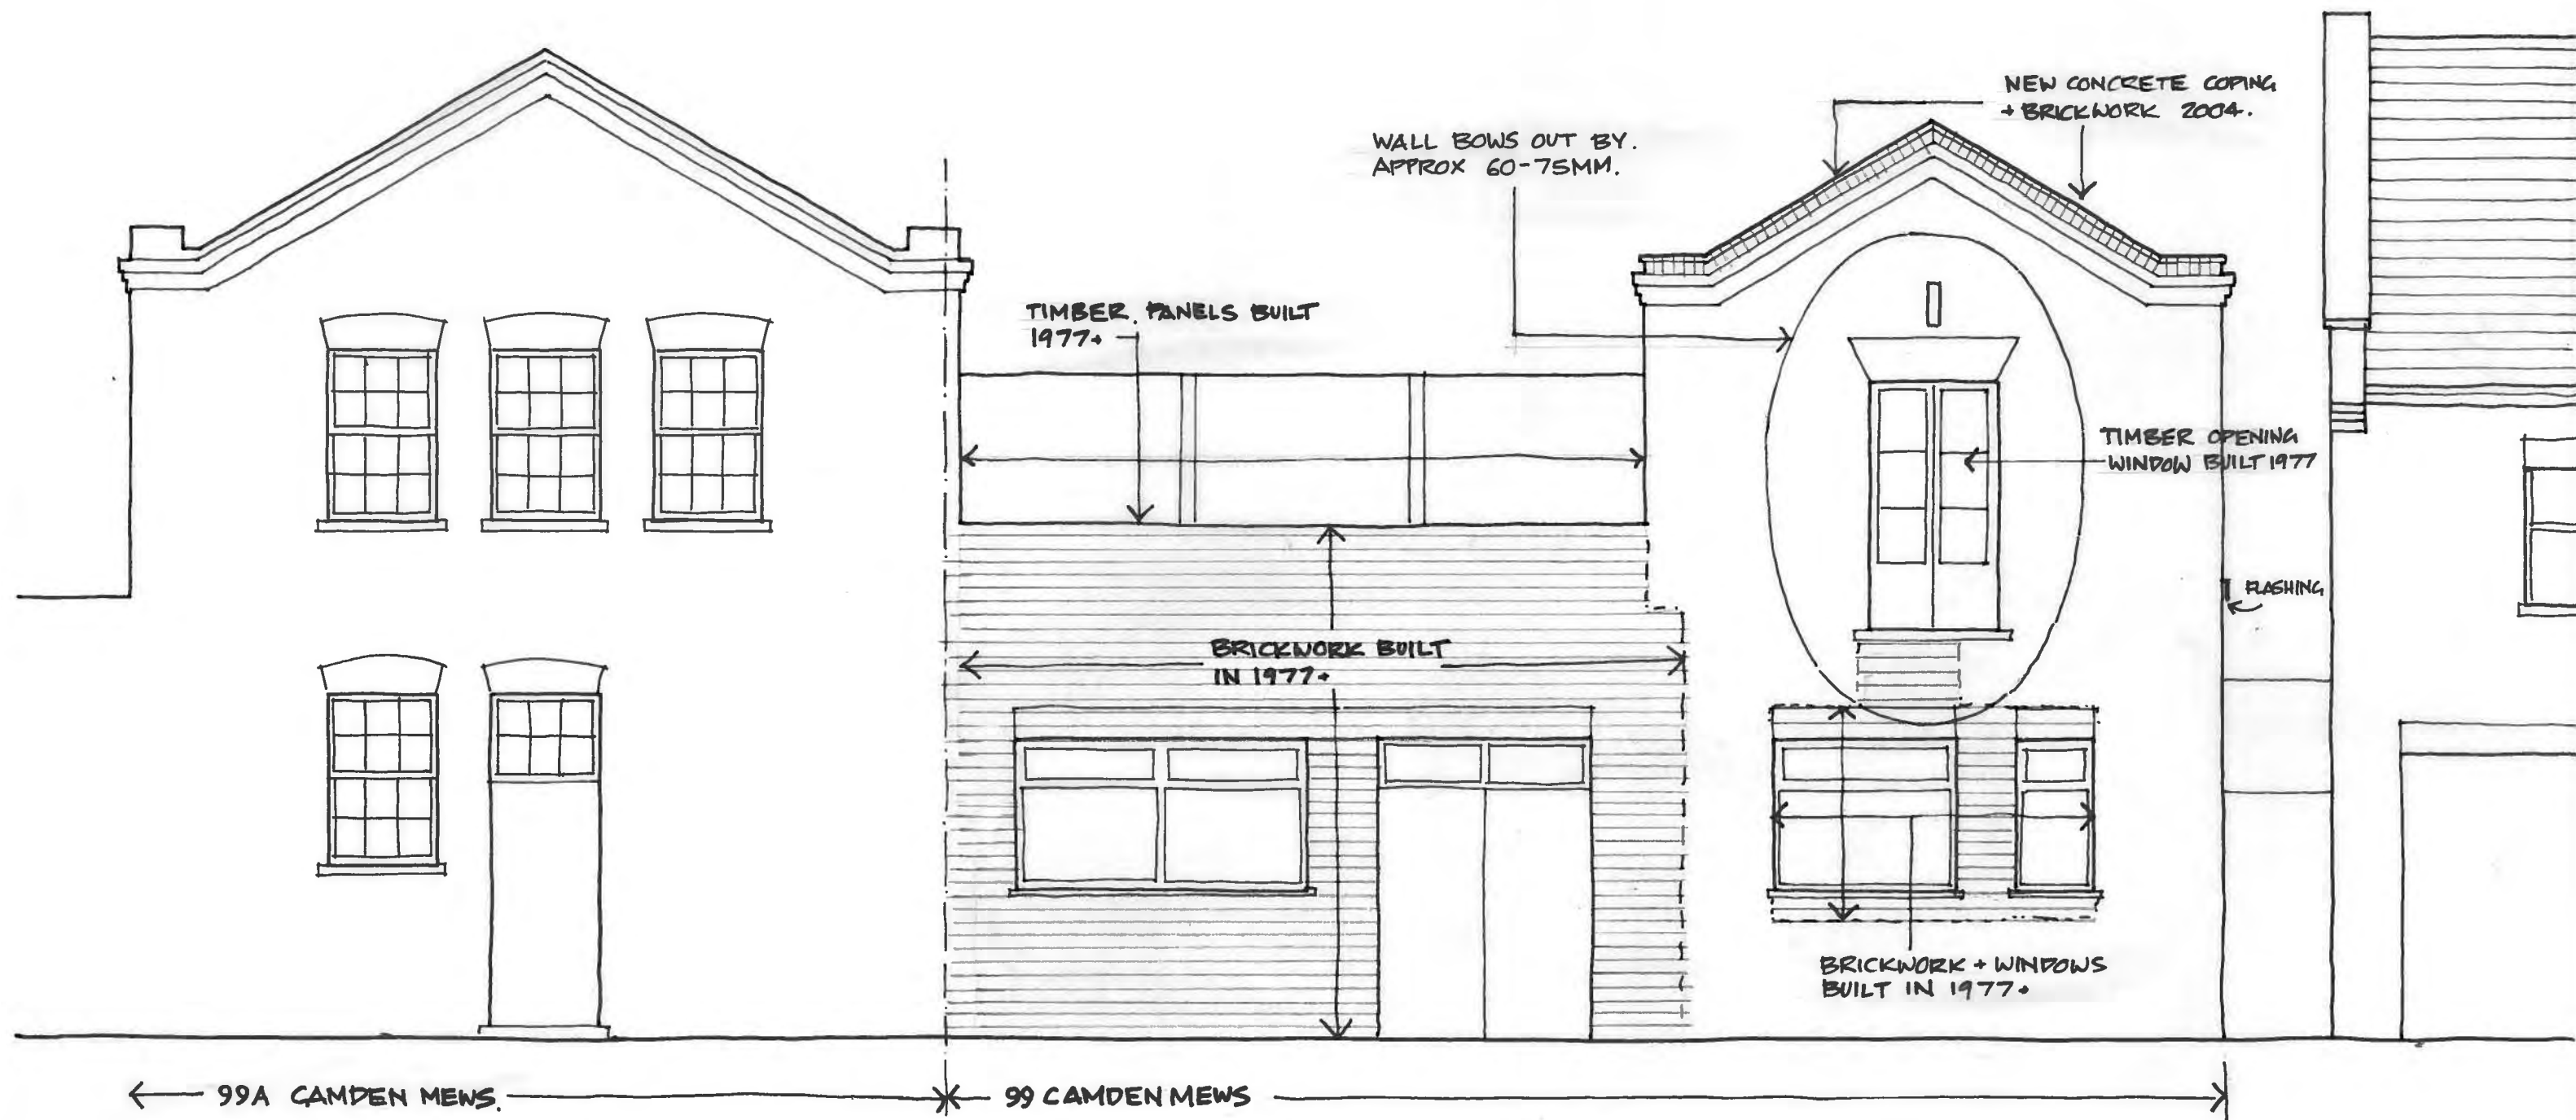
DRWG No W-12-001

The “middle” portion of the wall to the mews elevation of the old courtyard was built in 1977 as a single brick thick intervention in Flemish bond stocks. Although of poor quality, structurally this part currently is reasonably stable. However the design intention is for this part of the façade to be taken down and replaced in a rather more sympathetic manner as shown on the Architect’s proposals.

The gabled elevation to the mews is predominantly original, although compromised by the insertion of the two ground floor windows and possibly by an enlargement of the first floor window. The top courses of brickwork on the gable are much degraded and in order to prevent water penetration, in 2007, the gable was capped with modern cement coping stones.
