## Asbestos Refurbishment/Demolition Survey for

The Honourable Society Of Gray's Inn

Grays Inn Chambers  
19/20 High Holborn  
London, WC1V 6BS  
(Rymans)

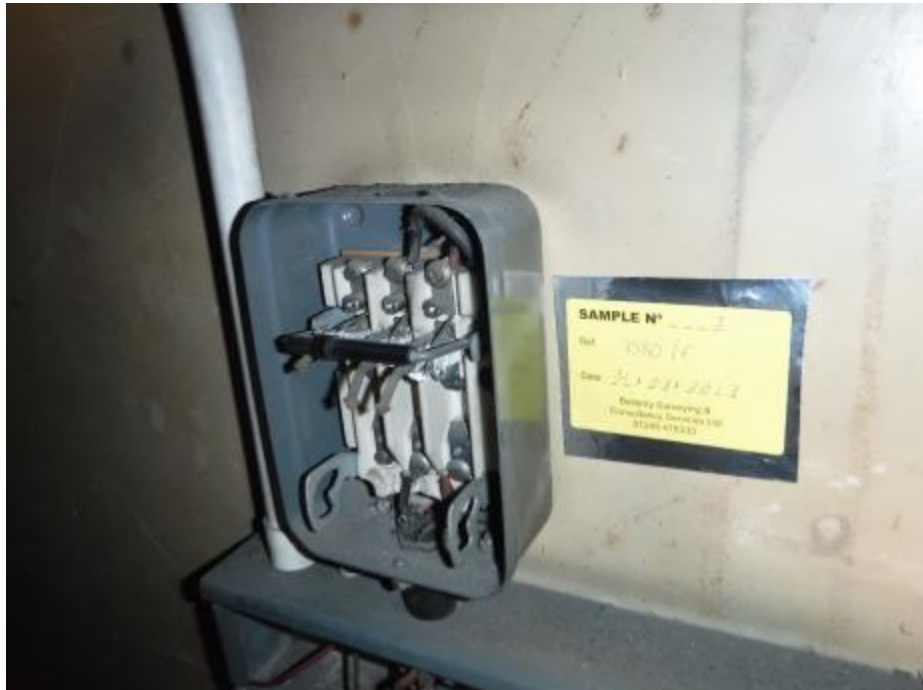
Location ID:	41271	Survey Type:	RDS
Location Ref:	Sample 1	Product Type:	Asbestos paper and felt
Product:	Paper / Card	Damage:	Medium damage
Area:	19/20 High Holborn	Treatment:	Unsealed laggings and sprays
Floor:	Mezzanine	Asbestos Type:	Chrysotile
Room:	A/C Room	Identification:	Identified
Surveyor Name:	Jack Stringer	Quantity:	Representative Paper/Card To Electrcis Sample
Drawing Ref:			
Asbestos ?	Yes		
Date:	31 July 2017		
Next Inspection:	29 October 2017

Material Risk Score:	8
Material Risk Band:	Medium Risk
Priority Risk Score:	N/A

Material Comments: A sample of paper/card to electrical box was removed for laboratory bulk sampling analysis from the a/c room at mezzanine level.

Action: **Removal By Licensed Contractors**

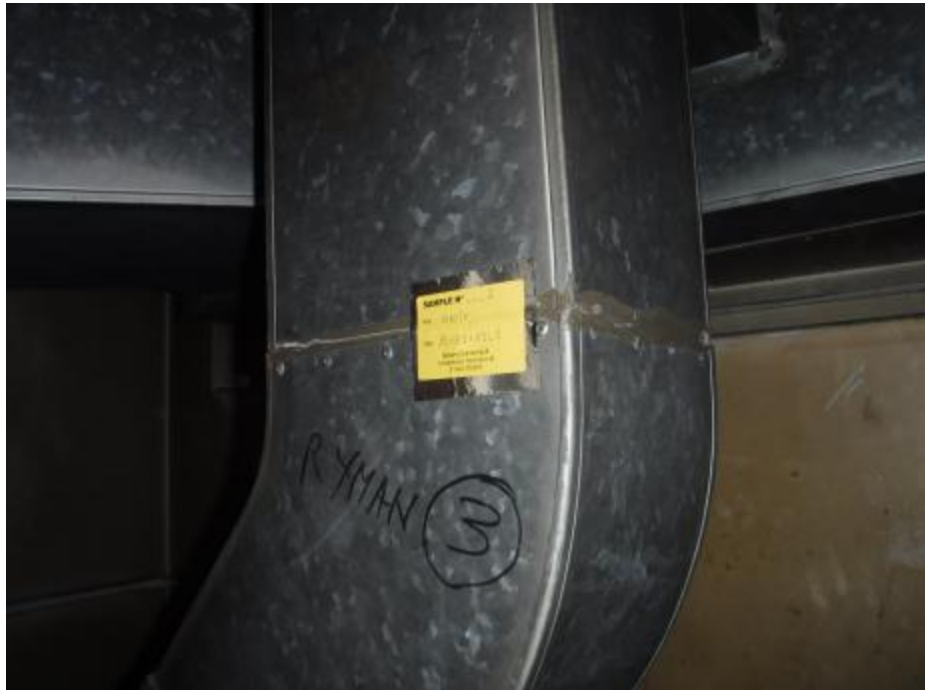
Location ID:	41272	Survey Type:	RDS
Location Ref:	Sample 2	Product Type:	NADIS
Product:	Mastic	Damage:	NADIS
Area:	19/20 High Holborn	Treatment:	NADIS
Floor:	Mezzanine	Asbestos Type:	NADIS
Room:	A/C Room	Identification:	Identified
Surveyor Name:	Jack Stringer	Quantity:	Representative Mastic Sample
Drawing Ref:			
Asbestos ?	No		
Date:	31 July 2017		
Next Inspection:	Not Applicable

Material Comments: A sample of mastic to ducting was removed for laboratory bulk sampling analysis from the a/c room at mezzanine level. NOTE - Mastic to ducting was noted throughout.

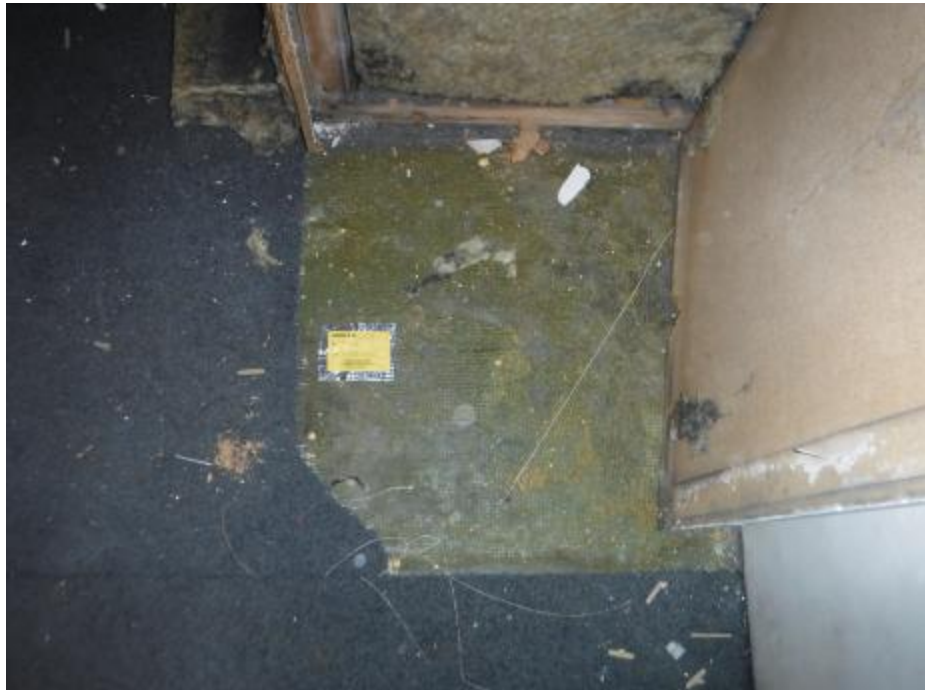
Location ID:	41273	Survey Type:	RDS
Location Ref:	Sample 3	Product Type:	NADIS
Product:	Lino	Damage:	NADIS
Area:	19/20 High Holborn	Treatment:	NADIS
Floor:	Mezzanine	Asbestos Type:	NADIS
Room:	A/C Room	Identification:	Identified
Surveyor Name:	Jack Stringer	Quantity:	Approx 150m <sup>2</sup>
Drawing Ref:			
Asbestos ?	No		
Date:	31 July 2017		
Next Inspection:	Not Applicable

Material Comments: A sample of lino to floor (green) was removed for laboratory bulk sampling analysis from the a/c room at mezzanine level. Note - Noted as underlay to hall & retail, see samples 10 & 11.

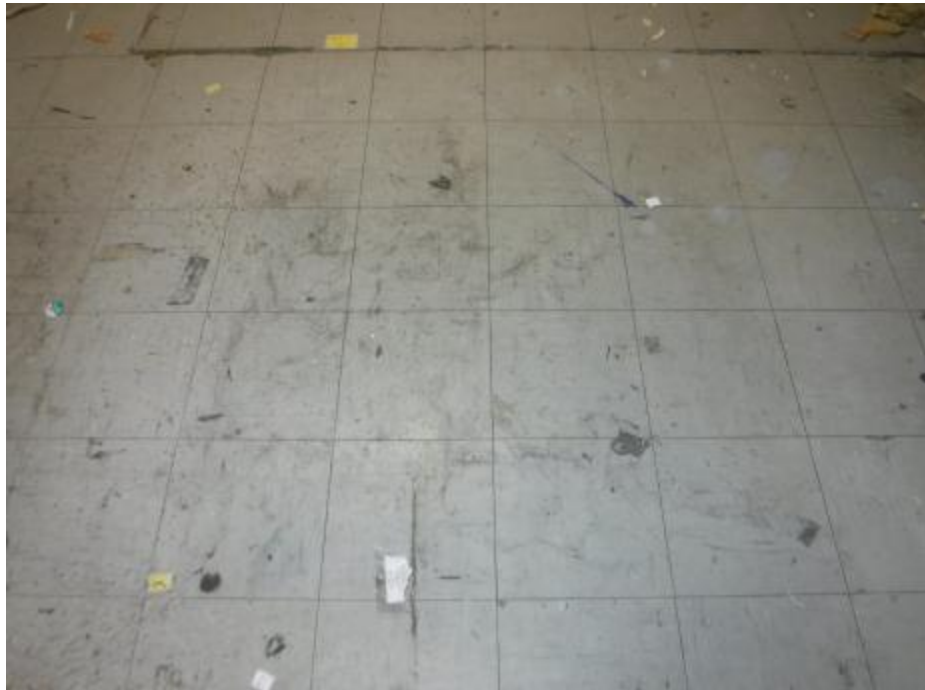
Location ID:	41274	Survey Type:	RDS
Location Ref:	Sample 4	Product Type:	NADIS
Product:	Floor tile	Damage:	NADIS
Area:	19/20 High Holborn	Treatment:	NADIS
Floor:	Mezzanine	Asbestos Type:	NADIS
Room:	A/C Room	Identification:	Identified
Surveyor Name:	Jack Stringer	Quantity:	Approx 25m <sup>2</sup>
Drawing Ref:			
Asbestos ?	No		
Date:	31 July 2017		
Next Inspection:	Not Applicable

Material Comments: A sample of floor tile (light grey) was removed for laboratory bulk sampling analysis from the a/c room at mezzanine level.

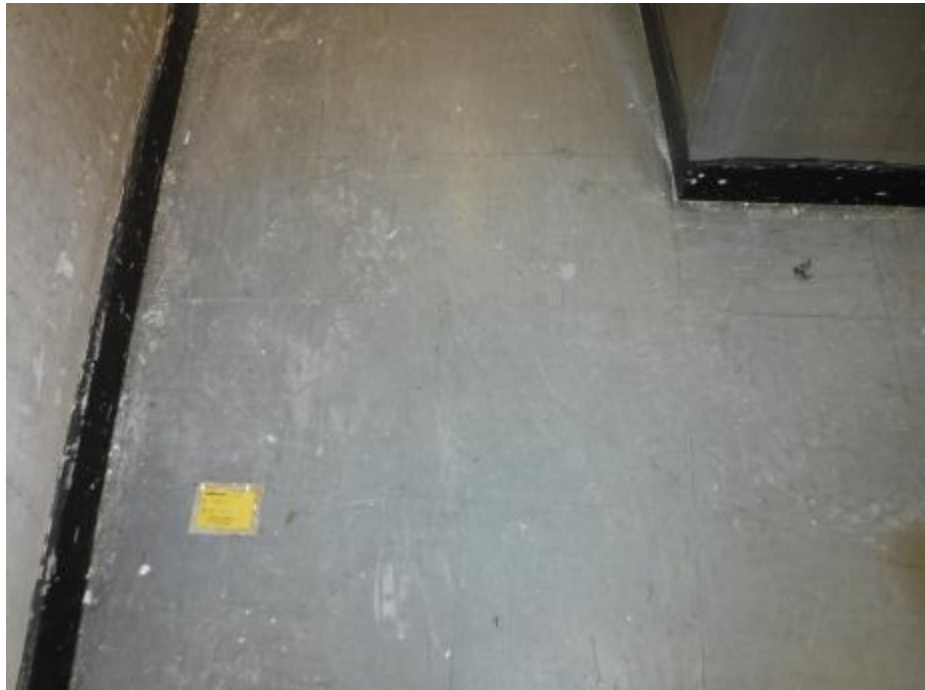
Location ID:	41275	Survey Type:	RDS
Location Ref:	Sample 5	Product Type:	NADIS
Product:	Floor tile	Damage:	NADIS
Area:	19/20 High Holborn	Treatment:	NADIS
Floor:	Ground floor	Asbestos Type:	NADIS
Room:	Corridor	Identification:	Identified
Surveyor Name:	Jack Stringer	Quantity:	Approx 25m <sup>2</sup>
Drawing Ref:			
Asbestos ?	No		
Date:	31 July 2017		
Next Inspection:	Not Applicable

Material Comments: A sample of floor tile was removed for laboratory bulk sampling analysis from the corridor at ground floor level.

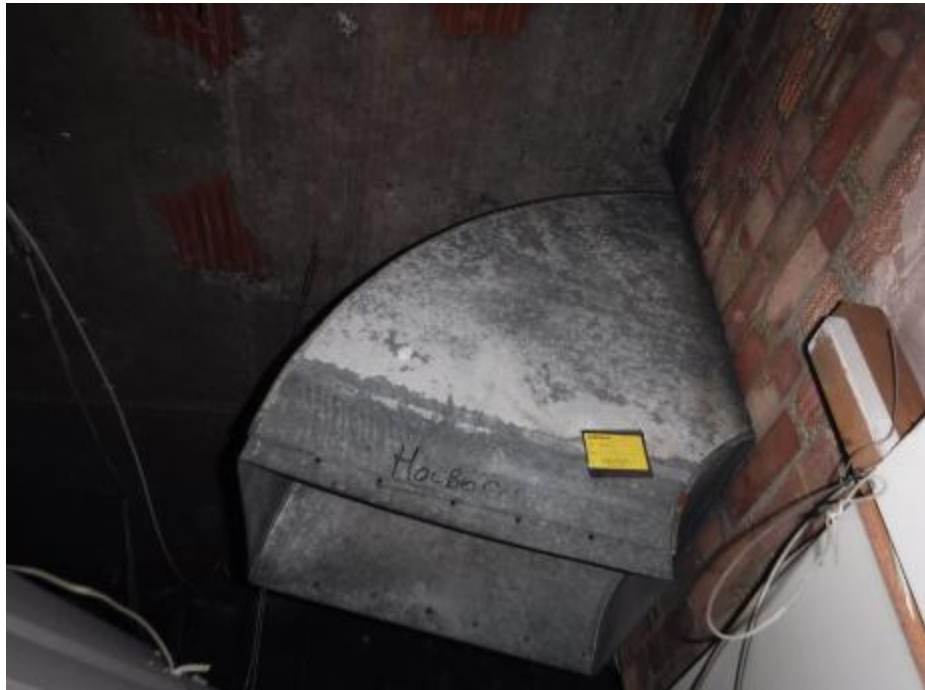
Location ID:	41276	Survey Type:	RDS
Location Ref:	Sample 6	Product Type:	NADIS
Product:	Residue	Damage:	NADIS
Area:	19/20 High Holborn	Treatment:	NADIS
Floor:	Ground floor	Asbestos Type:	NADIS
Room:	Retail	Identification:	Identified
Surveyor Name:	Jack Stringer	Quantity:	Representative Residue Sample
Drawing Ref:			
Asbestos ?	No		
Date:	31 July 2017		
Next Inspection:	Not Applicable

Material Comments: A sample of residue to ducting was removed for laboratory bulk sampling analysis from the retail ceiling void at ground floor level.

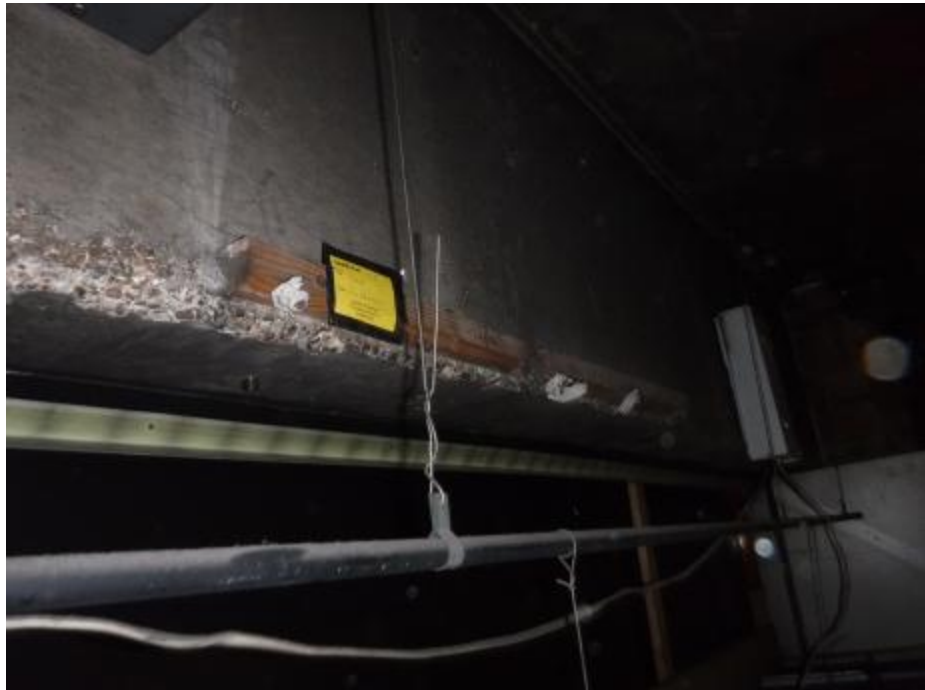
Location ID:	41279	Survey Type:	RDS
Location Ref:	Sample 7	Product Type:	NADIS
Product:	Board	Damage:	NADIS
Area:	19/20 High Holborn	Treatment:	NADIS
Floor:	Ground floor	Asbestos Type:	NADIS
Room:	Retail	Identification:	Identified
Surveyor Name:	Jack Stringer	Quantity:	Representative Board Residue Sample
Drawing Ref:			
Asbestos ?	No		
Date:	31 July 2017		
Next Inspection:	Not Applicable

Material Comments: A sample of board residue to studwork was removed for laboratory bulk sampling analysis from the retail ceiling void (adj shopfront) at ground floor level.

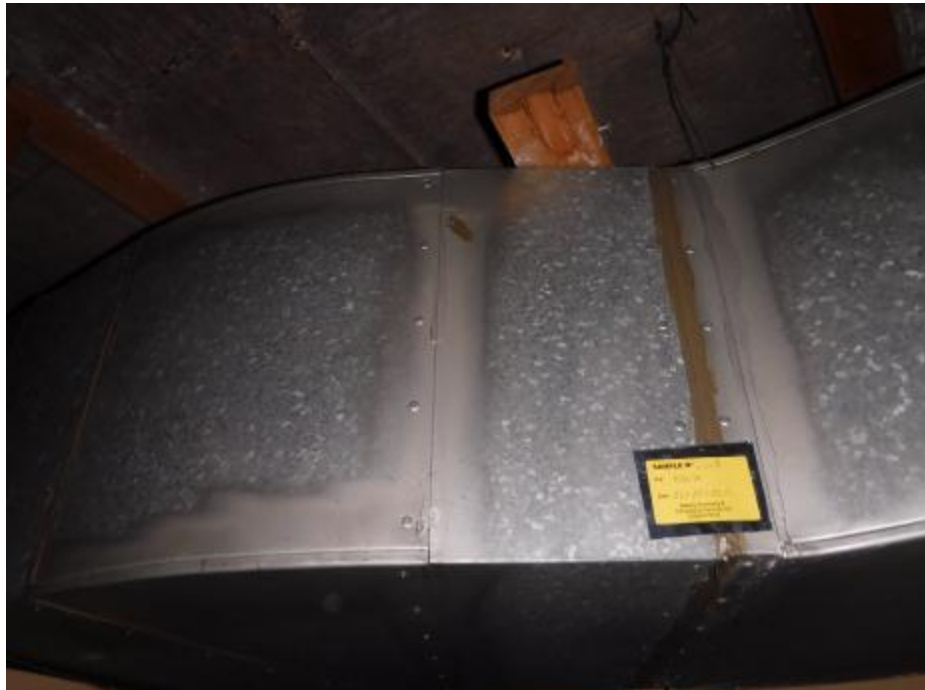
Location ID:	41281	Survey Type:	RDS
Location Ref:	Sample 8	Product Type:	NADIS
Product:	Mastic	Damage:	NADIS
Area:	19/20 High Holborn	Treatment:	NADIS
Floor:	Ground floor	Asbestos Type:	NADIS
Room:	Retail	Identification:	Identified
Surveyor Name:	Jack Stringer	Quantity:	Representative Mastic Sample
Drawing Ref:			
Asbestos ?	No		
Date:	31 July 2017		
Next Inspection:	Not Applicable

Material Comments: A sample of mastic to ducting was removed for laboratory bulk sampling analysis from the retail ceiling void at ground floor level.

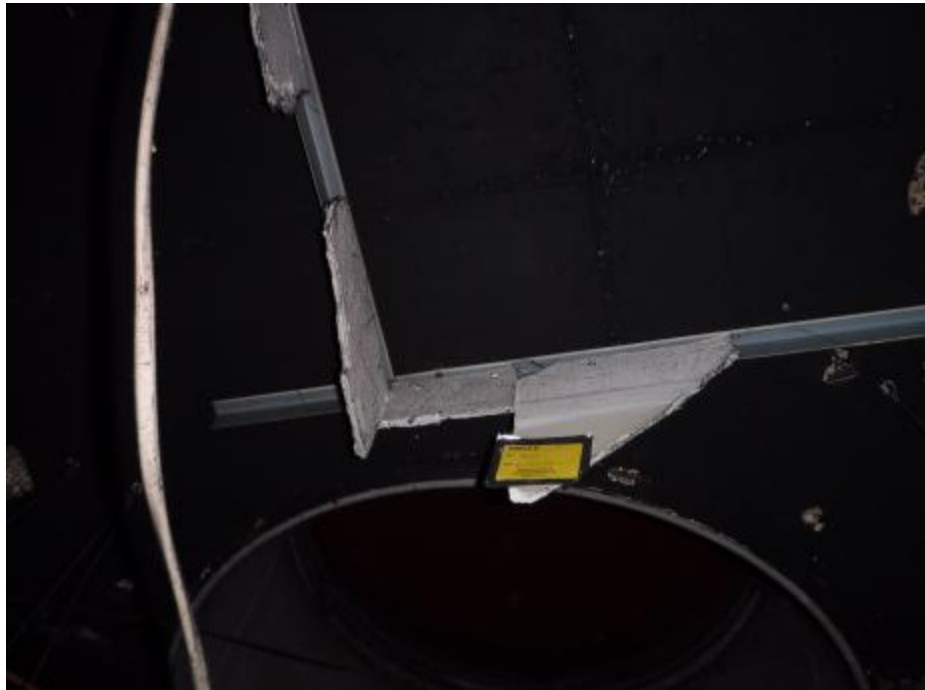
Location ID:	41283	Survey Type:	RDS
Location Ref:	Sample 9	Product Type:	NADIS
Product:	Board	Damage:	NADIS
Area:	19/20 High Holborn	Treatment:	NADIS
Floor:	Ground floor	Asbestos Type:	NADIS
Room:	Retail	Identification:	Identified
Surveyor Name:	Jack Stringer	Quantity:	Representative Board Residue Sample
Drawing Ref:			
Asbestos ?	No		
Date:	31 July 2017		
Next Inspection:	Not Applicable

Material Comments: A sample of board residue/debris to metal gridwork was removed for laboratory bulk sampling analysis from the retail ceiling void at ground floor level.

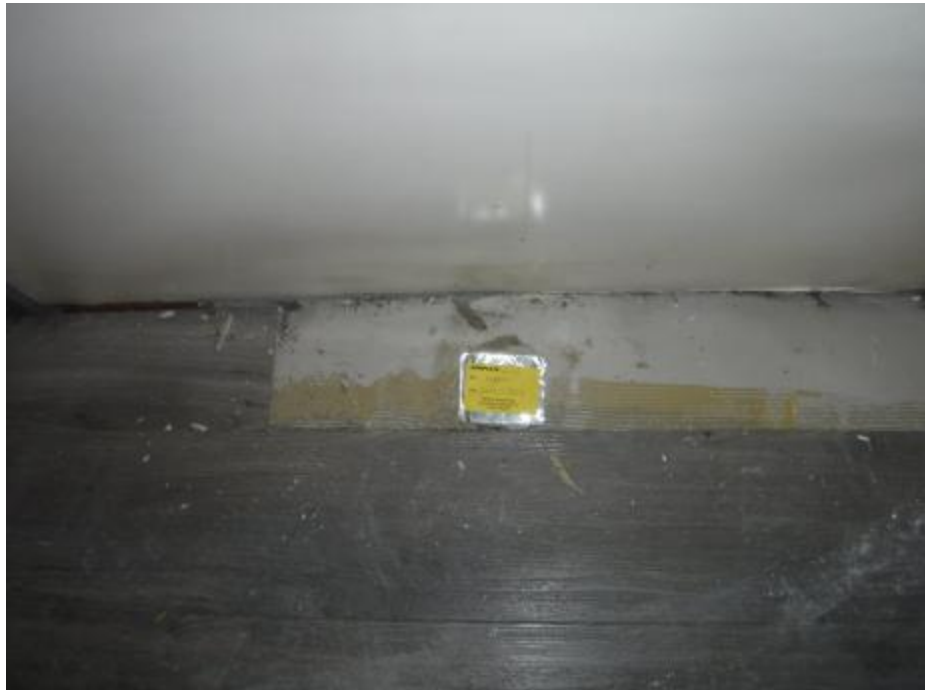
Location ID:	41285	Survey Type:	RDS
Location Ref:	Sample 10	Product Type:	NADIS
Product:	Lino	Damage:	NADIS
Area:	19/20 High Holborn	Treatment:	NADIS
Floor:	Ground floor	Asbestos Type:	NADIS
Room:	Retail	Identification:	Identified
Surveyor Name:	Jack Stringer	Quantity:	Approx 150m <sup>2</sup>
Drawing Ref:			
Asbestos ?	No		
Date:	31 July 2017		
Next Inspection:	Not Applicable

Material Comments: A sample of lino to floor (green) was removed for laboratory bulk sampling analysis from the retail at ground floor level. Note - Below screed.

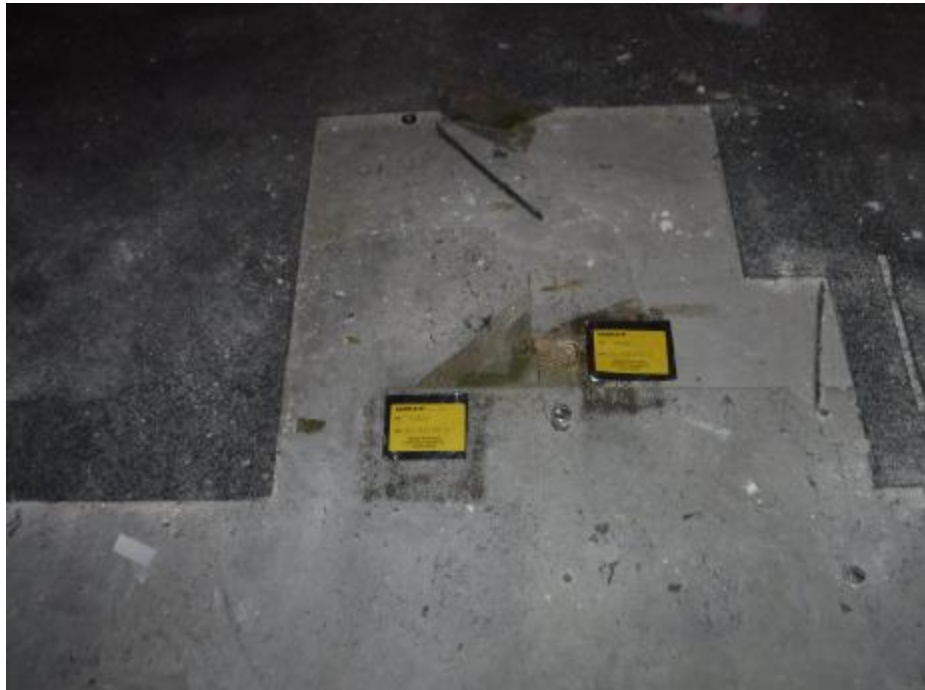
Location ID:	41286	Survey Type:	RDS
Location Ref:	Sample 11	Product Type:	NADIS
Product:	Lino	Damage:	NADIS
Area:	19/20 High Holborn	Treatment:	NADIS
Floor:	Ground floor	Asbestos Type:	NADIS
Room:	Retail	Identification:	Identified
Surveyor Name:	Jack Stringer	Quantity:	Approx 150m <sup>2</sup>
Drawing Ref:			
Asbestos ?	No		
Date:	31 July 2017		
Next Inspection:	Not Applicable

Material Comments: A sample of lino to floor (green - underlay) was removed for laboratory bulk sampling analysis from the retail at ground floor level.

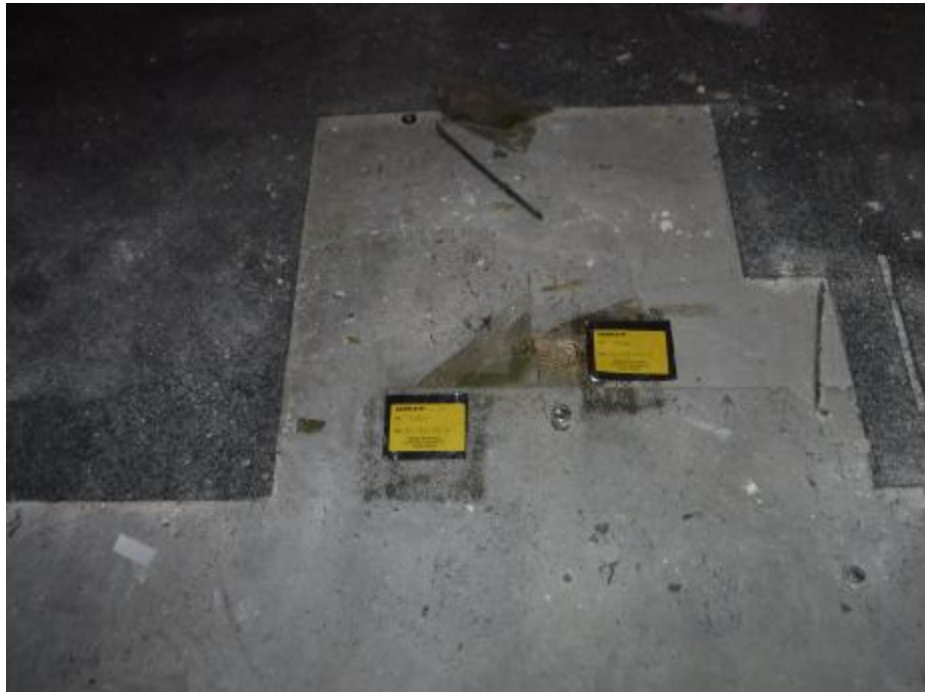
Material Risk Score:	0
Material Risk Band:	NADIS
Priority Risk Score:	N/A

Material Comments: A sample of floor tile (grey) was removed for laboratory bulk sampling analysis from the retail at ground floor level.

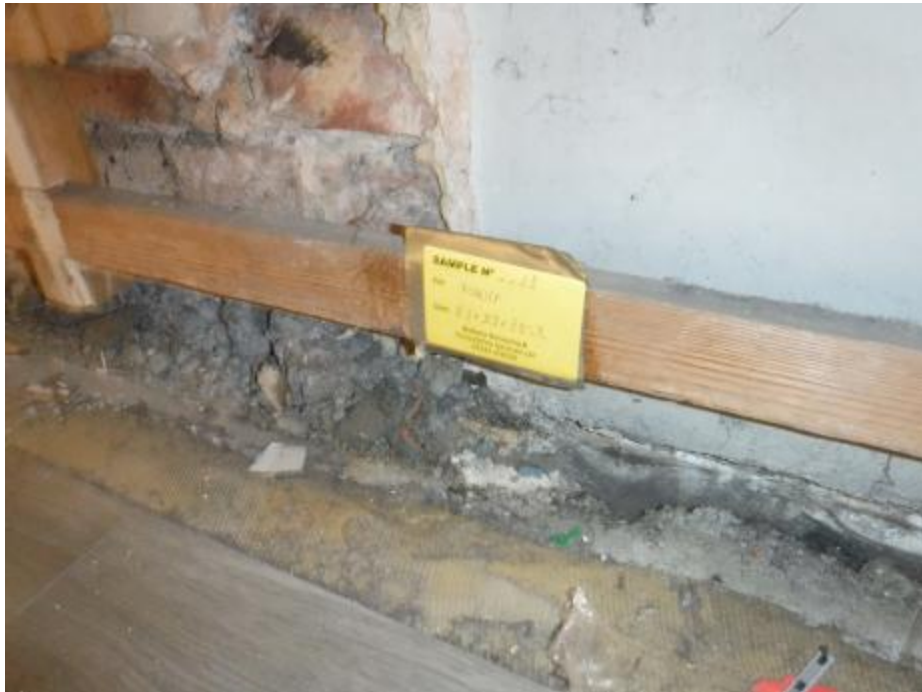
Material Risk Score:	5
Material Risk Band:	Low Risk
Priority Risk Score:	N/A

Material Comments: A sample of floor tile and bitumen debris was removed for laboratory bulk sampling analysis from behind the display panelling to retail at ground floor level. Note - chrysotile in both tile & bitumen.

Action: Environmental Clean by Licensed Contractors

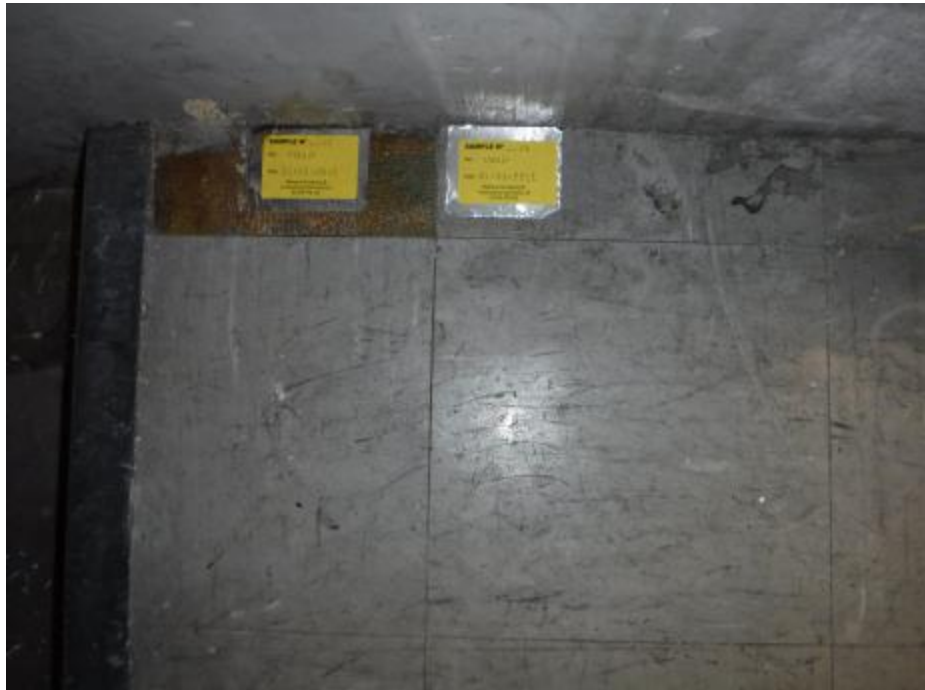
Material Risk Score:	0
Material Risk Band:	NADIS
Priority Risk Score:	N/A

Material Comments: A sample of floor tile (grey) was removed for laboratory bulk sampling analysis from the fire exit lobby to retail at ground floor level.

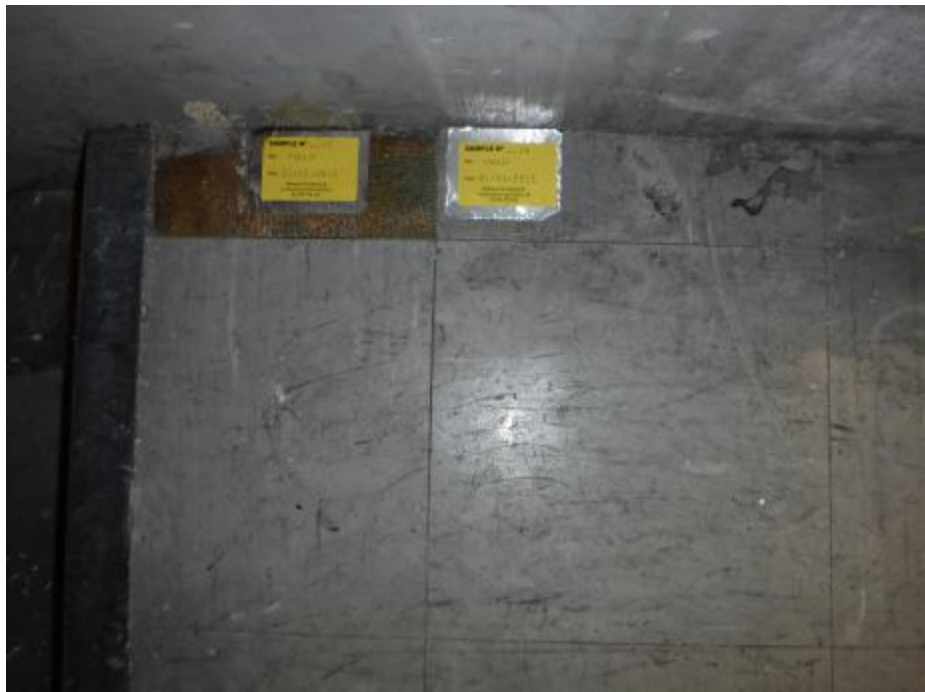
Material Risk Score:	2
Material Risk Band:	Very Low Risk
Priority Risk Score:	N/A

Material Comments: A sample of floor tile & bitumen (blue - underlay) was removed for laboratory bulk sampling analysis from the fire exit lobby to retail at ground floor level. Note - chrysotile in both tile & bitumen.

Action: **Removal By Licensed Contractors**

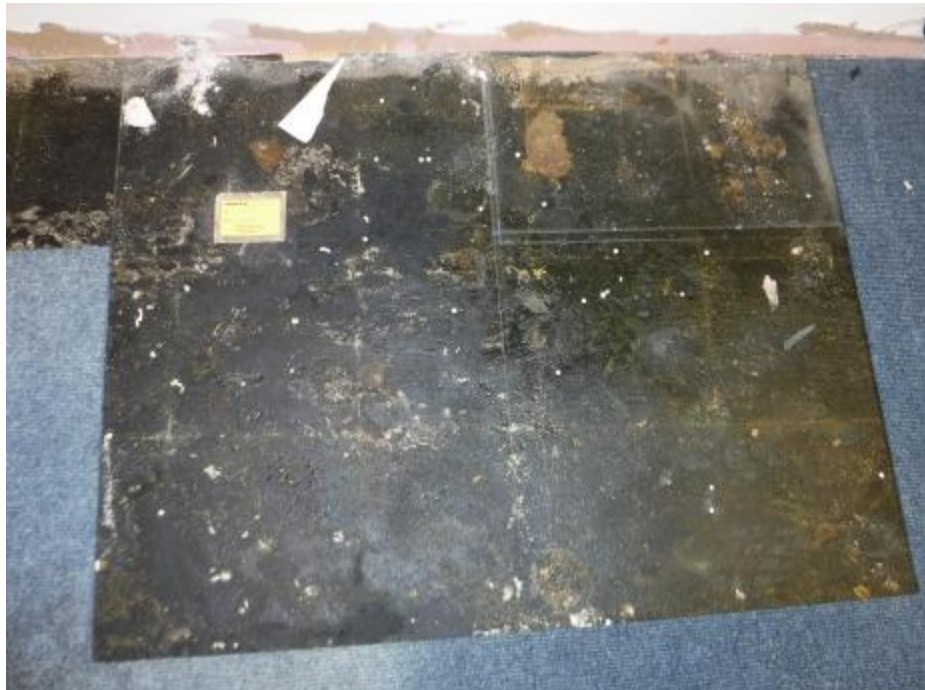
Material Comments: A sample of bitumen to floor was removed for laboratory bulk sampling analysis from the office area at basement level. Note - Bitumen noted throughout the basement.

Action: **Removal By Licensed Contractors**

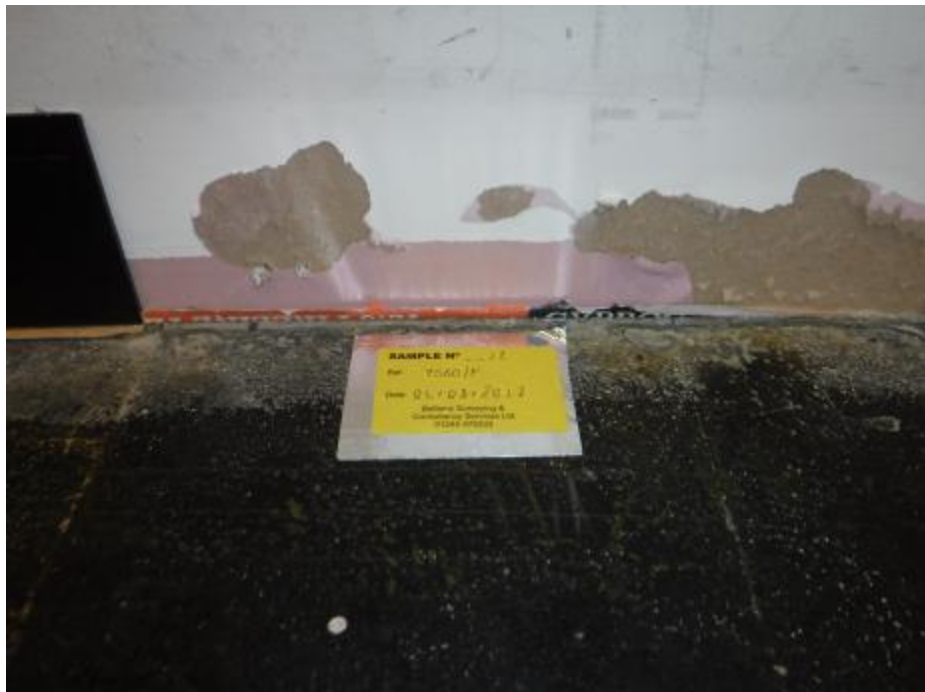
Material Risk Score:	5
Material Risk Band:	Low Risk
Priority Risk Score:	N/A

Material Comments: A sample of floor tile & bitumen debris was removed for laboratory bulk sampling analysis from the office area at basement level. Note - Floor tile debris noted to the perimeter & partition walls throughout the basement office areas.

Action: **Removal By Licensed Contractors**

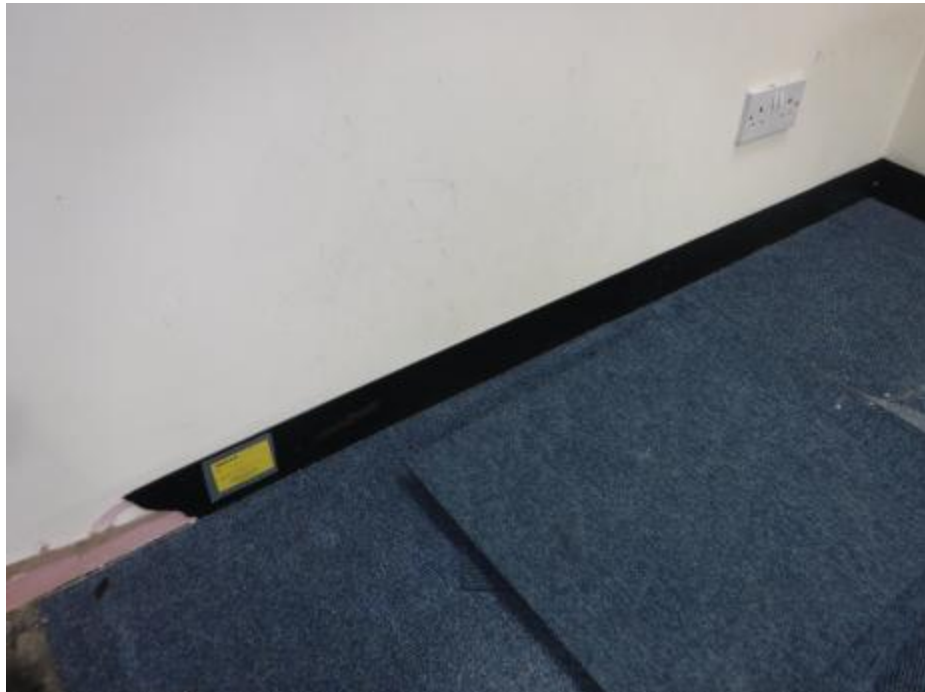
Material Risk Score:	0
Material Risk Band:	NADIS
Priority Risk Score:	N/A

Material Comments: A sample of skirting board was removed for laboratory bulk sampling analysis from the office area at basement level.

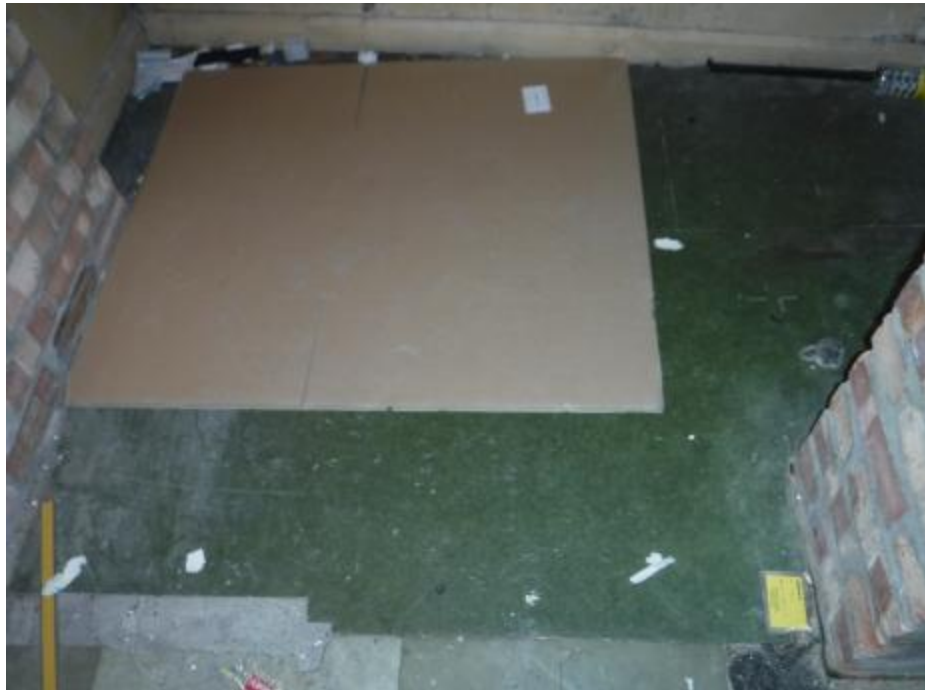
Material Risk Score:	0
Material Risk Band:	NADIS
Priority Risk Score:	N/A

Material Comments: A sample of lino to floor (green) was removed for laboratory bulk sampling analysis from the electrical cupboard at basement level.

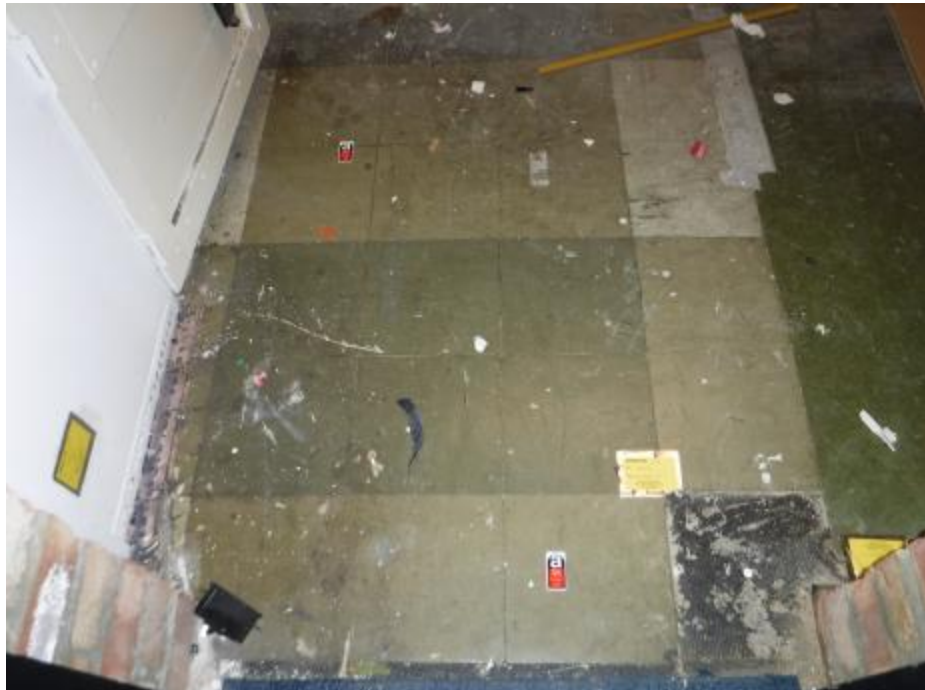
Material Risk Score:	3
Material Risk Band:	Very Low Risk
Priority Risk Score:	N/A

Material Comments: A sample of floor tile & bitumen (green) was removed for laboratory bulk sampling analysis from the electrical cupboard at basement level.

Action: **Removal By Licensed Contractors**

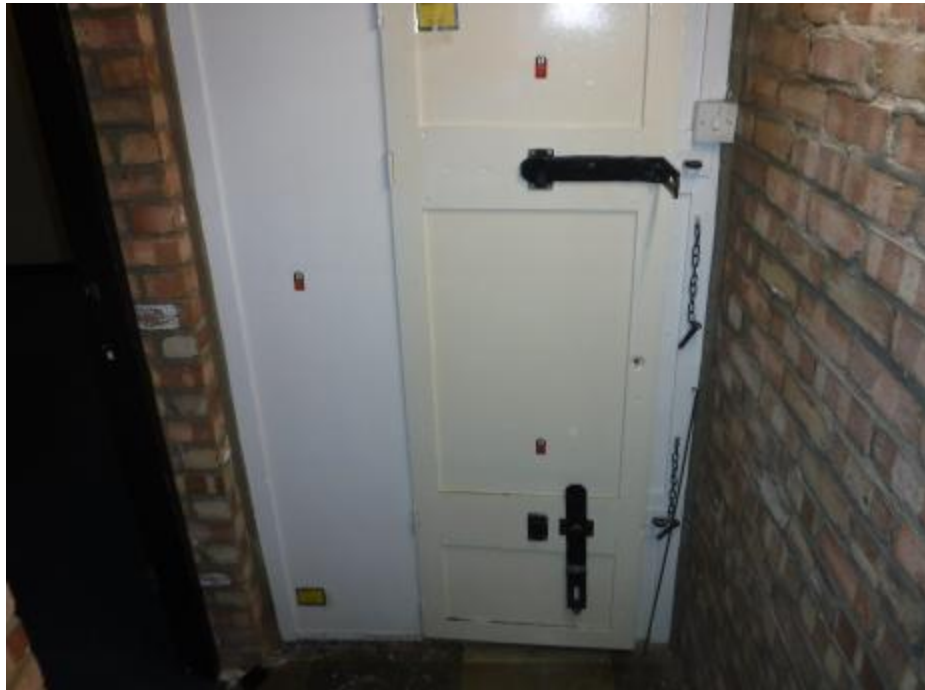
Material Risk Score:	5
Material Risk Band:	Low Risk
Priority Risk Score:	N/A

Material Comments: A sample of door lining was removed for laboratory bulk sampling analysis from the electrical cupboard at basement level. Note - Noted to both sides of door.

Action: **Removal By Licensed Contractors**

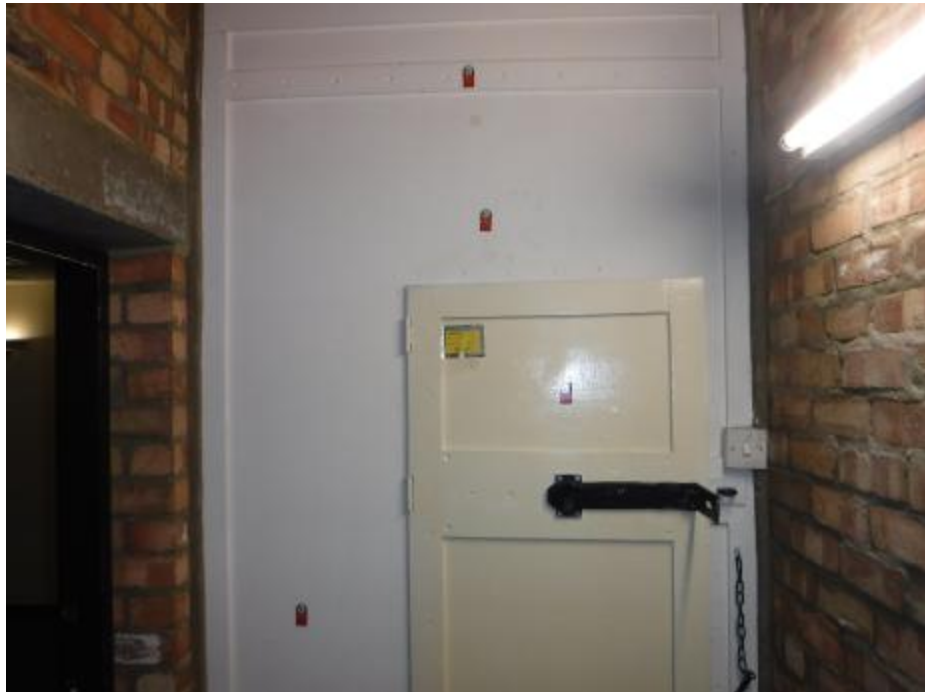
Material Risk Score:	5
Material Risk Band:	Low Risk
Priority Risk Score:	N/A

Material Comments: A sample of door surround board was removed for laboratory bulk sampling analysis from the electrical cupboard at basement level. Note - Noted to both sides of studwork.

Action: **Removal By Licensed Contractors**

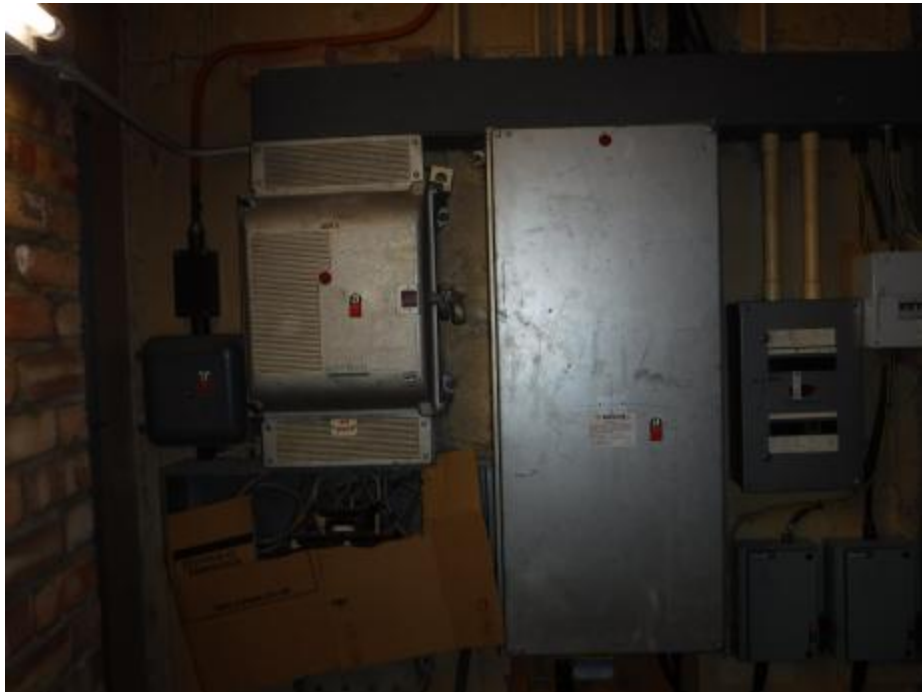
Material Risk Score:	4
Material Risk Band:	Very Low Risk
Priority Risk Score:	N/A

Material Comments: A photographic reference of electrics within the electrical cupboard at basement level, strongly presumed to contain asbestos i.e flash pads, ropes, gaskets etc. Note - Electrics were live at time of survey.

Action: **Removal By Licensed Contractors**

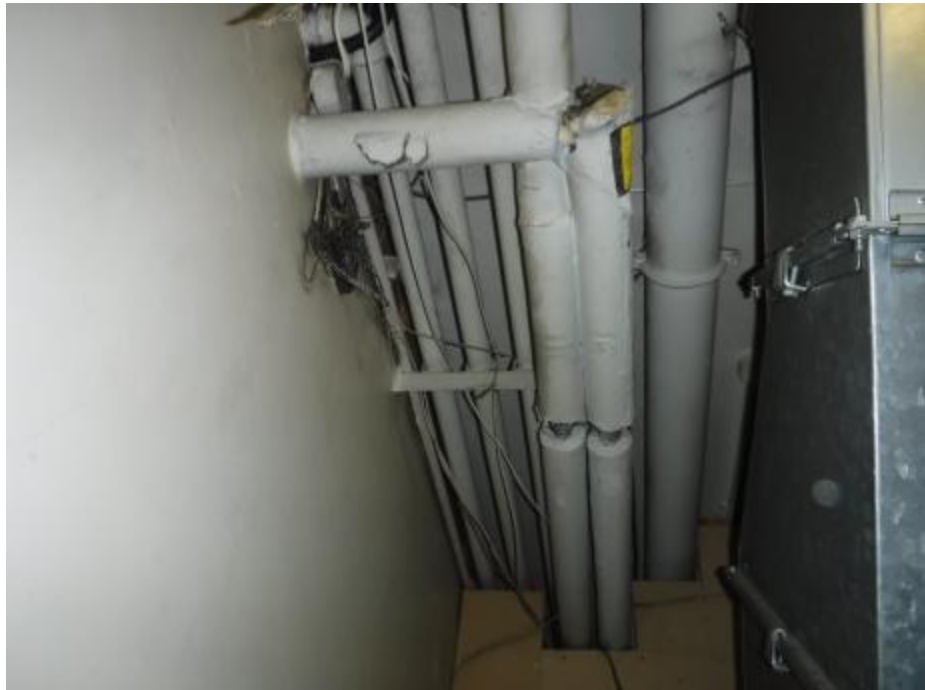
Material Risk Score:	0
Material Risk Band:	NADIS
Priority Risk Score:	N/A

Material Comments: A sample of pipe insulation was removed for laboratory bulk sampling analysis from the plant room at basement level.

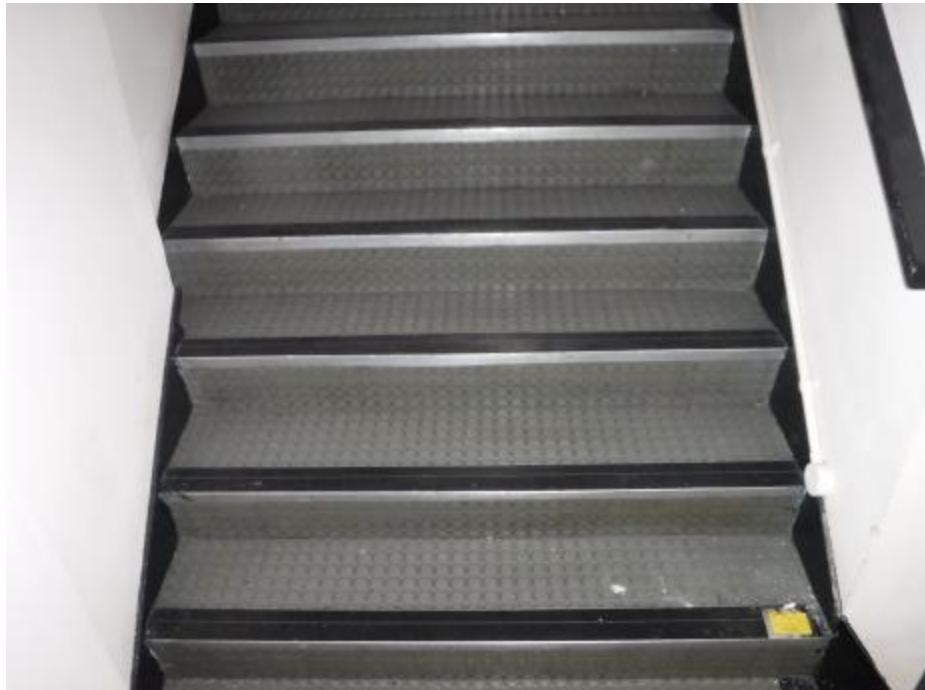
Material Risk Score:	0
Material Risk Band:	NADIS
Priority Risk Score:	N/A

Material Comments: A sample of stair nosing was removed for laboratory bulk sampling analysis from the fire escape stairs at basement level.

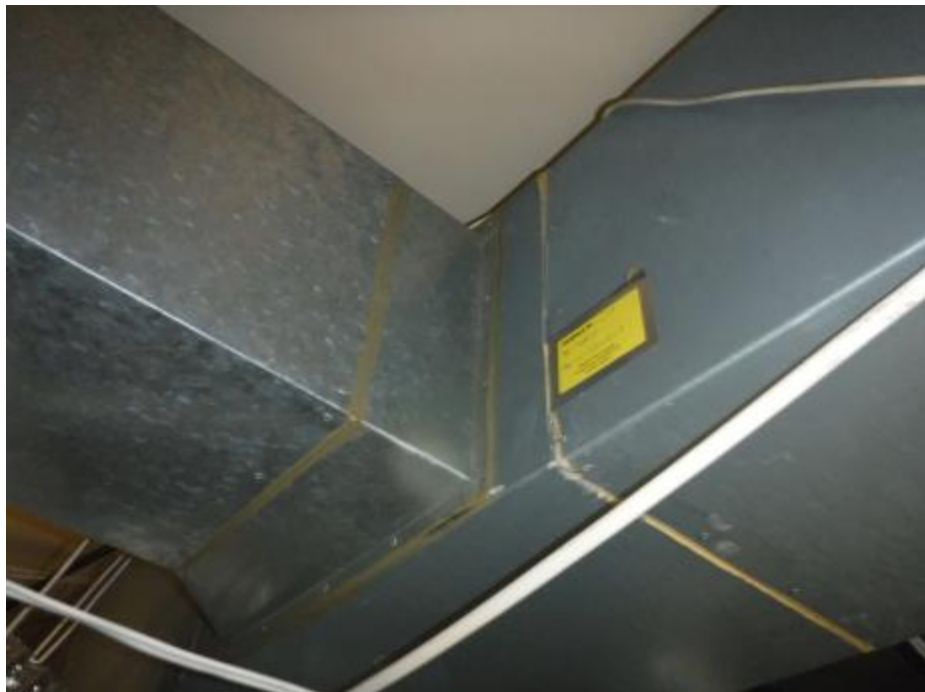
Material Risk Score:	0
Material Risk Band:	NADIS
Priority Risk Score:	N/A

Material Comments: A sample of mastic to ducting was removed for laboratory bulk sampling analysis from the office area ceiling void at basement level.

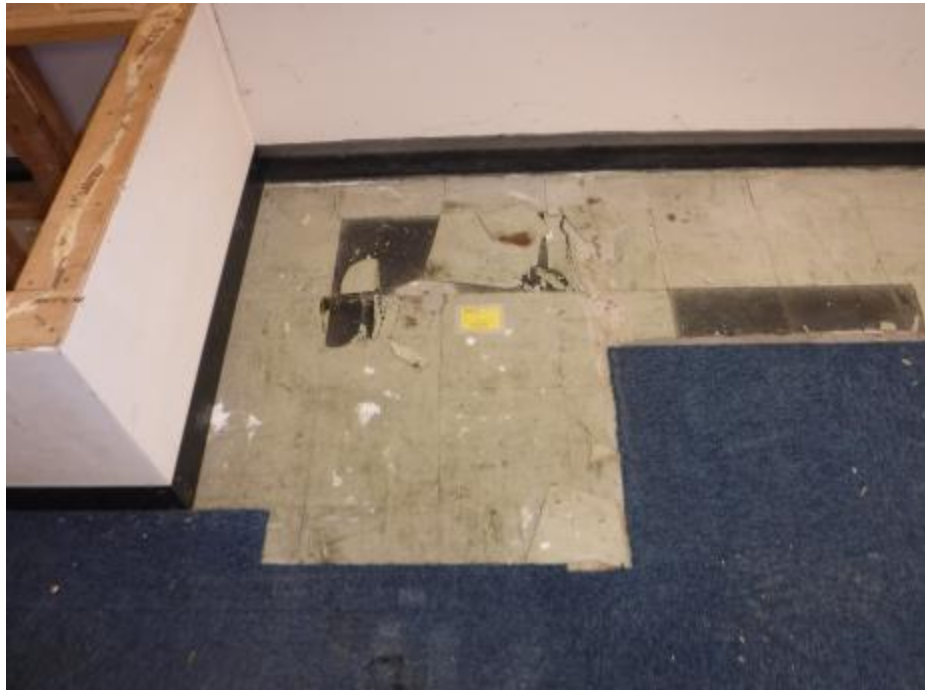
Material Risk Score:	5
Material Risk Band:	Low Risk
Priority Risk Score:	N/A

Material Comments: A sample of floor tile and bitumen (green) was removed for laboratory bulk sampling analysis from the office area at basement level. Note - Representative to all adjacent offices see photo 2.

Action: **Removal By Licensed Contractors**

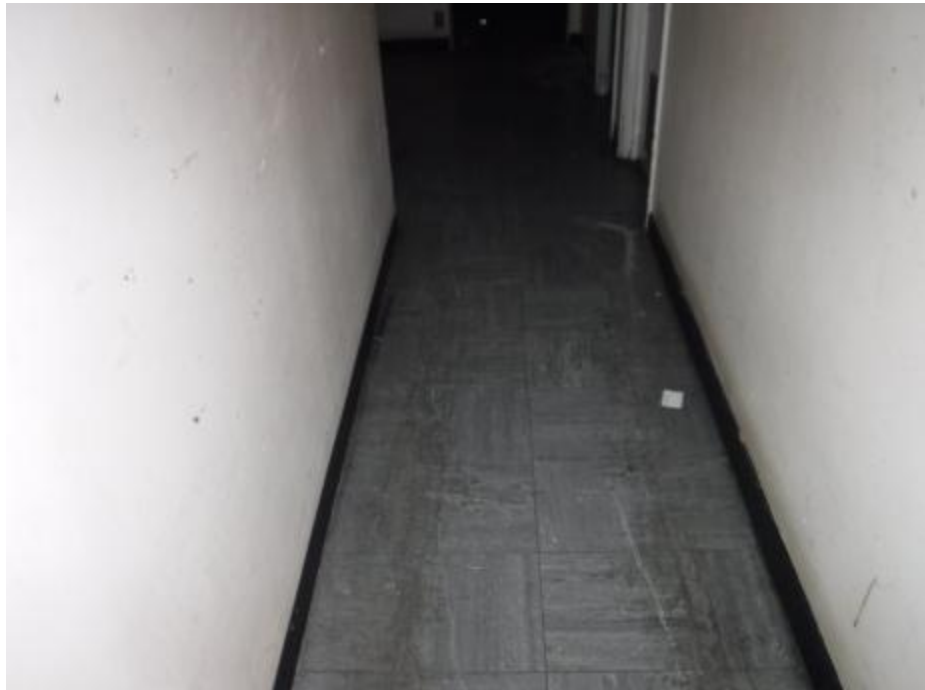
Material Risk Score:	2
Material Risk Band:	Very Low Risk
Priority Risk Score:	N/A

Material Comments: A photographic reference of floor tile & bitumen (green) noted as underlay to grey floor tiles within the hall to office area, strongly presumed to contain asbestos as sample 28.

Action: **Removal By Licensed Contractors**

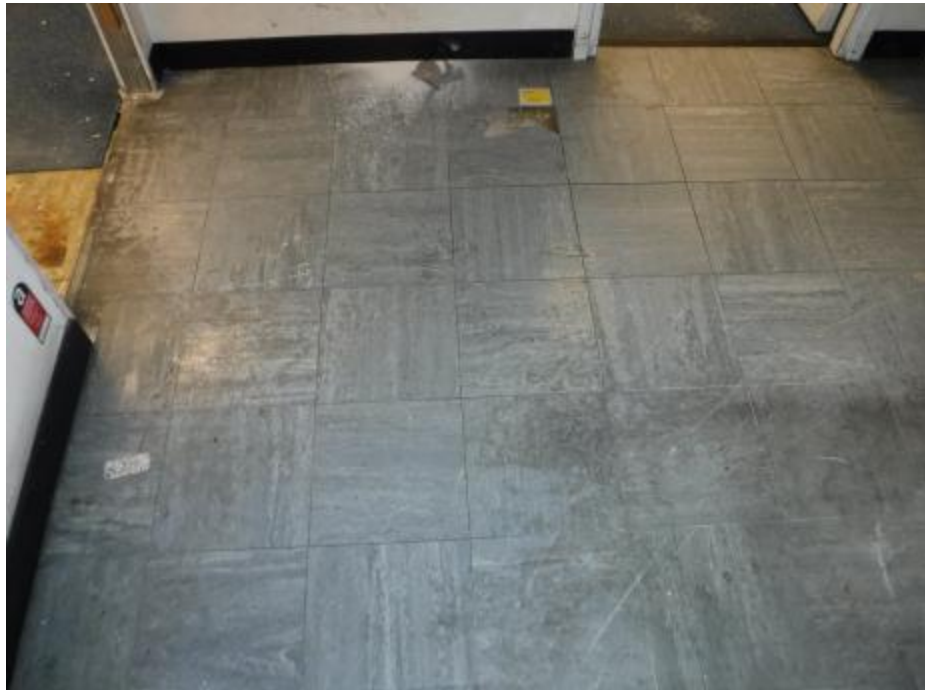
Material Risk Score:	0
Material Risk Band:	NADIS
Priority Risk Score:	N/A

Material Comments: A sample of floor tile (dark grey) was removed for laboratory bulk sampling analysis from the hall at basement level.

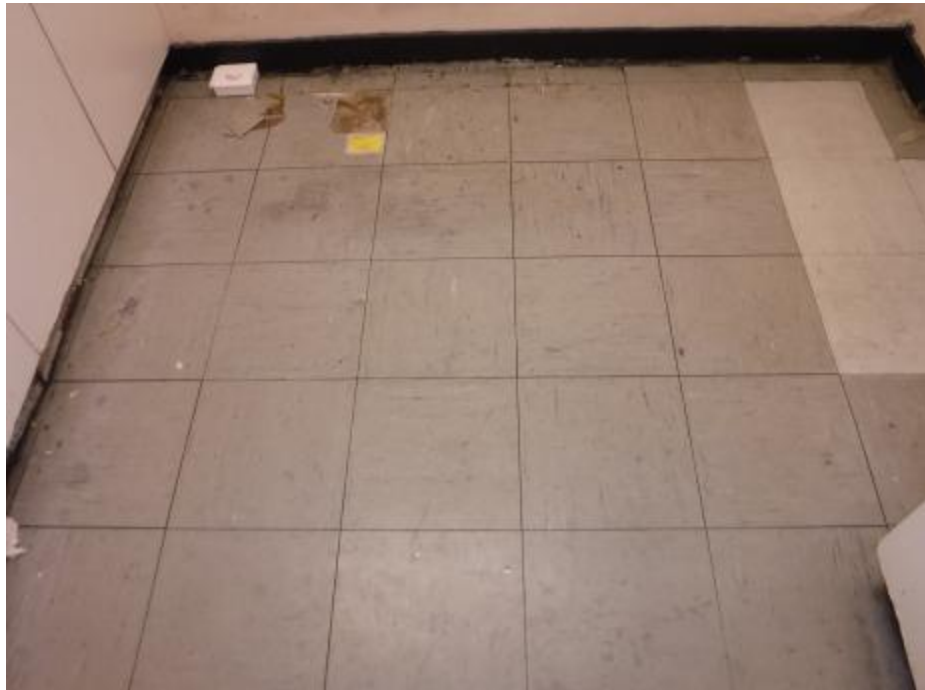
Material Risk Score:	0
Material Risk Band:	NADIS
Priority Risk Score:	N/A

Material Comments: A sample of floor tile (light grey) was removed for laboratory bulk sampling analysis from the kitchen at basement level.
