## Asbestos Refurbishment/Demolition Survey for

The Honourable Society Of Gray's Inn

Grays Inn Chambers  
19/20 High Holborn  
London, WC1V 6BS  
(Rymans)

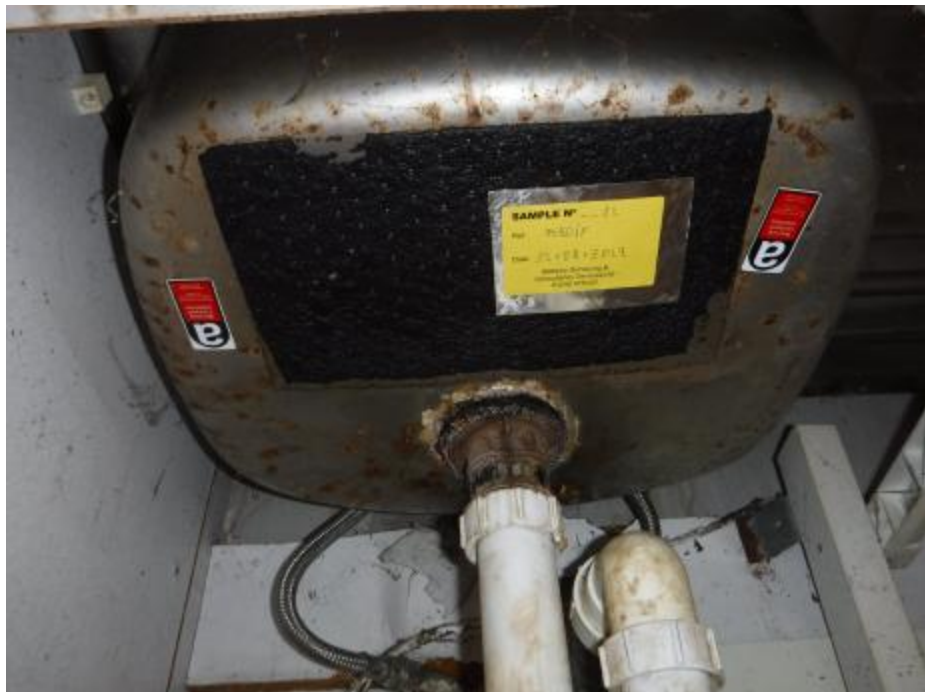
Material Risk Score:	<input type="text" value="2"/>
Material Risk Band:	<input type="text" value="Very Low Risk"/>
Priority Risk Score:	<input type="text" value="N/A"/>

Material Comments: A sample of the sink pad to the kitchen at basement level. (Please Note: Please refer to report carried out by Asbestos Management Solutions Ltd (Report Ref; J452 1014 - Sample Ref; 0007) dated 09/12/16. Sample tested Positive.

Action: Removal By Licensed Contractors

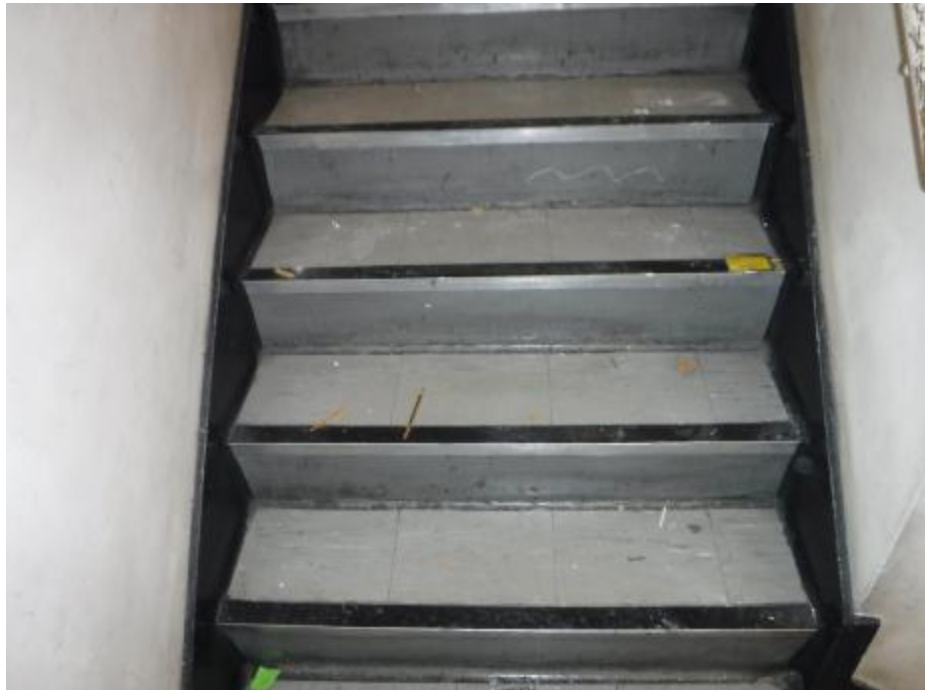
Material Risk Score:	0
Material Risk Band:	NADIS
Priority Risk Score:	N/A

Material Comments: A sample of stair nosing was removed for laboratory bulk sampling analysis from the stairs at basement level.
