TIM MOYA ASSOCIATES
ARBORICULTURE • LANDSCAPE • ECOLOGY

Project name:		Bedford Estates - Bedford Place
Drawing title:		160523 - Bedford Estates
Drawing number:	160523	Revision
Client:	Bedford Estates	
Agent:	TMA	
Date:	24/10/2017	
Scale:	1:700@A3

Health and Safety Tree Schedule & Works

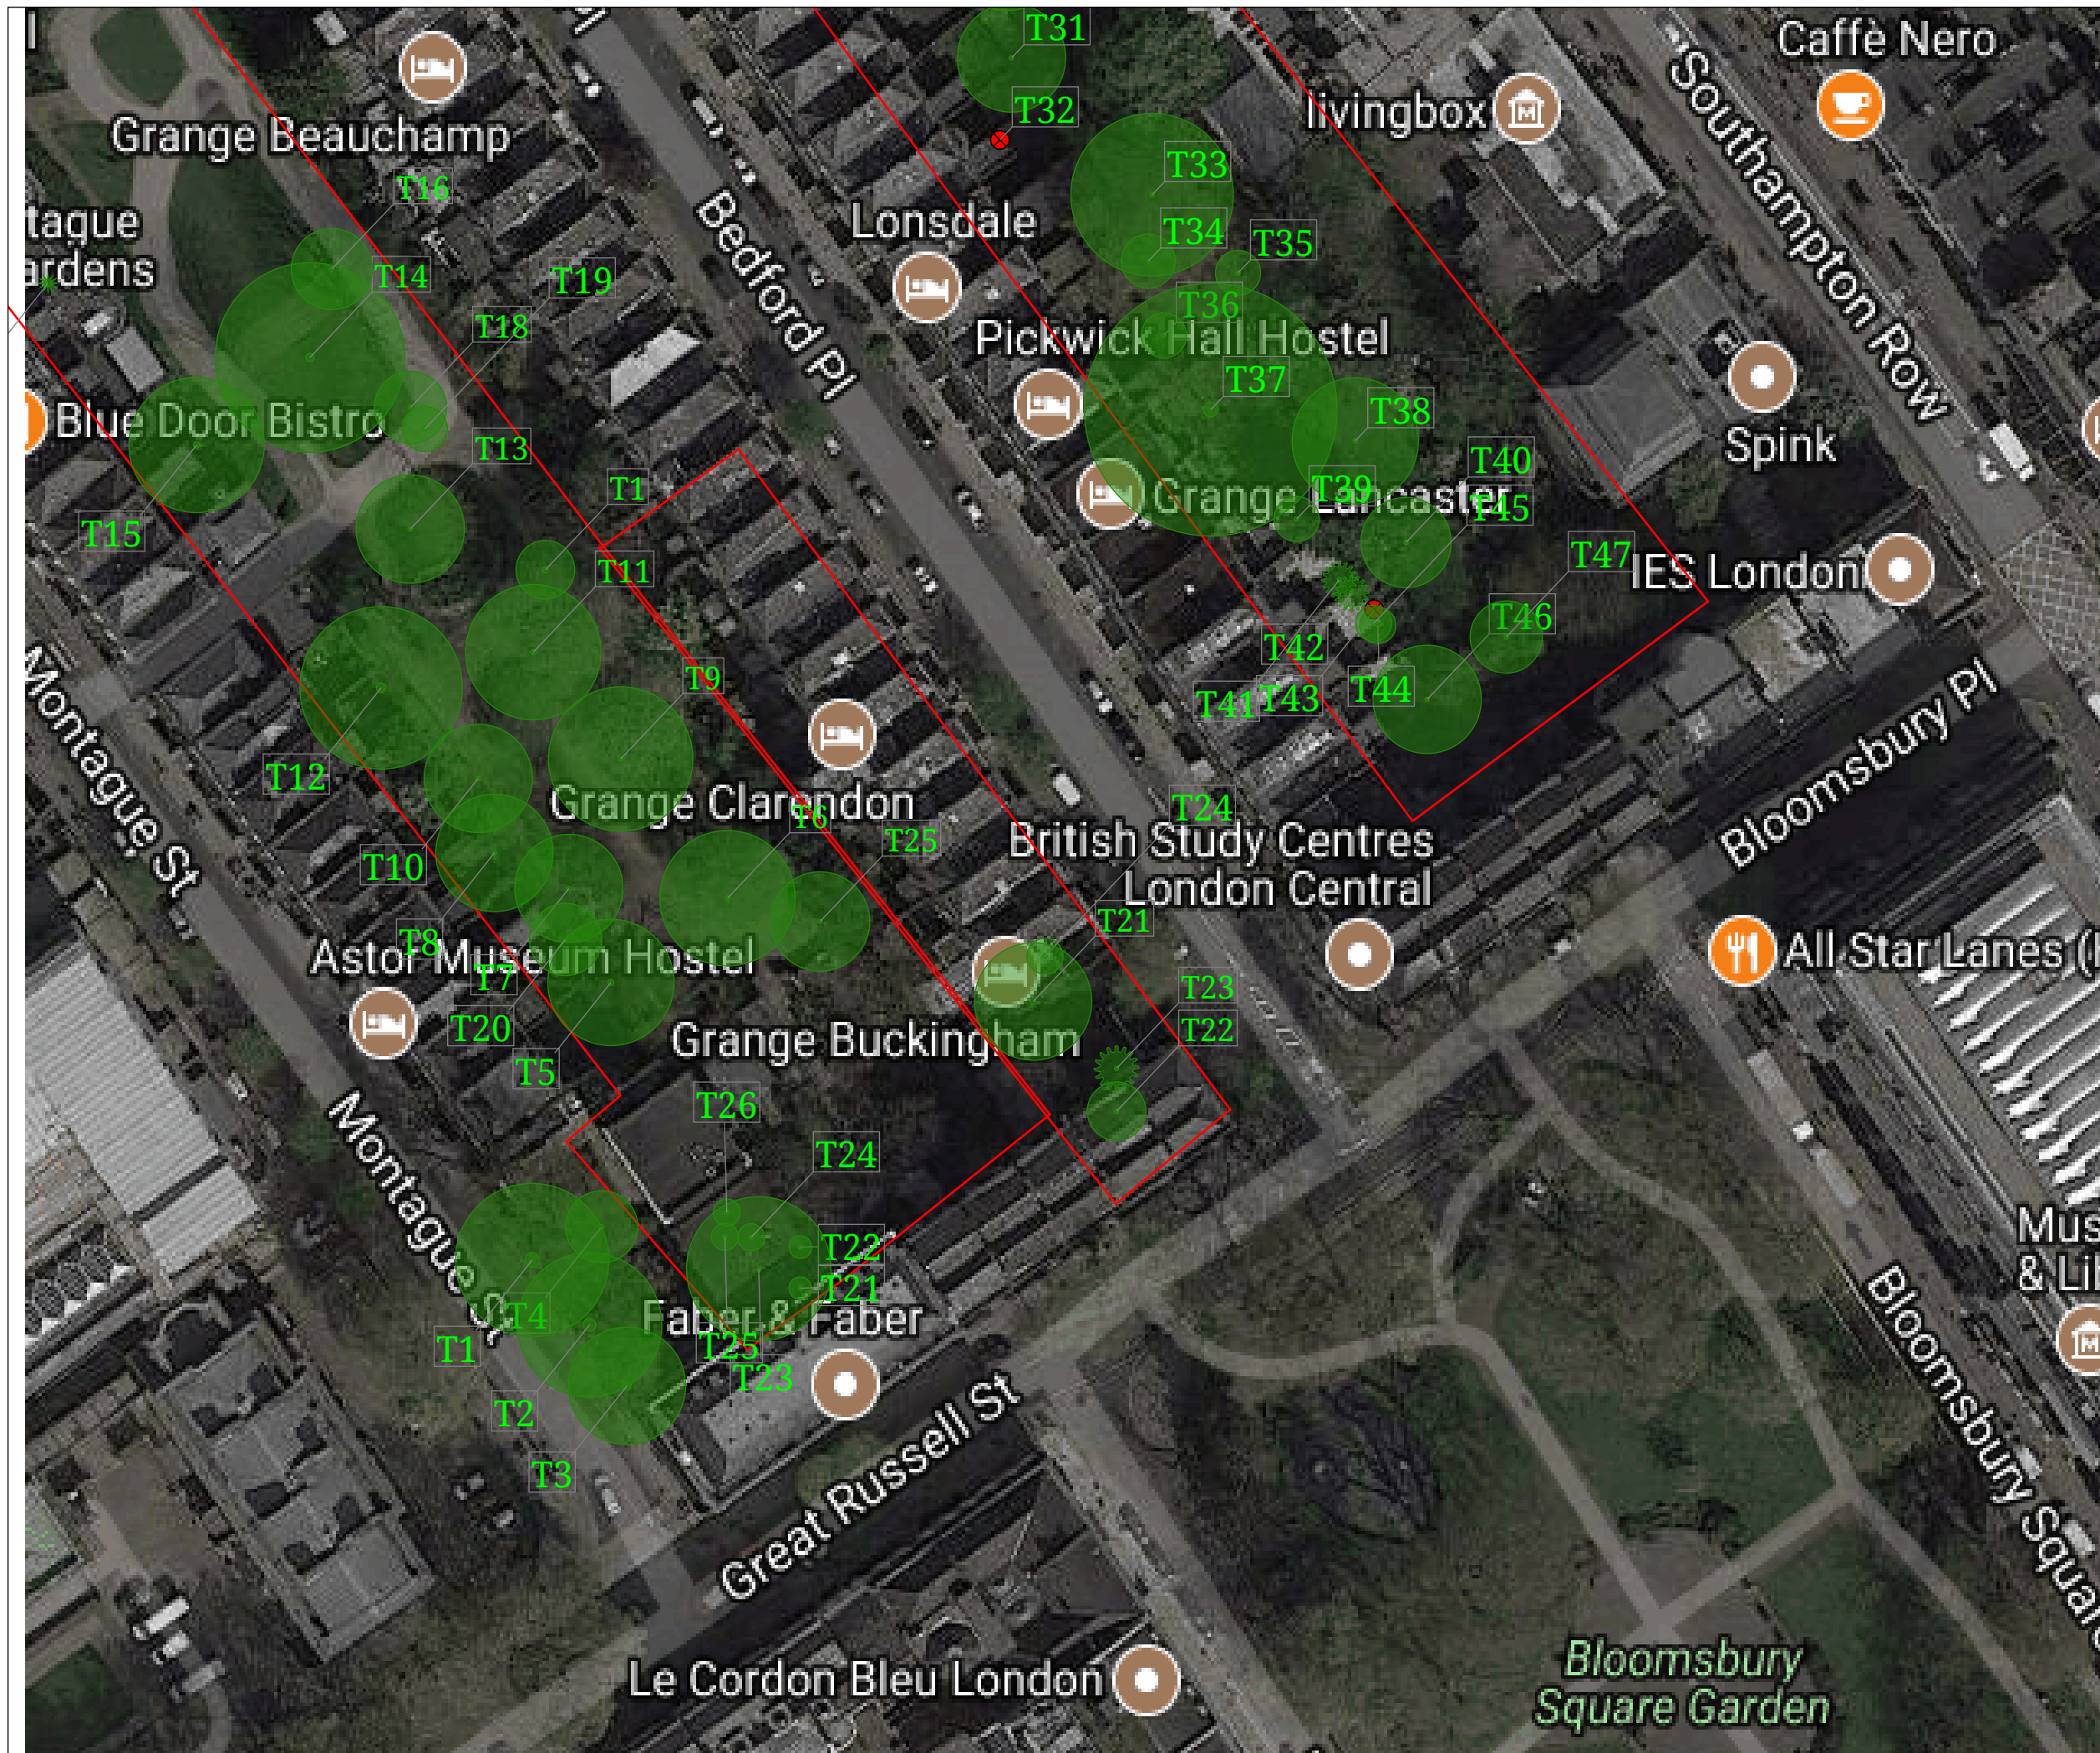
Bedford Place (No. of Trees: 4)

Tree / Group No.	No. of Trees	Species	Height (m)	DBH (cm)	Crown spread(m)	Vitality	Age Class	Physiological Condition	Structural Condition	Targets	Condition Notes	Priority
											Recommendations	
T21	1	Platanus x hispanica London Plane	19.0	65	13.0	Moderate	Mature	Fair	Fair	Building within crown spread. Road within crown spread. Tree overhangs neighbouring property.	Access to inspect base - Restricted / obscured. Base / stems obscured - Vegetation. Crown reduction - Recent. Epicormic growth - Crown. Reduce crown by - Specified extent reduce crown to previous reduction points, continuing established management and minising risk of branch failure onto road, footpath and neighbouring property	Within 1 year

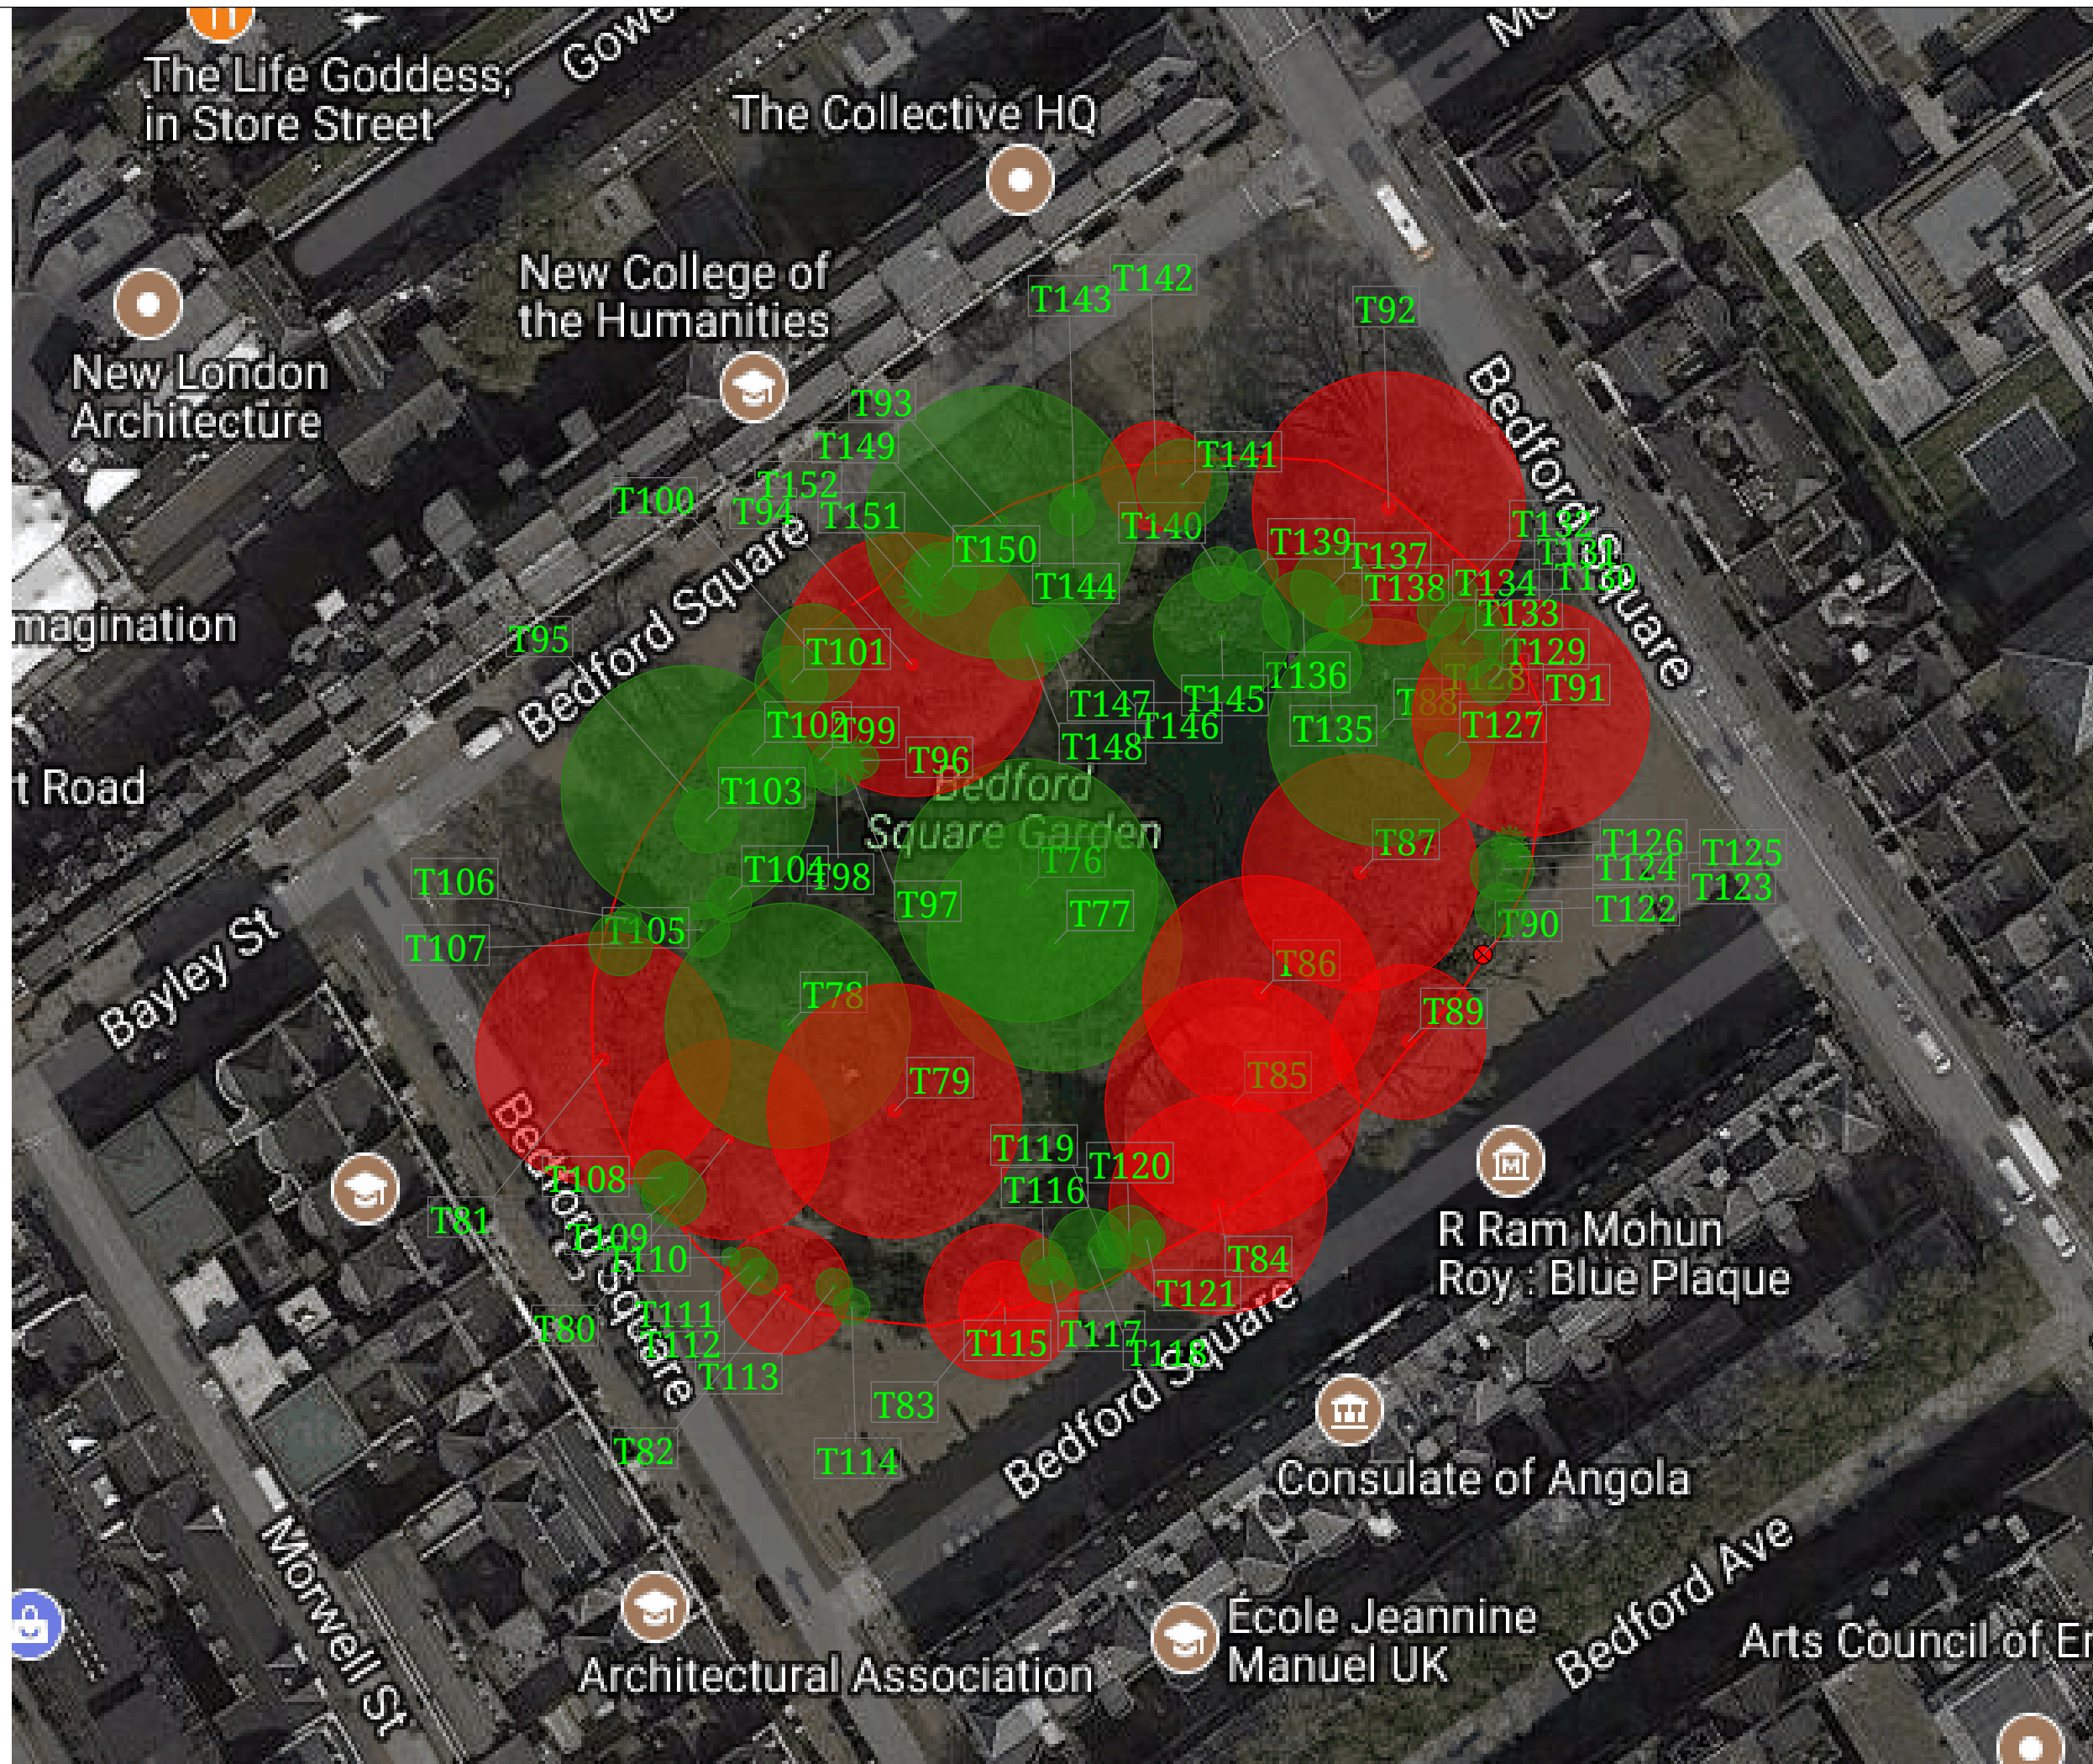
Bedford Square (No. of Trees: 77)

Tree / Group No.	No. of Trees	Species	Height (m)	DBH (cm)	Crown spread(m)	Vitality	Age Class	Physiological Condition	Structural Condition	Targets	Condition Notes Recommendations	Priority
T79	1	Platanus x hispanica London Plane	33.0	135	28.0	Moderate	Mature	Fair	Fair	Footpath within crown spread. Building within crown spread. Seating area within crown spread.	Branch weight - Heavy. Bark wound - Minor. Deadwood - Minor. Foreign object. Pruning wounds - Historic. Reaction wood / Adaptive growth - Stem / stems. Massaria confirmed Deadwood - Remove remove massaria branches from approximately 25m to the north, check crown for additional colonised branches not observed from ground level and remove those - PHOTOGRAPH IF COLONISATION IN EARLY STAGE TO PROVIDE EVIDENCE FOR COUNCIL	Within 6 months
T80	1	Platanus x hispanica London Plane	32.0	95	22.0	Moderate	Mature	Fair	Fair	Footpath within crown spread. Building within falling distance of tree. Seating area within falling distance of tree.	Access to inspect base - Restricted / obscured. Arboricultural work - Historic. Base / stems obscured - Vegetation. Branch weight - Heavy. Decay / structural defect in crown limb / limbs - Minor. Deadwood - Minor. Epicormic growth - Crown. Foreign object. Deadwood - Remove remove massaria branch at approximately 20m to the east, check crown for additional colonised branches not observed from ground level and remove those - PHOTOGRAPH IF COLONISATION IN EARLY STAGE TO PROVIDE EVIDENCE FOR COUNCIL	Within 6 months

T81	1	Platanus x hispanica London Plane	30.0	135	28.0	Moderate	Mature	Fair	Fair	Footpath within crown spread. Building within falling distance of tree. Road within crown spread.	Arboricultural work - Historic. Decay / structural defect in crown limb / limbs - Localised. Deadwood - Major. Poor past pruning. Pruning wounds - Historic. Reaction wood / Adaptive growth - Stem / stems. tree grown over railing two lower limbs heavily reduced Coprinus sp. fungal fruiting bodies observed near base to the south Reduce crown by - Specified extent reduce height and branch length by approximately 3m (particularly on extended lateral branch to the north west) to relieve loading on lateral branches and minimise risk of failure onto footpath and road	Within 1 year
T82	1	Platanus x hispanica London Plane	20.0	125	14.0	Moderate	Mature	Fair	Fair	Footpath within crown spread. Seating area within falling distance of tree.	Access to inspect base - Restricted / obscured. Base / stems obscured - Vegetation. Crown reduction - Recent. Decay / structural defect in crown limb / limbs - Localised. Deadwood - Minor. Decay / structural defect - Base. Epicormic growth - Crown. Fungal fruiting body - structural decay suspected. Decay - Rigidoporus ulmarius brackets at the base on the south and south-west side. Detailed investigation - Internal decay assessment PiCUS and or Resistograph investigation at base (5cm) to monitor development of decay, the consistency of the remaining wood and inform future management decision.	Within 2 years

T83	1	Platanus x hispanica London Plane	25.0	65	17.0	Moderate	Mature	Fair	Fair	Footpath within crown spread. Seating area within crown spread.	Access to inspect base - Restricted / obscured. Arboricultural work - Recent. Base / stems obscured - Vegetation. Deadwood - Minor. Reaction wood / Adaptive growth - Base. major reactive growth around base Reduce lateral limb / limbs reduce lateral limbs over seating and footpath by approximately 2-3m as appropriate to relieve loading and minimise risk of failure leave furnishing growth to minimise visual impact	Within 6 months

Tree / Group No.	No. of Trees	Species	Height (m)	DBH (cm)	Crown spread (m)	Vitality	Age Class	Physiological Condition	Structural Condition	Targets	Condition Notes Recommendations	Priority
T89	1	Platanus x hispanica London Plane	22.0	135	17.0	Moderate	Mature	Fair	Poor	Footpath within crown spread. Seating area within crown spread. Road within falling distance of tree.	Access to inspect base - Restricted / obscured. Base / stems obscured - Vegetation. Branch weight - Heavy. Branch - Suspended. Crown reduction - Historic. Deadwood - Minor. Fungal fruiting body - structural decay suspected. Form - Small sail area / crown extent. Decay - Inonotus hispidus bracket observed on floor near decayed stem (with large burr) to the west Deadwood - Remove remove dead massaria branch @ approximately 20m to the east over road, check crown for additional colonised branches not observed from ground level and remove those - PHOTOGRAPH IF COLONISATION IN EARLY STAGE TO PROVIDE EVIDENCE FOR COUNCIL	Within 3 months

T90	1	Platanus x hispanica London Plane	20.0	145	12.0	Low	Mature	Poor	Poor	Footpath within crown spread. Seating area within crown spread. Road within falling distance of tree.	Access to inspect base - Restricted / obscured. Base / stems obscured - Vegetation. Crown reduction - Historic. Decline - Evident / observed. Epicormic growth - Crown. Fungal fruiting body - structural decay suspected. Unbalanced crown - Major. Decay - Inonotus hispidus brackets in old pruning wounds at approximately 12m Decay - Perenniporia fraxinea bracket and Rigidoporus ulmarius brackets at base to north and east. PiCUS investigation reveals extensive internal decay Plant replacement tree plant semi mature Liriodendron tulipifera - Tulip tree to replace plane tree Fell - Ground level fell and grind stump to facilitate replacement planting Tree felled - Stump awaiting removal 19/09/2017	Within 1 year Within 1 year

T91	1	Platanus x hispanica London Plane	30.0	135	26.0	Moderate	Mature	Fair	Fair	Footpath within crown spread. Street lamp within crown spread. Road within falling distance of tree.	Deadwood - Minor. Epicormic growth - Base. Foreign object - Ingrown metal. tree growing over railings dead twig suspended over pavement at approximately 15m Reduce crown by - Specified extent reduce height and branch length by approximately 3m to relieve wind loading and minimise risk of branch or stem failure leaving furnishing growth to minimise visual impact - remove massaria branch at approximately 20m to the north, check crown for additional colonised branches not observed from ground level and remove those - PHOTOGRAPH IF COLONISATION IN EARLY STAGE TO PROVIDE EVIDENCE FOR COUNCIL	Within 6 months
T92	1	Platanus x hispanica London Plane	32.0	145	30.0	Moderate	Mature	Fair	Fair	Footpath within crown spread. Street lamp within crown spread. Road within falling distance of tree.	Arboricultural work - Historic. Branch weight - Heavy. Decay / structural defect in crown limb / limbs - Localised. Epicormic growth - Crown. End-loaded limb / limbs. Form - Spreading crown. Foreign object - Ingrown metal. Pruning wounds - Historic. tree growing over railings Reduce crown by - Specified extent reduce height and branch length by approximately 3-4m to relieve wind loading and minimise risk of failure, final cuts at suitable growth points, leaving furnishing growth to minimise visual impact	Within 6 months

Tree / Group No.	No. of Trees	Species	Height (m)	DBH (cm)	Crown spread (m)	Vitality	Age Class	Physiological Condition	Structural Condition	Targets	Condition Notes Recommendations	Priority
T94	1	Platanus x hispanica London Plane	32.0	125	29.0	Moderate	Mature	Fair	Fair	Footpath within crown spread. Road within falling distance of tree.	Arboricultural work - Recent. Branch weight - Heavy. Epicormic growth - Crown. End-loaded limb / limbs. Form - Spreading crown. Reaction wood / Adaptive growth - Stem / stems. Enormous bulge on main stem heavy lateral branch to the north recently reduced Reduce lateral limb / limbs reduce lateral branch length by approximately 2-3m to suitable growth points to relieve loading and minimise risk of branch failure over footpaths and seats	Within 1 year
T109	1	Ilex aquifolium Holly	8.0	31	7.0	Moderate	Mature	Fair	Fair	Footpath within crown spread. Street lamp within crown spread.	Epicormic growth - Base. Leaning trunk - Major. Prune from adjacent structure cut back to clear lamp column by 1m lift to 3.5m over footpath	Within 6 months

T115	1	Laurocerasus lusitanica Portugal Laurel	16.0	50	10.0	Moderate	Mature	Fair	Fair	Footpath within crown spread. Seating area within crown spread.	Form - Low canopy. Dimensions - Stem diameter estimated at base. Lift low canopy - Pedestrian clearance lift to 3.5m over footpath	Within 6 months
T133	1	Ilex aquifolium Holly	7.0	32	8.0	Moderate	Mature	Fair	Fair	Footpath within crown spread. Seating area within crown spread.	Fork - Suspected structurally sound. Form - Low canopy. Lift low canopy - Pedestrian clearance lift to 2.5m over footpath	Within 6 months
T142	1	Ulmus glabra Wych Elm	14.0	45	12.0	Low	Mature	Poor	Fair	Footpath within crown spread. Street lamp within crown spread. Seating area within falling distance of tree.	Access to inspect base - Restricted / obscured. Bark exudation. Base / stems obscured - Vegetation. Crown reduction - Recent. Die-back - Throughout crown. Decline - Evident / observed. Dutch elm disease. Decay / structural defect - Base. Fell - Ground level and grind stump to facilitate replanting with alternate species	Within 1 year

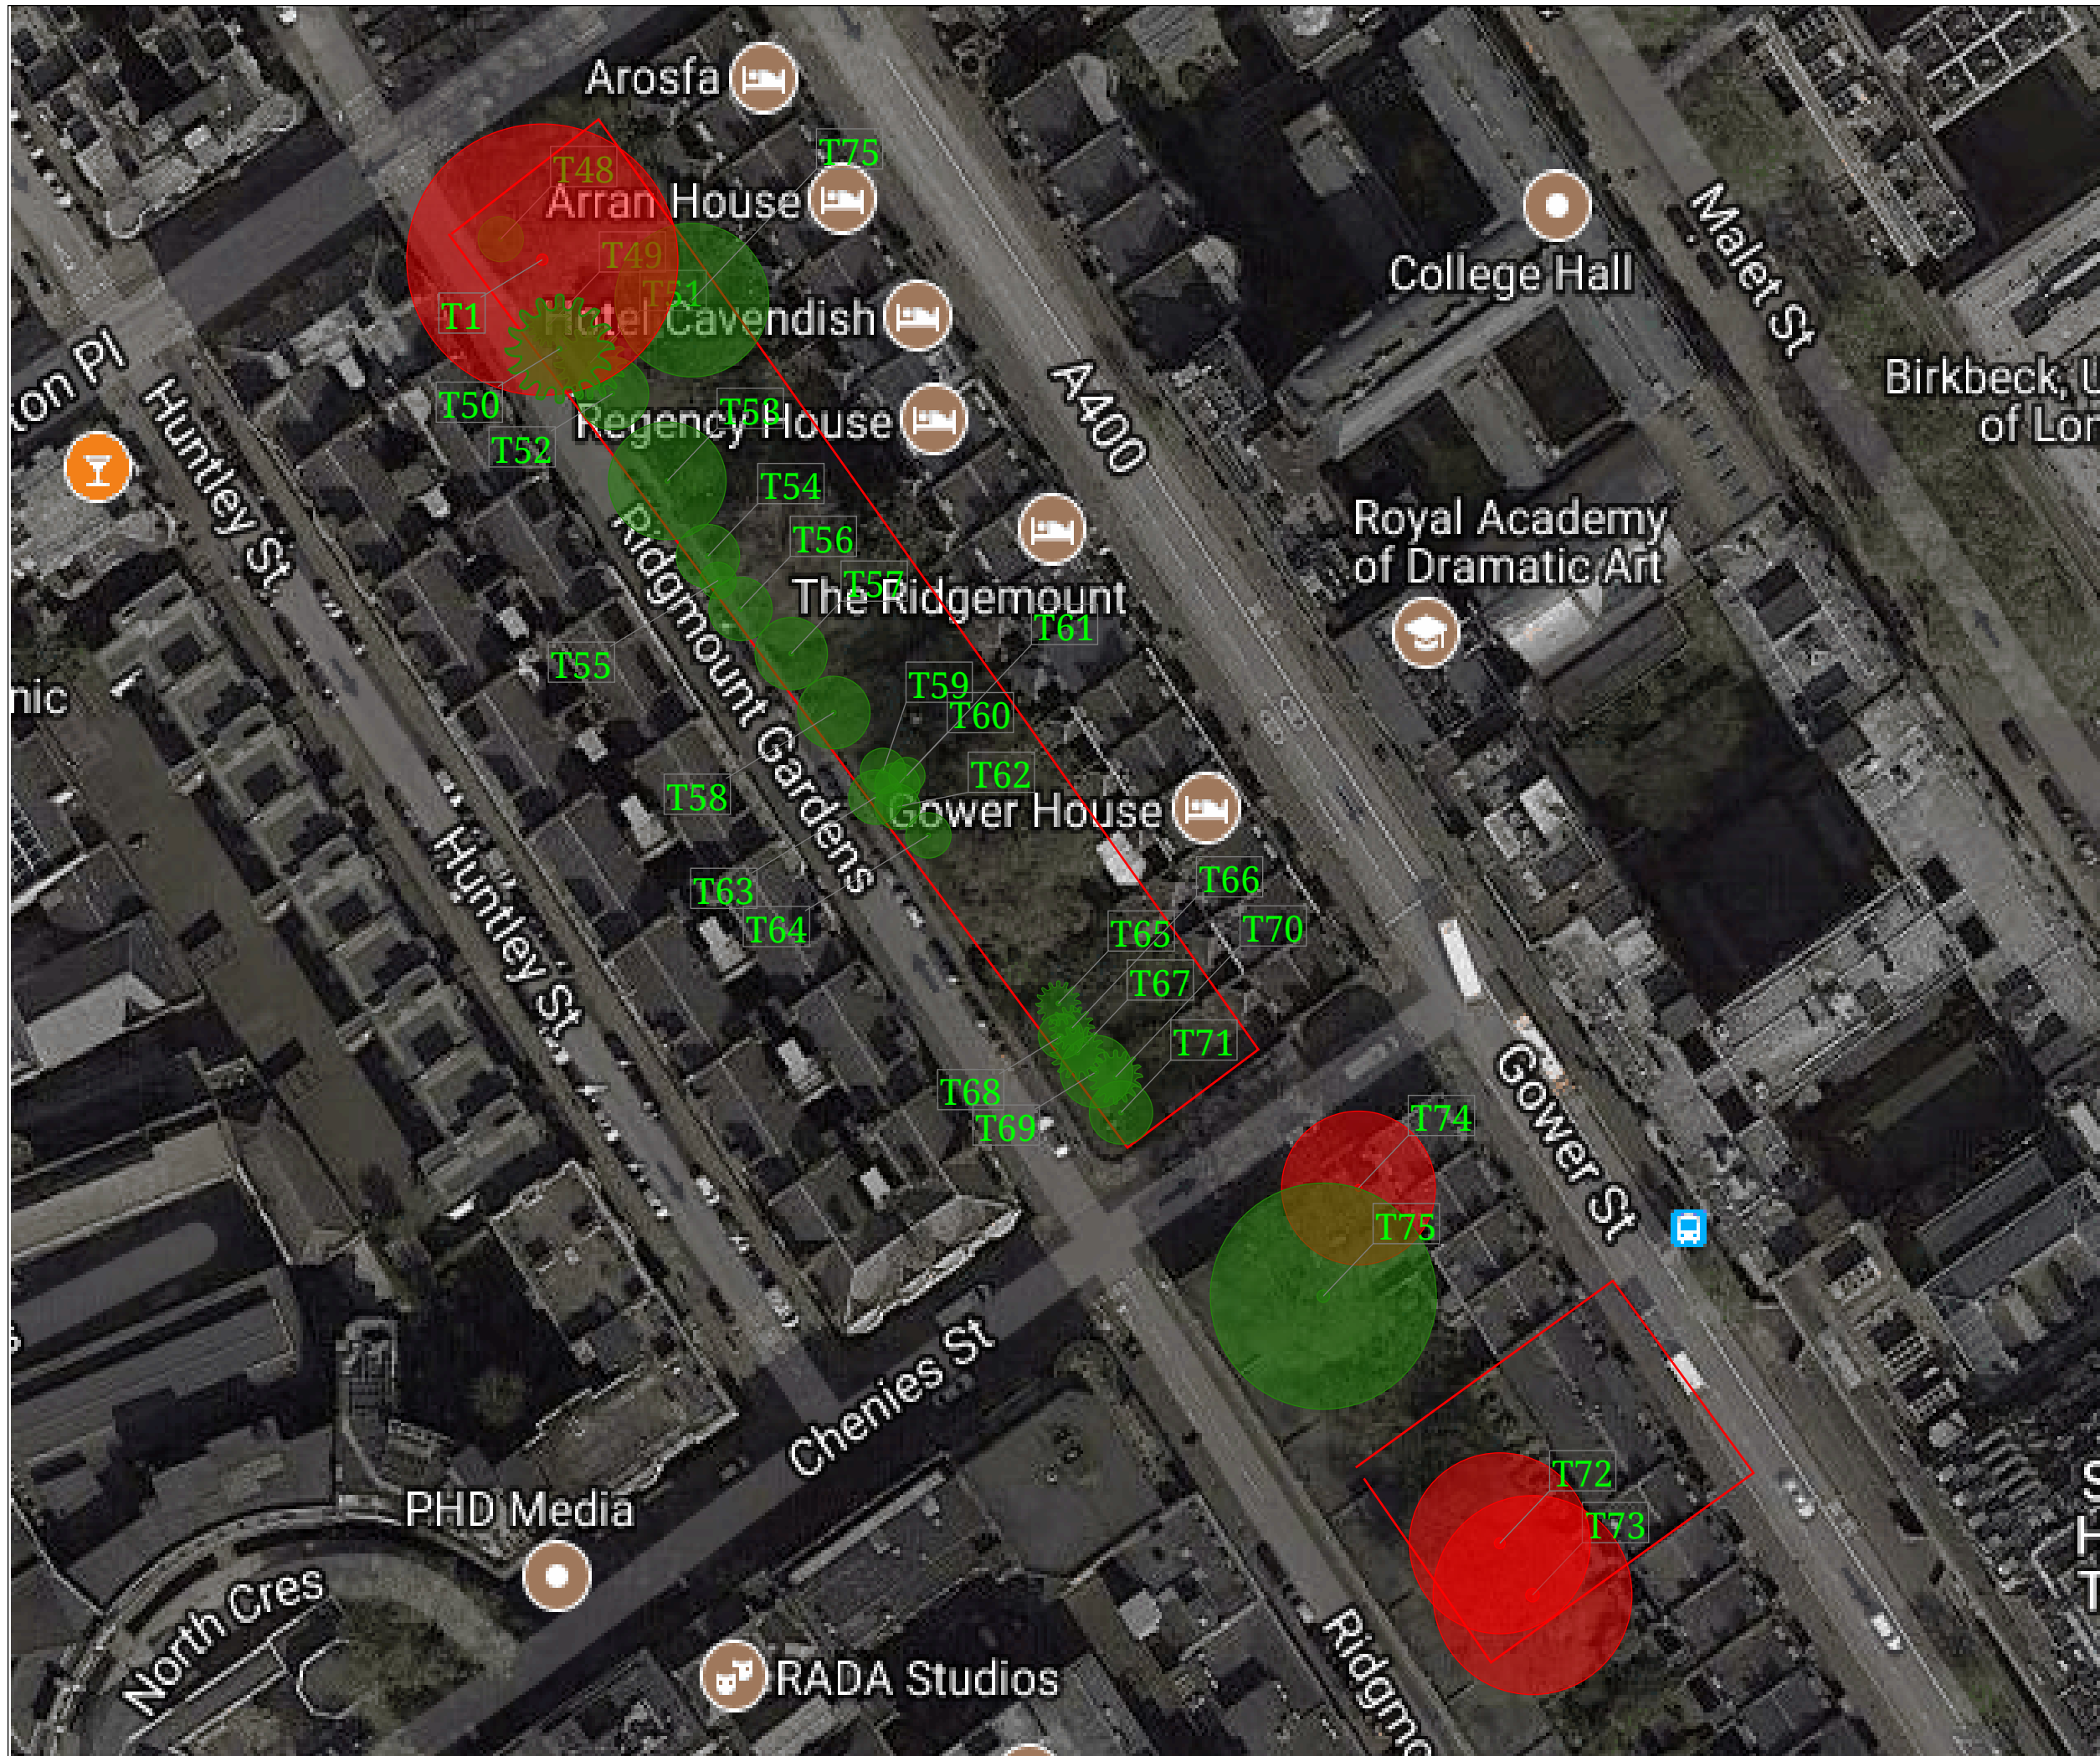
Gower Street (No. of Trees: 2)

Tree / Group No.	No. of Trees	Species	Height (m)	DBH (cm)	Crown spread (m)	Vitality	Age Class	Physiological Condition	Structural Condition	Targets	Condition Notes	Priority
											Recommendations	
T72	1	Platanus x hispanica London Plane	30.0	120	20.0	Moderate	Mature	Fair	Fair	Building within crown spread. Street lamp within crown spread.	Access to inspect base - Restricted / obscured. Base / stems obscured - Vegetation. Crown conflict - Structure / boundary / wire / tree. Epicormic growth - Crown. Pollard - Lapsed / Mature stems. Pruning wounds - Historic. Lift low canopy - Specified extent lift on west to clear building by 2m, remove deadwood and massaria branches, check crown for additional colonised branches not observed from ground level and remove those - PHOTOGRAPH IF COLONISATION IN EARLY STAGE TO PROVIDE EVIDENCE FOR COUNCIL	Within 6 months
T73	1	Platanus orientalis Oriental Plane cv.	30.0	150	22.0	Moderate	Mature	Fair	Fair	Building within crown spread.	Branch - Suspended. Crown conflict - Structure / boundary / wire / tree. Deadwood - Minor. Lift low canopy - Specified extent lift on west to clear building by 2m, remove deadwood and check for massaria - remove if found - check crown for additional colonised branches not observed from ground level and remove those - PHOTOGRAPH IF COLONISATION IN EARLY STAGE TO PROVIDE EVIDENCE FOR COUNCIL	Within 6 months

Tree / Group No.	No. of Trees	Species	Height (m)	DBH (cm)	Crown spread(m)	Vitality	Age Class	Physiological Condition	Structural Condition	Targets	Condition Notes	
											Recommendations	Priority
T74	1	Ailanthus altissima Tree Of Heaven	28.0	75	17.0	Moderate	Mature	Fair	Fair	Building within crown spread. Road junction within crown spread.	Arboricultural work - Recent. Crown conflict - Structure / boundary / wire / tree. Crown reduction - Historic. Fork - Suspected structurally sound. Unbalanced crown - Minor. recently cut back over property and road Reduce crown by - Specified extent reduce height and lateral branch length by approximately 2m, to suitable growth points, to relieve wind loading and minimise risk of branch failure remove any deadwood	Within 1 year

Tree / Group No.	No. of Trees	Species	Height (m)	DBH (cm)	Crown spread(m)	Vitality	Age Class	Physiological Condition	Structural Condition	Targets	Condition Notes Recommendations	Priority
T1	1	Platanus x hispanica London Plane	28.0	125	30.0	Moderate	Late Mature	Good	Fair	Building within falling distance of tree. Road within falling distance of tree. Tree overhangs neighbouring property.	<p>Access to inspect base - Restricted / obscured. Base / stems obscured - Vegetation. Branch weight - Heavy. Epicormic growth - Crown. Excavation within root zone - Burrowing. Form - Spreading crown. Ivy or climbing plant. Raised surface roots. Dimensions - Estimated due to inaccessibility.</p> <p>Remove debris / vegetation to allow inspection of base clear away ivy, vegetation and detritus to facilitate detailed inspection at base Climbing plant - Sever and strip clear away ivy to 2m to facilitate detailed inspection at base and strip from stem to prevent smothering of crown Reduce lateral limb / limbs reduce lateral limbs over gardens area by approximately 2-3m as appropriate and large regrowth to the south west over road by approximately 4m to relieve loading and minimise risk of failure leave furnishing growth to minimise visual impact, remove any deadwood, and massaria branches at approximately 15 & 20m to the east check crown for massaria colonised branches not observed from ground level and remove those - PHOTOGRAPH IF COLONISATION IN EARLY STAGE TO PROVIDE EVIDENCE FOR COUNCIL</p>	<p>Within 1 month</p> <p>Within 1 year</p> <p>Within 1 year</p>

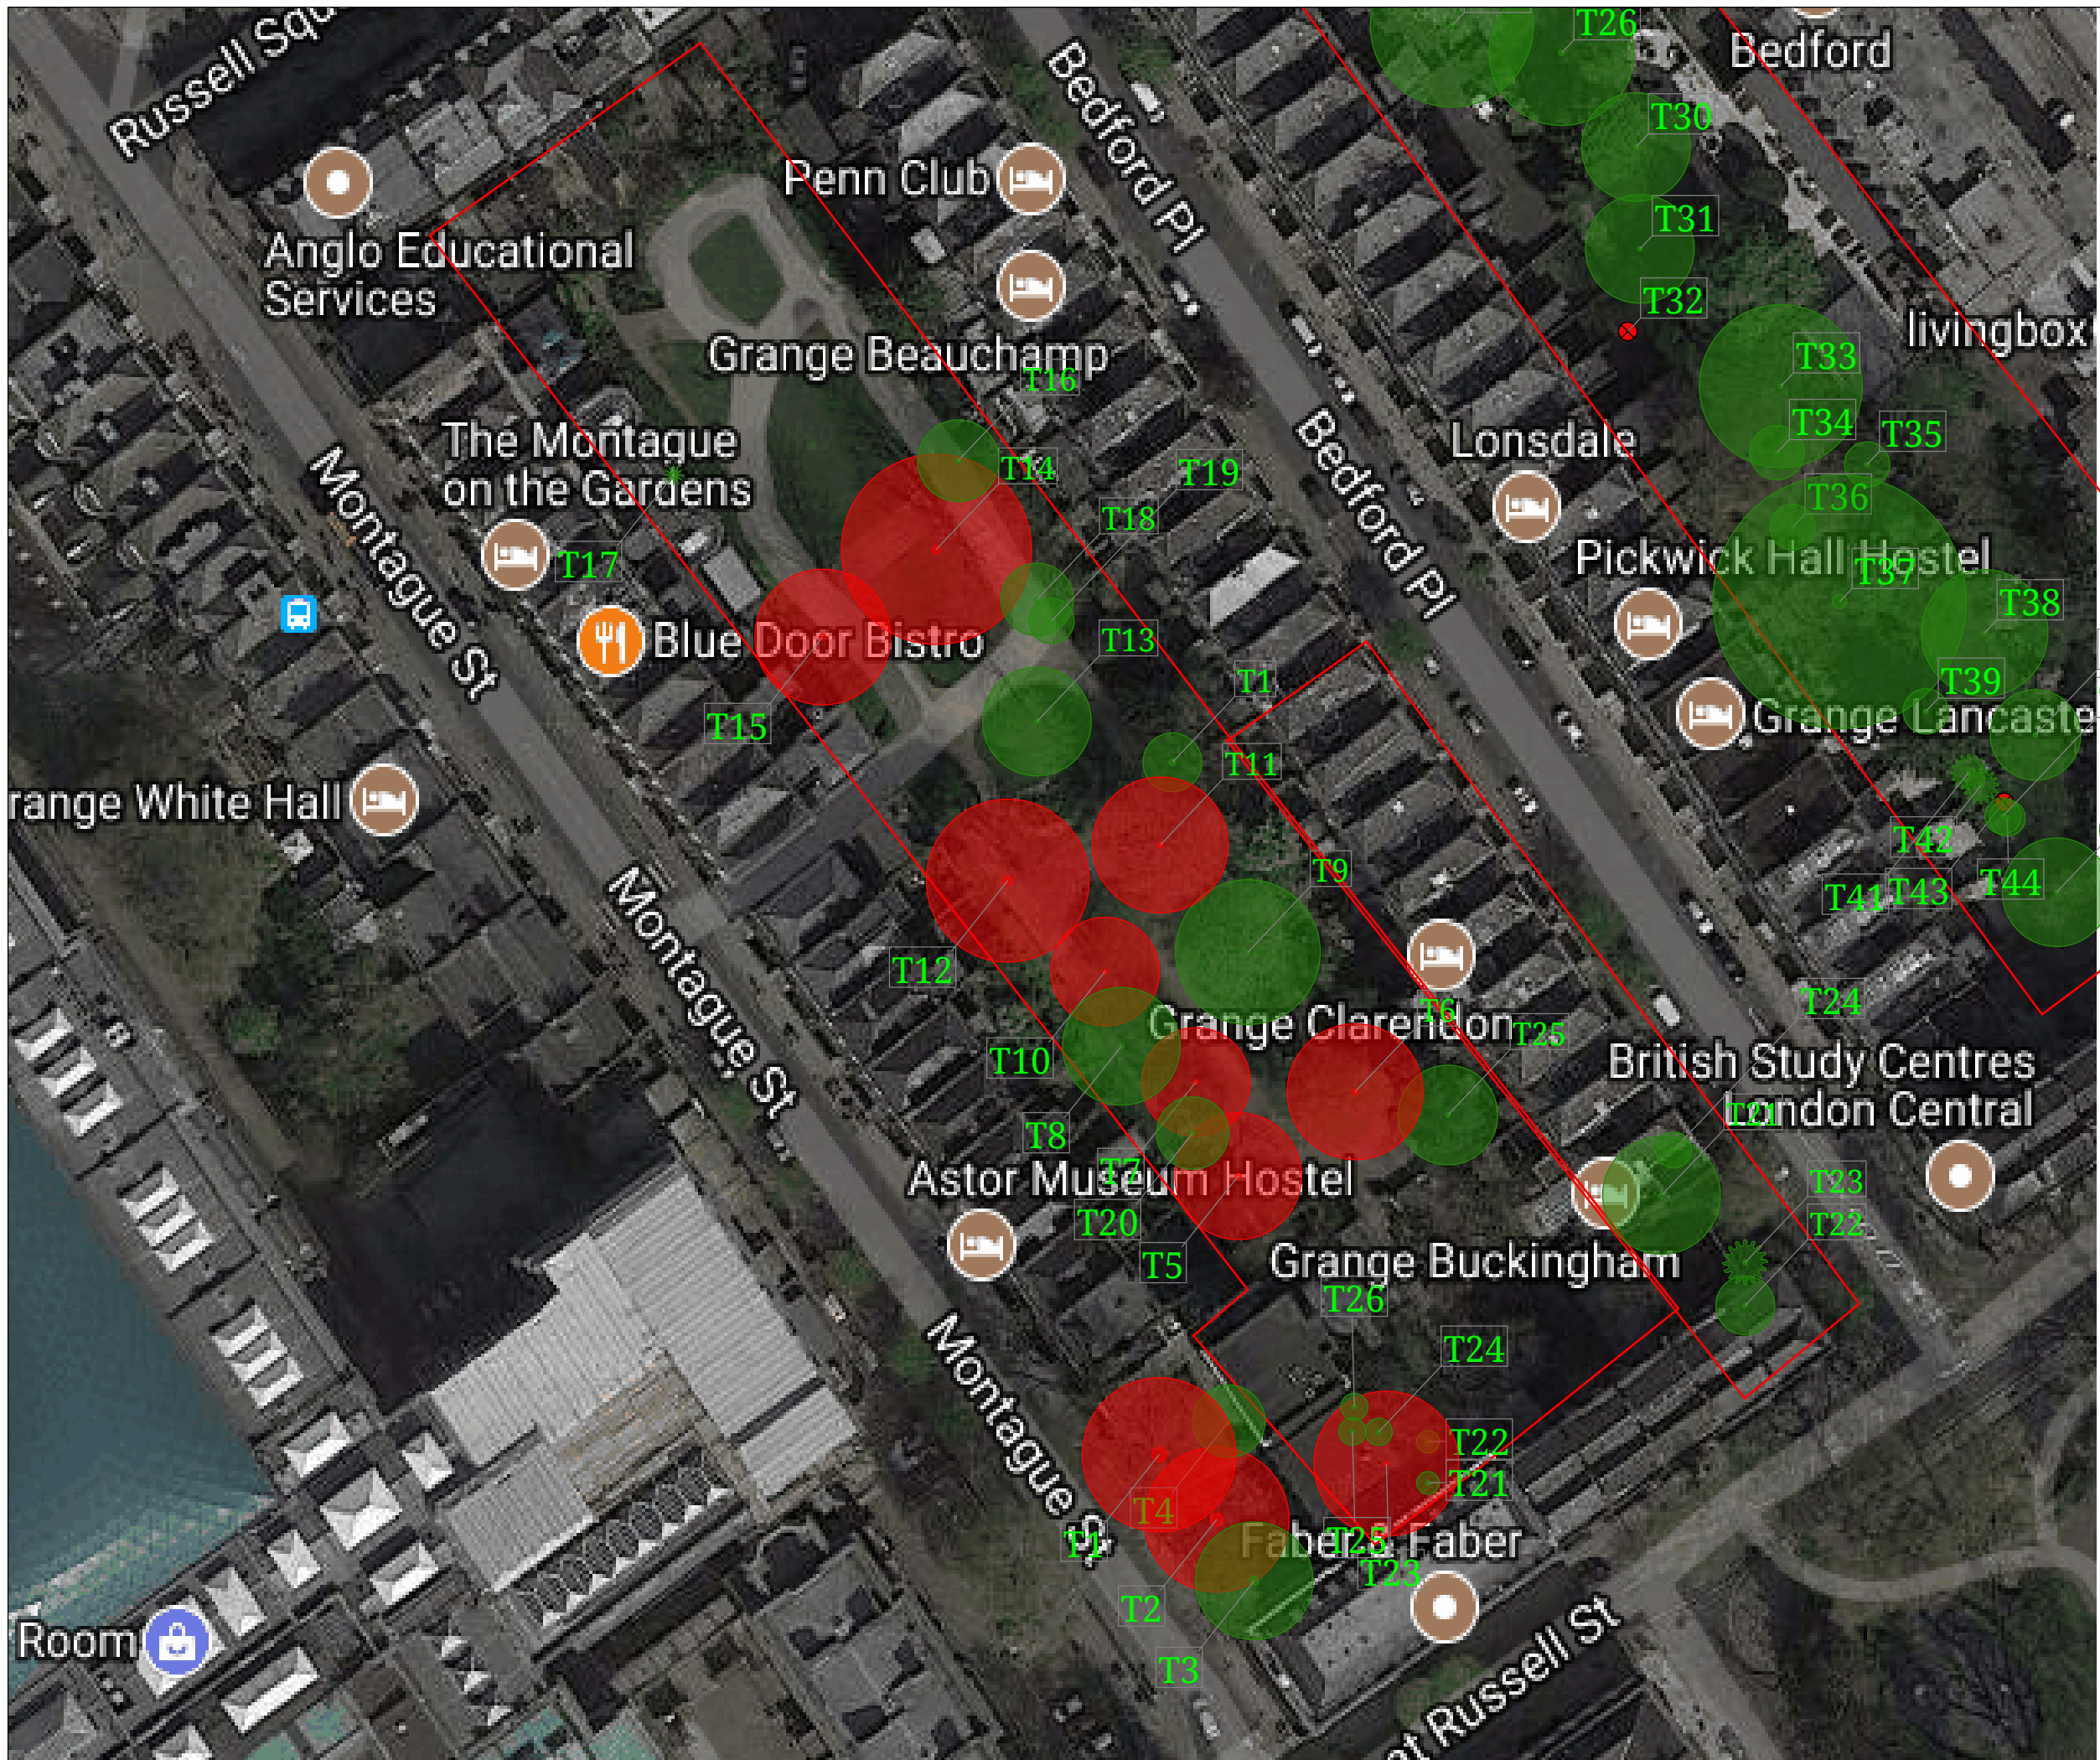
Montague Street (No. of Trees: 26)

Tree / Group No.	No. of Trees	Species	Height (m)	DBH (cm)	Crown spread(m)	Vitality	Age Class	Physiological Condition	Structural Condition	Targets	Condition Notes Recommendations	Priority
T1	1	Platanus x hispanica London Plane	28.0	160	17.0	Moderate	Mature	Fair	Fair	Building within crown spread. Footpath within crown spread. Road within crown spread.	Access to inspect base - Restricted / obscured. Base / stems obscured - Vegetation. Crown reduction - Recent. Decay / structural defect in crown limb / limbs - Open cavity / cavities. Epicormic growth - Crown. Reaction wood / Adaptive growth - Limb / limbs. End-weight reduction - Specified extent reduce lateral branch length over estate grounds to the north and east by approximately 2-3m to suitable growth points to relieve loading and minimise risk of failure	Within 1 year
T2	1	Platanus x hispanica London Plane	28.0	140	16.0	Moderate	Mature	Fair	Fair	Building within falling distance of tree. Footpath within crown spread. Road within crown spread.	Access to inspect base - Restricted / obscured. Base / stems obscured - Vegetation. Bark wound - Minor. Crown reduction - Recent. Epicormic growth - Crown. Foreign object - Ingrown metal. Fused limb / limbs. Ivy or climbing plant. tree has grown over railings End-weight reduction - Specified extent reduce lateral branch length over estate grounds to the east by approximately 2-3m to suitable growth points to relieve loading and minimise risk of failure	Within 1 year

T5	1	Catalpa bignonioides Indian Bean Tree	12.0	65	14.0	Moderate	Mature	Fair	Fair	Building within crown spread. Footpath within crown spread. Seating area within crown spread.	Arboricultural work - Historic. Bark wound - Minor. Crown conflict - Structure / boundary / wire / tree. Deadwood - Minor. Epicormic growth - Bole / principal stems. Form - Spreading crown. Leaning trunk - Minor. Exposed roots. Deadwood - Remove	Within 6 months
T6	1	Liriodendron tulipifera Tulip Tree	25.0	65	15.0	Moderate	Mature	Good	Good	Building within falling distance of tree. Footpath within crown spread. Seating area within crown spread.	Crown conflict - Structure / boundary / wire / tree. Deadwood - Minor. Form - Low canopy. Reduce lateral limb / limbs reduce lower lateral branches to the east by approximately 1.5m to address conflict with neighbouring holly tree, and remove deadwood	Within 6 months
T7	1	Catalpa bignonioides Indian Bean Tree	13.0	50	12.0	Moderate	Mature	Fair	Fair	Neighbouring property in falling distance. Footpath within crown spread.	Die-back - Upper crown. Decline - Evident / observed. Decay / structural defect in crown limb / limbs - Localised. Deadwood - Minor. Girdling roots - Minor. Leaning trunk - Minor. Rubbing limbs. Woodpecker holes. Reduce crown by - Specified extent reduce height and branch length by approximately 1-2m to suitable growth points, remove deadwood works recommended to relieve wind loading, minimise risk of branch or stem failure and encourage new growth in an attempt to revitalise the crown - final cuts to be <4cm diameter	Within 1 year

Tree / Group No.	No. of Trees	Species	Height (m)	DBH (cm)	Crown spread(m)	Vitality	Age Class	Physiological Condition	Structural Condition	Targets	Condition Notes	Priority
											Recommendations	
T10	1	Liquidambar styraciflua Sweet Gum	11.0	22	12.0	High	Early Mature	Fair	Poor	Neighbouring property in falling distance. Footpath within crown spread.	Arboricultural work - Recent. Die-back - Upper crown. Decay / structural defect in crown limb / limbs - Localised. Epicormic growth - Base. Form - Spreading crown. Shedding limb / limbs - Recent. large branch failure on central leader at approximately 4.5m above ground level likely summer branch drop Reduce crown by - Specified extent reduce height and branch length by approximately 3-4m to relieve wind loading and minimise risk of failure, reduce central leader (dying back) to beneath large tear wound and reduce long lateral branches by 2-3m, balance crown leaving furnishing growth to minimise visual impact	Within 1 year

T11	1	Cerasus avium Wild Cherry	17.0	60	15.0	Moderate	Mature	Fair	Poor	Tree overhangs neighbouring property. Footpath within crown spread.	Bark exudation. Crack - Longitudinal / shear crack. Deadwood - Minor. Decay / structural defect - Extensive. Form - Spreading crown. Poor past pruning. Pruning wounds - Historic. Root damage - Mechanical. Fell - Ground level fell tree due significant structural weakness caused by major crack in stem to north east - approximately one third of crown with high potential of failure over footpath and neighbouring property grind stump and roots to facilitate replanting Plant replacement tree plant extra heavy standard Aesculus flava	Within 3 months Within 6 months
T12	1	Catalpa bignonioides Indian Bean Tree	17.0	106	18.0	Moderate	Late Mature	Fair	Poor	Tree overhangs neighbouring property. Footpath within crown spread.	Arboricultural work - Recent. Branch weight - Heavy. Coalesced decay seam - Suspected. Die-back - Upper crown. Decline - Evident / observed. Decay / structural defect in crown limb / limbs - Localised. Deadwood - Minor. Decay / structural defect - Principal stems. cavity under base to the south, no decay visible. main leader visibly decayed with numerous holes Pollard - Specified pollard height remove main stems back to fork at approximately 7m from ground level, reduce lateral branches to south east by approximately 2-3m and reduce branch weight to the north west by removing northernmost section (cracked) back to upright branch (removed section approximately 5m x 17cm) to relieve loading and minimise risk of branch failure Fell - Ground level and grind stump to facilitate replanting Fell due to poor structural condition, particularly on the main leader with various pruning wounds, cavities, coalesced decay seams and cracks throughout crown, recent limb failures and potential for harm to staff or residents of neighbouring property Plant replacement tree plant extra heavy standard Taxodium distichum	Within 6 months Within 6 months Within 6 months

T14	1	Ailanthus altissima Tree Of Heaven	26.0	90	21.0	High	Late Mature	Fair	Fair	Neighbouring property in falling distance. Footpath within crown spread.	Branch weight - Heavy. Crown reduction - Historic. Decay / structural defect in crown limb / limbs - Suspected. Deadwood - Major. Form - Low canopy. Leaning trunk - Minor. Woodpecker holes. Reduce crown by - Specified extent reduce height and branch length by approximately 3m (or previous reduction points where appropriate) to reduce loading on stems with decay pockets and minimise risk of branch failure, continuing established management	Within 1 year

Tree / Group No.	No. of Trees	Species	Height (m)	DBH (cm)	Crown spread (m)	Vitality	Age Class	Physiological Condition	Structural Condition	Targets	Condition Notes Recommendations	Priority
T15	1	Ailanthus altissima Tree Of Heaven	20.0	70	15.0	Moderate	Mature	Poor	Fair	Neighbouring property in falling distance. Footpath within crown spread.	Crown reduction - Historic. Die-back - Lower crown. Die-back - Upper crown. Decay / structural defect in crown limb / limbs - Localised. Deadwood - Minor. Epicormic growth - Crown. Shedding limb / limbs - Historic. Woodpecker holes. Reduce crown by - Specified extent reduce crown to previous reduction points, continue established management, relieve loading on limbs with decay and minimise risk of branch failure	Within 1 year
T23	1	Sophora japonica Japanese Pagoda Tree	18.0	45	16.0	Moderate	Mature	Fair	Fair	Building within crown spread. Footpath within crown spread.	Crown conflict - Structure / boundary / wire / tree. Crown reduction - Historic. Die-back - Throughout crown. Decay / structural defect in crown limb / limbs - Localised. Deadwood - Major. Epicormic growth - Crown. Fused limb / limbs. Prune from adjacent structure cut back by approximately 3-4m over building to provide clearance and avoid damage/conflict with building remove deadwood throughout crown	Within 1 year
