TIM MOYA ASSOCIATES
ARBORICULTURE • LANDSCAPE • ECOLOGY

Project name:		Bedford Estates - Bedford Place
Drawing title:		160523 - Bedford Estates
Drawing number:	160523	Revision
Client:	Bedford Estates	
Agent:	TMA	
Date:	24/10/2017	
Scale:	1:700@A3

Health and Safety Tree Schedule & Works

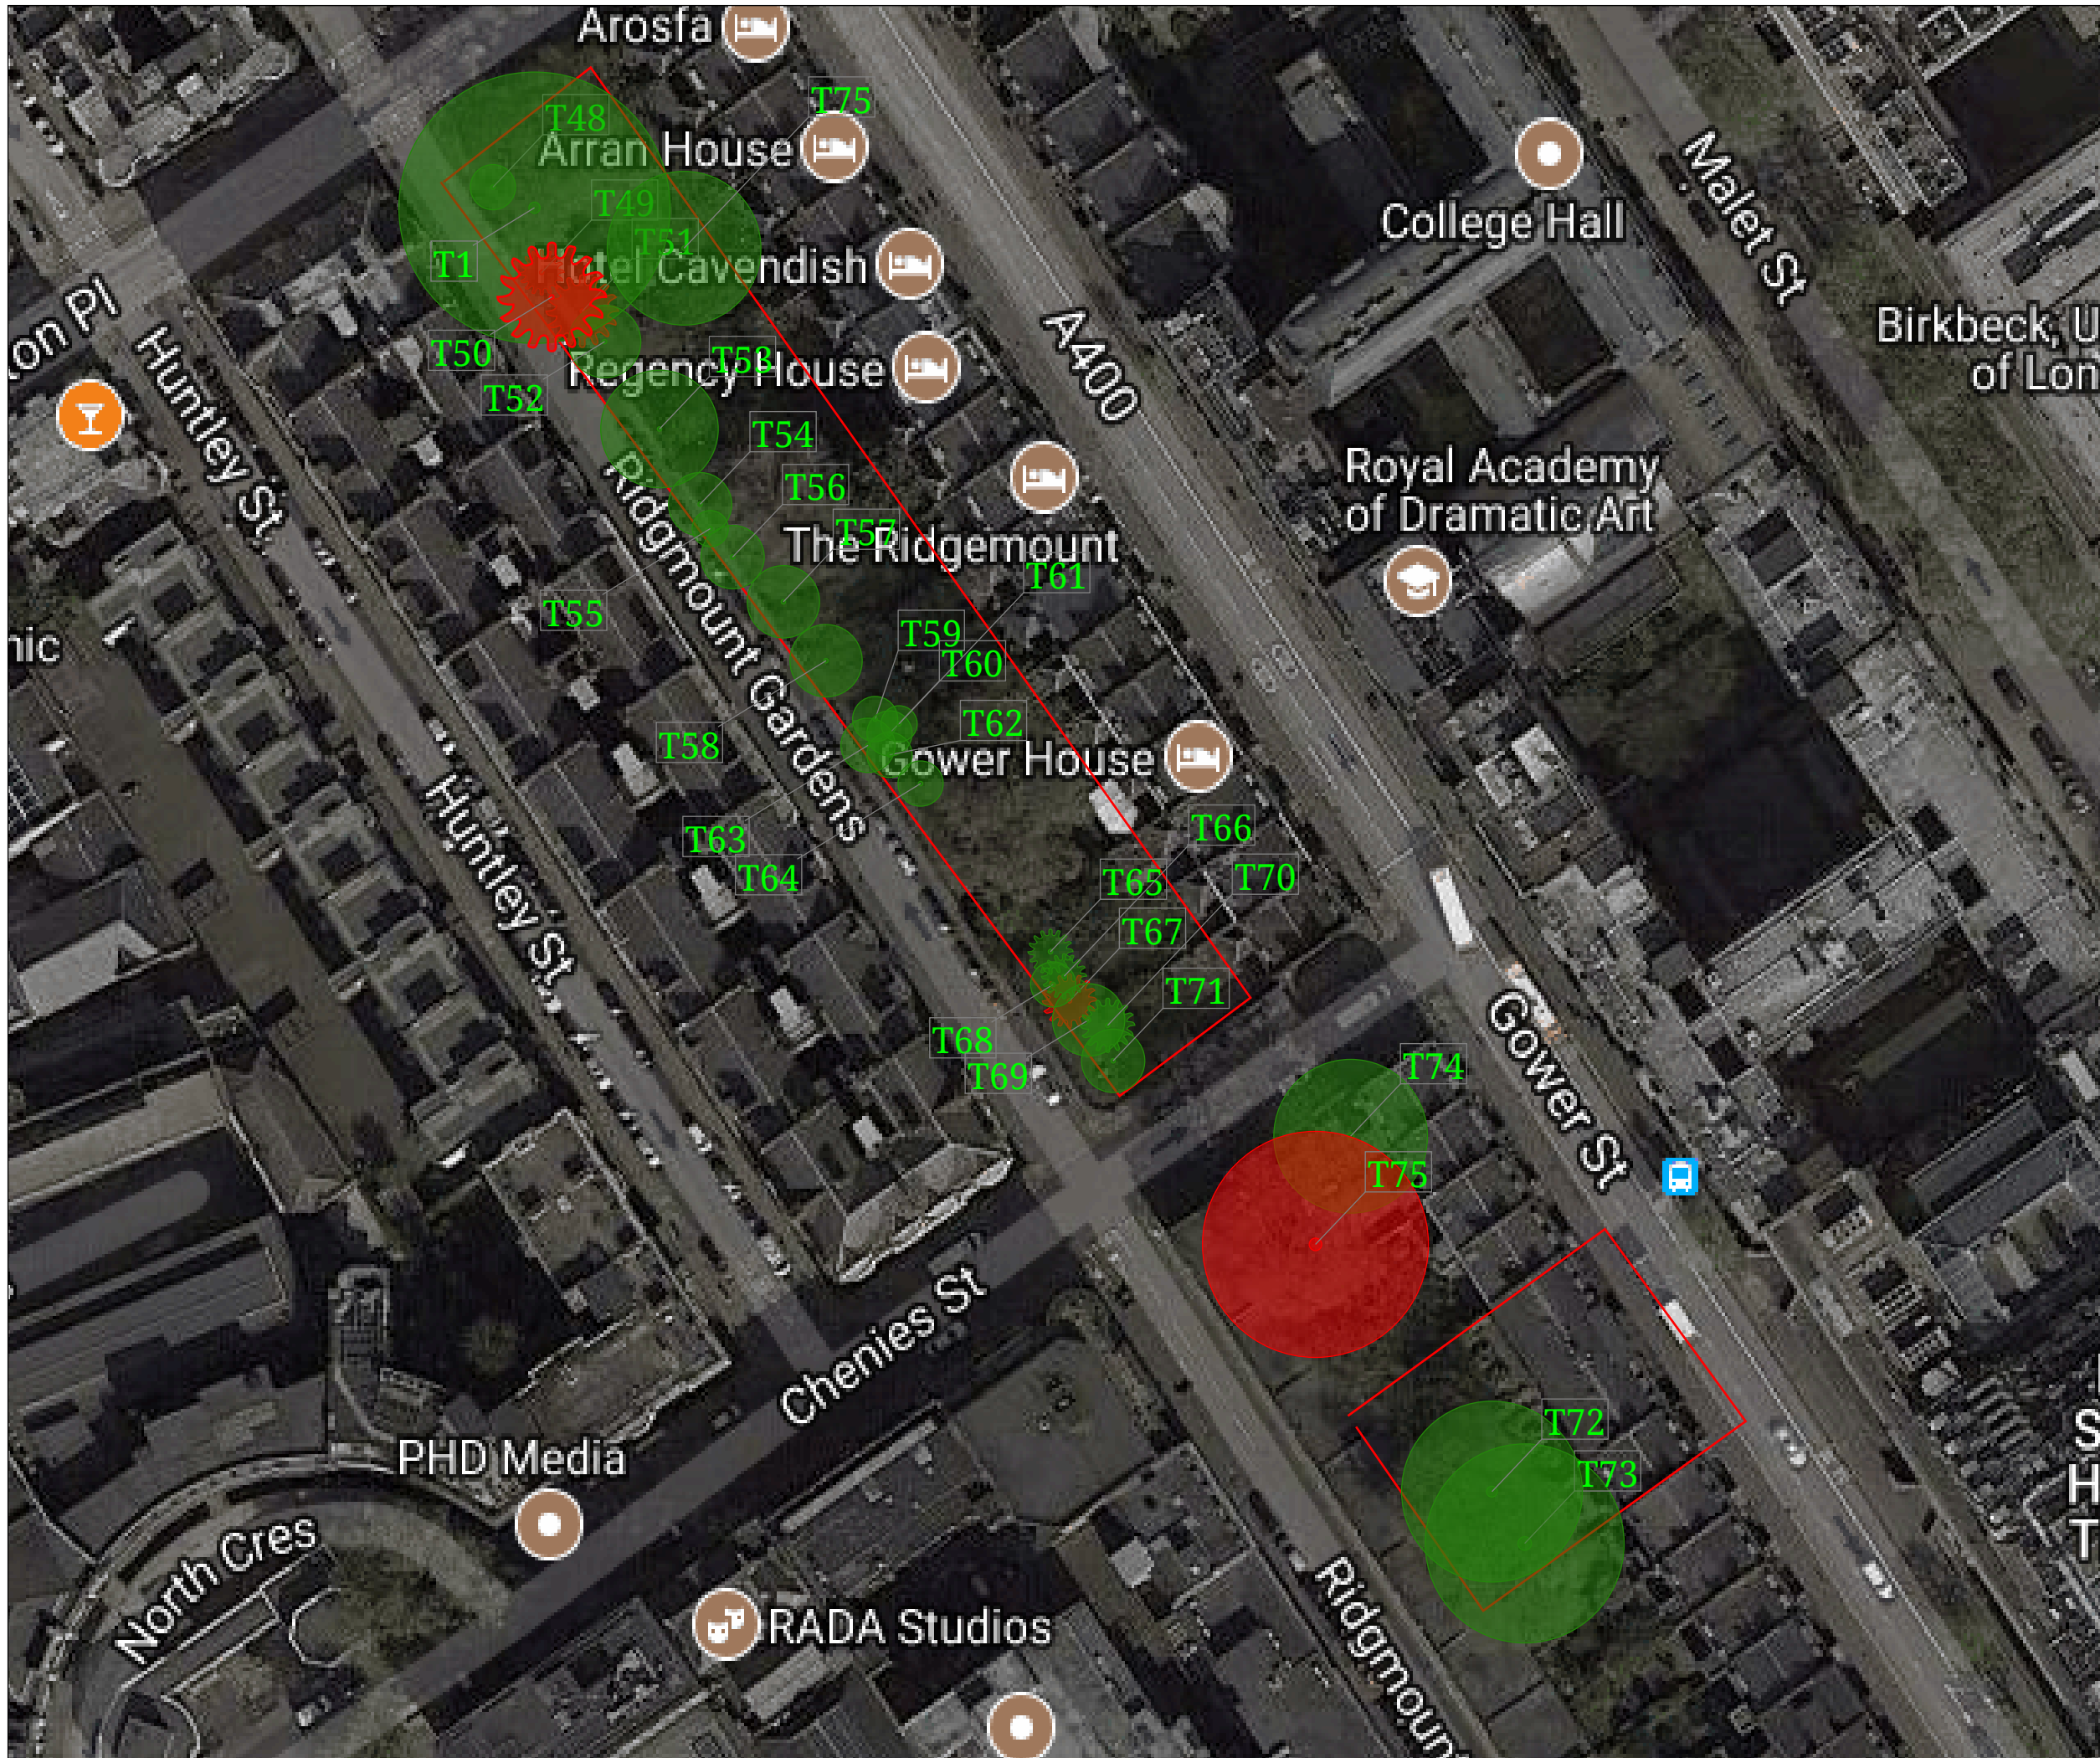
Ridgmount Gardens (No. of Trees: 24)

Tree / Group No.	No. of Trees	Species	Height (m)	DBH (cm)	Crown spread (m)	Vitality	Age Class	Physiological Condition	Structural Condition	Targets	Condition Notes Recommendations	Priority
T75	1	Platanus x hispanica London Plane	33.0	139	25.0	Moderate	Mature	Fair	Fair	Building within crown spread.	Buttresses / buttress roots - Undeveloped. Crown conflict - Structure / boundary / wire / tree. Form - Spreading crown. Reduce lateral limb / limbs reduce lower lateral limbs over building and rear garden area by approximately 2-3m as appropriate to relieve loading and minimise risk of failure leave furnishing growth to minimise visual impact, remove any deadwood, check crown for massaria colonised branches not observed from ground level and remove those - PHOTOGRAPH IF COLONISATION IN EARLY STAGE TO PROVIDE EVIDENCE FOR COUNCIL	Within 1 year

Tree / Group No.	No. of Trees	Species	Height (m)	DBH (cm)	Crown spread(m)	Vitality	Age Class	Physiological Condition	Structural Condition	Targets	Condition Notes Recommendations	Priority
T49	1	Cotoneaster sp. Tree Cotoneaster	4.0	26	5.0	Moderate	Mature	Fair	Fair	Footpath within falling distance of tree. Building within crown spread.	Deadwood - Minor. Leaning trunk - Major. Exposed roots. Suppressed crown - Major. Unbalanced crown - Major. branch resting on neighbouring wall Lift low canopy - Pedestrian clearance lift to 2.5m over footpath	Within 6 months
T50	1	Cotoneaster sp. Tree Cotoneaster	5.0	20	12.0	Moderate	Mature	Fair	Fair	Footpath within crown spread. Car parking below tree canopy.	Arboricultural work - Historic. Branch - Broken. Decay / structural defect in crown limb / limbs - Localised. Deadwood - Minor. Epicormic growth - Base / bole / principal stems. Form - Low canopy. Leaning trunk - Minor. Exposed roots. natural bracing between stems, branch is now moribund and apparently decayed End-weight reduction - Specified extent reduce lateral branches over road by approximately 1.5-2m to relieve loading on stem leaning toward road and remove low branches likely to otherwise impede access - branch which was providing natural bracing between stems has decayed	Within 6 months

T51	1	Cotoneaster sp. Tree Cotoneaster	6.0	26	8.0	Moderate	Mature	Fair	Fair	Neighbouring property in falling distance. Car parking within falling distance of tree.	Access to inspect base - Restricted / obscured. Base / stems obscured - Vegetation. Deadwood - Minor. Fork - Weak with included bark. Fused limb / limbs. Fused stems. historic stem failure, horizontal trunk at base fused stems/branches - natural bracing Lift low canopy - Pedestrian clearance lift to 3.5m over footpath	Within 6 months
T67	1	Cotoneaster sp. Tree Cotoneaster	5.0	26	6.0	Moderate	Mature	Fair	Fair	Footpath within crown spread.	Deadwood - Minor. Form - Spreading crown. Leaning trunk - Major. Suppressed crown - Major. Unbalanced crown - Major. Lift low canopy - Pedestrian clearance lift to 2.5m over footpath	Within 6 months

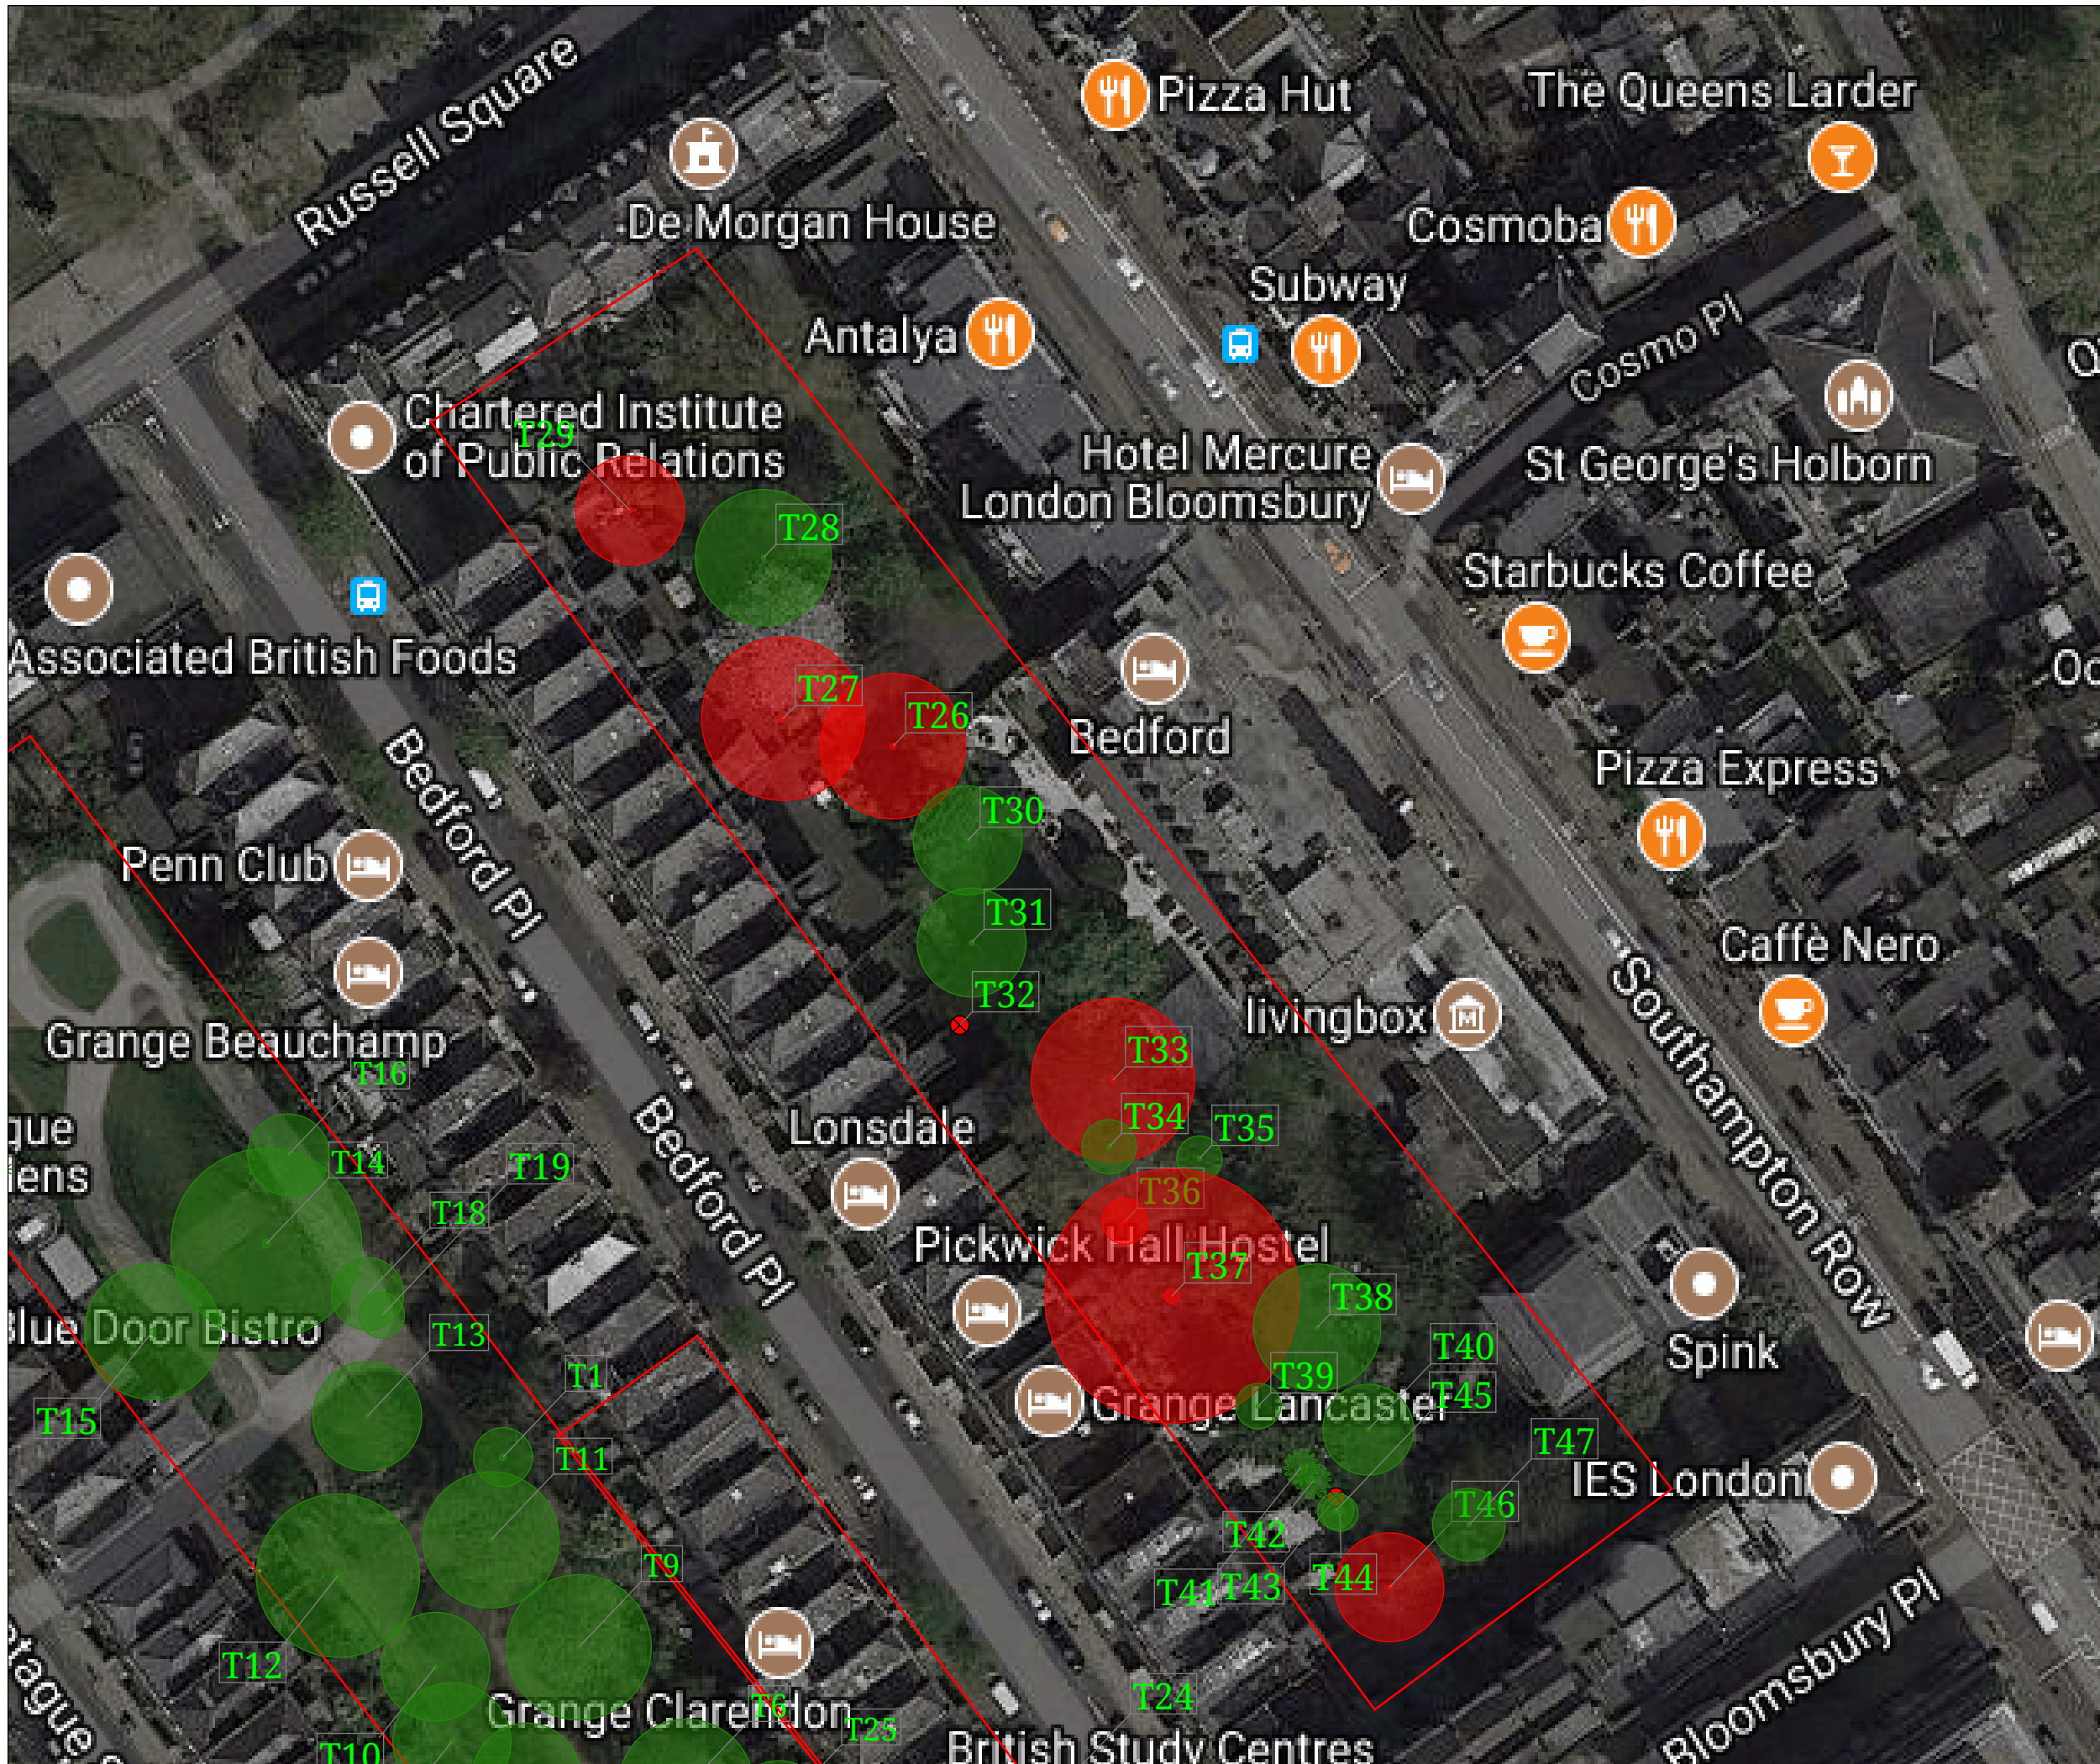
Southampton Row (No. of Trees: 22)

Tree / Group No.	No. of Trees	Species	Height (m)	DBH (cm)	Crown spread(m)	Vitality	Age Class	Physiological Condition	Structural Condition	Targets	Condition Notes Recommendations	Priority
T26	1	Tilia cordata Small Leaved Lime	18.0	60	16.0	Moderate	Mature	Fair	Fair	Seating area within crown spread. Car parking within falling distance of tree. Building within crown spread.	Access to inspect base - Restricted / obscured. Arboricultural work - Recent. Branch - Broken. Dense crown. Deadwood - Minor. Fork - Suspected structurally sound. Fork - Weak with included bark. Form - Spreading crown. Reduce lateral limb / limbs reduce lateral branches to east and west over car park and polytunnel by approximately 2-3m to relieve loading and minimise risk of failure, all final cuts to be made at suitable growth points	Within 1 year
T27	1	Cerasus avium Wild Cherry	19.0	60	18.0	Moderate	Mature	Fair	Fair	Tree overhangs neighbouring property.	Access to inspect base - Restricted / obscured. Arboricultural work - Historic. Branch - Broken. Deadwood - Minor. Fork - Weak with included bark. Fused limb / limbs. Ivy or climbing plant. Lesion or fracture on limb / limbs - Minor. fused limbs at approximately 5m, 2.5m above weak fork - natural bracing - must be retained Reduce lateral limb / limbs reduce lowest lateral branches to the west (over neighbouring property) by approximately 3m to minimise risk of failure. Remove pruning stubs and deadwood	Within 1 year

T29	1	Ailanthus altissima Tree Of Heaven	17.0	50	12.0	Moderate	Mature	Fair	Poor	Neighbouring property in falling distance.	Access to inspect base - Restricted / obscured. Base / stems obscured - Vegetation. Crown reduction - Historic. Decay / structural defect in crown limb / limbs - Localised. Decay / structural defect in crown limb / limbs - Open cavity / cavities. Hot spot on stem. Ivy or climbing plant. Pollard points - Structurally suspect. Tree not fully inspected due understory, inaccessibility and ivy. Unable to inspect tree(s) closely due to dense undergrowth/shrubs. Unable to inspect tree(s) closely due to ivy/climbing plant(s). Dimensions - Estimated due to inaccessibility. Reduce crown by - Specified extent reduce crown to previous reduction points Remove debris / vegetation to allow inspection of base clear away ivy and vegetation to 2m to facilitate detailed inspection at base and strip from stem to prevent smothering of crown	Within 1 year Within 1 year

T33	1	Aesculus hippocastanum Horse Chestnut	12.0	50	18.0	Low	Mature	Poor	Fair	Tree overhangs neighbouring property.	Branch weight - Heavy. Bark wound - Minor. Crown conflict - Structure / boundary / wire / tree. Deadwood - Minor. Foliar / bud damage - Insect. Form - Spreading crown. Leaning trunk - Minor. Pruning wounds - Decayed. large lateral limb removed Reduce lateral limb / limbs reduce lateral limbs over car park by approximately 2-3m as appropriate to relieve loading and minimise risk of failure leave furnishing growth to minimise visual impact - particularly over neighbouring property and to provide clearance from nearby Magnolia of 1-2m	Within 6 months

Tree / Group No.	No. of Trees	Species	Height (m)	DBH (cm)	Crown spread(m)	Vitality	Age Class	Physiological Condition	Structural Condition	Targets	Condition Notes Recommendations	Priority
T36	1	Acer pseudoplatanus Sycamore	9.0	10	5.0	High	Early Mature	Good	Good	Building within crown spread.	Crown conflict - Structure / boundary / wire / tree. Inappropriate retention costs. touching neighbouring property Fell - Ground level fell self-sown tree due inappropriate location, to prevent damage to building	Within 1 year
T37	1	Platanus x hispanica London Plane	30.0	160	28.0	Moderate	Mature	Fair	Fair	Building within crown spread. Tree overhangs neighbouring property.	Access to inspect base - Restricted / obscured. Base / stems obscured - Structure. Base / stems obscured - Vegetation. Branch weight - Heavy. Deadwood - Major. End-loaded limb / limbs. Ivy or climbing plant. Shedding limb / limbs - Recent. tree growing across property boundary Reduce lateral limb / limbs reduce heavy lateral branches to the north and south by approximately 4m and lateral branches to east and west by approximately 2m to relieve loading and minimise risk of failure, all cuts to be made to suitable growth points, leaving furnishing growth to minimise visual impact remove deadwood and massaria branches clear away climber and strip from stem and crown to prevent smothering of crown	Within 6 months

T46	1	Fraxinus excelsior Ash	16.0	40	12.0	Moderate	Mature	Fair	Fair	Tree overhangs neighbouring property.	Access to inspect base - Restricted / obscured. Base / stems obscured - Vegetation. Die-back - Upper crown. Deadwood - Minor. Ivy or climbing plant. Unable to inspect tree(s) closely due to ivy/climbing plant(s). Dimensions - Estimated due to inaccessibility. sparse crown Climbing plant - Sever and strip clear away ivy to 2m to facilitate detailed inspection at base and strip from stem to prevent smothering of crown	Within 6 months
