Arboricultural Consultancy for Covéa Insurance

1. Case Details

Scope of Report: To survey the property and determine significant vegetation contributing to subsidence damage, make recommendation for remedial action and assess initial mitigation and recovery prospects. The survey does not make an assessment for decay or hazard evaluation.

Property: 16 Goldhurst Terrace, London, NW6 3HU

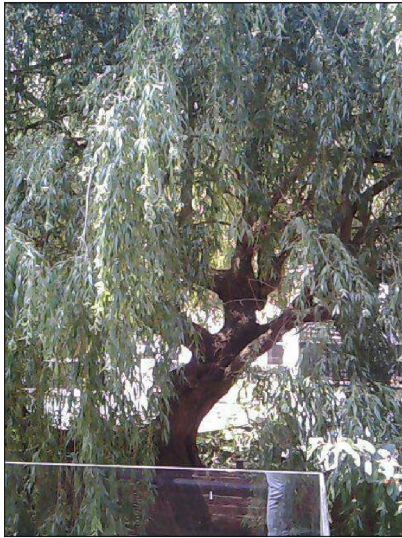
T1 - Willow (Weeping)

Please note that the footing of the insured property fall within the anticipated rooting distance of additional vegetation which we believe presents a foreseeable risk of future damage and accordingly we have made recommendations in respect of this.

Some of the remaining vegetation recorded (T1) was found to be at such proximity to the insured property that pruning to reduce the risk of future subsidence is not deemed viable (with a view to achieving long-term stability).

The only certain option in respect of mitigating future risk would be to remove as recommended.

Tree No.	Species	Age Cat	Approx. Height (m)	Distance to Building (m) *	Ownership	Action	Requirement
T1	Willow (Weeping)	3	14	6	C - Insured	Action to avoid future risk	Remove close to ground level and treat stump to inhibit regrowth.
T2	Lime	1	15	15	A - Third Party 20 Goldhurst Terrace London NW6 3HU	Action to avoid future risk	Crown reduce by 3m – 4m all around and maintain at reduced dimensions by way of regular re-pruning (3-year max).
TG1	Lime	1	7	10	A - Third Party 14 Goldhurst Terrace London NW6 3HU	Action to avoid future risk	Do not allow to exceed current dimensions by way of regular pruning.
Age Cat: 1 = Younger than property; 2 = Similar age to the property; 3 = Significantly older than property

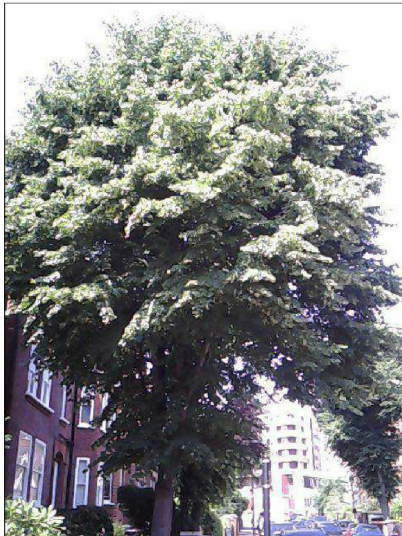
T3 - Lime

Based on our observations on site, T3 (Lime) will, in our opinion, be the source of the *Tilia* spp roots recovered from TP/BH1.

In assessing the potential drying influence of the vegetation on site, T3 (Lime) is clearly the dominant feature proximate to the front elevation of the insured property and accordingly we have identified it as the principal cause of the subsidence damage.

The size, orientation and proximity of T3 (Lime) is consistent with the location of damage and mechanism of movement.

Removal of T3 (Lime) will offer the most certain and reliable arboricultural solution likely to restore long-term stability.

Tree No.	Species	Age Cat	Approx. Height (m)	Distance to Building (m) *	Ownership	Action	Requirement
T3	Lime	1	14	5	C - Insured	Remove	Remove close to ground level; do not treat stump due to translocation risk. Where such a risk exists, we advise that any emergent regrowth is removed annually.
Age Cat: 1 = Younger than property; 2 = Similar age to the property; 3 = Significantly older than property
