Claim Assessment Report

On behalf of **Covéa Insurance**

Report Date: 07 April 2017

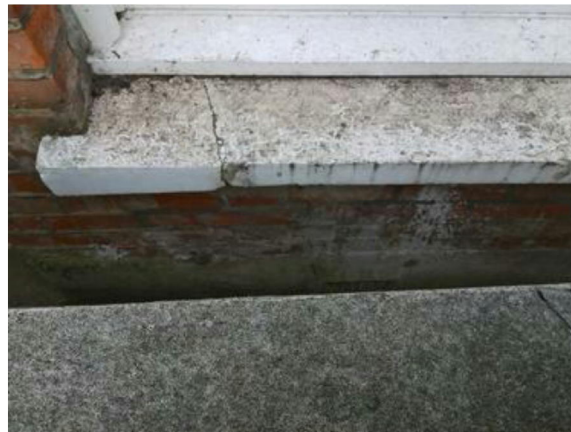
FIGURE 03 Below front bay

Cracking below the front bay at lower ground floor level, dropped brick arch and 2mm cracking above the lower ground floor centre window.

Generally cracks 1mm wide or less will be filled (internal) or re-pointed (external). Internally, where the cracks are wider than 1mm, but less than 5mm the underlying brickwork or blockwork will be exposed and prior to making good the plaster finishes the cracking will be covered with expanded metal lathe. Where cracks are 5mm across or wider, some form of bed joint reinforcement will be introduced.

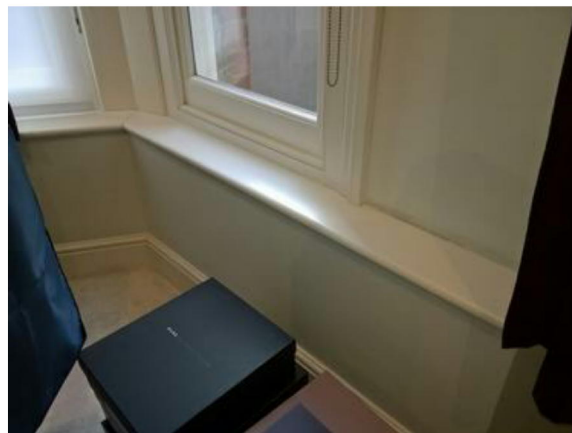
FIGURE 05 Lower front bedroom bay

1mm cracking to the front bay, around the window and by the door to the en-suite. Bedroom door is also binding.
