# Supplementary Engineer's Report

Report Date	30 <sup>th</sup> November 2017
Policyholder	16 Goldhurst Terrace Limited
Address	16 Goldhurst Terrace, London, NW6 3HU

## INTRODUCTION

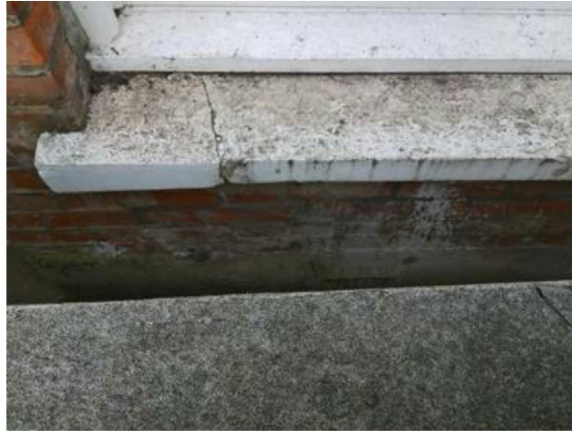
Fig 01 – Below front bay

- Cracking below the front bay at lower ground floor level, dropped brick arch and 2mm cracking above the lower ground floor centre window.

The indicated mechanism of movement is a seasonal, downward movement of the front of the property.

It is common practice to categorise the structural significance of the damage in this instance, the damage falls into Category 1 (Very Slight).

Where it is possible to mitigate further movement by removal of the implicated vegetation, we consider that superstructure repairs alone will suffice. The current estimated cost of this work is £3986.68. Where it is not possible to prevent further damage caused by seasonal movement induced by the effects of the implicated vegetation, it will be necessary to stabilise the building by foundation augmentation.
