CERTIFICATE OF REOCCUPATION

Report	J410800/HQ02	Date: 16 Oct 2017	Time arrived on site: 09:15
Client Name	Medway Insulations Ltd		
Address	7 Viewpoint, Boxley Road, Penenden Heath, Maidstone, Kent, ME14 2DZ		
Name, address and contact information for contractor	Medway Insulations Ltd, 7 Viewpoint, Boxley Road, Penenden Heath, Maidstone, Kent, ME14 2DZ		
Site address for clearance	76669 / AB077 - 19-21 High Holborn, Grays Inn Chambers,, WC1R 5ET		
Detail scope of works in method statement areas to be assessed and brief description of works i.e. AIB/ spray coating insulation/cement	The removal and disposal of thermal insulation debris to walls, ceiling and floor including the environmental clean of area within 6th floor boiler room at 19-21 High Holborn. All works under fully controlled conditions.		
STAGE 1 OF 4 - PRELIMINARY SITE ASSESSMENT			
Plan of work defines entire working area	Yes	Hygiene facilities operating and clean	Yes

CLIENT: Medway Insulations Ltd 7 Viewpoint Boxley Road Penenden Heath Maidstone Kent ME14 2DZ	SITE: 76669 / AB077 - 19-21 High Holborn Grays Inn Chambers, WC1R 5ET	CONTRACTOR: Medway Insulations Ltd, 7 Viewpoint, Boxley Road, Penenden Heath, Maidstone, K

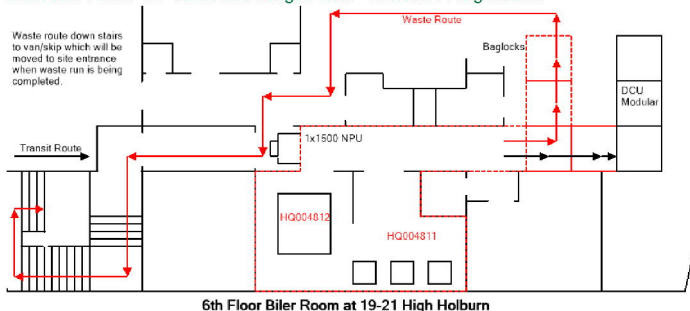
Enclosure Width: 4m Enclosure Length: 4.7m Enclosure Height: 2.5m
