**Hampstead manor project
Kidderpore avenue
Hampstead
London
NW37ST**

On Monday the 30/10/17 Langley Arboriculture Ltd have been asked by **Gareth Guest of Mount Anvil Ltd** to look at all trees at **Hampstead Manor Project**.

With a view to carrying out some remedial tree surgery on identified trees that we have recommended work to be carried out on.

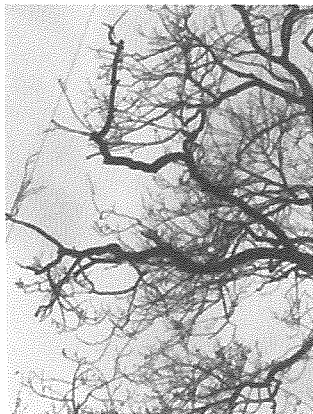
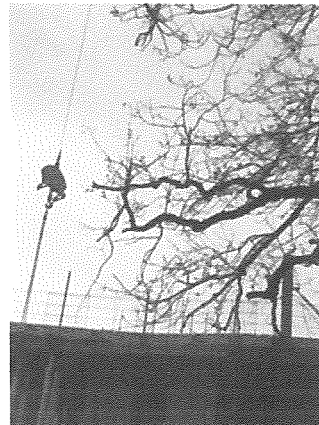
(T6) Ash tree:

Looking around the base of this tree there are no signs of any movement or any fungal fruiting bodies at the time of our site visit.

Moving up main stem and into the trees canopy the tree is showing signs of apical die back also some minor damage on some of the branches, Gareth Guest the site manager has asked us to remove all dead wood and also tidy up damaged branches. As these branches at present time are overhanging new builds seating area. Looking around this location there are a number of dead branches which have been blown out of the tree in high winds.

Carryout dead wooding operation in the interests of safety to protect work force on site and residents when they move in to their new homes. Also tidy up all damaged branches back to suitable growth points as per BS3998- revised 2010.

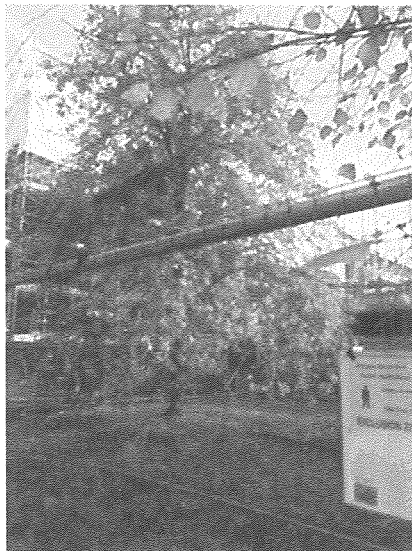
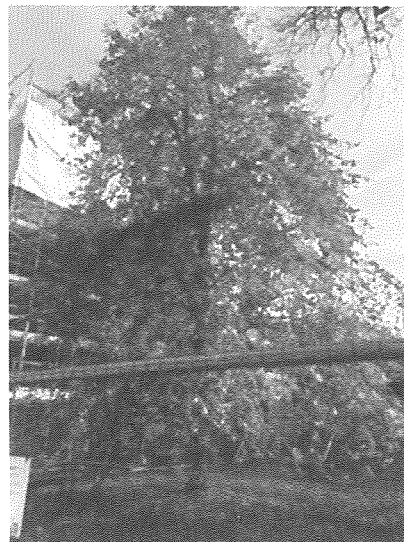
(T9) Lime tree:

Looking around the base of this tree there are no signs of any movement or any fungal fruiting bodies at the time of our site visit.

Looking up into the trees canopy there are a number of broken branches lodged within the tree these will need to be removed in the interests of safety, also the tree would benefit by a 20% crown thin and as this tree is under mature in age this help the tree to have a well-balanced and even crown. This will let air and light penetrate the tree and reduce wind sail.

Remove all damaged branches prune back to suitable growth points as per BS3998 – revised 2010. Also, carryout crown thin by 20%.

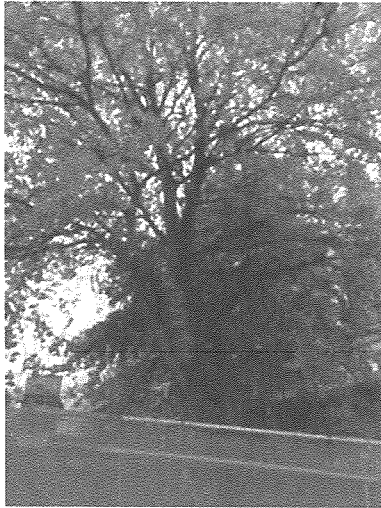
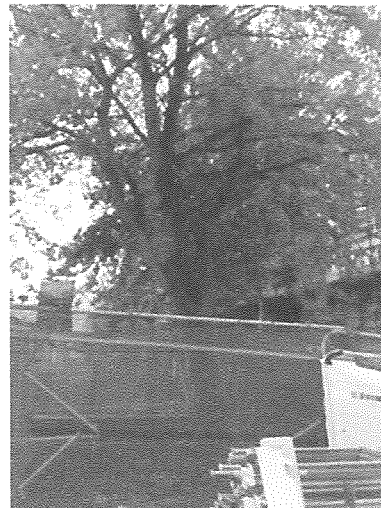
(T20) Oak tree:

Looking around the base of this tree there are no signs of any movement or any fungal fruiting bodies at the time of our site visit.

Looking up into the trees canopy there are a number of dead branches throughout the tree which will need to be removed in the interests of safety due to high target area.

To remove deadwood from crown of tree and tidy up any damaged branches, all work to be carried out to BS3998 – revised 2010.

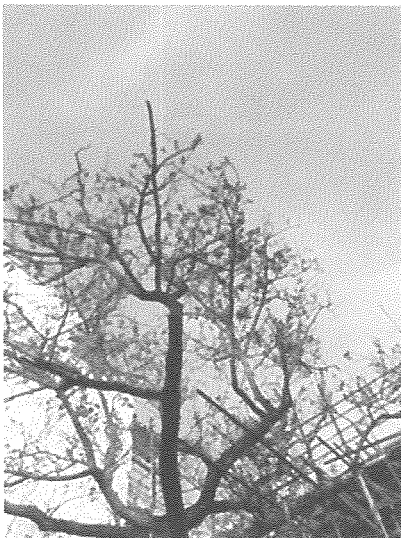
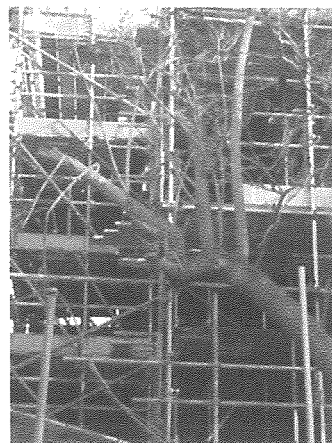
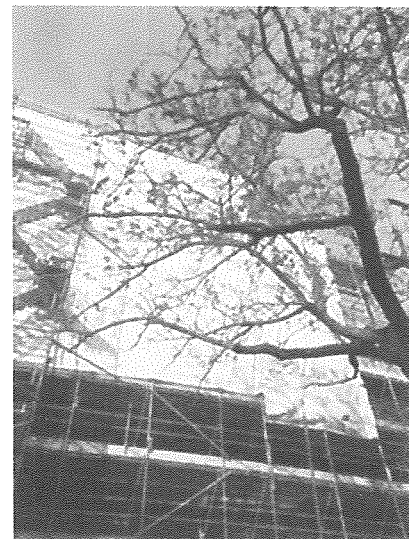
(T52) Polonia tree:

Looking around the base of this tree there are no signs of any movement or any fungal fruiting bodies at the time of our site visit.

Looking up into the trees canopy there are signs of broken off branches which are showing old stumps with suitable growth points growing on them. We would suggest being cut back to suitable growth points. Also, there are a number of dead branches which are overhanging walkways, these will need to be removed in the interests of safety.

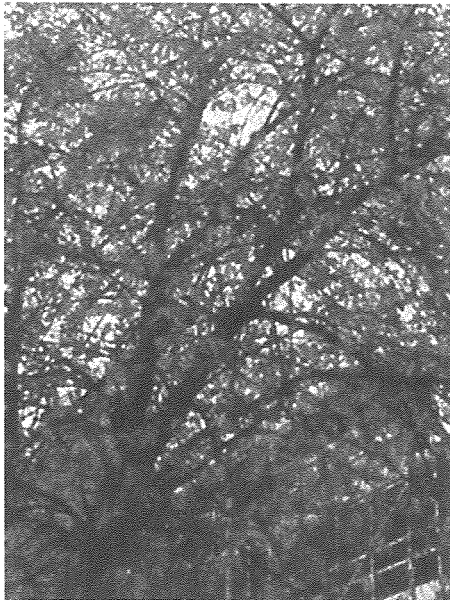
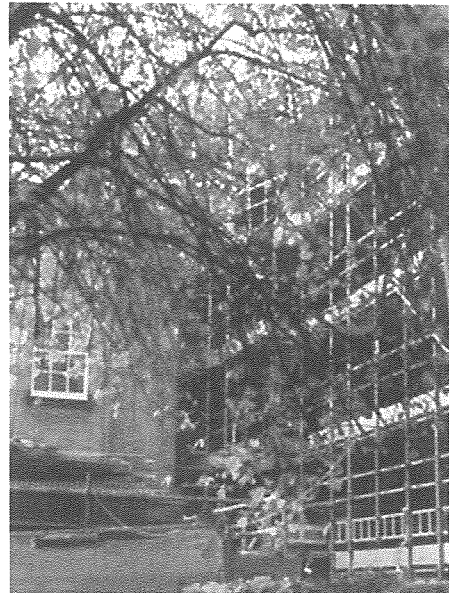
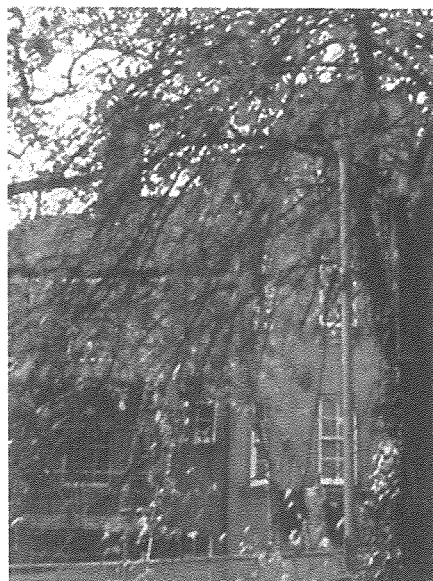
(T53) Bird cherry:

Looking around the base of this tree due to ivy clad around base of tree and growing up main stem we are unable to see if tree is moving or any fungal fruiting bodies are present at the time of our site visit. So, we have asked to have the ivy cut to allow it to die off. This will benefit the tree. Also, the lower branches are overhanging walkway which will need to be raised to approx. 8 feet all round this keep the crown balanced. We would also suggest that the crown would benefit a crown thin by 20% which then would allow air and light to penetrate the tree.

Cut and remove ivy from tree, carryout crown thin by 20 %, crown raise all round to approx. 8 feet.

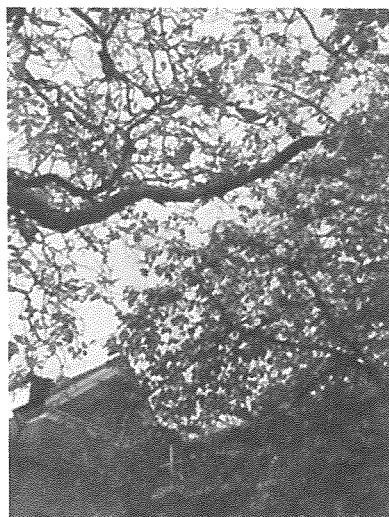
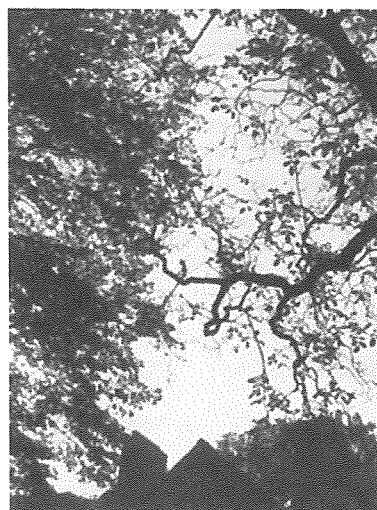
(T1) Walnut tree:

Looking around the base of this tree there are no signs of any movement or any fungal fruiting bodies at the time of our site visit.

Moving up into main stem there are a number of dead branches which need to be removed in the interests of safety due to high target area.

To remove all deadwood this is to be done in winter if not when tree is in full leaf, due to in spring the tree will bleed heavily.

All work to be carried out to BS3998 – REVISED 2010.

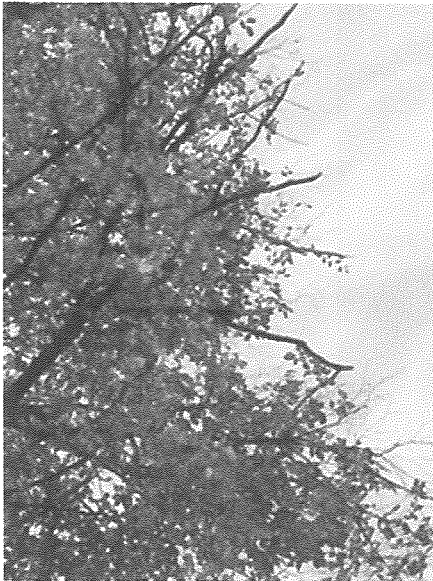
(T50) Hornbeam:

Looking around the base of this tree there are no signs of any movement or any fungal fruiting bodies at time of our site visit. Moving up into the trees canopy on south elevation there are some branches that have been damaged some time age, these will need to be prune back to suitable growth points. Also on north elevation again there are a number of branches with some damage again these need to be pruned back to suitable growth points as per BS3998 – REVISED 2010.

Prune all damaged branches back to suitable growth points, and remove any major deadwood. All work to be carried out in winter or when the tree is in full leaf due to heavy bleeds in spring.

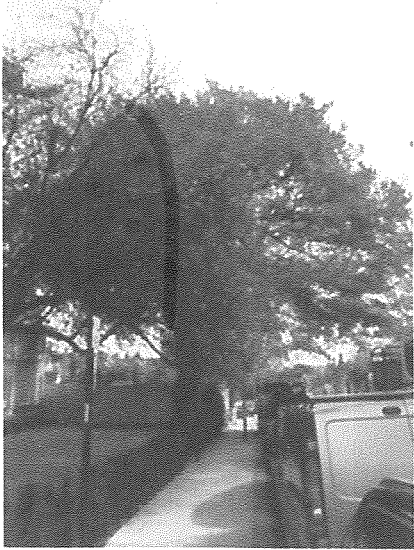
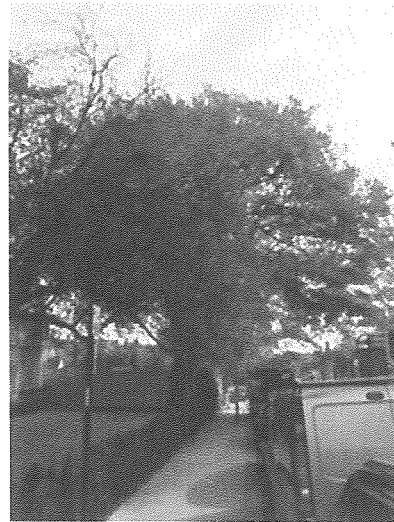
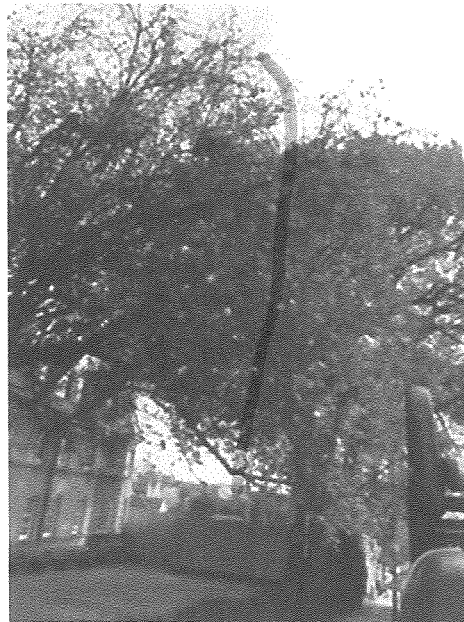
(T34) Purple leaved plum tree:

Looking around the base of this tree there are no signs of any movement or any fungal fruiting bodies at the time of our site visit. But this tree is leaning and overhanging the foot path, at kidderpore avenue. Which will be problem for members of public walking into branches when walking by.

Reduce side branches back to suitable growth points 1.5 metres, this will clear the walkway also this will reduce end loading on the tree.

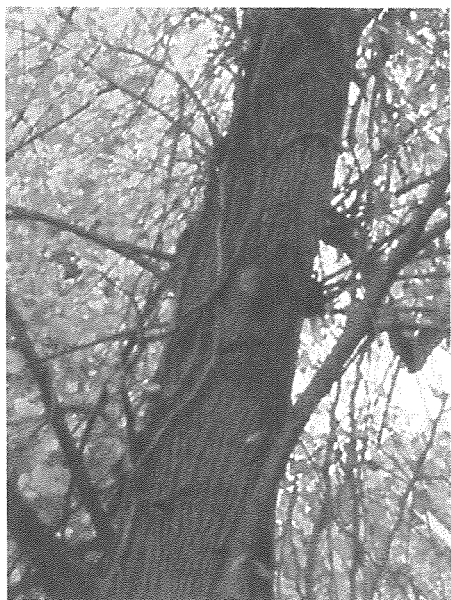
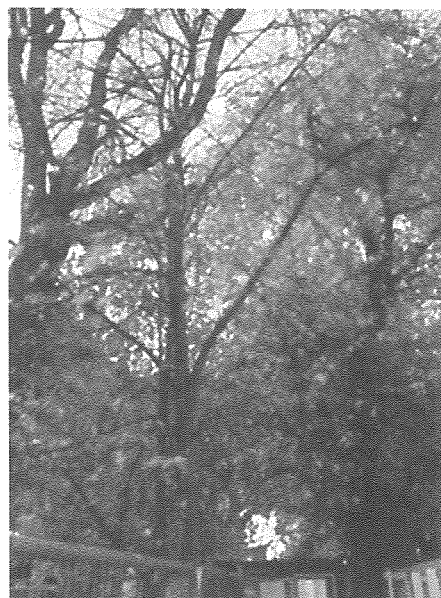
(T5) Lime tree:

Looking around the base of this tree there are no signs of any movement or any fungal fruiting bodies at the time of our site visit. Looking up the main stem the ivy has been cut and now has died which will need to be removed. Moving up into the trees canopy we suggest that any deadwood is removed in the interests of safety.

Remove dead ivy and also any deadwood throughout the crown of the tree.
