# Health & Safety Duty of Care Report©

Site: 4 The Grove, Highgate, London N6 6JU

Client: Jamie Oliver c/o Tim Dignum

Date: October 2017 Surveyor: Hugo Loudon

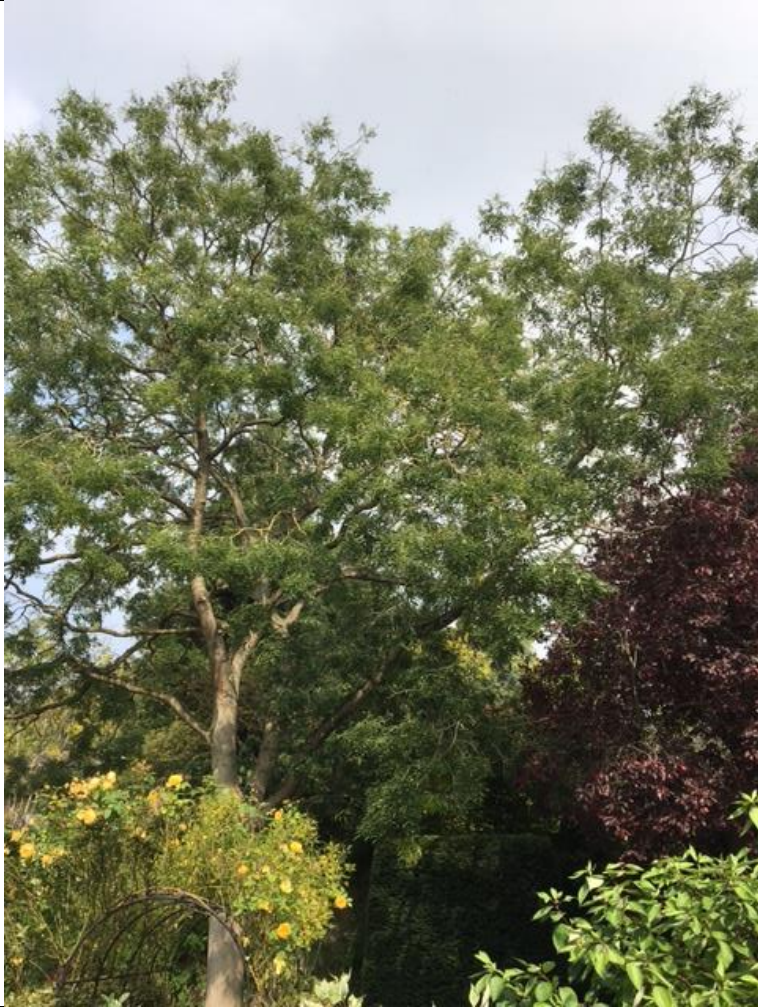
T1 - Japanese Pagoda Tree. Some substantial deadwood could be removed. Additionally, the stem to east is slightly over-developed/exposed and could be reduced by 2-2.5m to avoid a secondary 'pseudo leader' developing and reduce vulnerability to damaging wind loading.

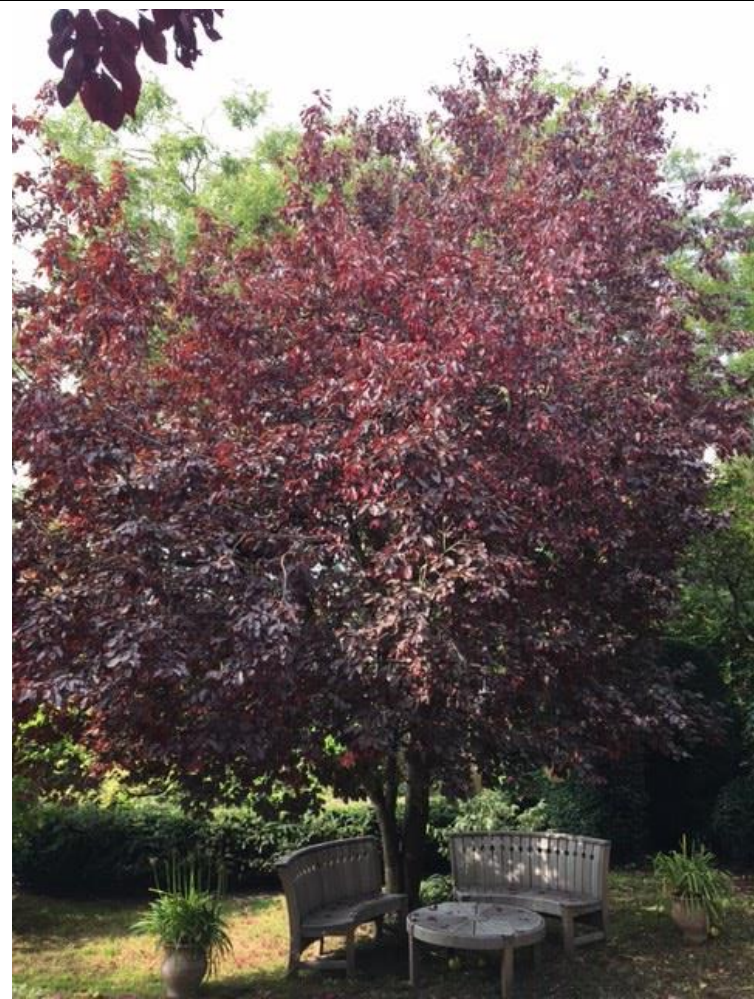
T2 - The ornamental Plum could be lightly shaped overall by 2.0m to retain far reaching views to west. The original vision of the architect had when designing the house and terrace, most probably.

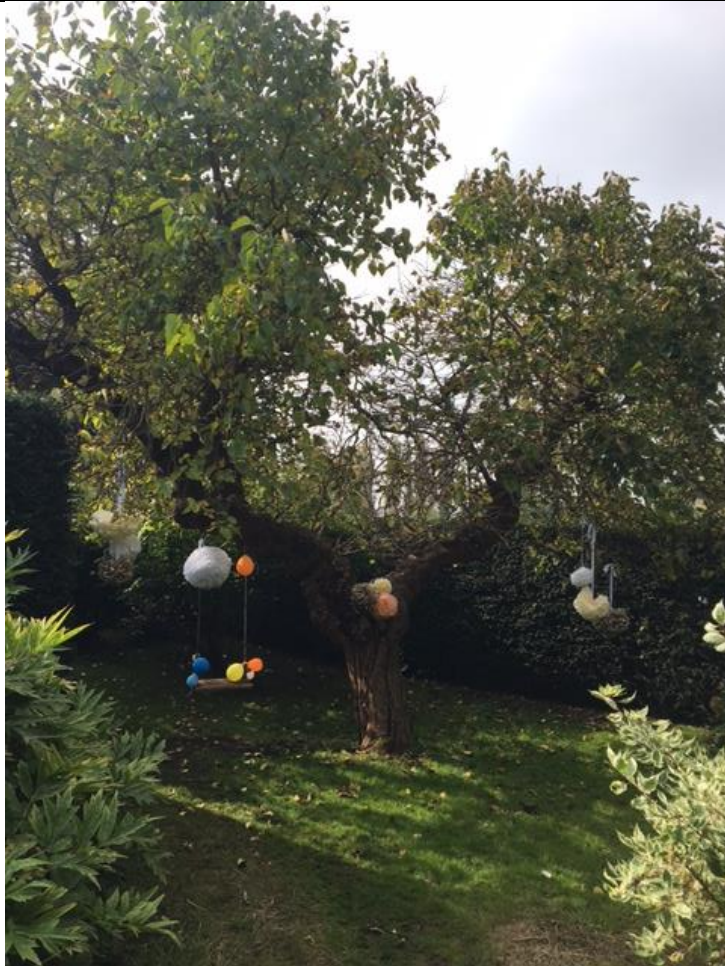
T3 - The ancient Mulberry has a partially collapsed 'trifurcation'. The historical bracing appears visually sound. Additional propping using old Oak driftwood would contribute to structural assistance.

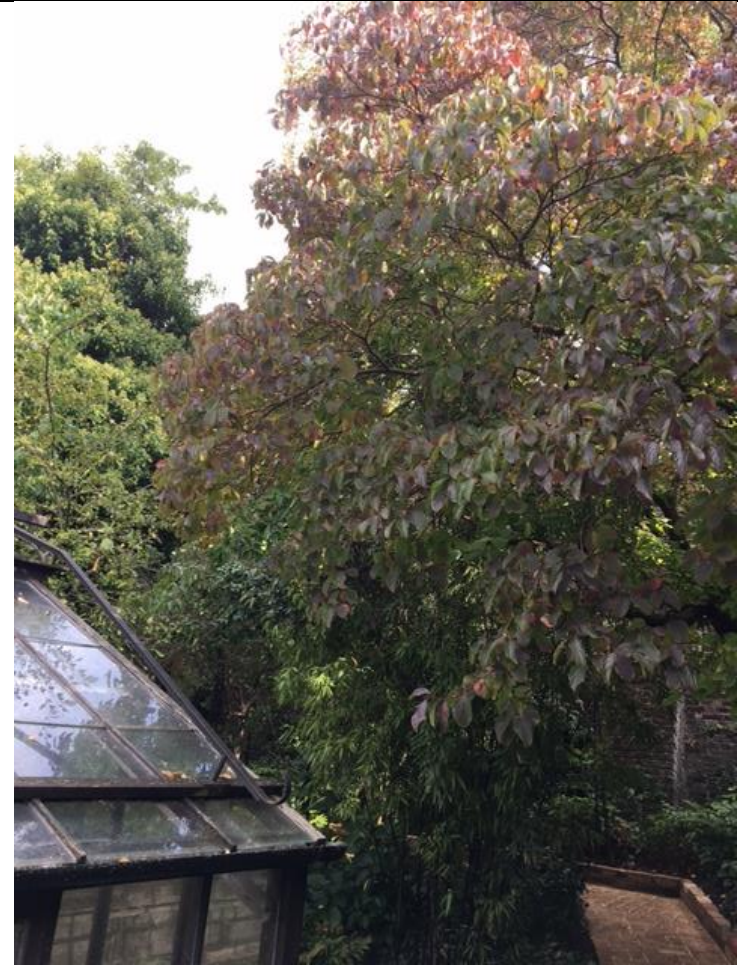
T4 - Late mature *Cornus kousa* produces early morning shade over the greenhouse. Not considered a significant issue. However, light mitigation pruning of laterals to west by 500mm would be worthwhile.

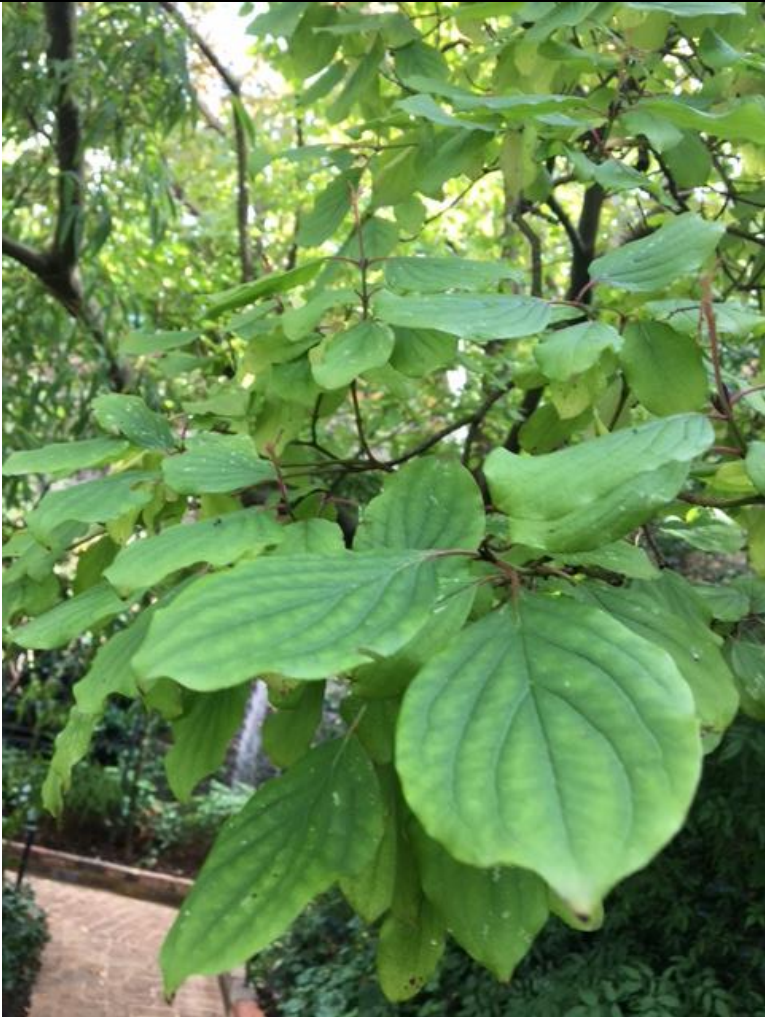
T4 - Cornus kousa foliage.

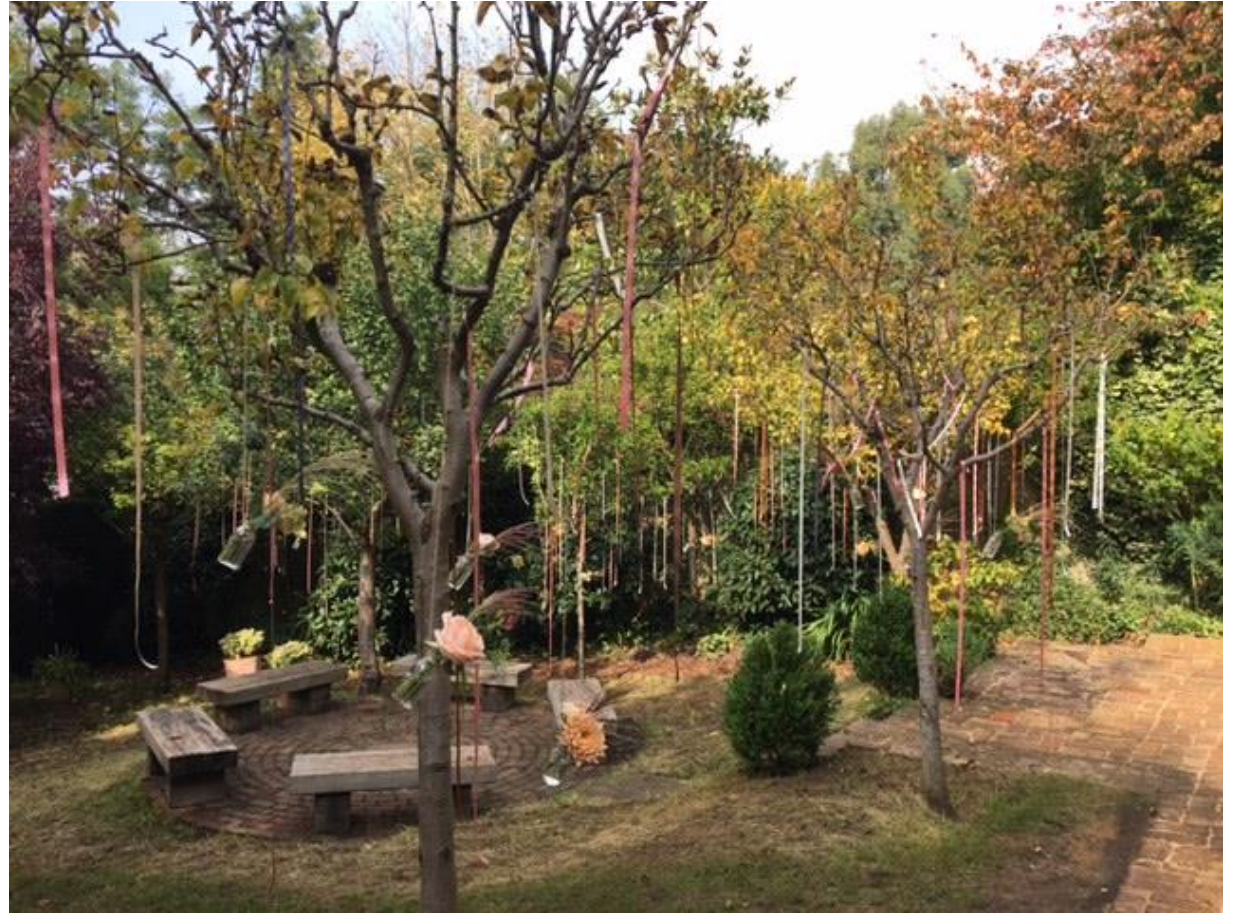
T5 - Pear trees displaying 'root rock' so potential girdled roots (future stability issues). These may need re-staking. Installation of mulch circles will be good holistic practice.

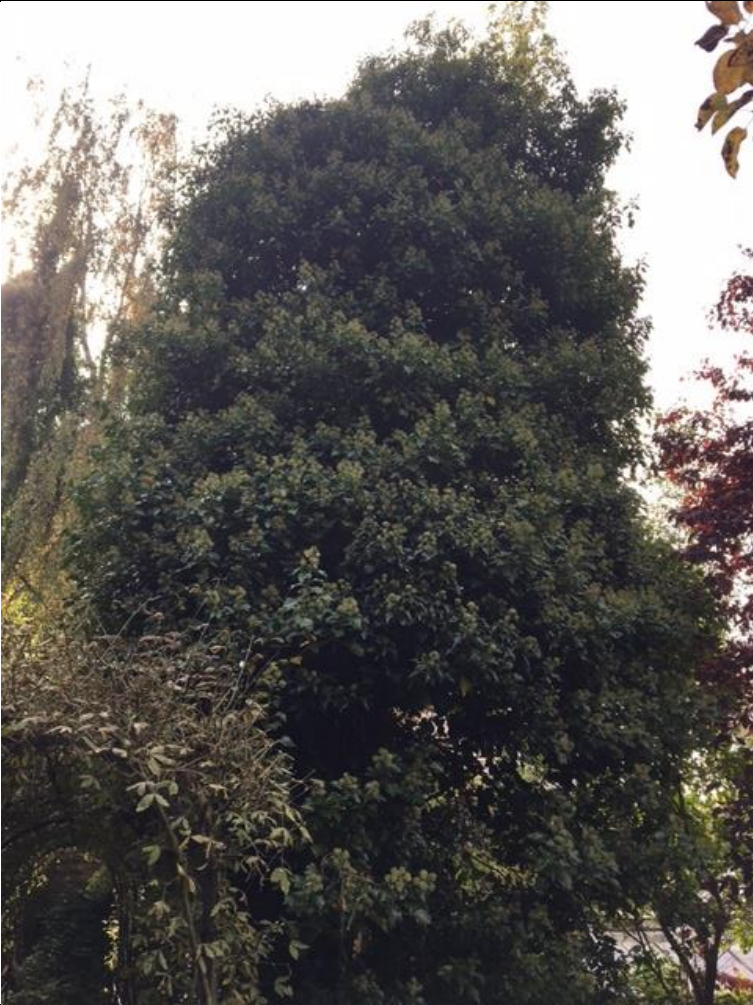
T6 Robinia - somewhat of a dilemma; the Ivy infestation is so dominant, it may diminish the trees phototropic ability, killing off the majority of foliage, and eventually the tree. The Ivy produces screening from next door but provides ecological habitat and late food (flowers) for bees. The solution would be to removing top 4.0m of Ivy to leave some functioning foliage.

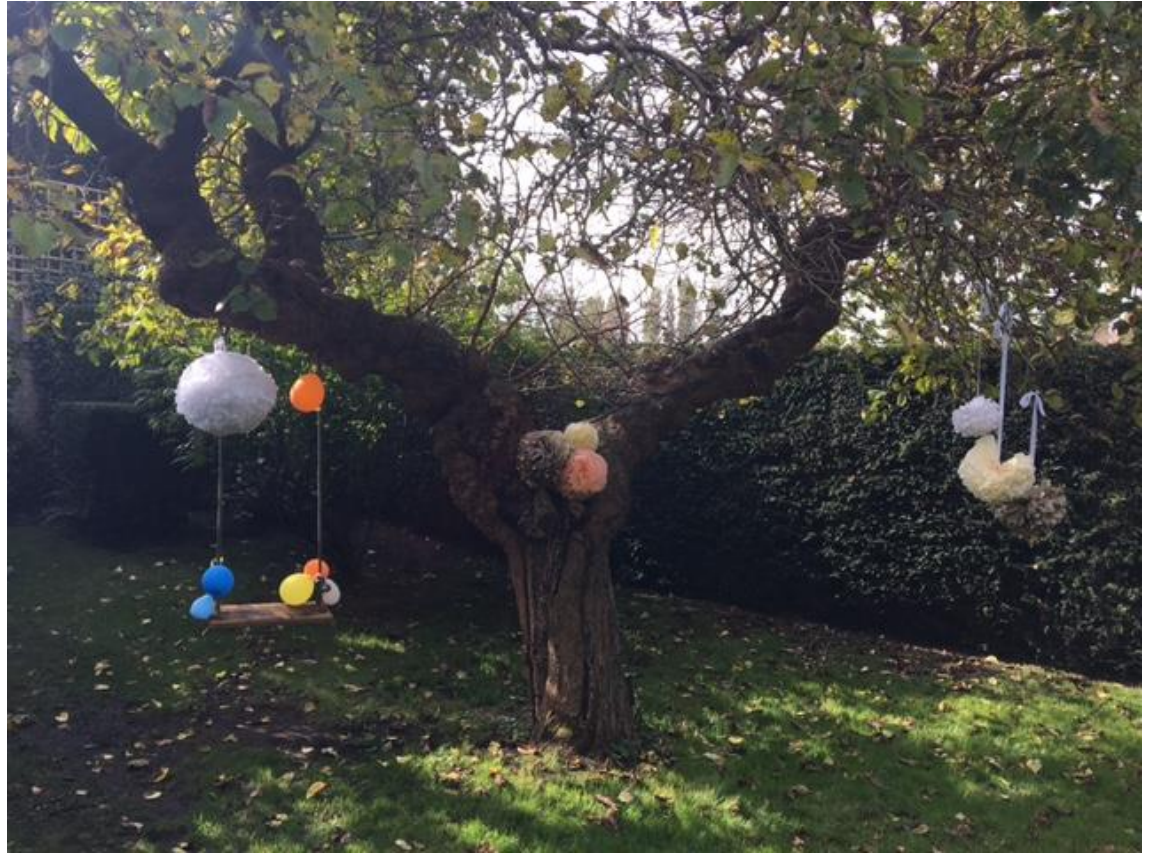
T3 - Mulberry with 9mm galvanised (bit rusty) cable which is actually holding the tree together and preventing it breaking into three! Additional propping recommended. Cable should be inspected for integrity every 12-24 months.

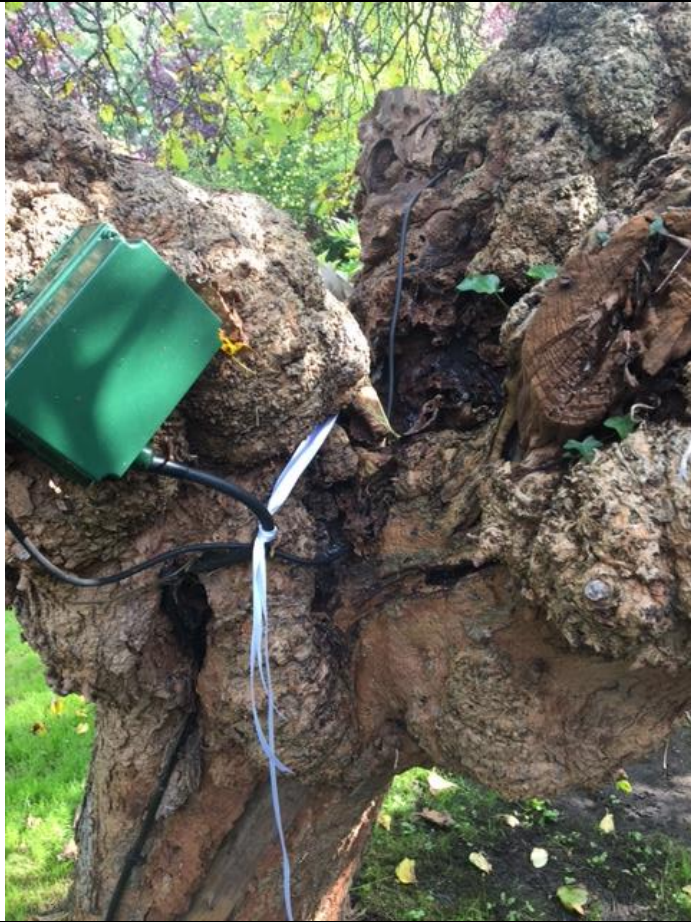
T3 - Trifurcation area partially collapsed in Mulberry.

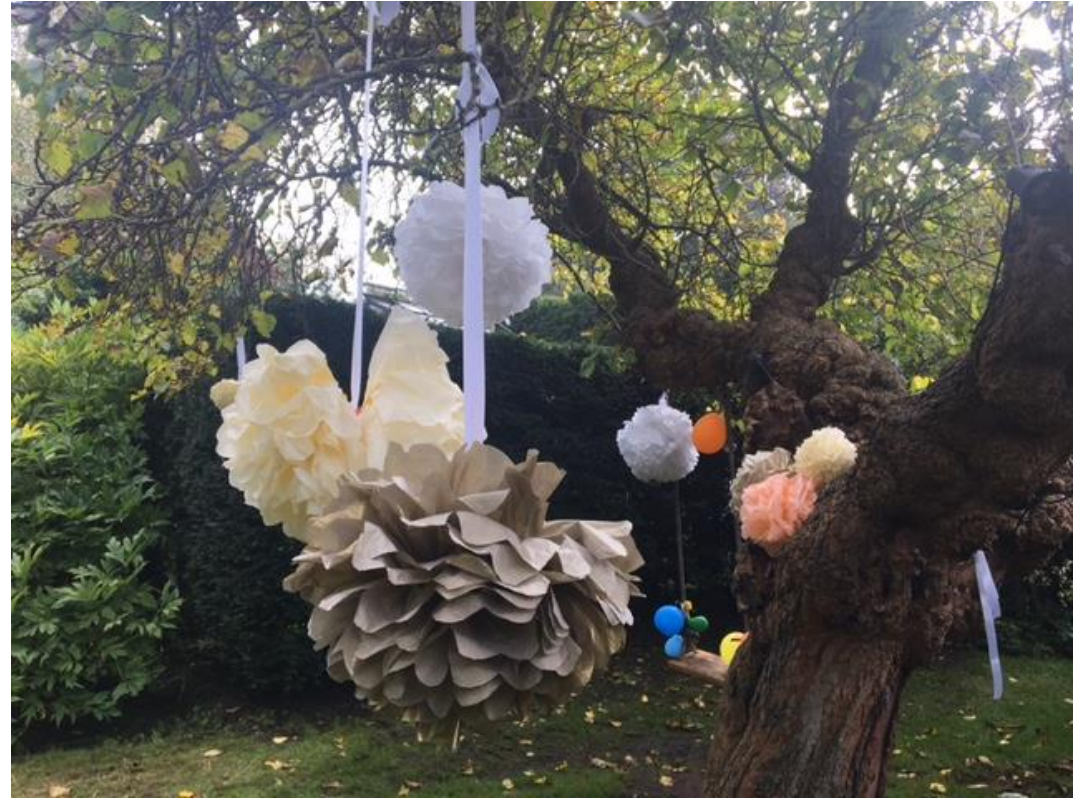
T3 - Veteran Mulberry tree.

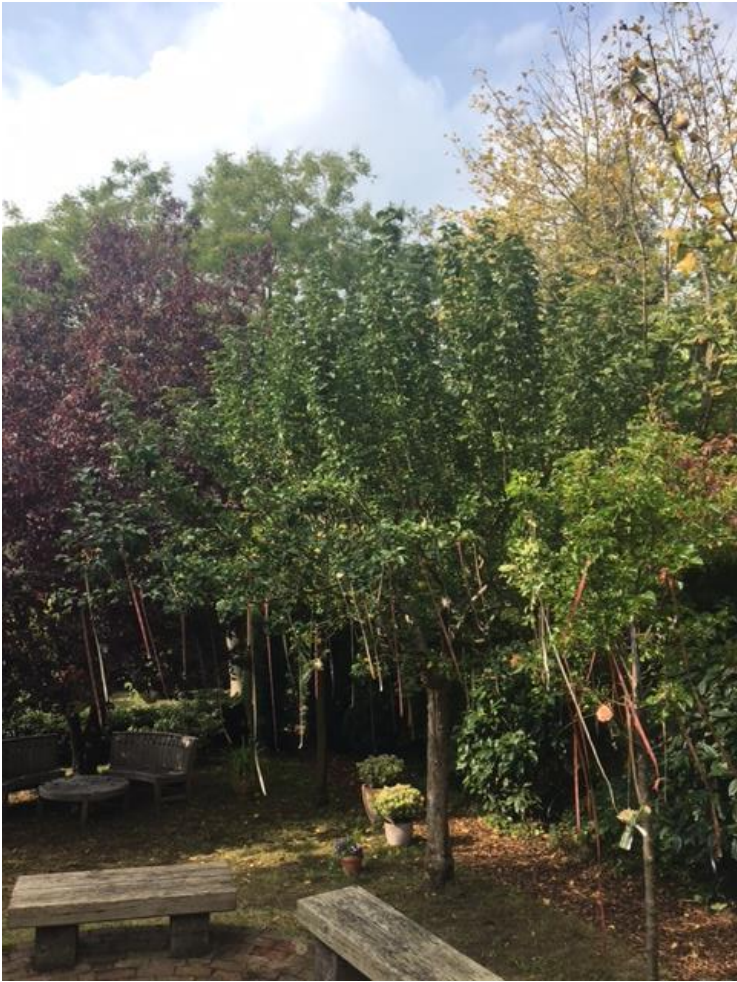
T7 Apple tree - pruned overall some three years ago, shows 'adventitious' growth. Carry out overall canopy reduction by 1.0m to spur points.

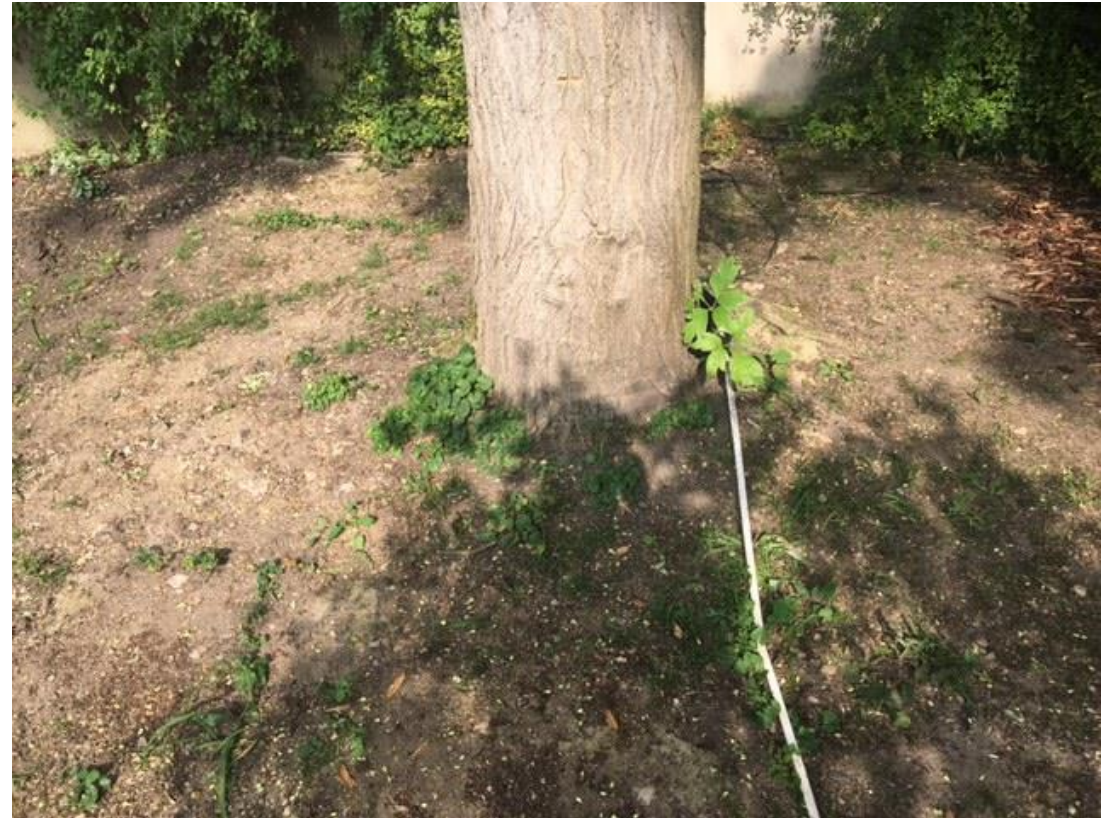
T1 Japanese Pagoda Tree - Old hard standing removed. A good move as compaction and physiological conditions are not ideal and potentially damaging. Incorporate 'top dress biochar' and light, slow release fertiliser.
