Simon Pryce Arboriculture

Report

Site: 24 Daleham Gardens, London, NW3 5DA

Subject: Trees and other vegetation near the house and their effects on it.
Specification for necessary or appropriate work.

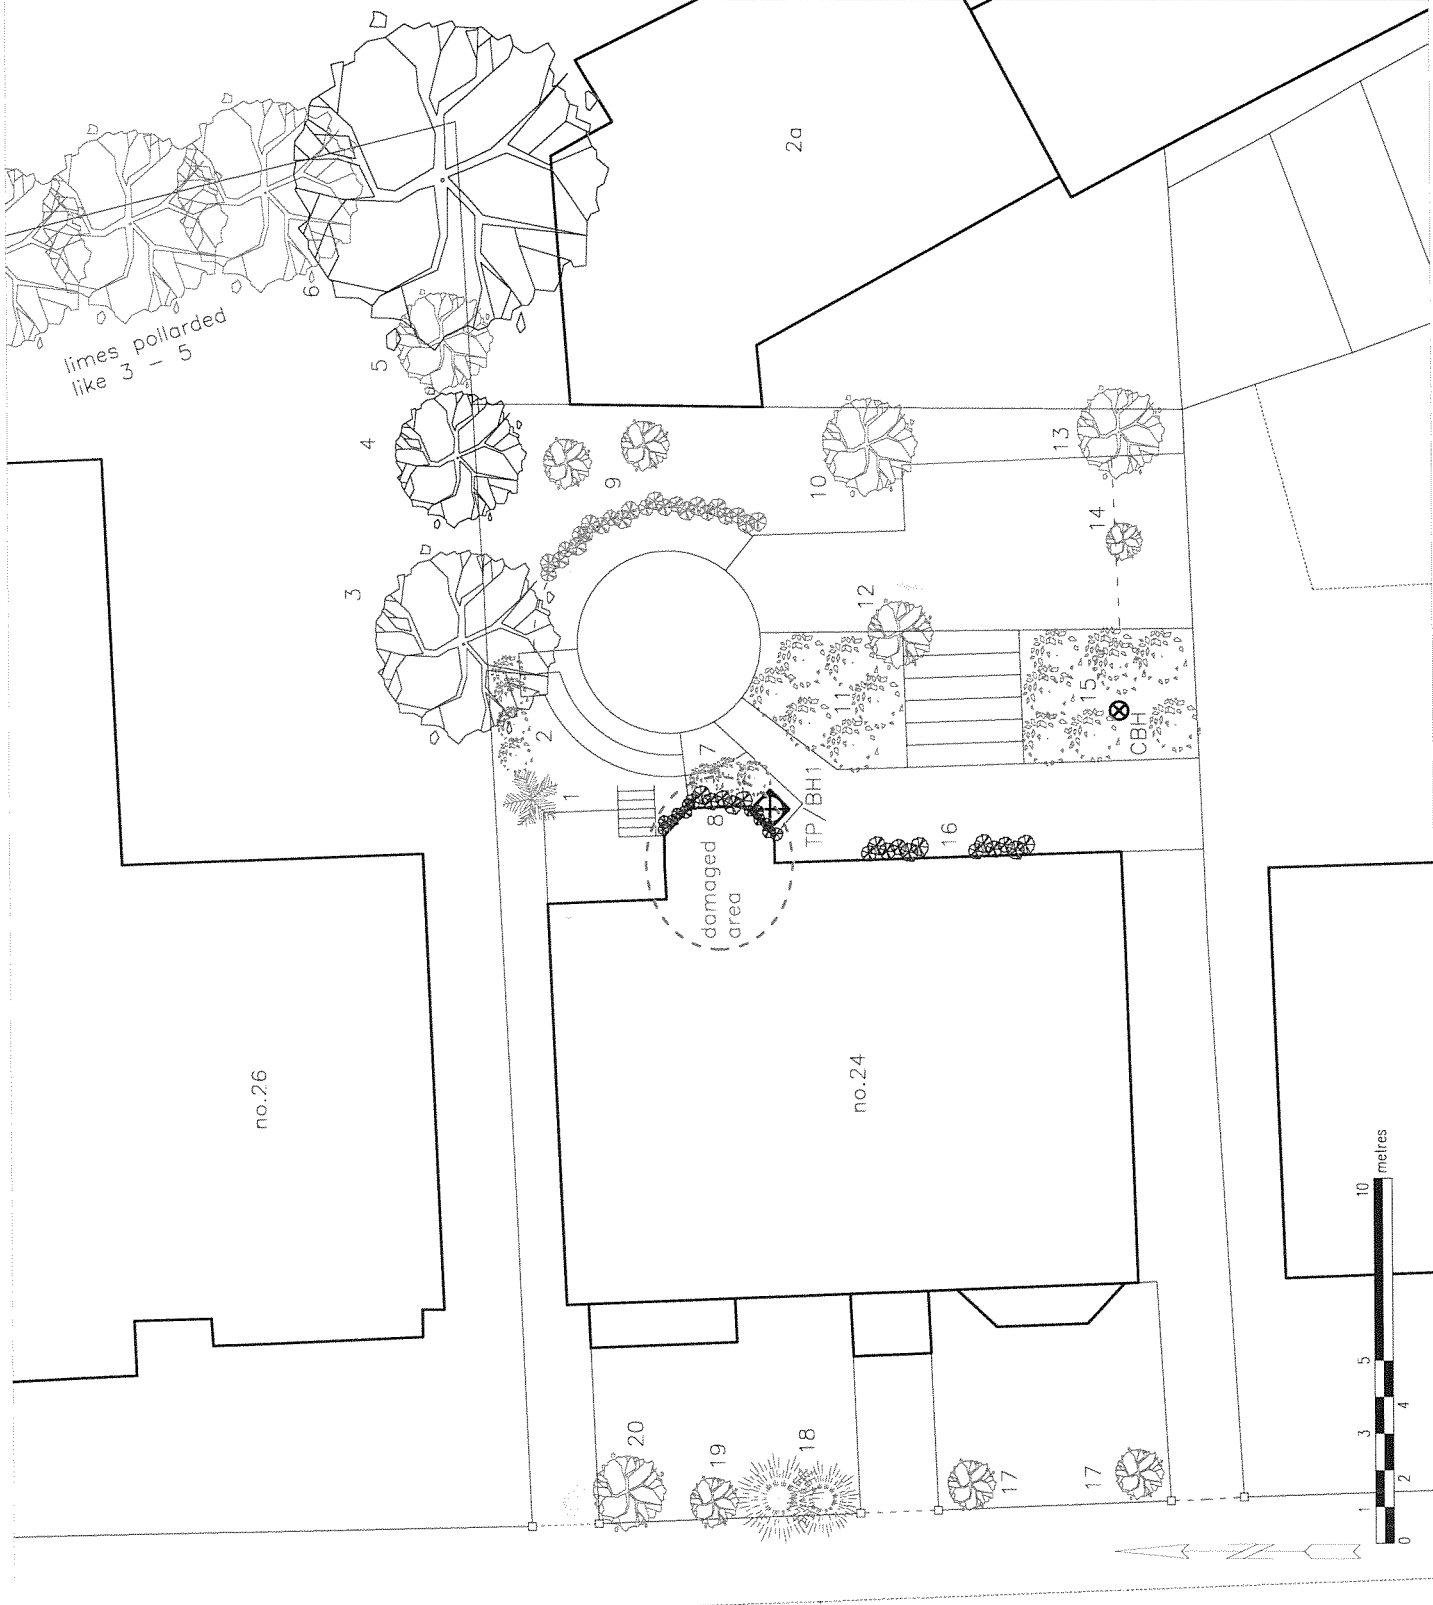
Title:
Trees and subsidence claim

- 3.1 There are assorted shrubs and climbing plants in the rear garden, including a wisteria growing on the bay. There are some small trees, most of them some way from the house. The most significant trees in the vicinity are in the rear garden of no.26 Daleham Gardens, to the left, and include a row of pollarded limes growing just beyond the boundary between the two gardens.
- 3.2 These are described individually in the schedule forming the second part of this report, with recommendations for work where necessary or appropriate. They are also shown on the attached site plan.
