Re: The Apple tree (T5) at 54 Compayne Gardens, NW6 3RY:

**5 day Notice under The Town and Country Planning
(Tree Preservation) (England) Regulations 2012
Part 3 Prohibited Activities and Exceptions
Trees in Conservation Areas – Reg 15 (1)(i)**

ARBORICULTURAL ASSESSMENT REPORT

For:	Client:	Cunningham Lindsey (Maidstone)
	Insurer:	
Site:	Policyholder:	
	Risk Address:	54 Compayne Gardens, London, NW6 3RY
Refs:	OCA Ref:	63797
	Client Ref:	
	Insurer Ref:

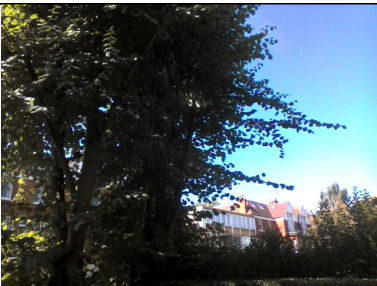
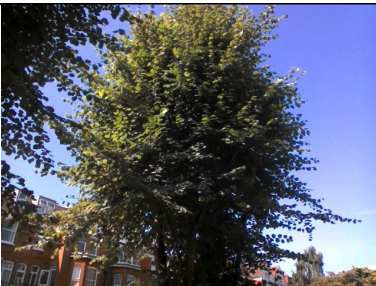
<p>T1 - Lime</p>	<p>T2 - Lime</p>

London Borough of Camden has confirmed that the implicated Limes trees T1 to T4 are subject to a Tree Preservation Order. T5 & T6 are covered by Conservation Area Controls.

Tree No:	Species	Works Required
C2	Clematis	Fell close to ground level (approx 50mm)
T1	Lime	Fell and treat stump
T2	Lime	Fell and treat stump
T3	Lime	Fell and treat stump
T4	Lime	Fell and treat stump
T6	Ash	Fell and treat stump

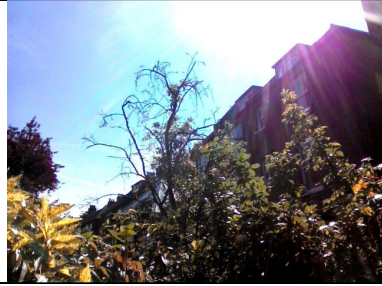
T5 - Apple

It is the view of the chartered arboricultural experts appointed to survey the trees on site, that the apple tree (T5) is dead.

Tree No:	Species	Works Required
T5	Apple	Fell and treat stump

We therefore give this notice of our intention to remove this tree after the expiry of this period of notice.
