Our Ref: JLR/22753

23 November 2017

Re: 34 Eton Avenue, London NW3 3HL
Report on fire damage

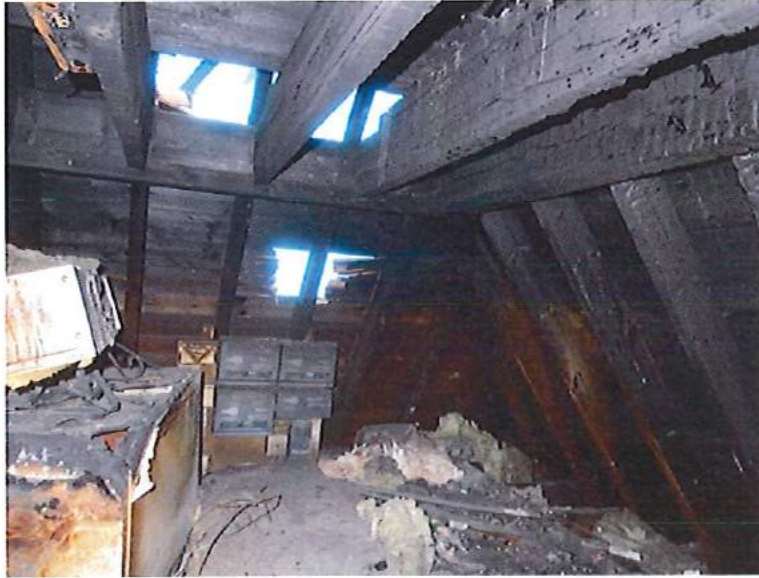
- 5.1 We believe from discussions with Mr Parritt on site and from our own observations that the fire started at ceiling level third floor or in the roof space immediately above the north gable window.
- 5.2 The fire caused extensive damage to the roof around the north gable window extending up into the roof space as illustrated in the following photos.

Badly charred rafter beams plus joists to the flat roof

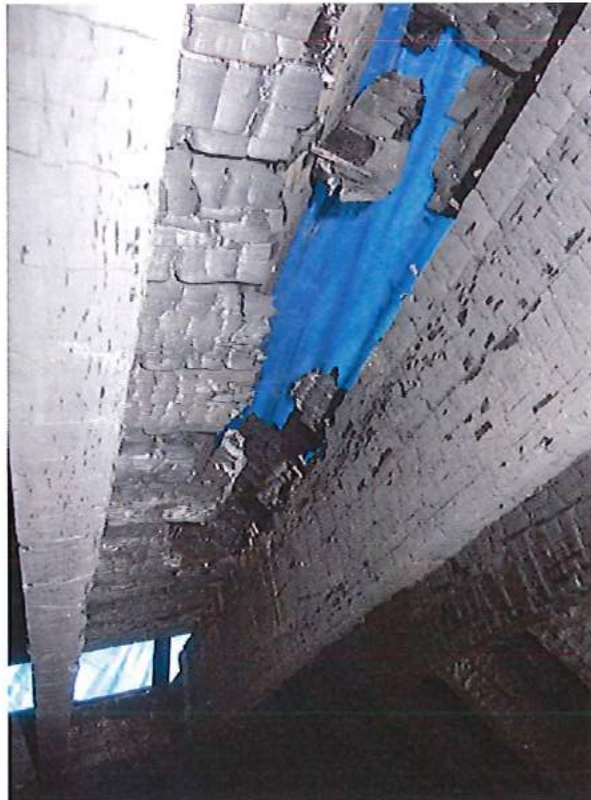
Heavily charred joists to the flat roof section plus sarking boards burnt thro' locally

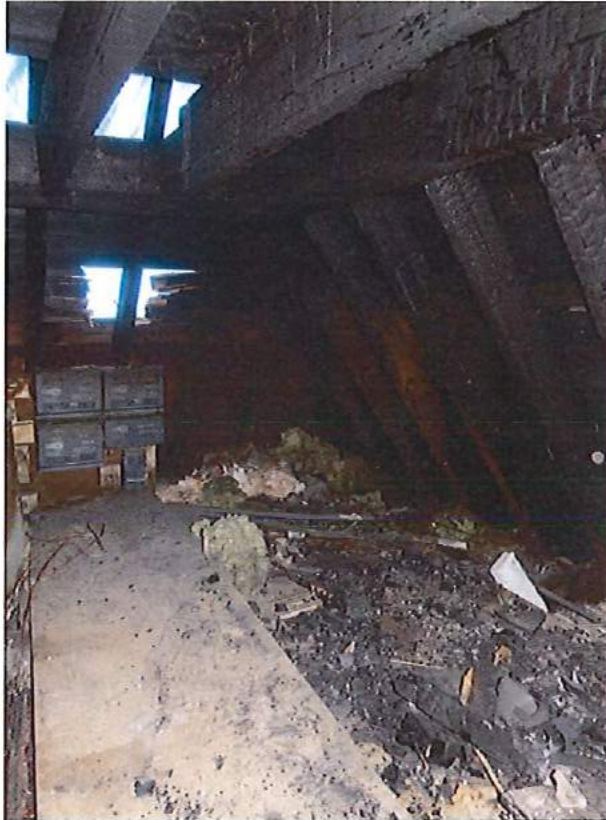
Further view of fire damaged roof section

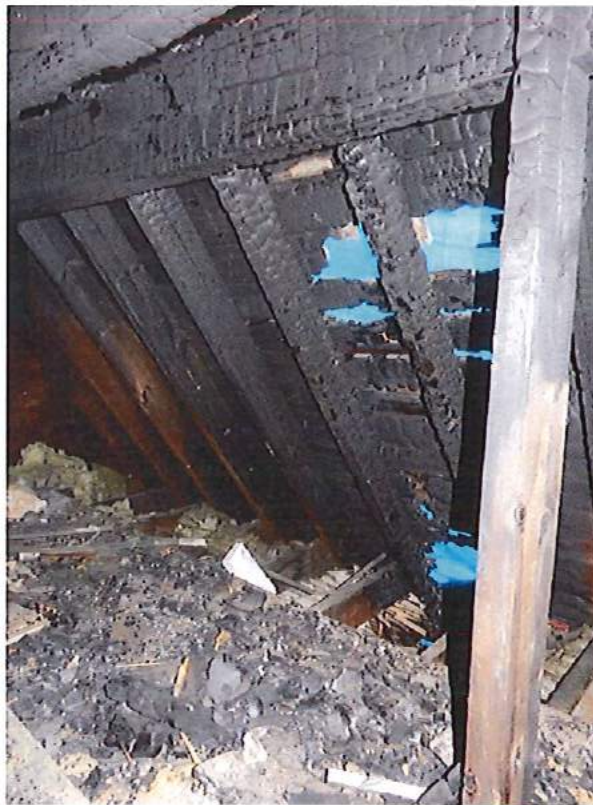
Badly damaged rafters plus sarking boards above dormer window

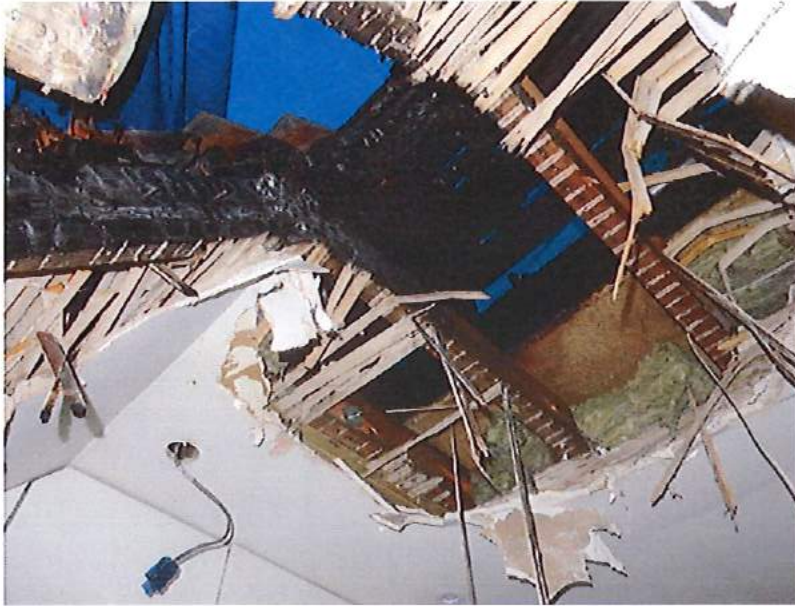
The north dormer window construction is also heavily damaged

- 6.5.14 Re-construction to include insulation etc. to comply with building regulations to architects details and subject to agreement with insurers.
- 6.5.15 Re-build dormer window and roof.

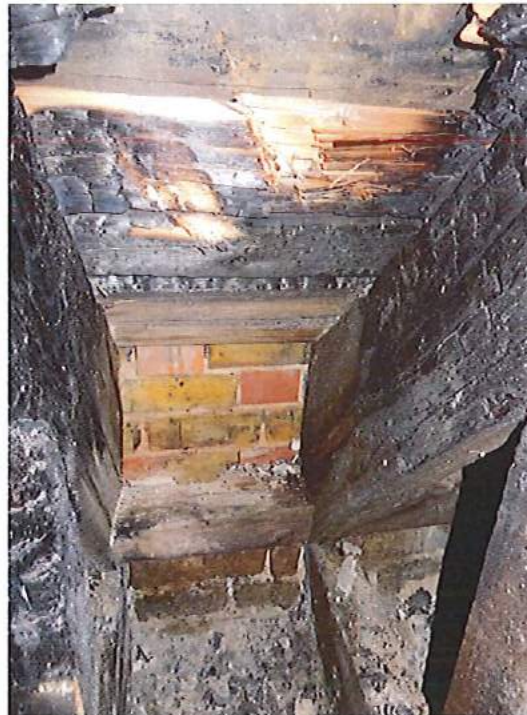
- 5.3 Whilst the fire seems to have occurred in the ceiling / roof over the dormer window some local burning of rafters extends locally down to the wall plate at third floor level. See photo.

Fire damage to rafters extending down to timber wall plate at third floor level

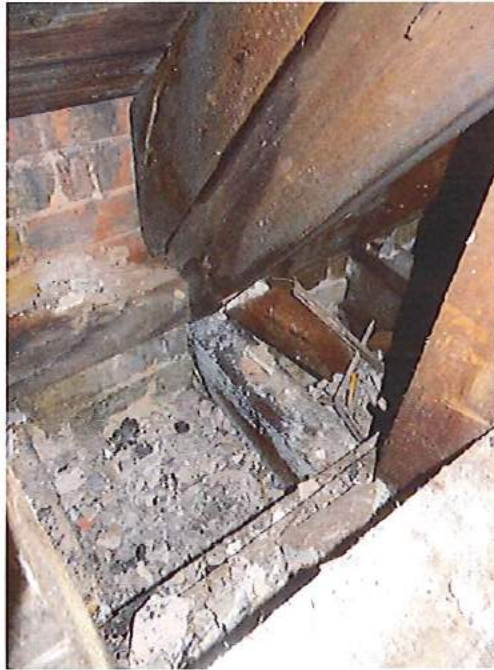
- 5.4 It was evident that there was water staining to the ends of the third floor joists where they bear on to the north elevation wall.

Water staining to rafters in vicinity of north dormer window

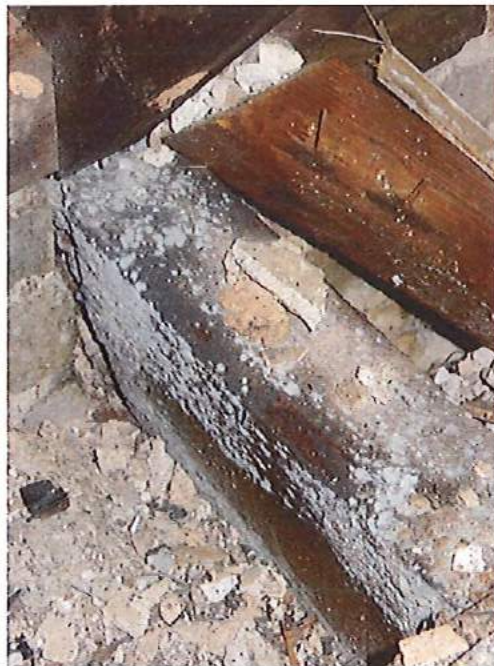
On closer inspection we could discern mould growth on these joists and note that the conditions for wet and / or dry rot were present. It is assumed the water was provided by the brigade in extinguishing the blaze for there were no direct signs of an on-going leak. Note, we have not at this stage inspected the floor beneath to establish the extent of water damage arising from the blaze and actions taken by the fire brigade to extinguish it. The spores can be seen in the following photo.

Spores on 3rd floor timber beam which was showing signs of water staining

- 6.5.12 Consider extent of water damage in third floor.
 - (i) check second floor ceiling below
 - (ii) Establish via timber rot specialist / consultant extent and / or risk of rot of timber section in third floor due to water ingress and agree extent / scope of remedial work needed with contract administrator / loss adjuster

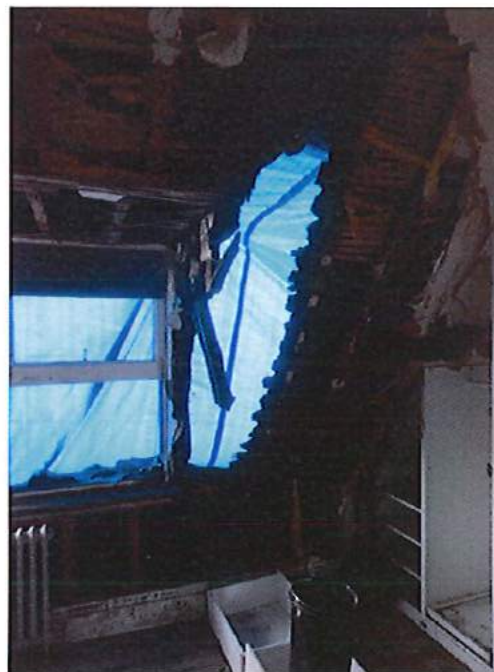
Dormer cheek burnt away

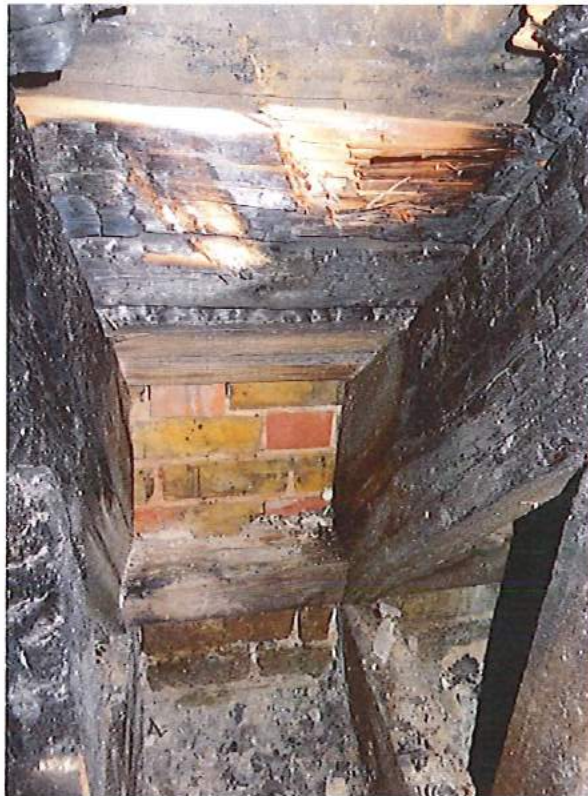
Charring of rafters down to third floor wall plate

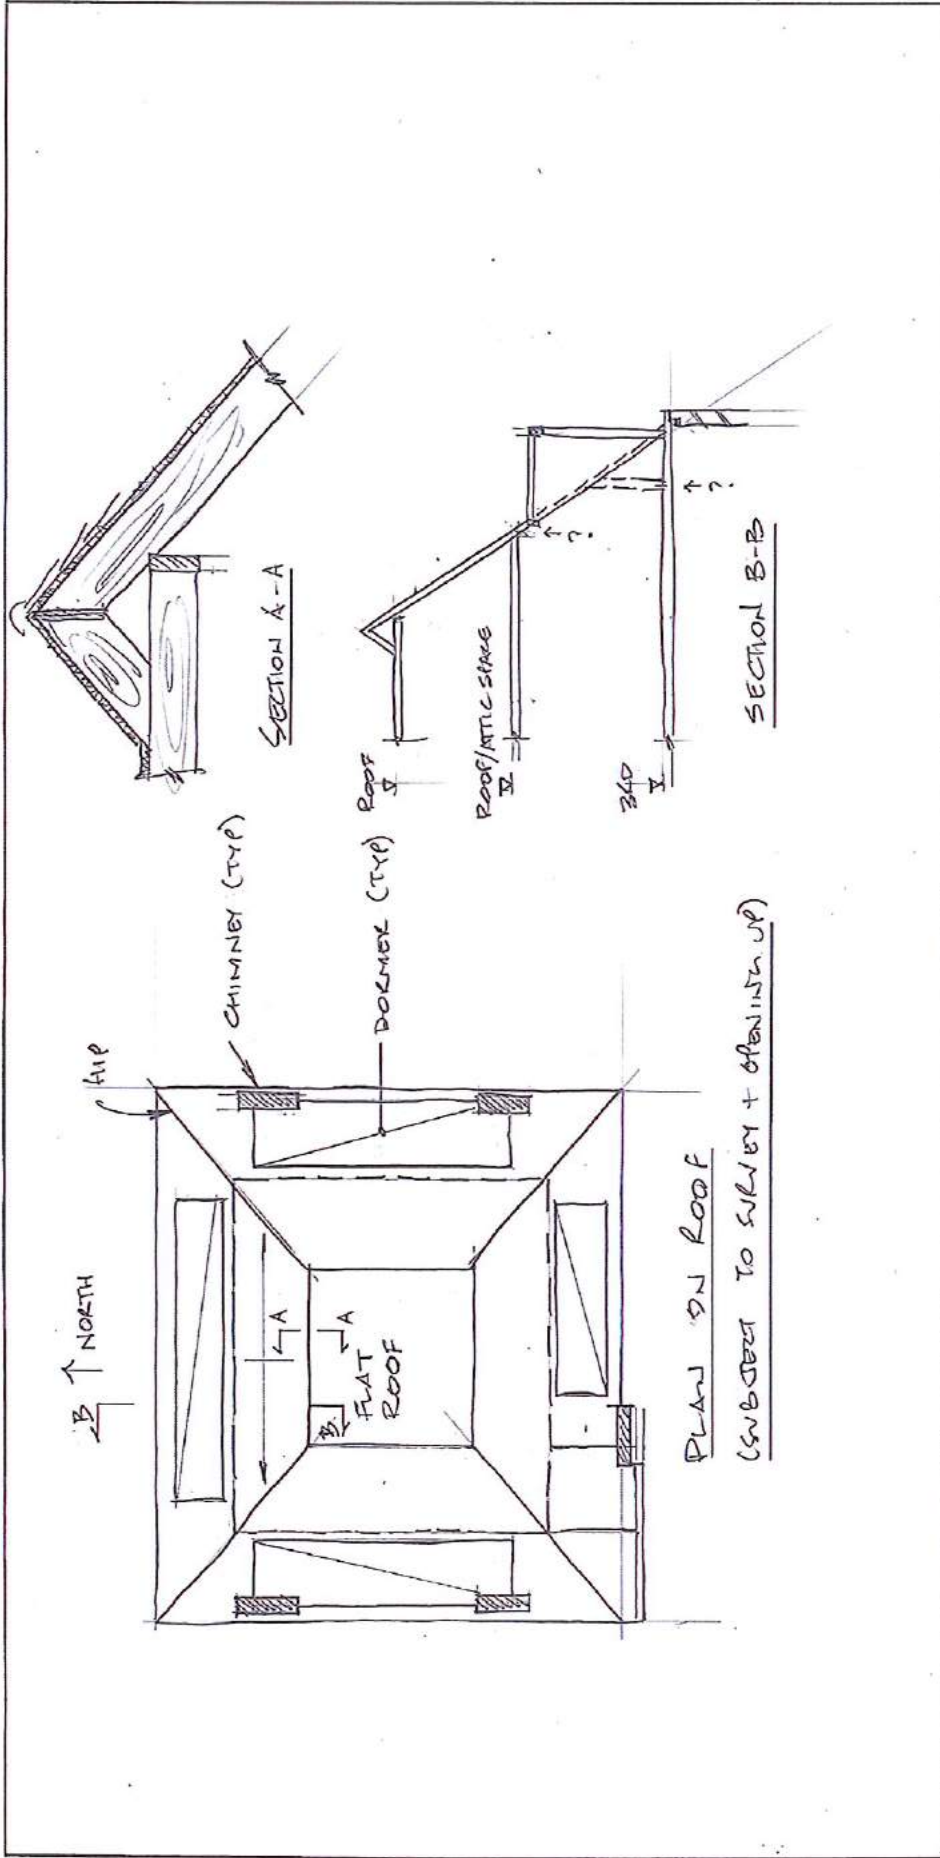
<p>Scale</p> <p>NTS</p>	<p>Status</p> <p>FOR INFORMATION.</p>	<p>Drawing No.</p> <p>22753/SK-01</p>	<p>Scale</p> <p>NTS</p>	<p>Drawing No.</p> <p>22753/SK-01</p>

- 5.6 A sketch of the roof structure together with a provisional assessment of the extent of damage is included as drawing 22753 / SK01. See attached.
- 6.0 Discussions
- 6.1 The fire seems to have started in or about the level of the third floor ceiling in the north west corner of the building. It spread around the roof void causing significant damage to the roof structure above badly damaging a number of rafters, the trimmer beams to the flat roof and burnt through the sarking boards in a number of places.
- 6.2 The fire spread across the dormer to the master bedroom (bedroom 1) causing damage across its roof structure, both sides and extending down on some rafters to the timber wall plate at third floor level. See photos.

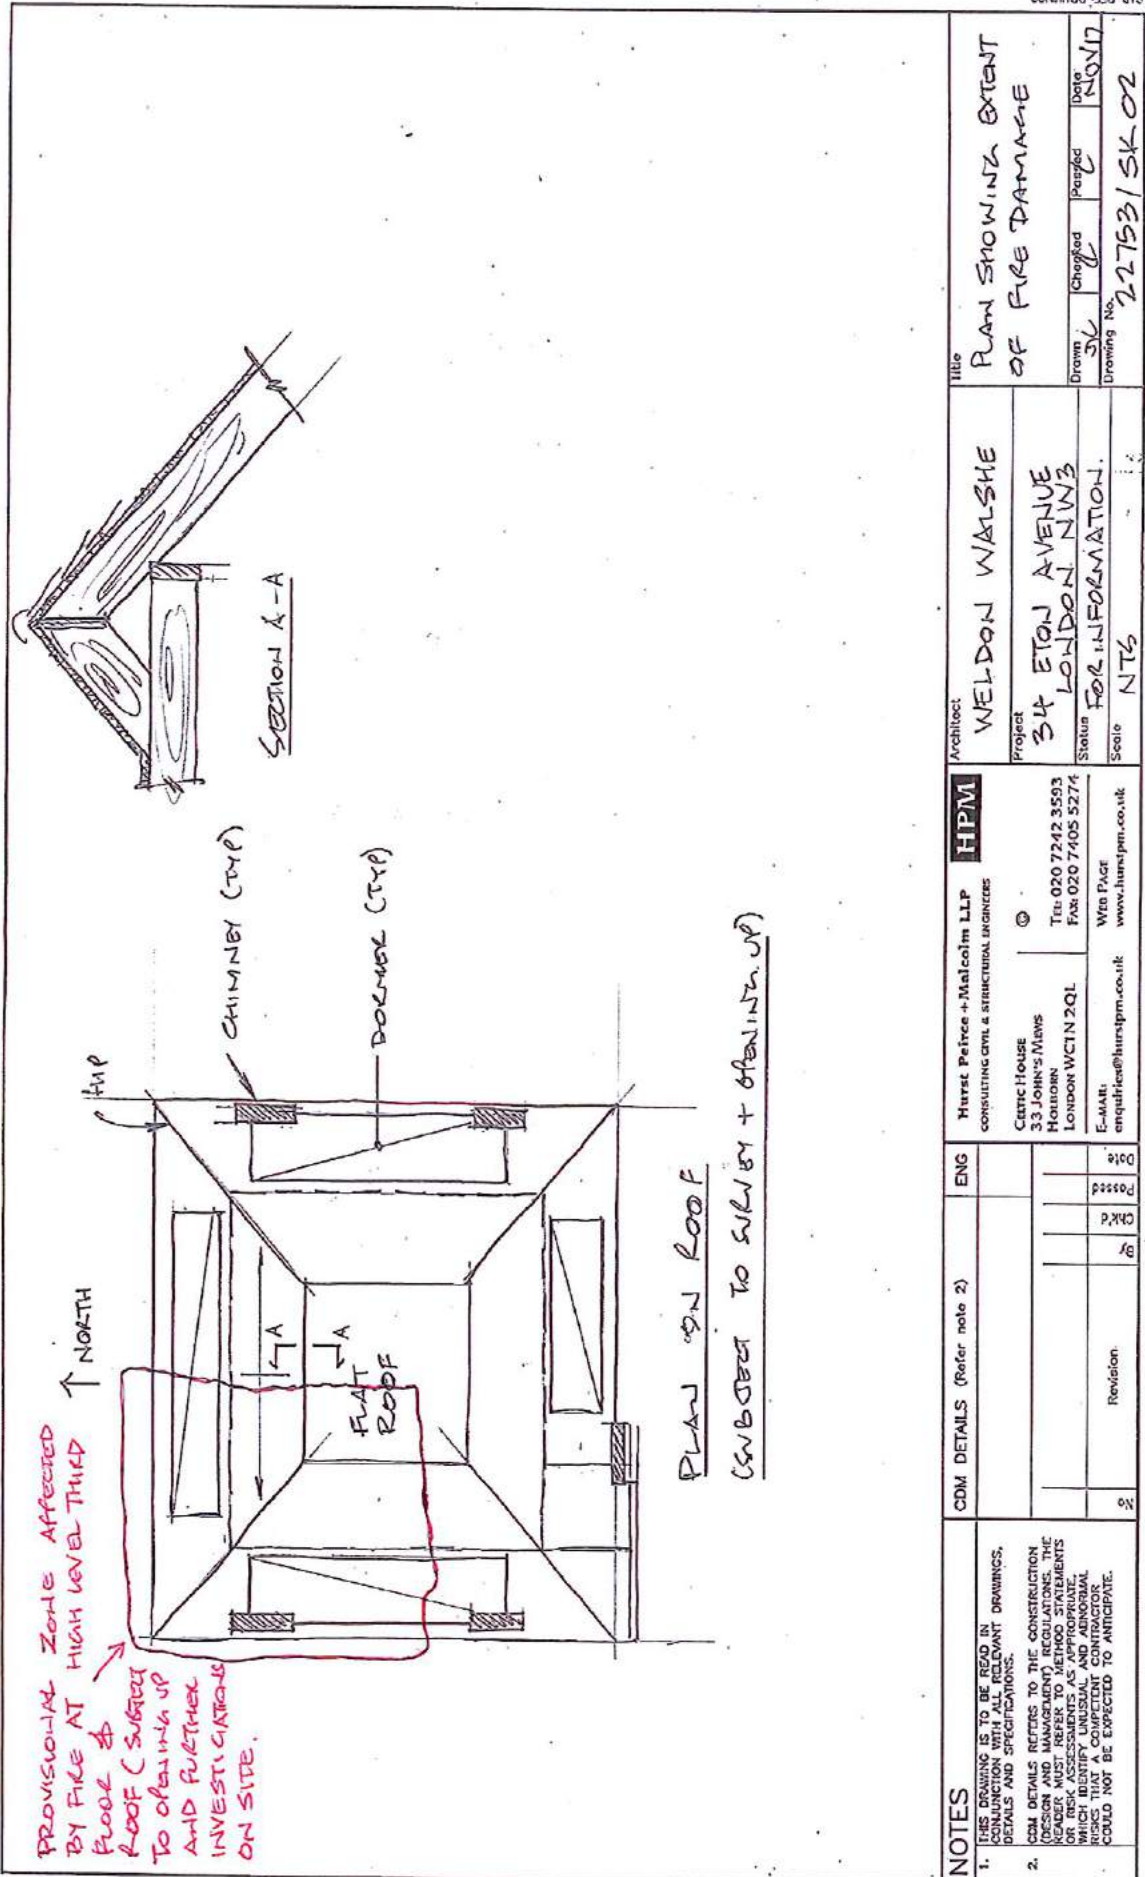
PLAN ON ROOF
(SUBJECT TO SURVEY + OPENING UP)

- 6.4 A provisional of the area where the structure is likely to have been affected by the fire is marked on drawing 22753 / SK02 – see attached. This area is subject to alteration / amendment after to further investigations / opening up on site.

PROVISIONAL ZONE AFFECTED BY FIRE AT HIGH LEVEL THIRD FLOOR & SUBTILE ROOF (SUBJECT TO OPENING UP AND FURTHER INVESTIGATIONS ON SIDE).
