Summary Of Structural Assessment And Strengthening Works Required

| project name<br>6 Denmark Street | | | |
| sketch title<br>Proposed Structural Details | | | date<br>20/11/2017 |
| project no<br>879 | sketch no<br>04-XX-LB-S-0001.0 | rev<br>01 | by<br>RK |

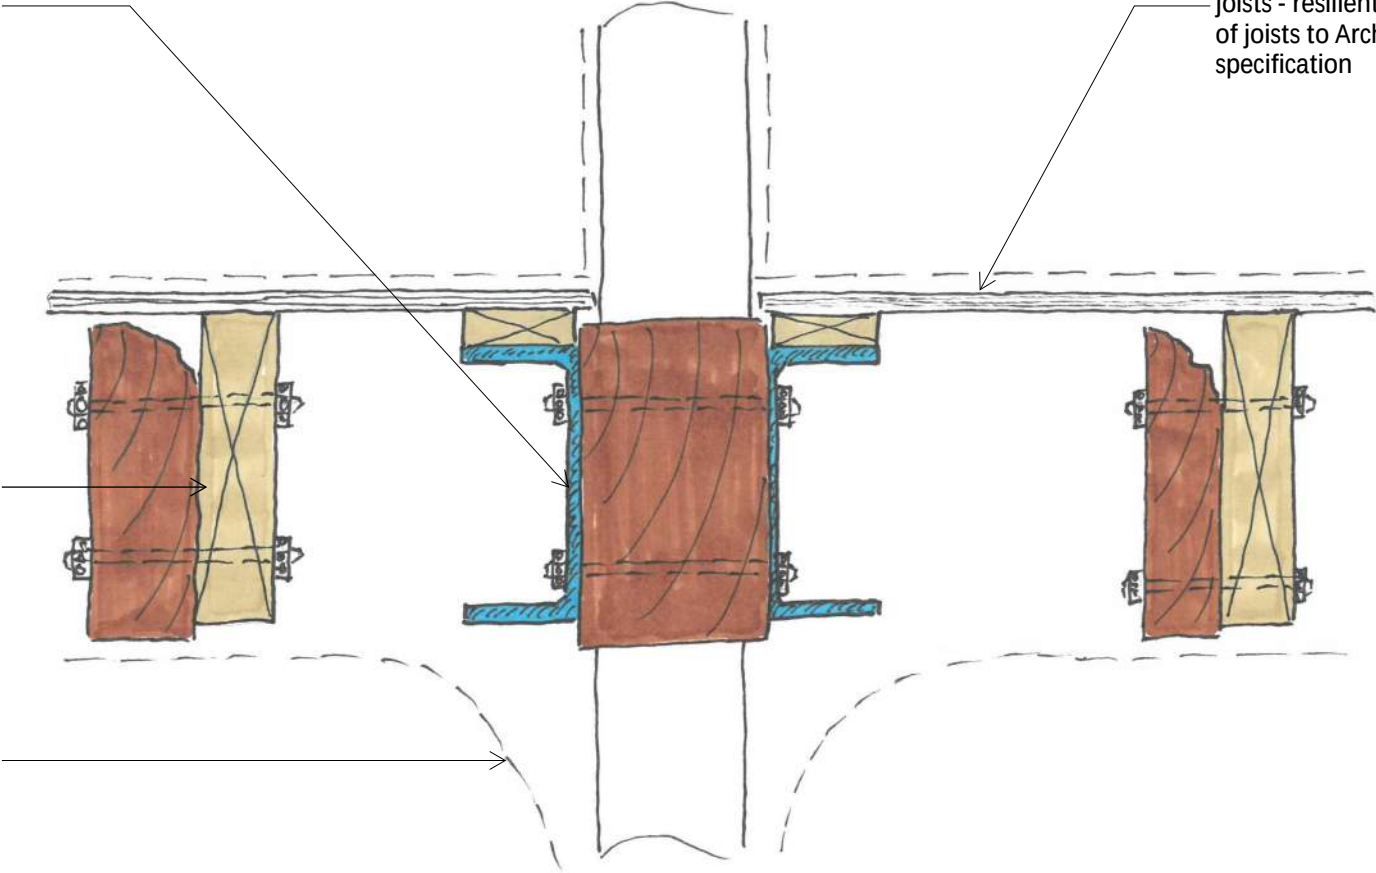
**Detail 1: Spine Beam & Joist Strengthening Requirements, 1:10**

Existing Timber Spine Beam Assessment:

The spine wall has been removed at ground floor level so the existing timber floor beams at each level have been assessed.

Bending Stresses @ 230% capacity => strengthening required  
Deflection @ 200% limit => strengthening required

Existing Timber Floor Joist Assessment:

The existing floor joists vary in both depth and width, typically they are 160x60 at 380 c/c. They have been assessed for their maximum span.

Bending Stresses @ 98% capacity  
Deflection @ 160% limit => strengthening required

- The existing spine wall beam can not be justified to support the required residential loadings to current standards therefore strengthening is required.
- The existing floor joists require strengthening due to comply with current standards and allow for levelling of existing floors
- Generally all structural strengthening proposed will reduce deflections and movements within the building to protect the historic structure and materials from further damage
- Steel beams to bear onto padstones in masonry party walls

- This option provides the required strengthening to the existing spine beam while minimising impact on the historic finishes.
- This option does require the existing floor beams to be trimmed and re-supported on the new steelwork
- Option A is considered to have the least impact on the historic building fabric while achieving the required structural strengthening

Existing timber spine wall beams to be strengthened with pairs of PFC steel beams - through bolted to spine beam with pairs of bolts at 600mm c/c

Existing joists to be strengthened with 200x50 C24 timber joists - bolted together at 400mm staggered c/c

Proposed spine beam strengthening allows for finishes to remain largely undisturbed

New plywood sheathing fixed down to new timber joists - resilient bars to tops of joists to Architects specification

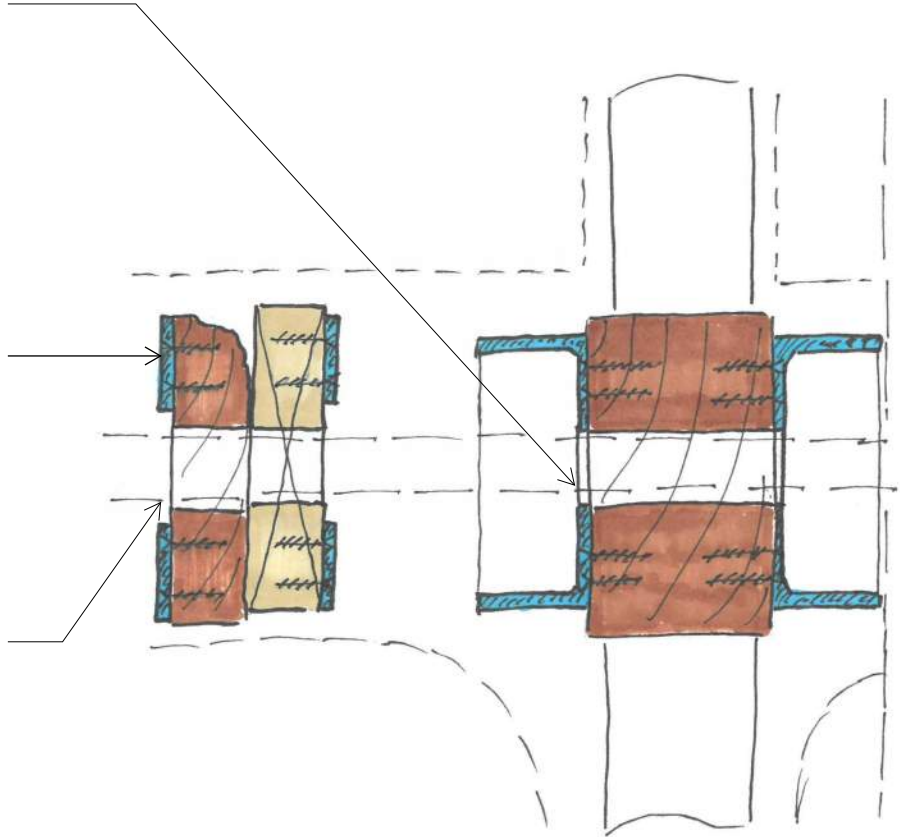
**Detail 2: Spine Beam & Joist Service Penetration, 1:10**

- The strengthening is required to allow the waste pipe from the proposed kitchen island unit to run through the floor zone. The island unit is required to avoid any damage to historic wall finishes
- The service run for the kitchen waste pipe will effect a maximum of 3 joists and the spine beam at each level

Strengthening steel beams to existing timber spine wall beams allow for kitchen waste pipe to run through to riser beyond - steel beams to be strengthened locally around penetration

Existing and proposed joists to be strengthened locally with steel plates to allow for kitchen waste pipe to run within floor zone - plates to be screw fixed to joists

Service penetration to mid depth of joists

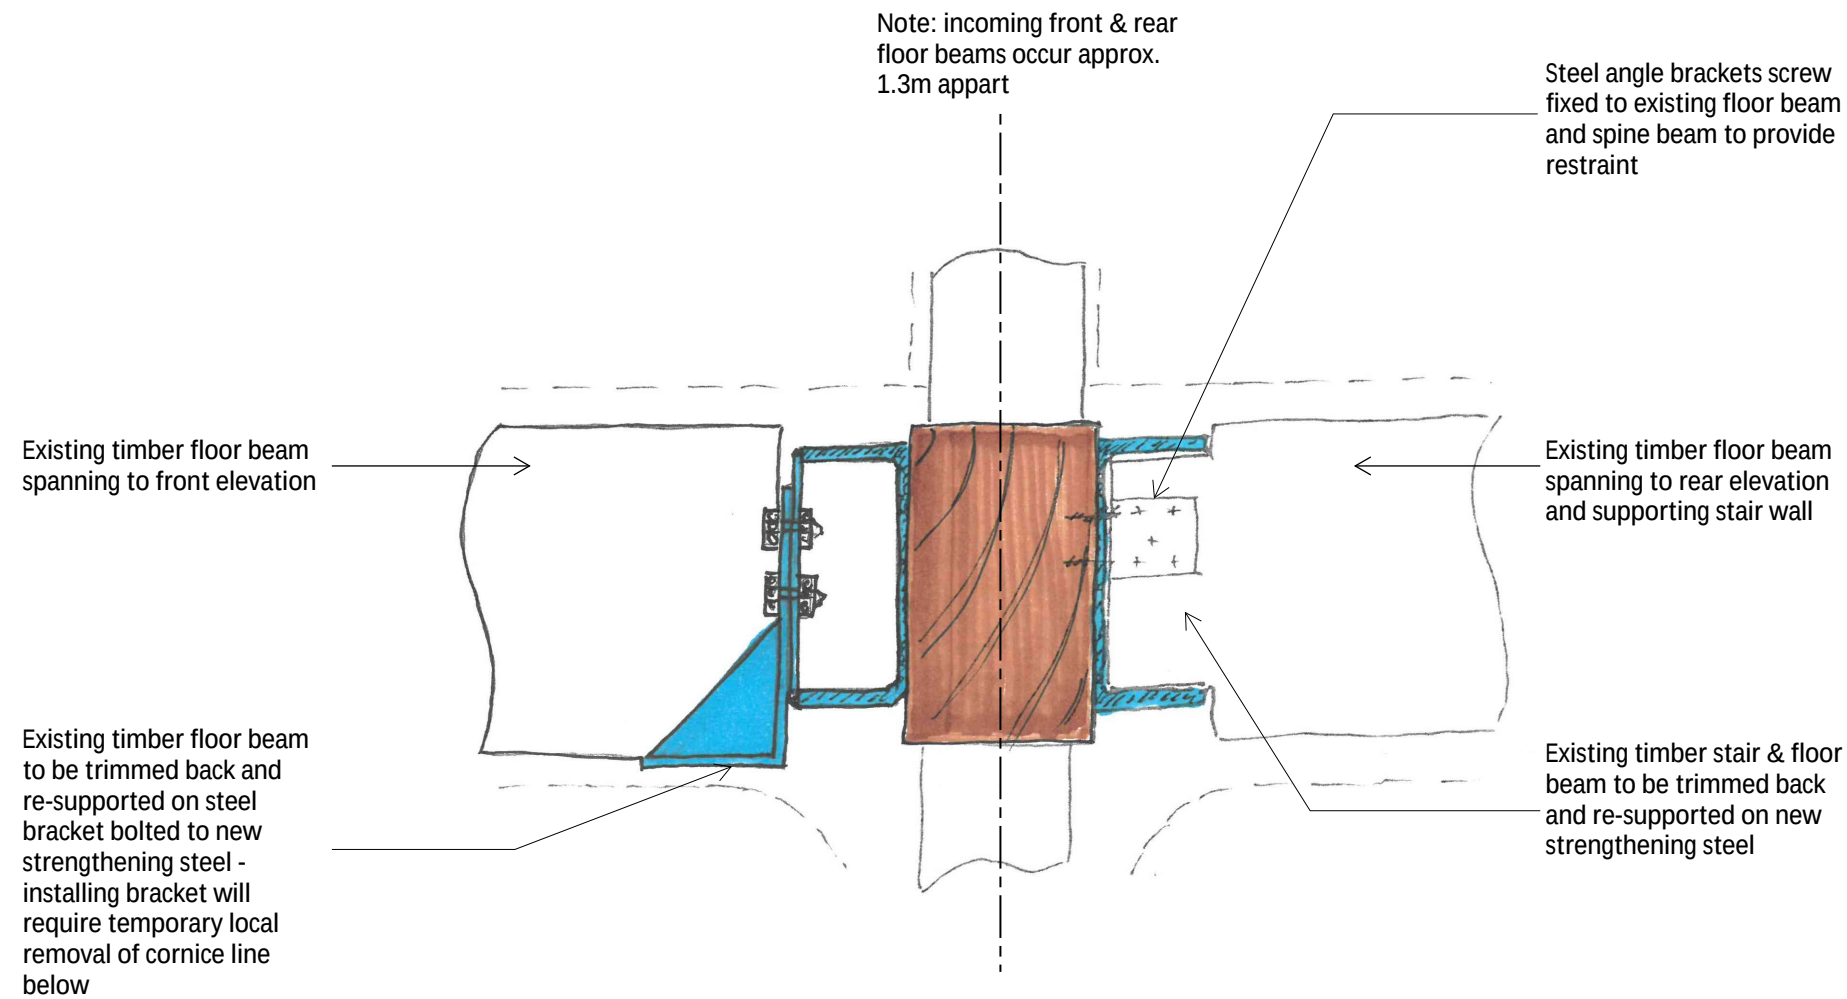
### **Detail 3: Floor Beam To Be Re-supported, 1:10**

- The strengthening is required to the bearing of the floor beams to justify the connection for required residential loadings to current standards
