Summary Of Structural Assessment And Strengthening Works Required

project name			
7 Denmark Street			
sketch title			date
Proposed Structural Details			20/11/2017
project no	sketch no	rev	by
879	03-XX-LB-S-0001.0	01	RK

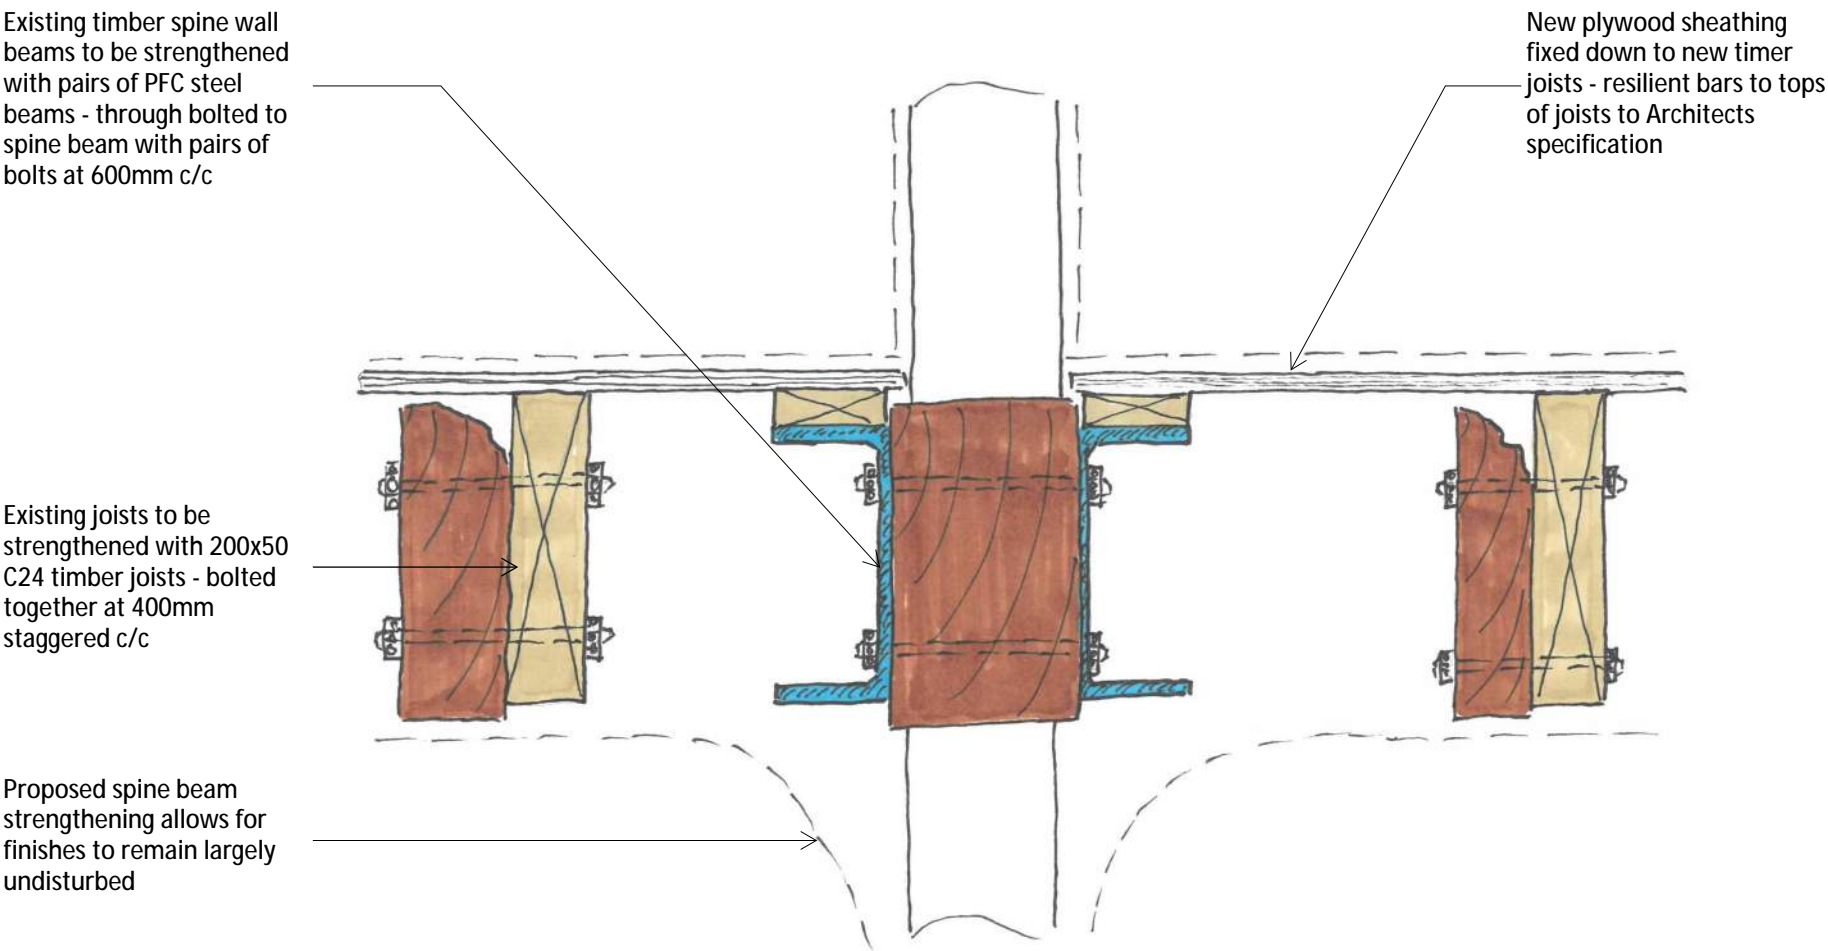
**Detail 1: Spine Beam & Joist Strengthening Requirements, 1:10**

Existing Timber Spine Beam Assessment:

The spine wall has been removed at ground floor level so the existing timber floor beams at each level have been assessed.

Bending Stresses @ 230% capacity => strengthening required  
Deflection @ 200% limit => strengthening required

Existing Timber Floor Joist Assessment:

The existing floor joists vary in both depth and width, typically they are 160x60 at 380 c/c. They have been assessed for their maximum span.

Bending Stresses @ 98% capacity  
Deflection @ 160% limit => strengthening required

- The existing spine wall beam can not be justified to support the required residential loadings to current standards therefore strengthening is required.
- The existing floor joists require strengthening due to comply with current standards and allow for levelling of existing floors
- Generally all structural strengthening proposed will reduce deflections and movements within the building to protect the historic structure and materials from further damage
- Steel beams to bear onto padstones in masonry party walls

- This option provides the required strengthening to the existing spine beam while minimising impact on the historic finishes.
- This option does require the existing floor beams to be trimmed and re-supported on the new steelwork
- Option A is considered to have the least impact on the historic building fabric while achieving the required structural strengthening

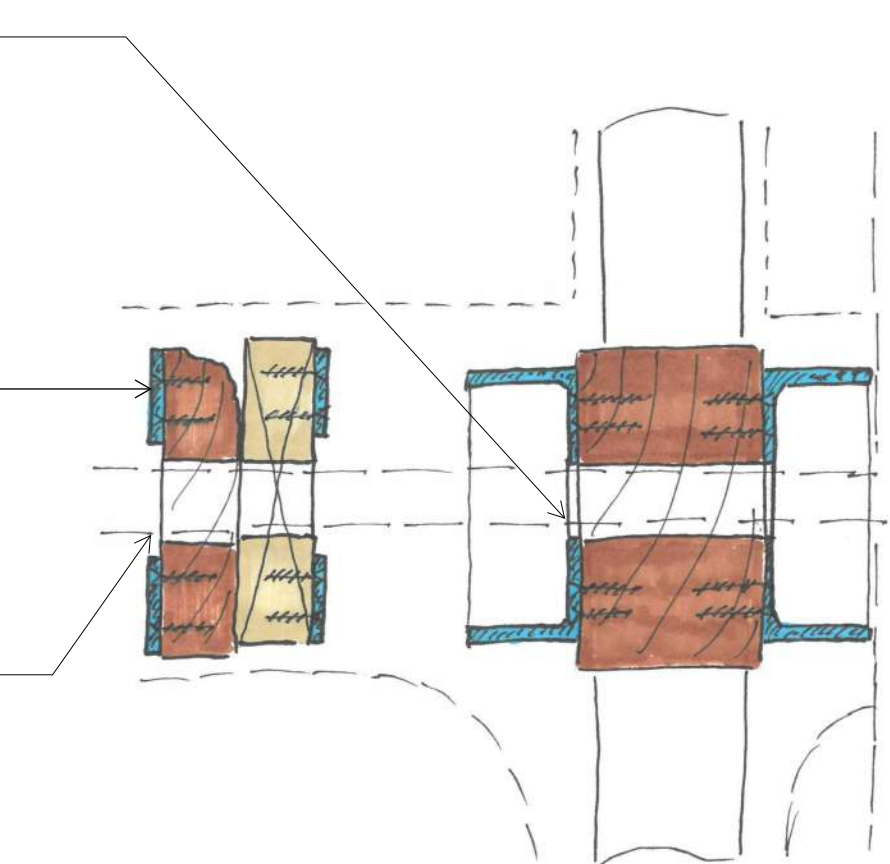
**Detail 2: Spine Beam & Joist Service Penetration, 1:10**

- The strengthening is required to allow the waste pipe from the proposed kitchen island unit to run through the floor zone. The island unit is required to avoid any damage to historic wall finishes
- The service run for the kitchen waste pipe will effect a maximum of 3 joists and the spine beam at each level

Strengthening steel beams to existing timber spine wall beams allow for kitchen waste pipe to run through to riser beyond - steel beams to be strengthened locally around penetration

Existing and proposed joists to be strengthened locally with steel plates to allow for kitchen waste pipe to run within floor zone - plates to be screw fixed to joists

Service penetration to mid depth of joists

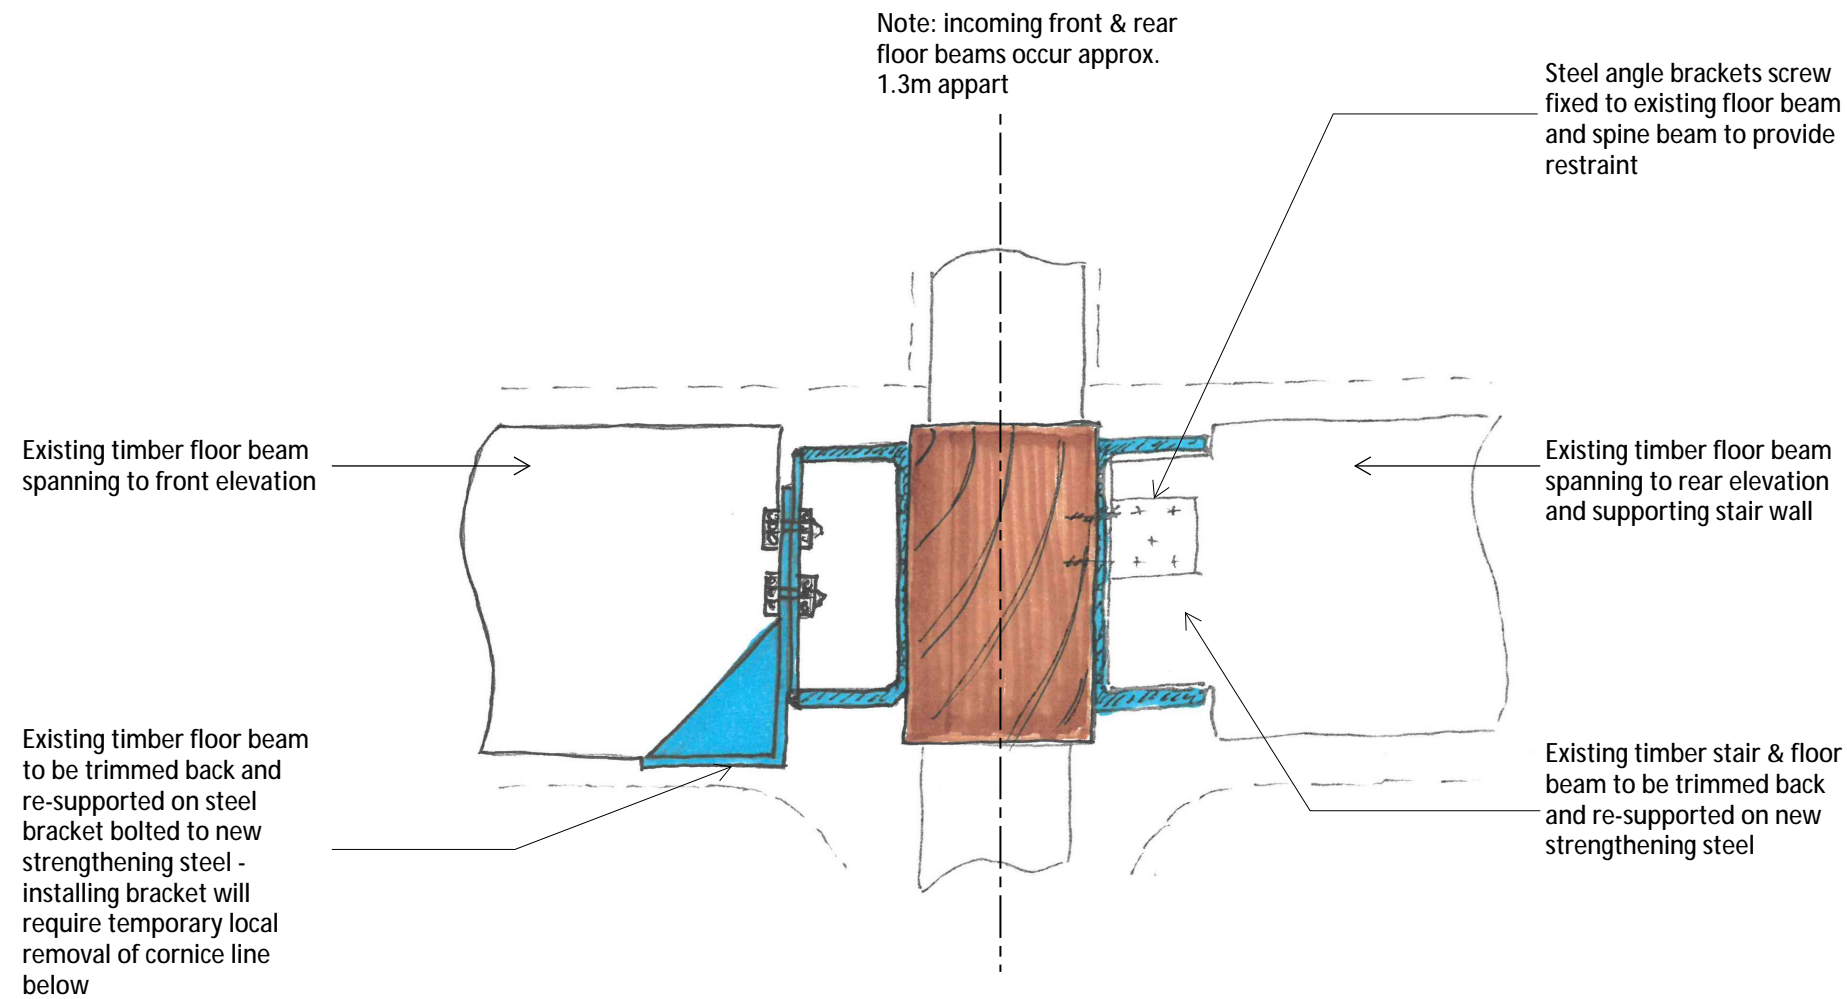
### Detail 3: Floor Beam To Be Re-supported, 1:10

- The strengthening is required to the bearing of the floor beams to justify the connection for required residential loadings to current standards
