Ref:ha/let1rpt1/99canfieldrd

Tree Inspection and Recommendations – 99 Canfield Road, London, NW6

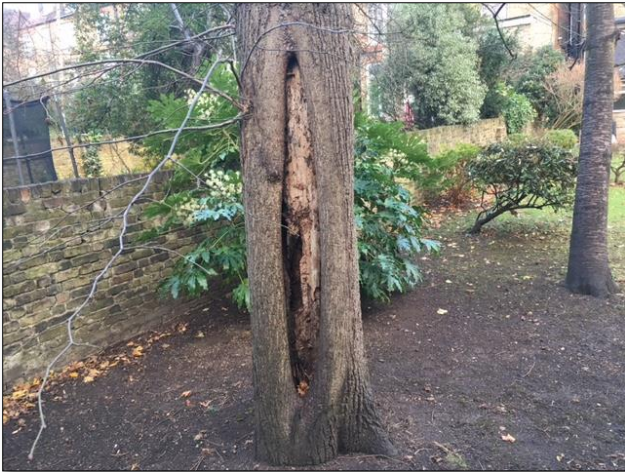
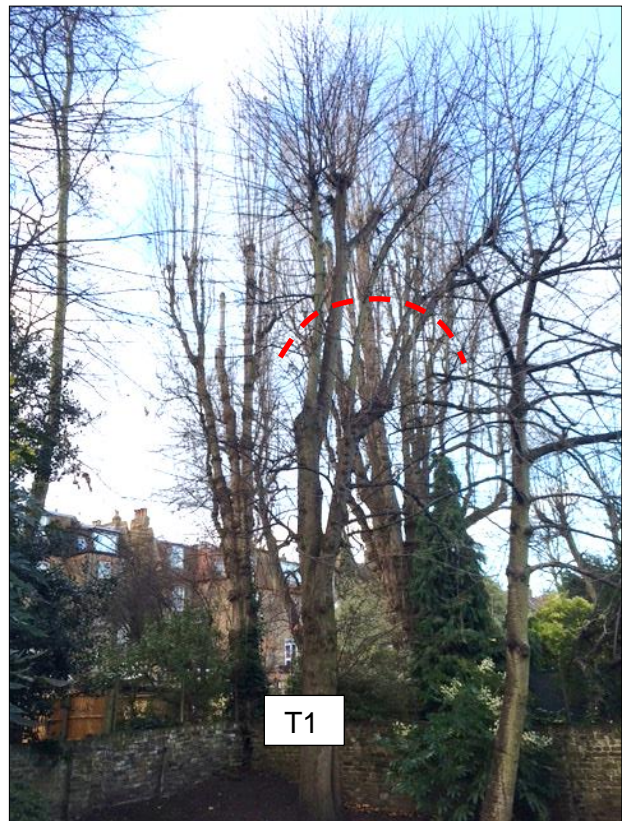
The tree is mature and stands around 14m in height. Its trunk diameter is 550mm. The tree appears to be growing with normal vitality, evident by the density of shoots and buds. The tree has been pollarded (removal of all stems and branches to a given point above ground level) and reduced in height and spread also. The tree does carry a number of structural defects.

At the tree's base, open cavities exist and the trunk is partially hollow, which is confirmed by tapping with a sounding mallet. In spite of the cavities and hollowness, strong and thick wound wood has formed around the cavity openings. Coupled with previous size reduction work, the tree is, in my view reasonably safe but I recommend that some further size reduction work is carried out in the form of re-pollarding. This work will further reduce the size of the tree and reduce wind purchase and stress placed upon the weakened trunk area. I note a number of decay areas at the sites of previous pollarding and it will be sensible to reduce the length of the stems for general tree management and safety reasons, particularly given that the tree is located within a residential garden, used frequently throughout the year.

Fig. 1 T1 Lime With decayed trunk cavity and pollarded canopy – dashed line of new pollarding

Tree Ident. and location*	Tree Dimensions** (approx.)	Proposed Works (refer to spec.)	Summary Reasons
T1 Lime	14 x 3 x 550	Pollard to 8m (remove 5-6m from height) (Sp7)	Decayed base; reduce canopy area and wind purchase; reduce risk of branch and stem failure
T2 Lime	17 x 3 x 500	Fell (Sp6)	Extensive decay in trunk base;

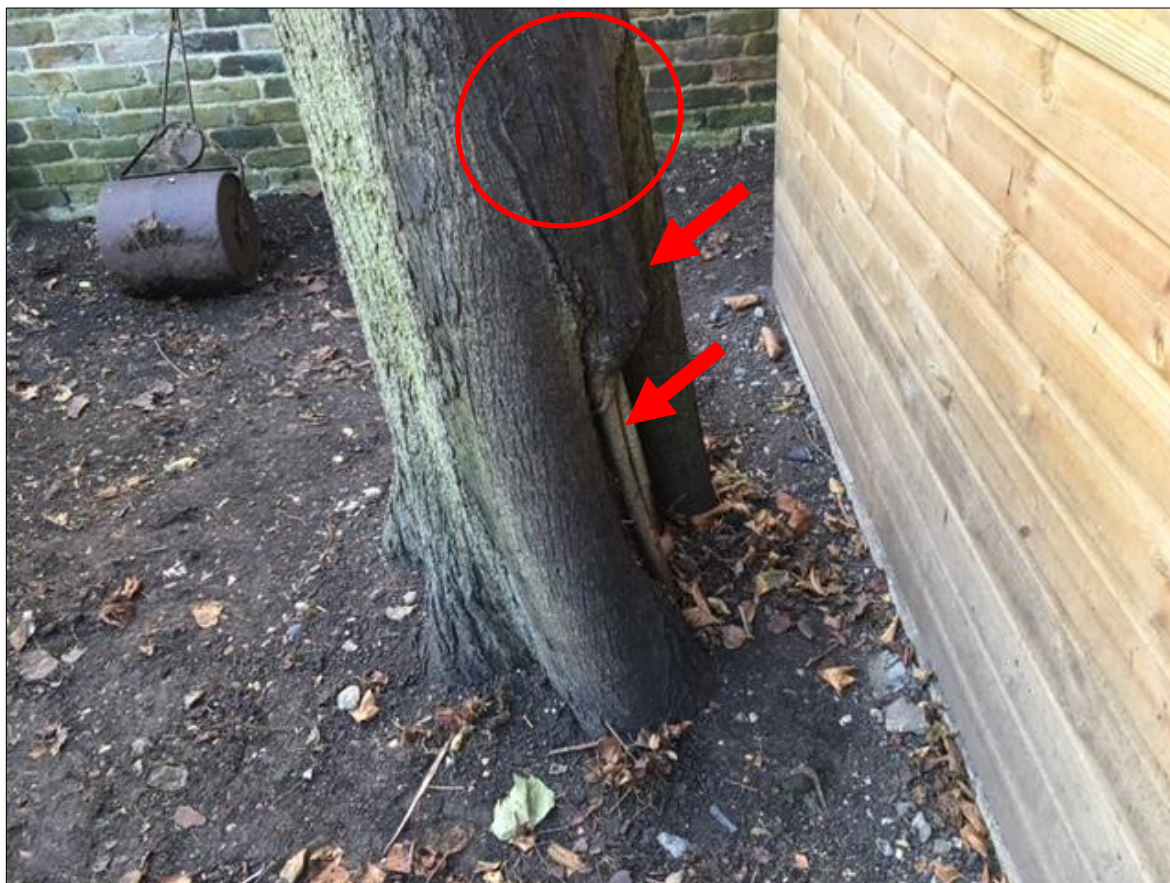
This tree appears to have been permitted to grow somewhat taller than T1 and stands around 17m in height. Its trunk is around the same diameter at 500mm. The tree has been reduced in the past and it is clear why this has been carried out because the base of the tree is significantly decayed. However, unlike T1, which is relatively upright and even, this tree leans north in the opposite direction to the side of the decay, which is on the tree's southern side. The decay is extensive and well-established. Dead wood decay fungi are present in the base (*Ramaria* spp.), which indicates the longevity of the wood decay.

I note flattened form of the trunk above the open cavity at the base, which can be an indication of trunk weakening, in advance of complete failure. Certainly, the extent of the decay at the base is severe and given the position of the decay and the majority of the weight leaning away from the weakened area, the flattening effect if the trunk is consistent with a weakened trunk structure. I also note the darkened colour of the bark, which is often associated with internal weakness in Lime in my experience.

Fig. 2 T2 Lime with extensive decay (arrowed) and flattened area of trunk (circled)

It is possible to retain this tree with heavy pollarding, which would remove at least 50-60% of the tree, leaving a tall stump to re-sprout new shoots. I am not convinced that this tree will tolerate this type of tree work and which may lead only to further decline and decay, triggered by the imbalance of energy resources distributed throughout the tree, when

Bearing in mind the above structural problems with this tree, coupled with the residential location and presence of many other trees in the area, I recommend that this tree be removed completely. This will eliminate the risk of failure but, owing to the presence of other trees locally, will not impact adversely upon the quality of the conservation area.
