## **CONDITION REPORT**

**ODEON COVENT GARDEN  
135-149 SHAFTSBURY AVENUE  
LONDON  
WC2 8AH**

| <b>PURPOSE OF THIS REPORT:</b> | Prepare a condition report for the scheme |
| <b>DATE:</b> | 7 <sup>th</sup> August 2017 |

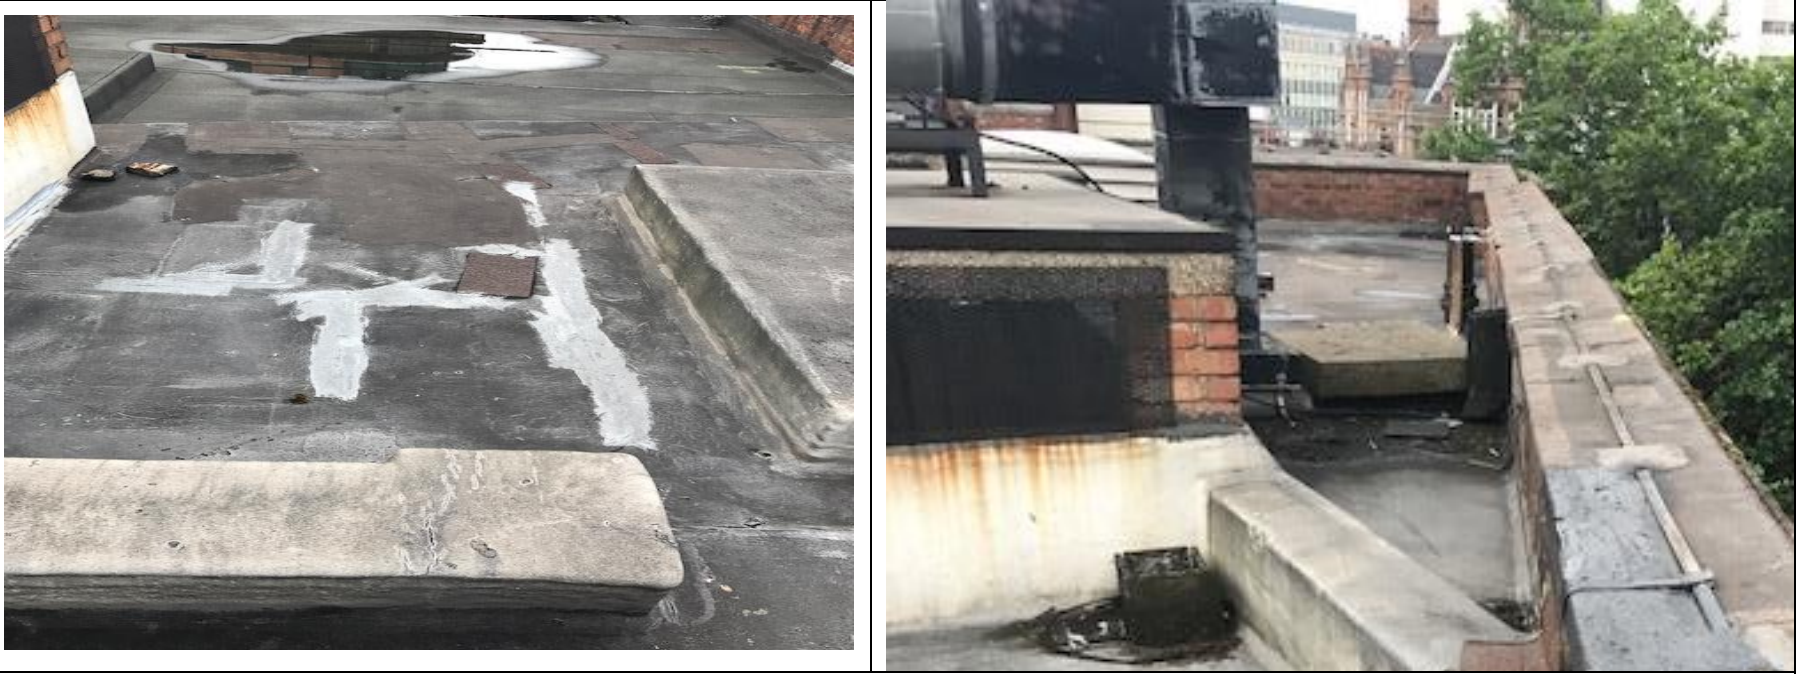
The general conditions of the coverings are poor with evidence of numerous patch repairs which have been carried out on a piecemeal basis in the past. The parapets have also been treated using a variety of liquid waterproofing treatments.

| Photographs and Descriptions | |
|---|---|
| 1. | <p>Sections of roof showing numerous patch repairs</p> |

- Removal of all asbestos.
- Upgrading of electrical services including all lighting, and power sockets to current NIC EIC standards.
- Upgrading of plant.
- Refurbishment of areas that have fallen into disrepair.
- Renewal of main roof coverings.
- Renewal of windows.

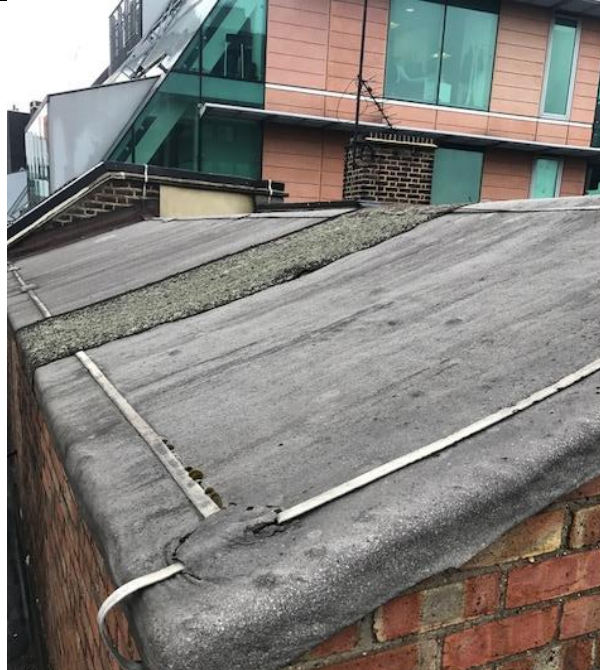
2.

The roof coverings are mainly covered in mineral felt whilst other sections (the void and tank housing) are finished in asphalt.

Asphalt roof covering showing patch repairs using mineral felt to tank housing

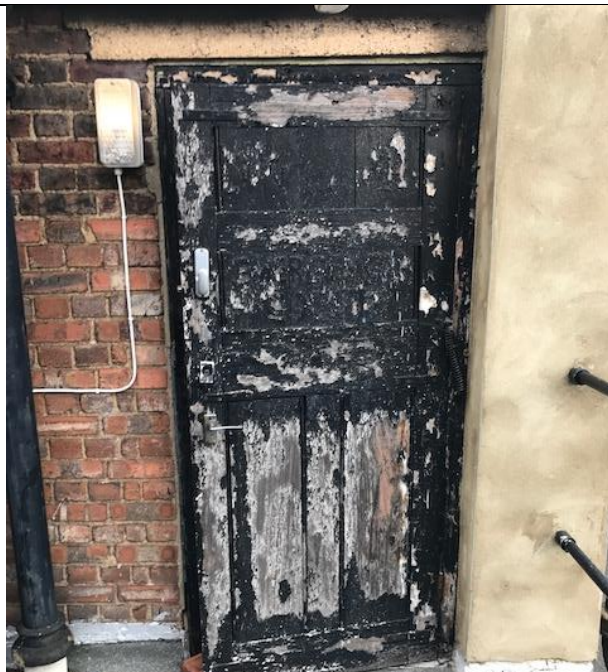
3.

The timber doors and paintwork to the tank housing rooms are beyond economical repair.

Door leading from staircase A onto roof

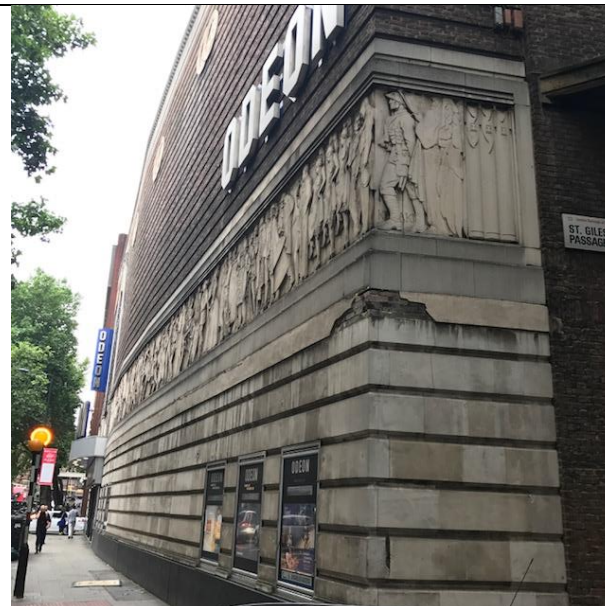
There is also damage to the front right hand corner of the frieze. There is also evidence of piecemeal repairs to the front lower masonry sections.

Damage to stonework of frieze

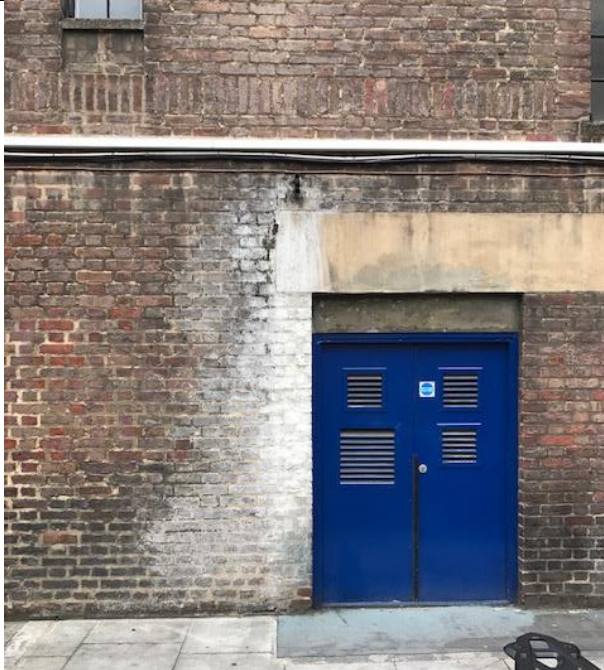
4.

The brickwork is in generally fair condition. However, overflows have caused damage to the brickwork to the rear elevation at lower level.

Damage caused to brickwork of rear elevation by defective overflow.

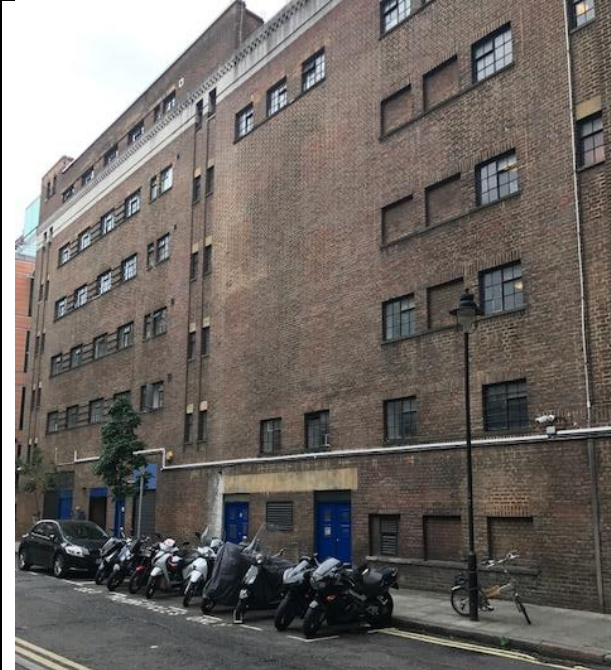
The windows are single glazed metal with side hung casements. These windows are in generally poor condition throughout with cracked glazing and poorly fitting openers.

General view of rear elevation showing metal windows.

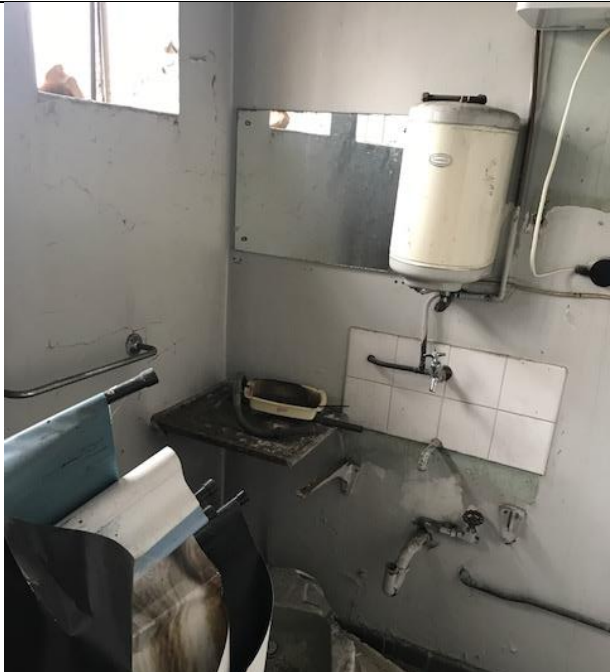
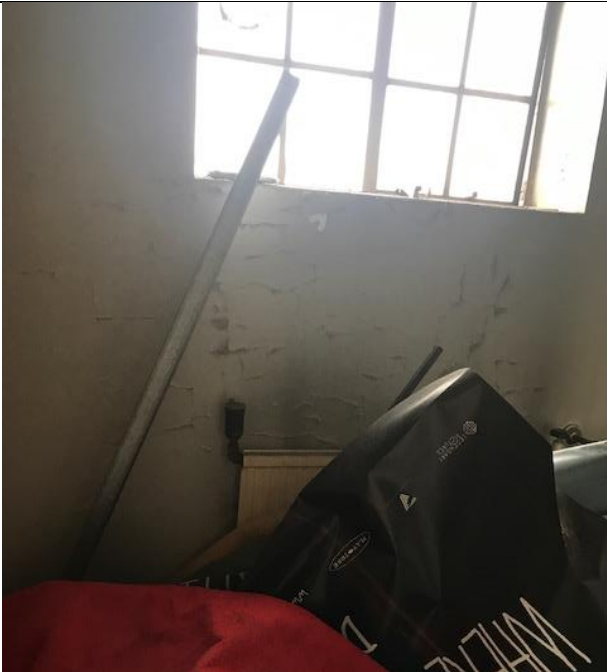
5.

Typical condition of level 9 washroom

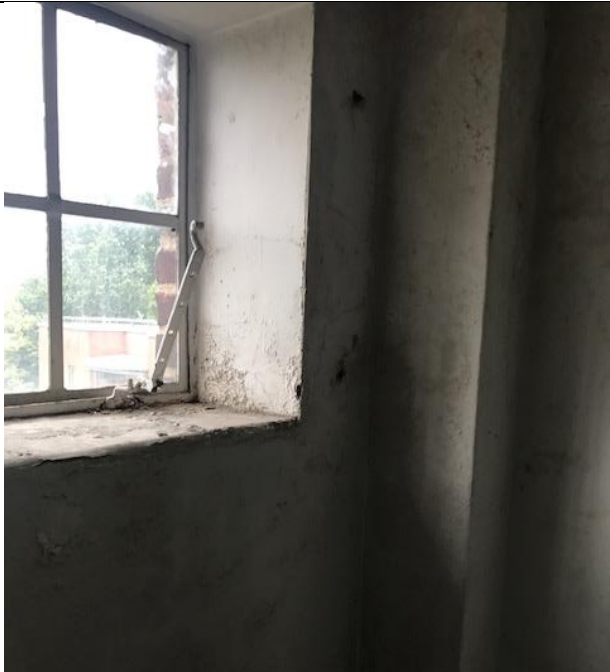
6.

Walls to staircase A

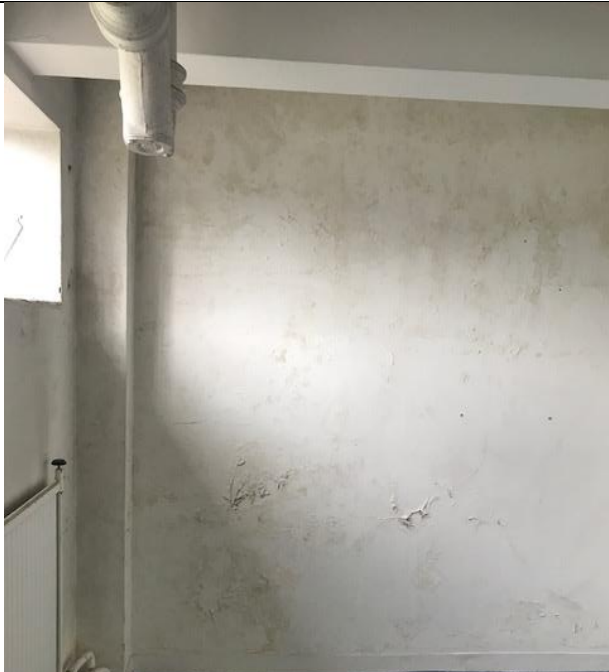
Wall to unused office affected by penetrating dampness

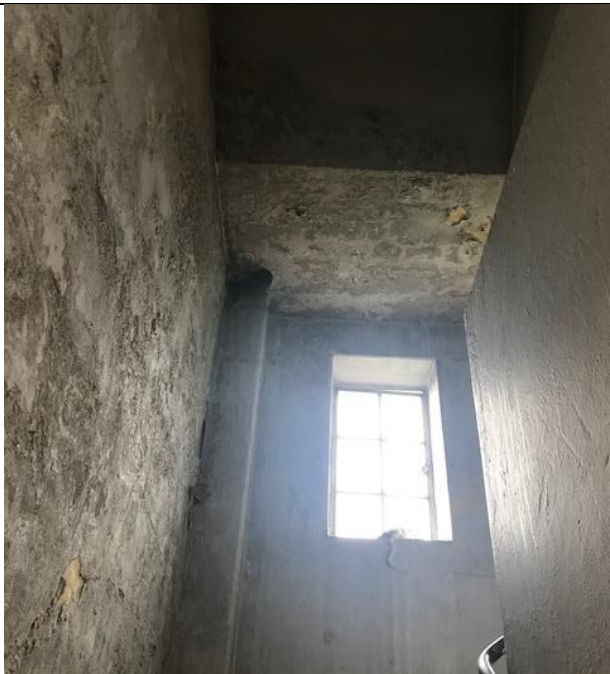
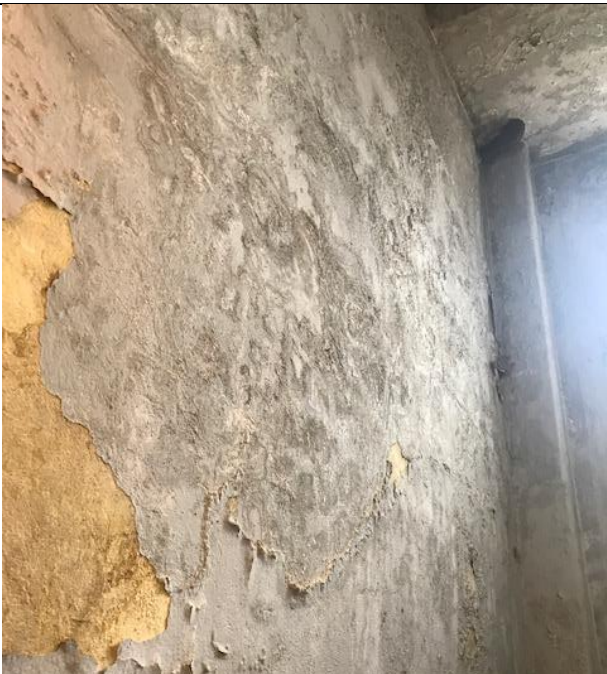
7.

We found evidence of a major roof leak that has caused damage to the upper stories of staircase C which is situated to the right hand side of the building.

Staircase C damage caused by penetrating dampness

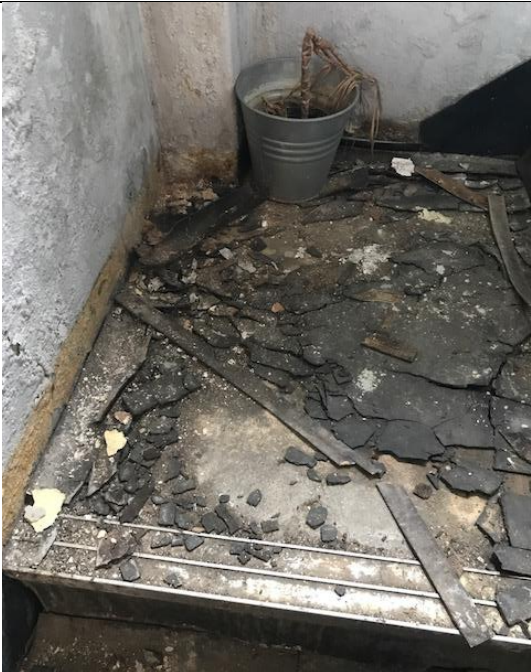
8.

The staircases (A-C) require new floor coverings as these have generally fallen into disrepair.

Flooring to staircase C

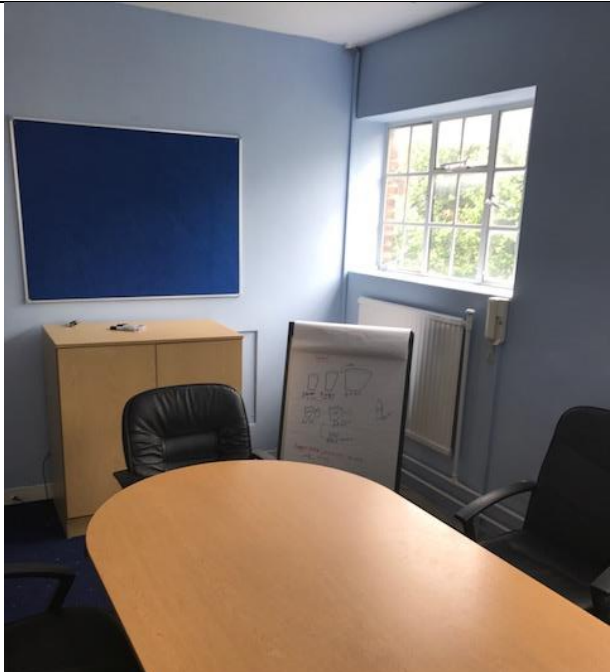
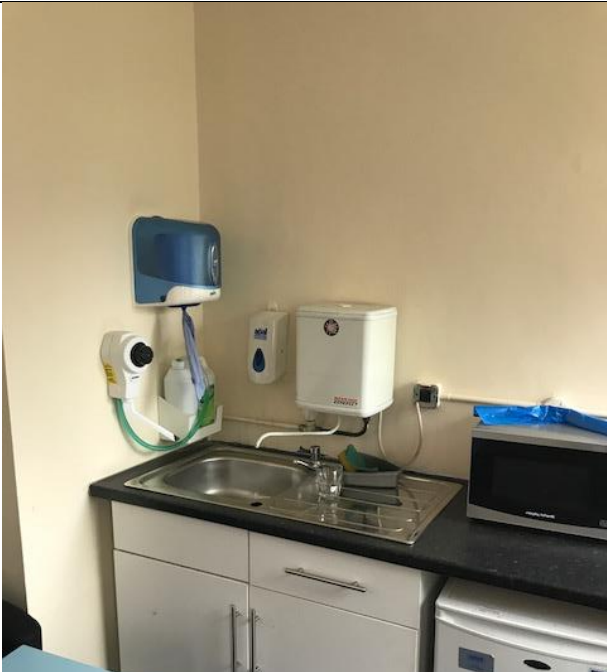
9.

Office and kitchen areas currently being used

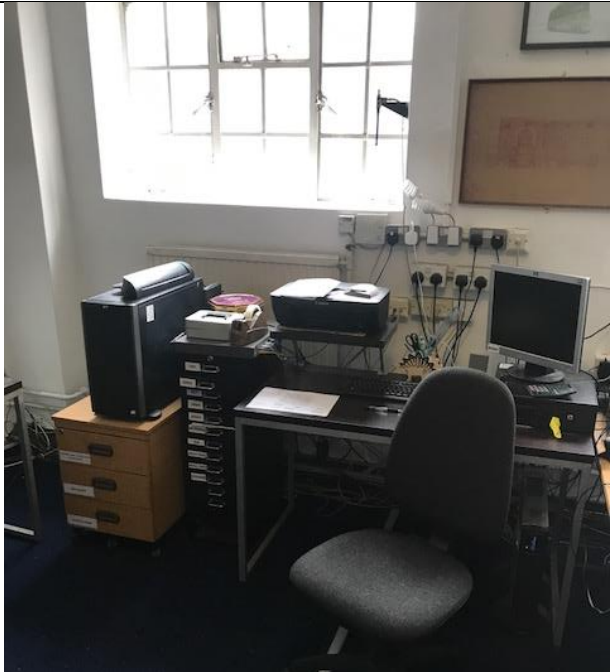
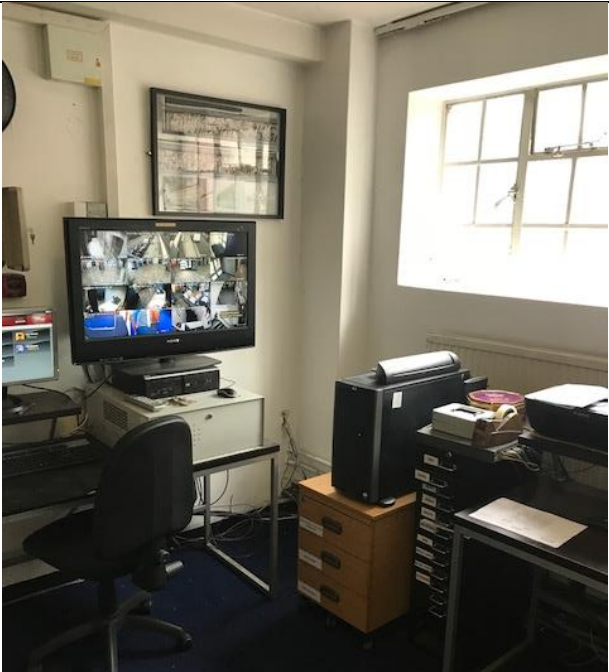
10.

However, it was noted that there are a limited amount of electrical sockets and lighting which would be required to bring these areas up to an acceptable standard for future use.

Offices showing additional electrical sockets

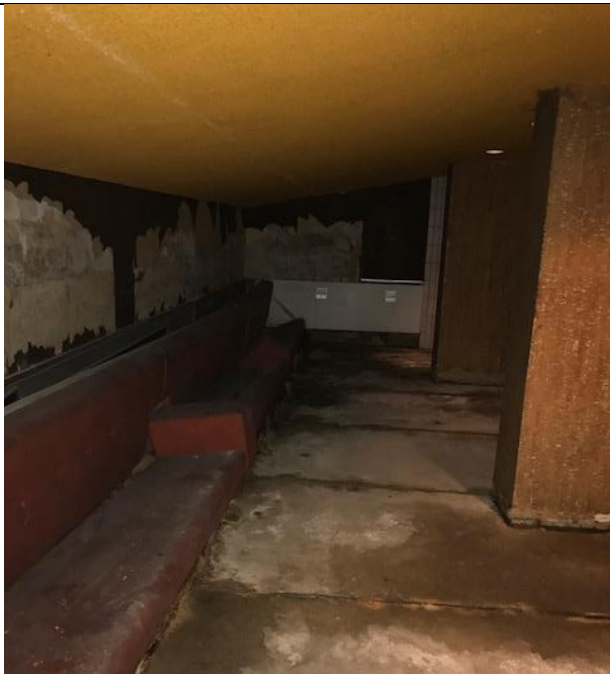
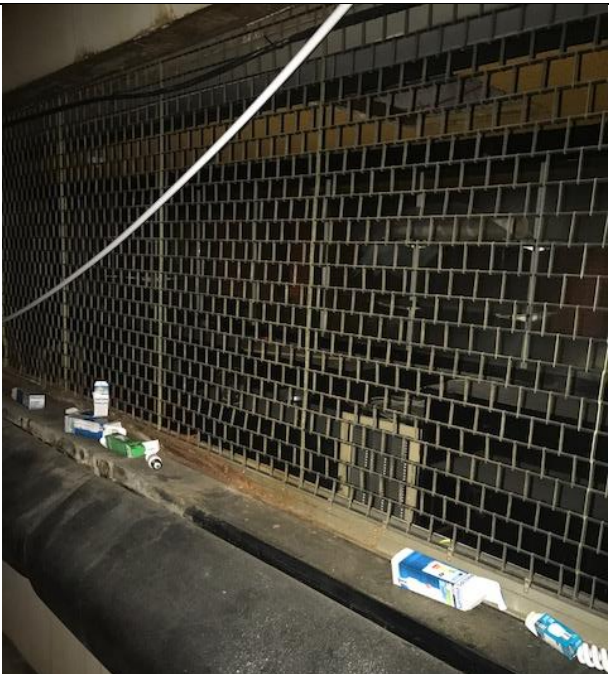
11.

Disused bar area to lower level

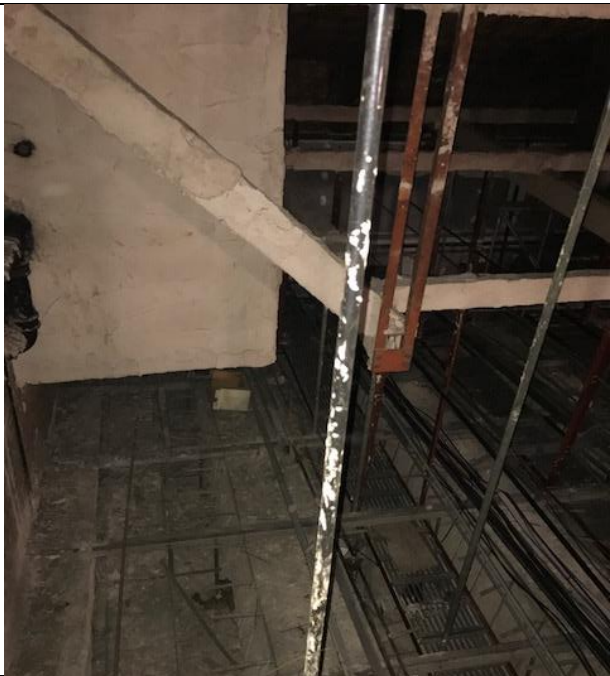
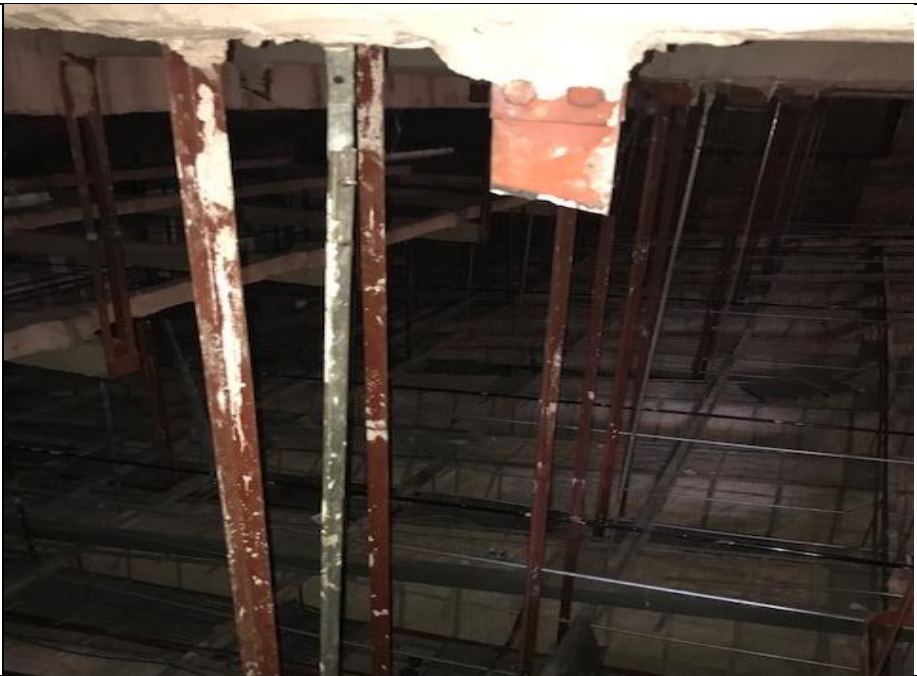
12.

Roof void

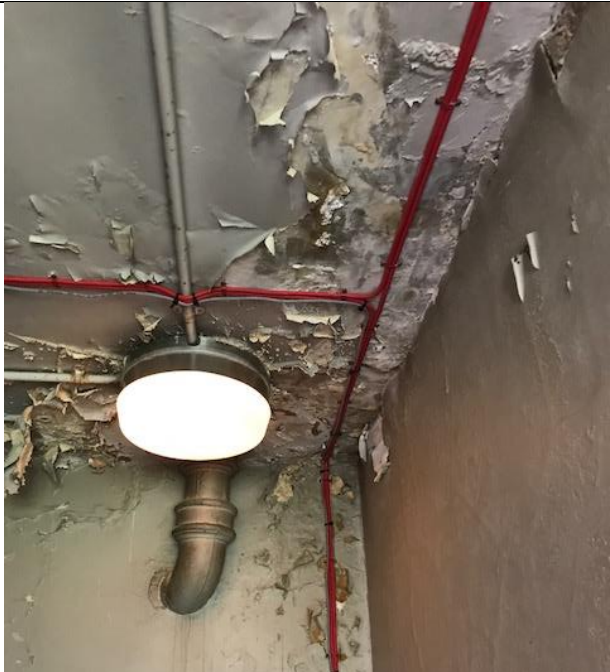
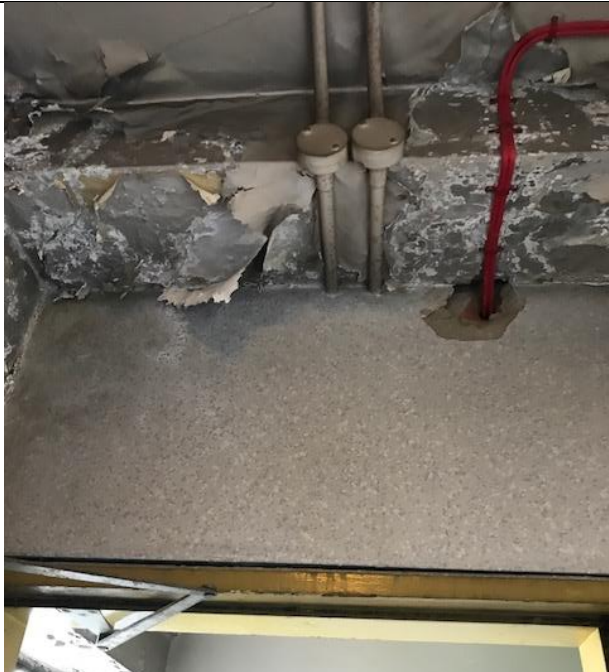
13.

General condition of upper and lower levels

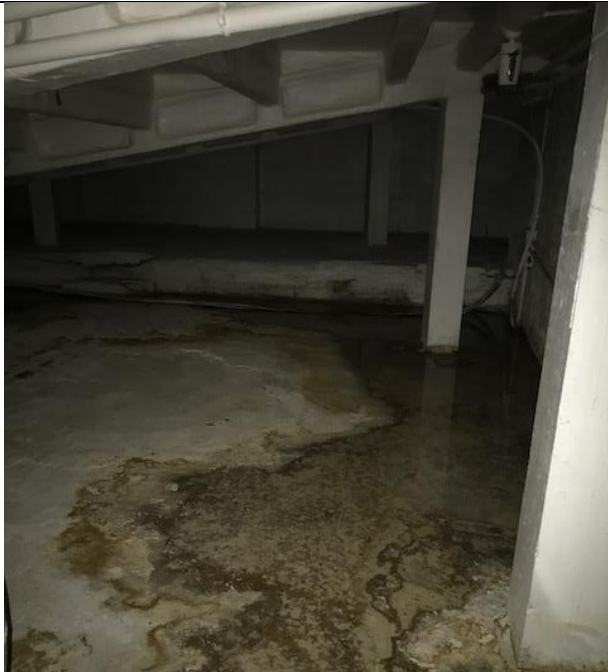
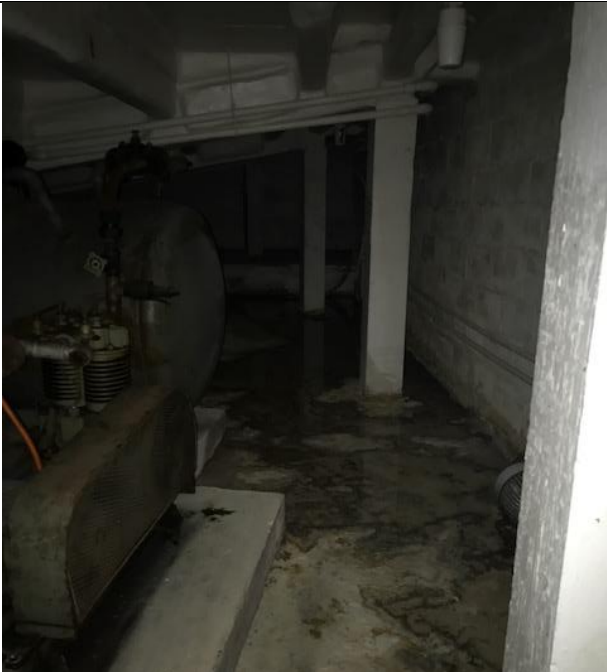
14.

We inspected the basement levels and noted flooding has occurred to the plant room.

Flooding to plant room at basement level
