BASEMENT PHOTO RECORD

GROUND FLOOR - EXISTING, STRIP OUT & PROPOSED

FIRST FLOOR - EXISTING, STRIP OUT & PROPOSED

SECOND FLOOR - EXISTING, STRIP OUT & PROPOSED

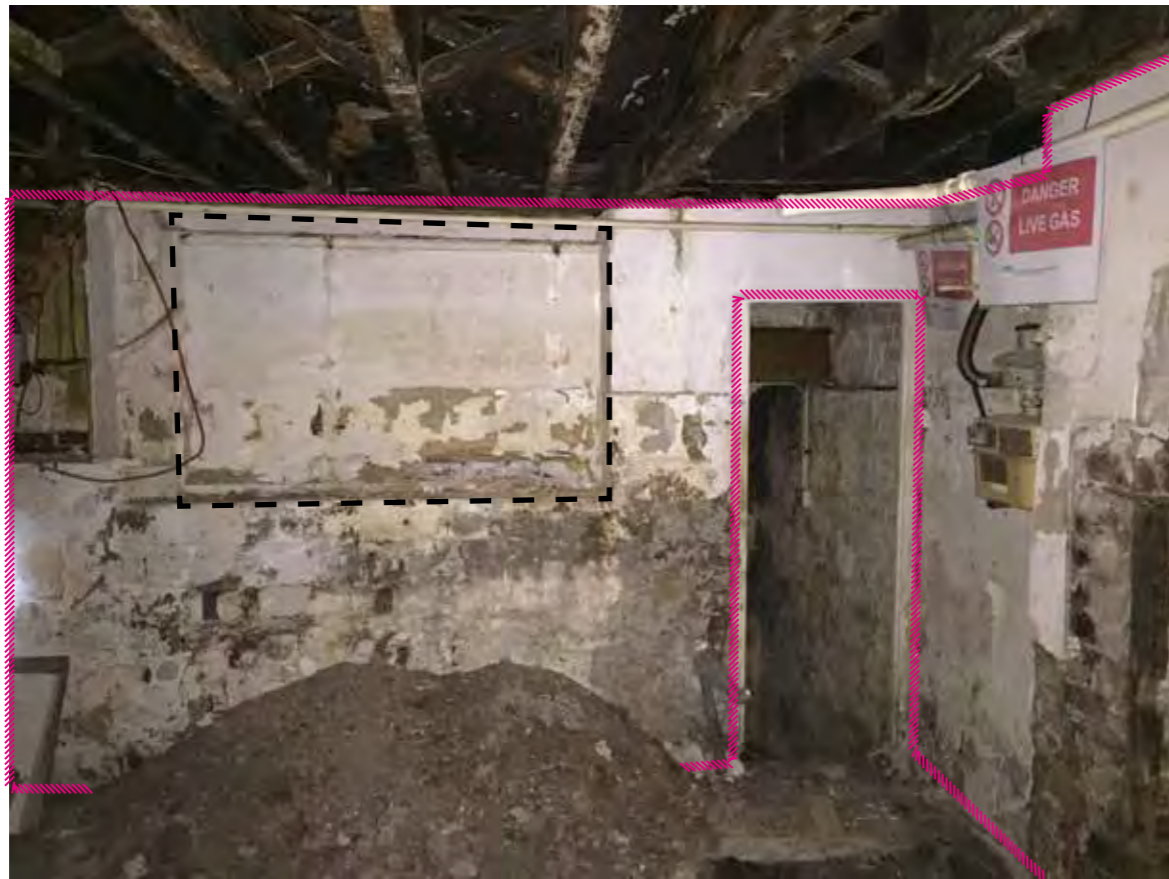
1 - Opening to area beneath St Giles High Street pavement - currently inaccessible. Note possible original window opening to street, filled in

- All linings to masonry wall to be removed to assess brickwork and structural integrity
- Area below St Giles High Street inaccessible - area still to be checked

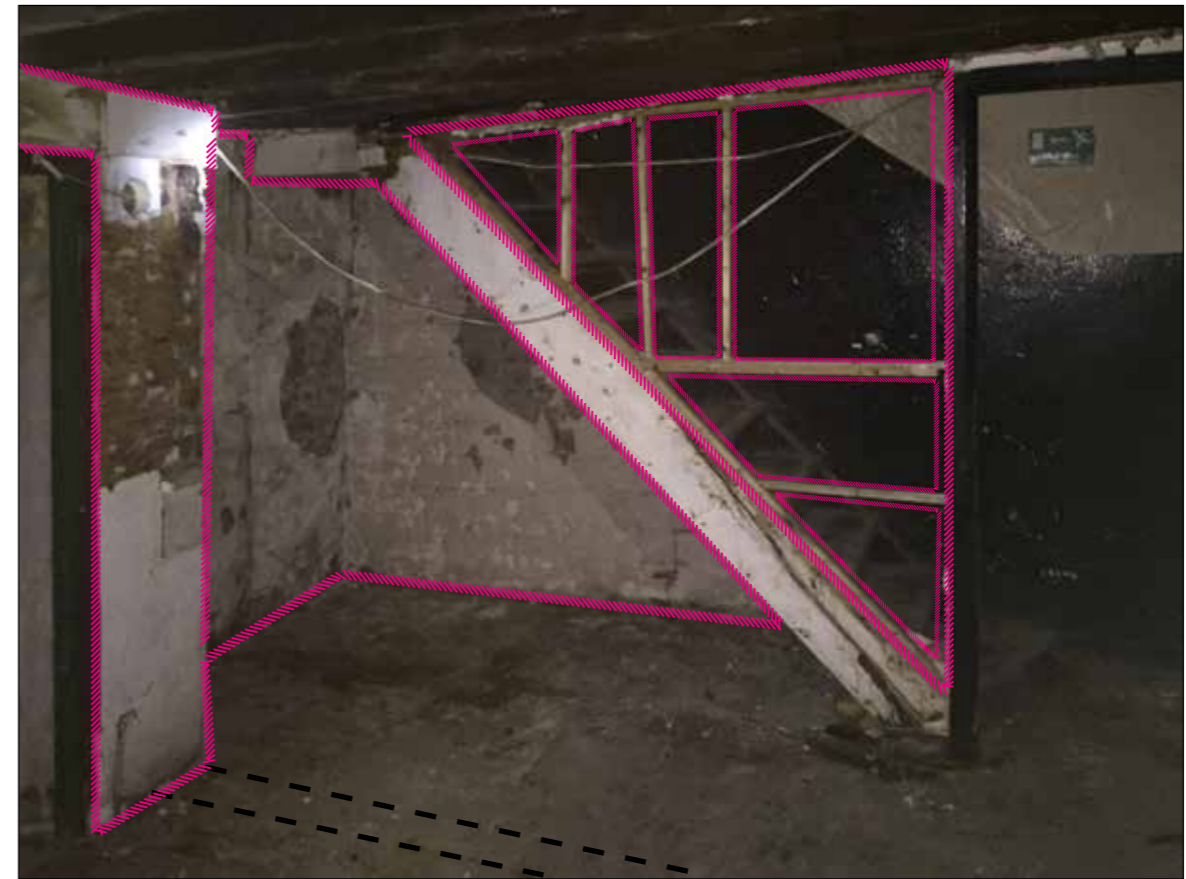
2 - Staircase up to ground floor. Line of original masonry wall dotted on floor.

- All linings to masonry wall to be removed to assess brickwork and structural integrity. Timbers to stair removed.

- New limecrete flooring throughout.
- New balustrade to stair.

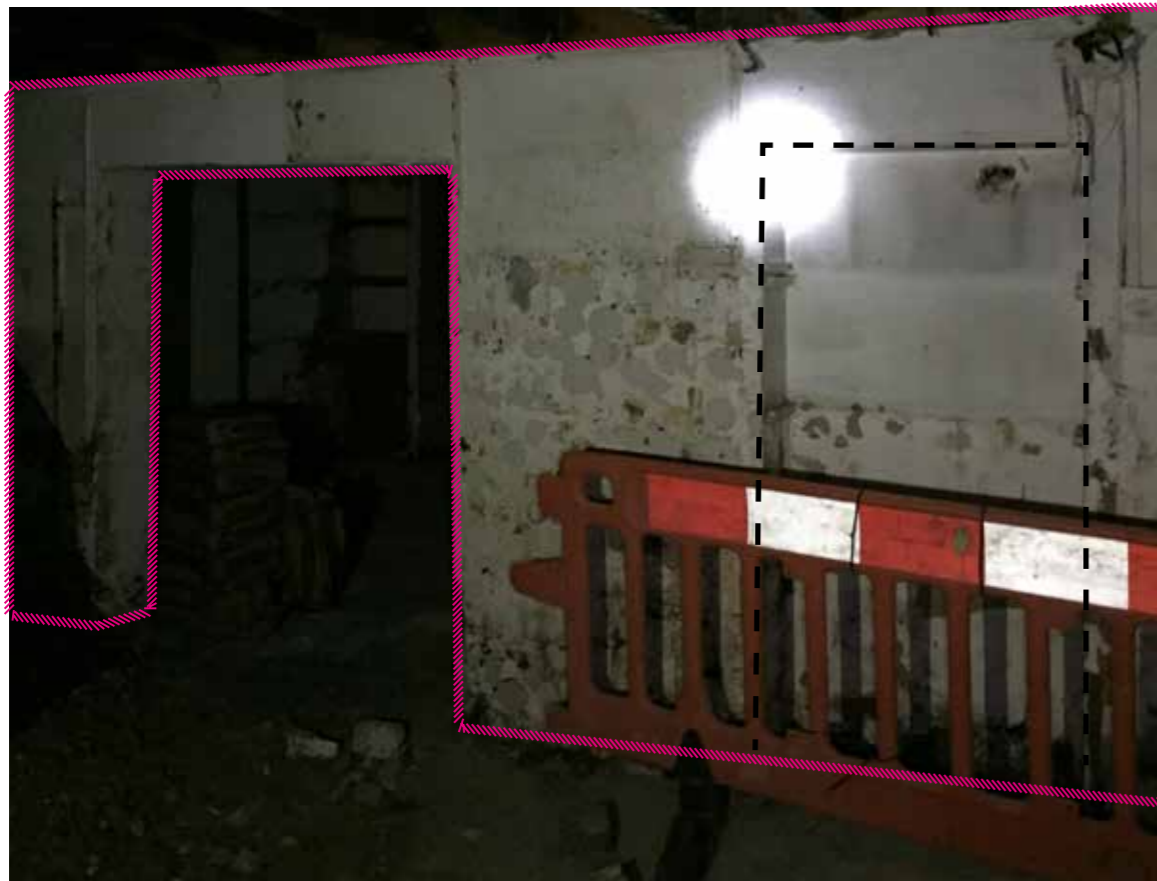
3 - Original opening from stair to primary room filled in. Lintols very low

-All linings to masonry wall to be removed to assess lintols, brickwork and structural integrity

-New lintol to raise height of opening.
-New limecrete flooring throughout.

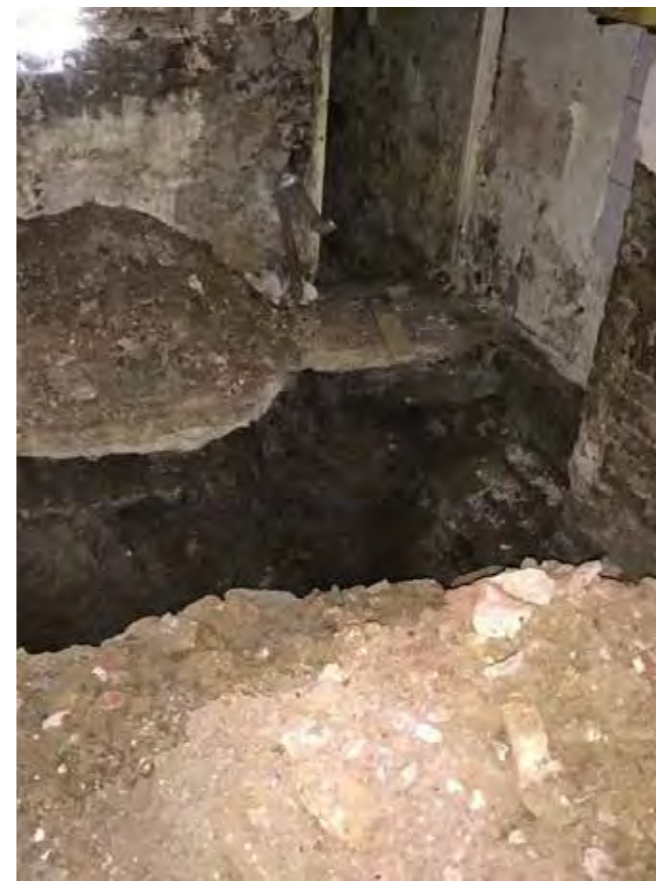
4 - Hole dug for UKPN works by Skanska
Corbeled brick foundation visible adjacent chimney stack in primary room. Opening to area beneath St Giles High Street visible - currently inaccessible .

-Hole to be infilled after Skanska works, new limecrete flooring throughout.

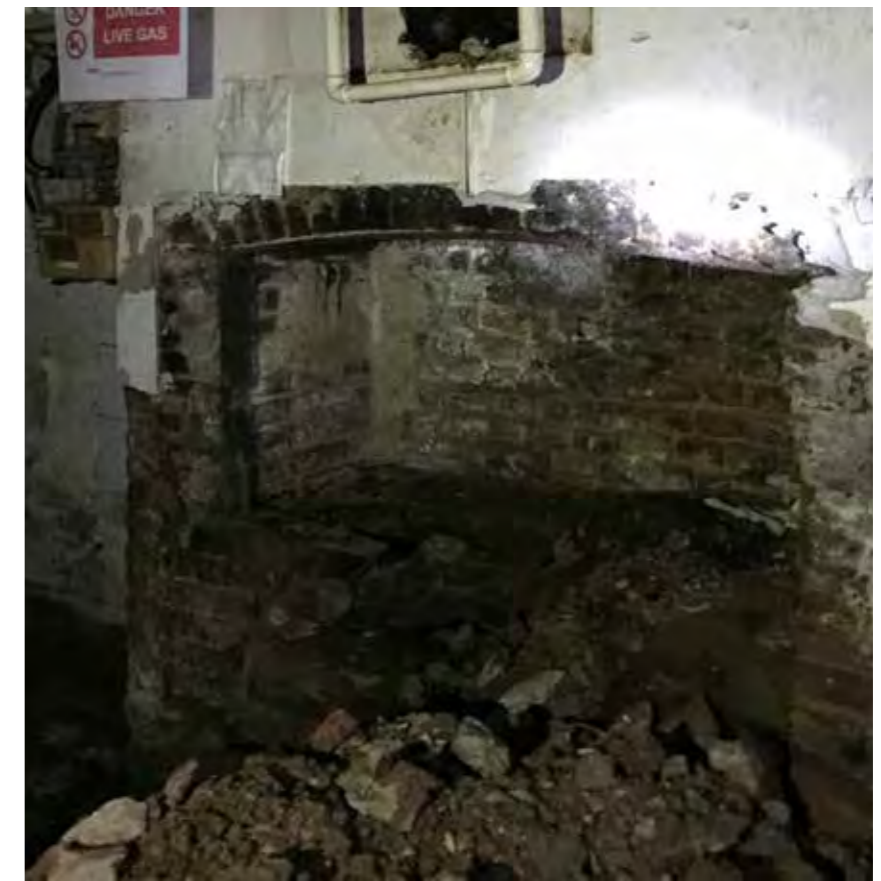
5 - Chimney stack and opening in primary room.

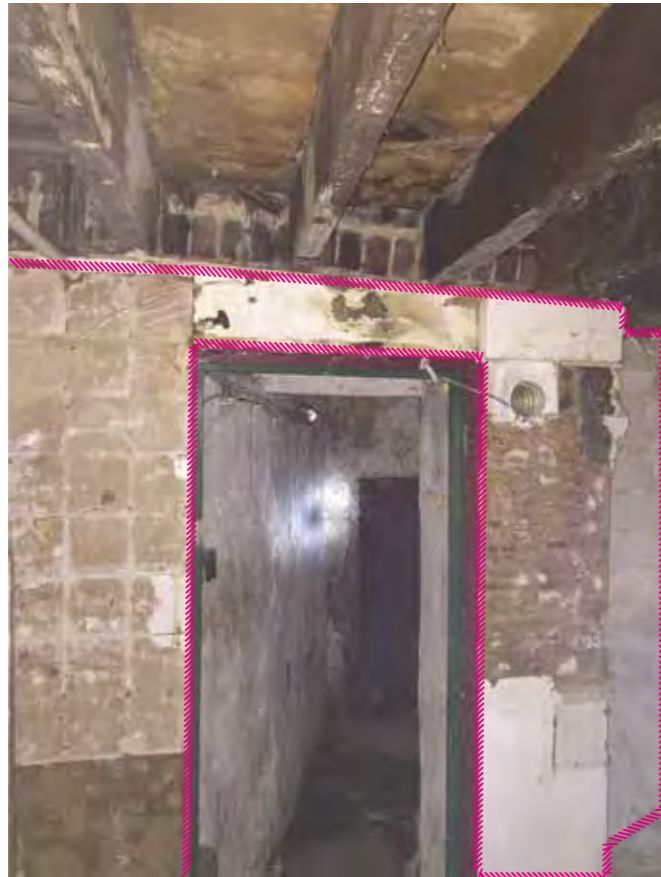
6 - Original back door to yard - now infilled through to coal stores.

Strip-Out Note:
 - All wall linings to masonry to be removed to assess brick-work and structural integrity

Proposed Note:
 - New limecrete flooring throughout.

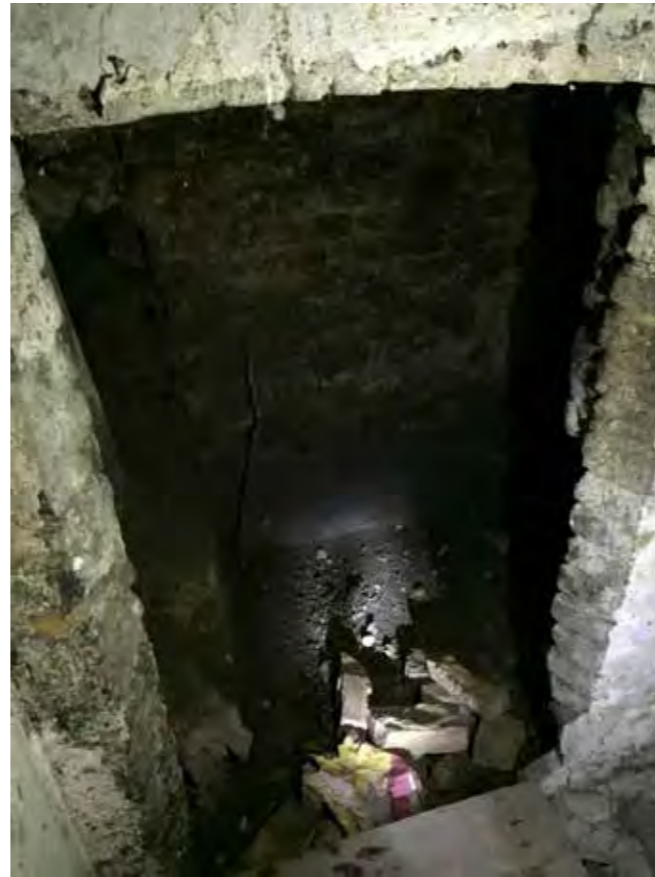
7 - Original coal store in in-filled yard to the rear

Proposed Note:
 - New timber doors to coal stores.

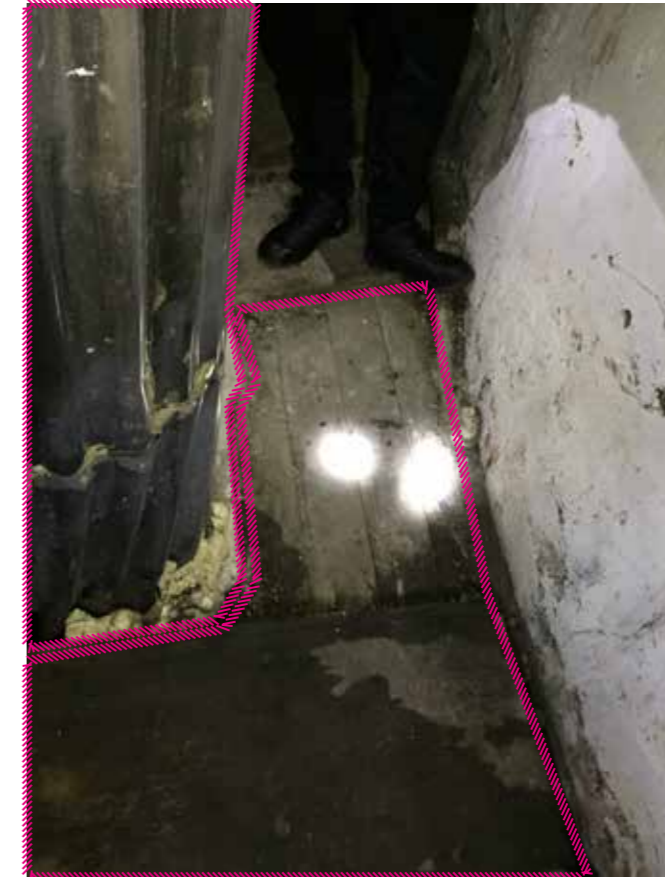
8 - Timber flooring soft underfoot and corrugated steel stuffed with foam to masonry wall in infill to the rear of the building.

Strip-Out Note:
 - Floor finish and corrugated metal wall linings to be removed to show extent of damage / water ingress behind

Proposed Note:
 - New limecrete flooring throughout.

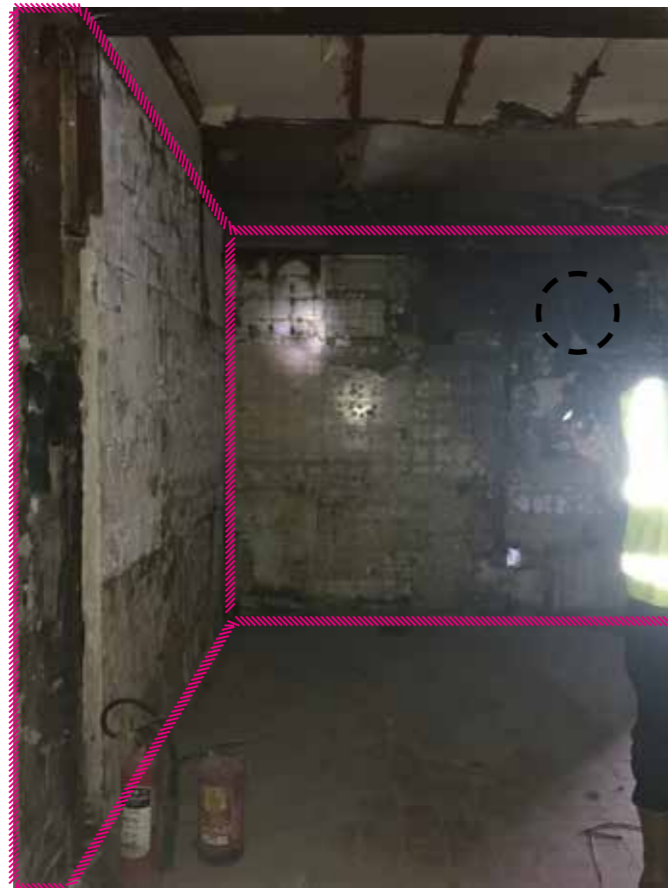
9 - Secondary room of ground floor. Extract duct visible in background.

-All linings to wall and ceiling to be removed back to line of lathe to expose build up behind

- New timber floor.

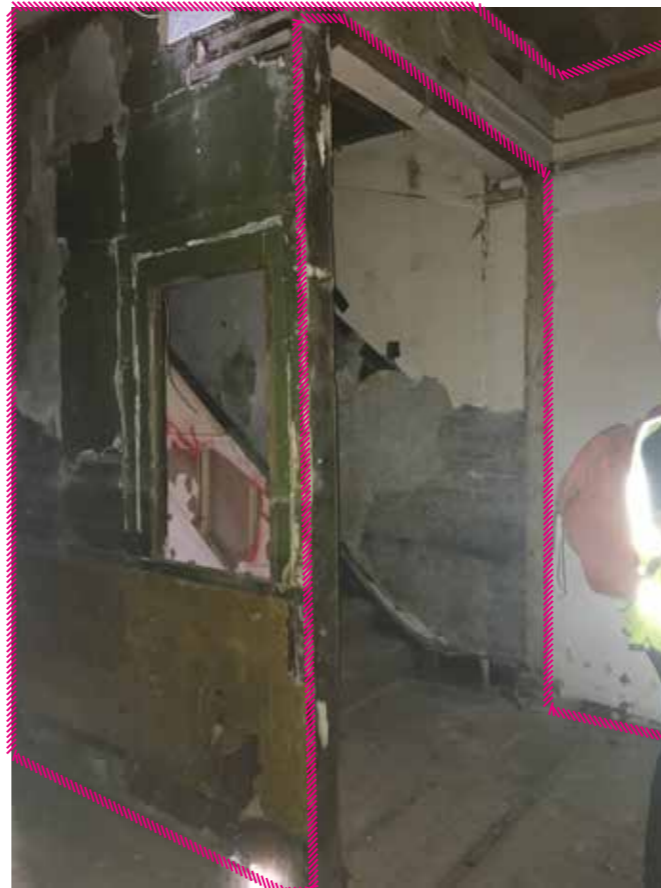
10 - Stair up to first floor. Original door opening partially boarded up and used as window.

-All linings to wall and ceiling to be removed back to line of lathe or plaster to expose build up behind
 -Partition structure to remain.

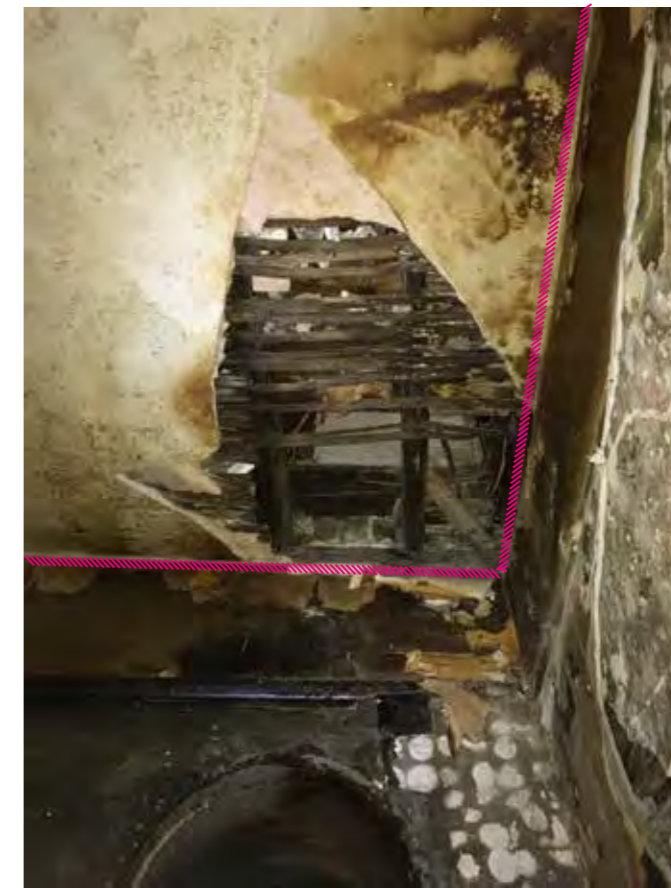
11 - damage to ceiling linings in secondary room at ground floor exposing partial lathe and joists above. Extract duct partially visible.

-All linings to wall and ceiling to be removed back to line of lathe to expose build up behind

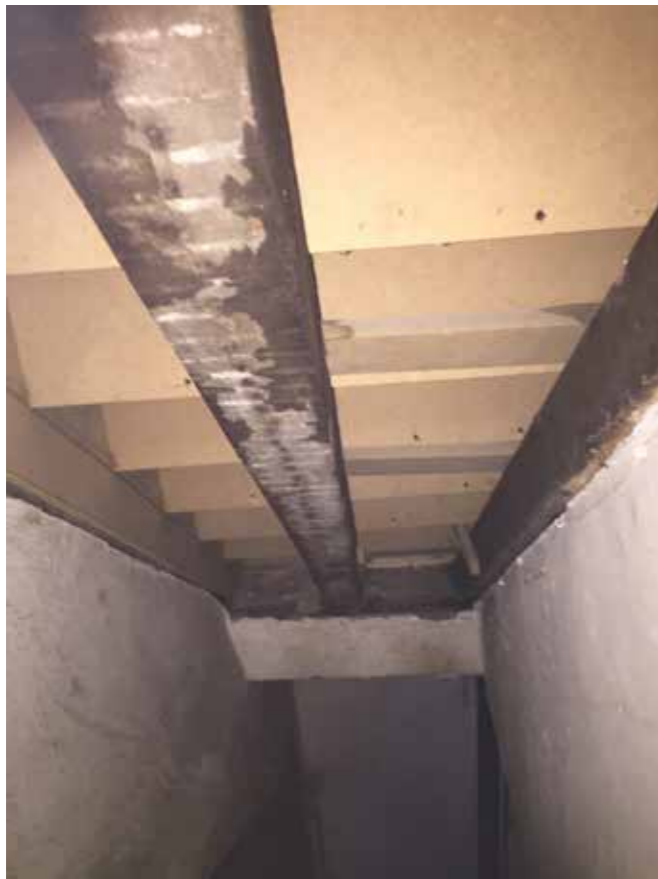
12 - Underside of MDF stair from ground to first floor

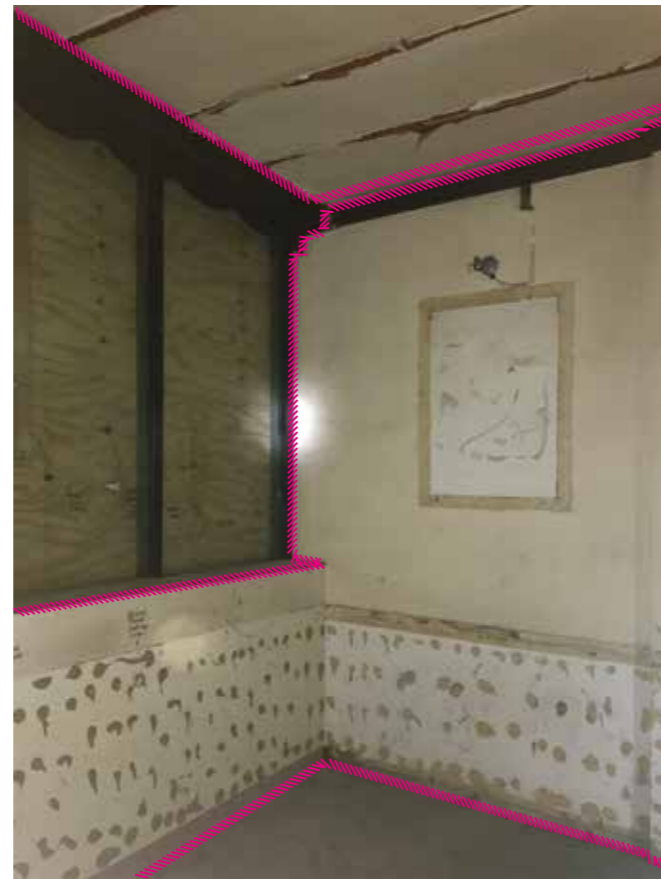
13 - Shop front boarded up

-Linings to wall and ceiling to be removed to expose build up behind

- Shopfront works by others

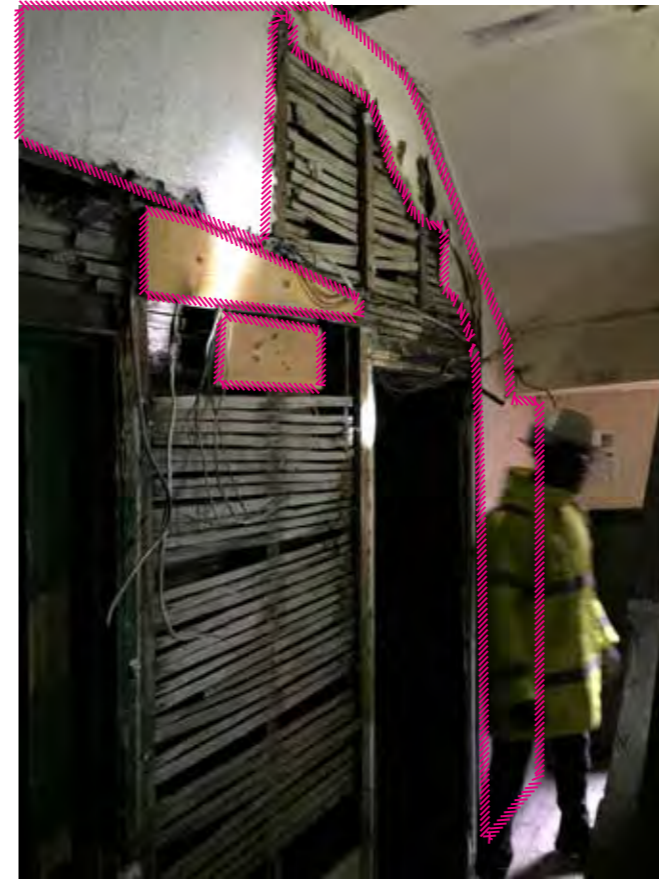
14 - Lathe and plaster stud wall in original position in stairwell, with new door opening

- Over-boarding to original lathe and plaster wall to be carefully removed. Lathe to be retained. Boarding up of original door opening to be removed

- Original door opening to be reinstated. Existing opening to be boarded up.

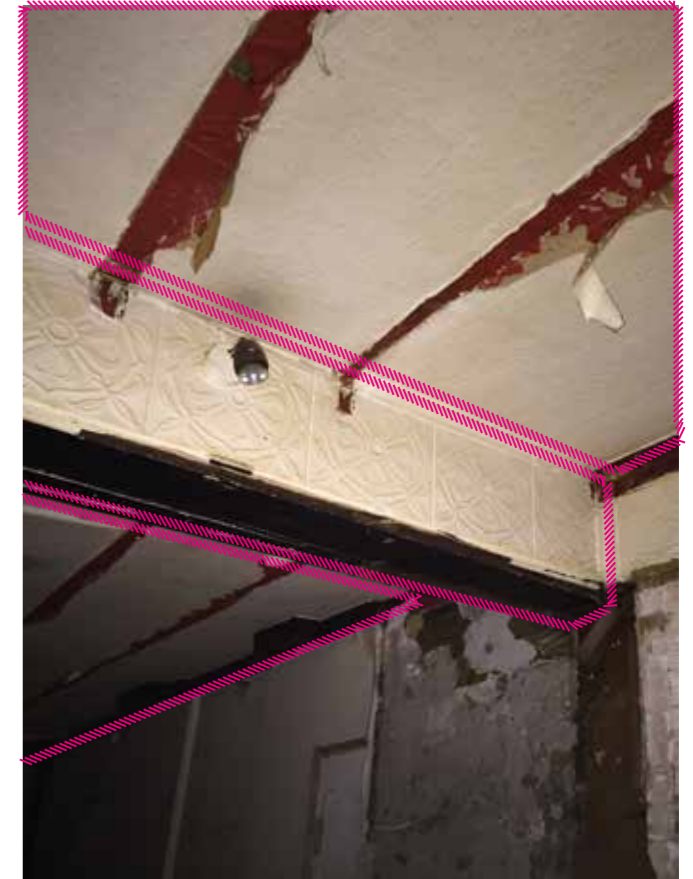
15 - Assumed steel beam boxed out at high level ground floor, on original partition line

Lining to beam to be removed to expose assumed steel I-section behind. All Lining to ceilings to be removed.

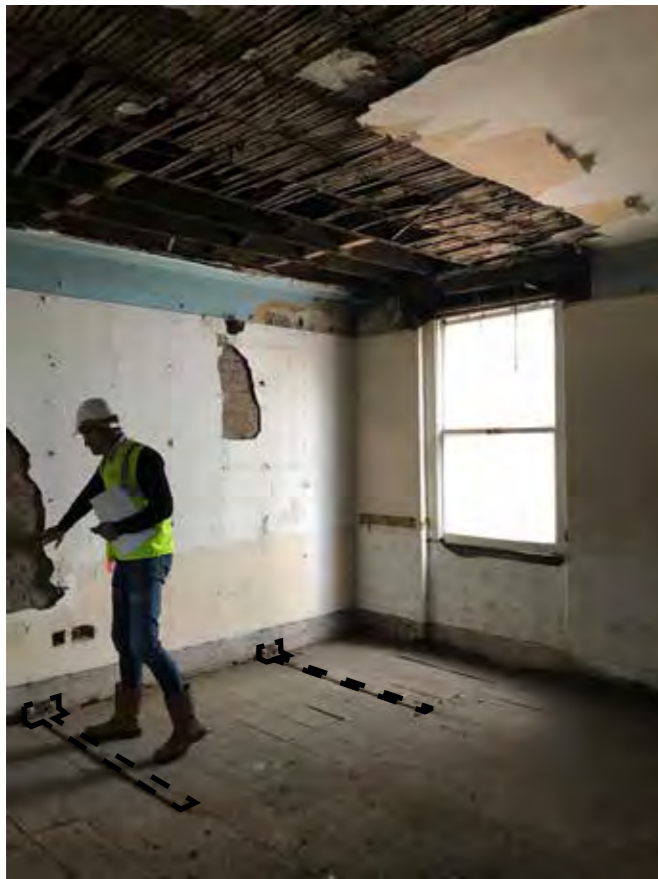
16 - Party wall strapping visible on timber floor. High level joists visible. Damage to window opening / cill visible.

- Single panel sash window to be removed and replaced with appropriate six over six panel sash windows
- Shutter boxes reinstated
- Ceiling to be repaired with traditional lathe and lime plaster.
- All corncing to be repaired

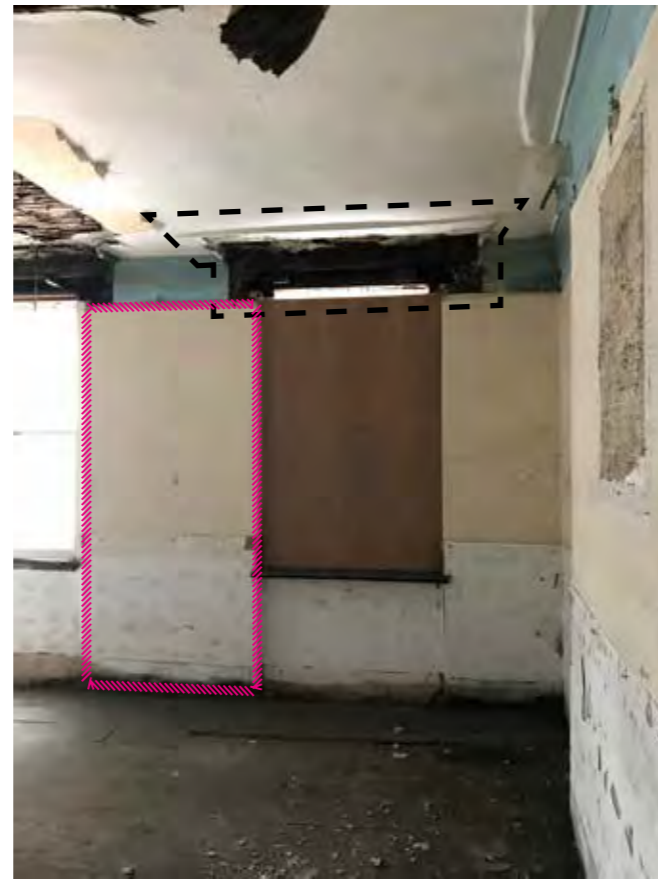
17 - Boarded window in primary room. Timber lintols exposed. Cornice line suggests original shutter box around windows.

- Plaster removed to reveal extent of build up behind.

- Lintols to be repaired if required.
- Single panel sash window to be removed and replaced with appropriate six over six panel sash window.
- Shutter boxes reinstated
- All corncing to be repaired

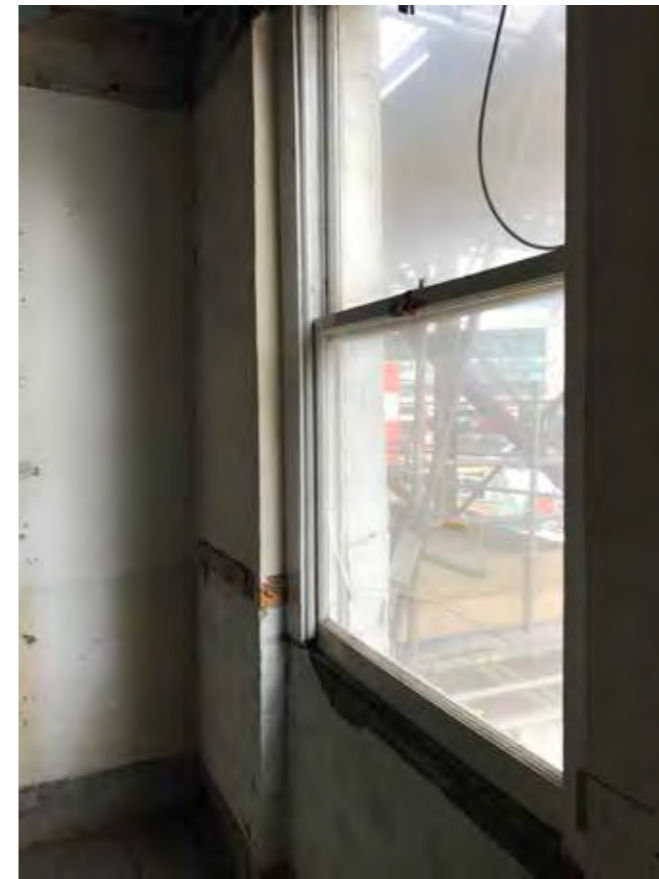
18 - Detail of window opening. Unoriginal single pane sash window, inappropriate to building period.

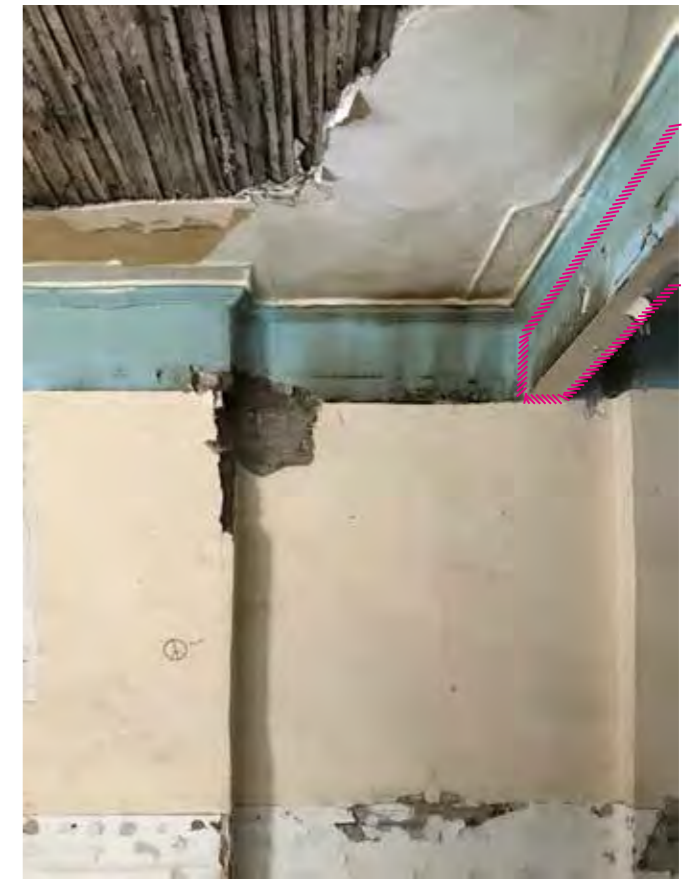
19 - Original corncing in front and rear rooms. Possible original timber beam holding joists above. Original chimney breast visible, opening boarded up.

- Lining around assumed timber beam to be removed to full extent of beam to assess structural integrity

- All corncing to be repaired

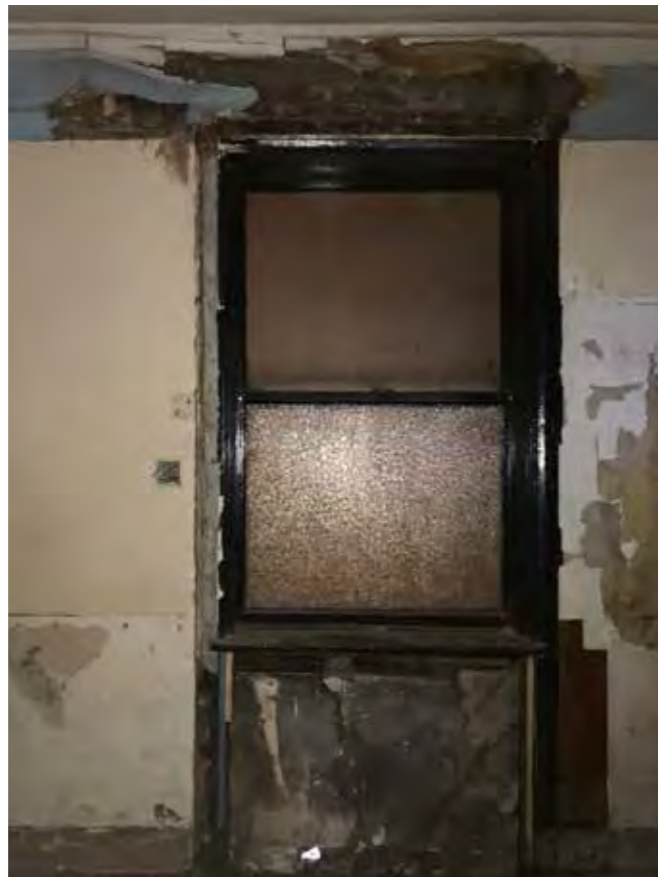
20 - Window in secondary room. Original cornicing damaged. No original architraves

-Lining around assumed timber beam to be removed to full extent of beam to assess structural integrity

-Single panel sash window to be removed and replaced with appropriate six over six panel sash window.
- All cornicing to be repaired

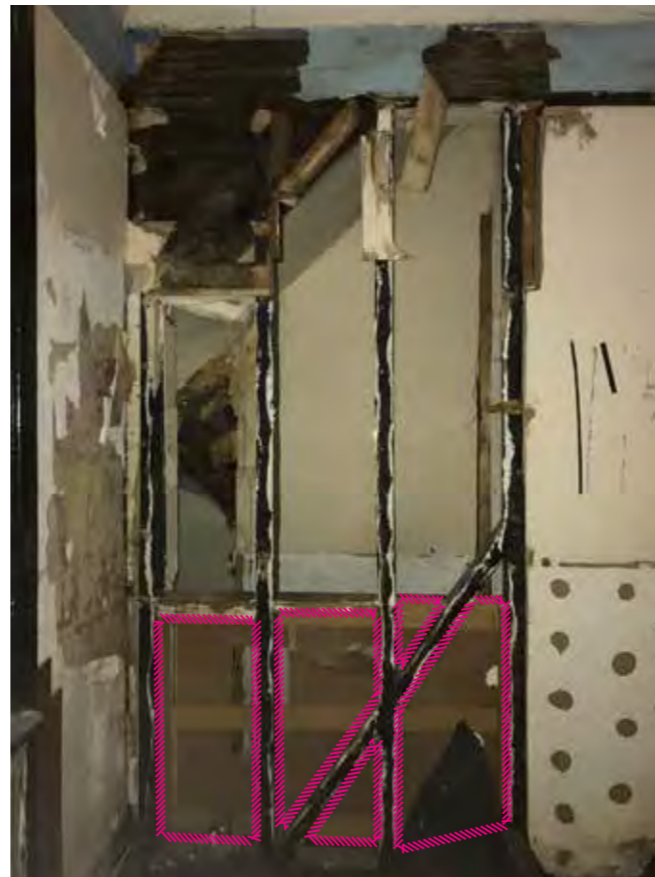
21 - Original partition between stair and rear room. Original cornicing damaged

-MDF panels to be removed

- Traditional lathe and plaster linings to be reinstated
- All cornicing to be repaired

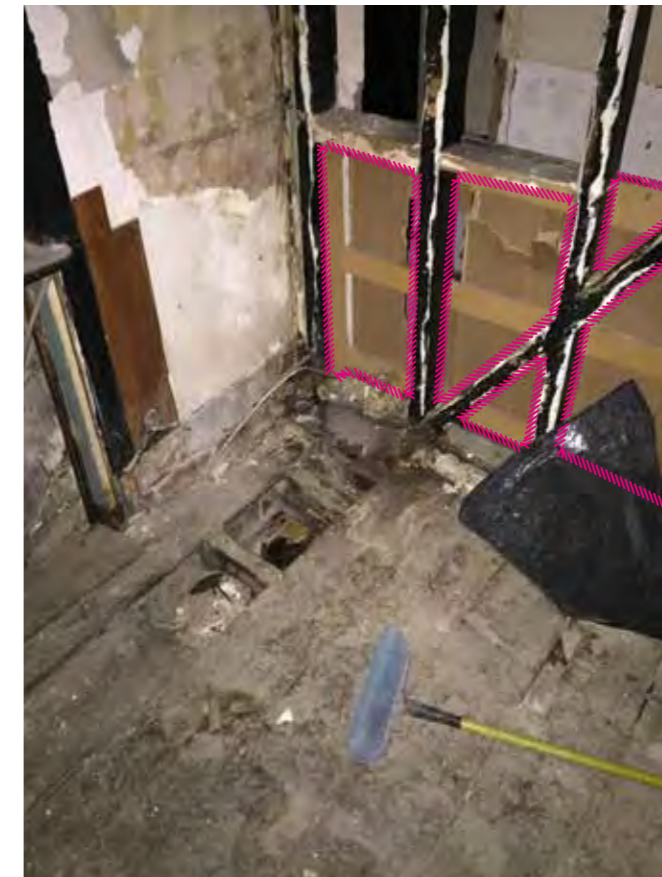
22 - Floor joists in rear room

- Floor boards to be repaired / replaced where necessary

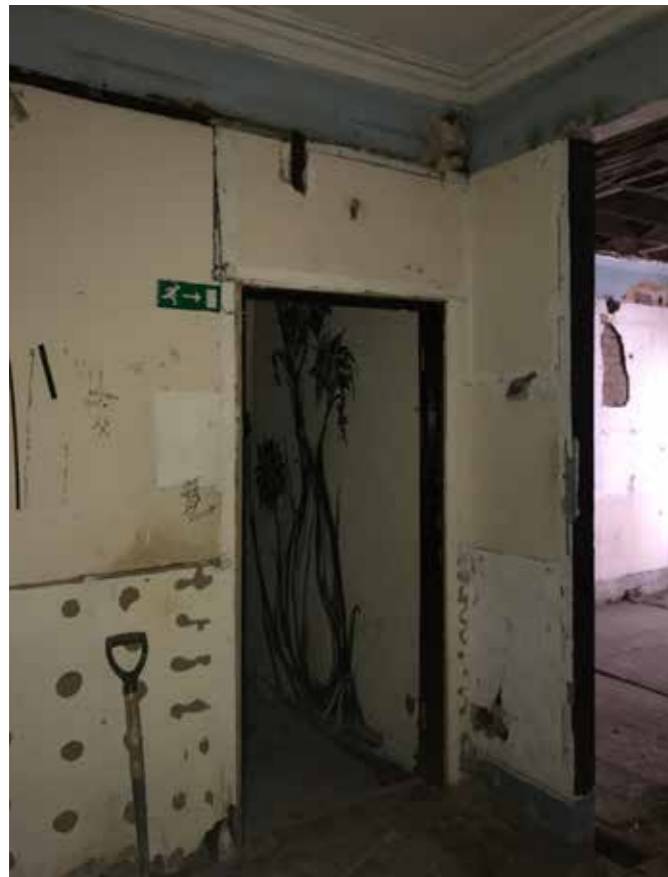
23 - Original door opening to rear room. Architrave missing. Original door opening to Primary room missing. Large opening linking primary and secondary rooms in original partition location.

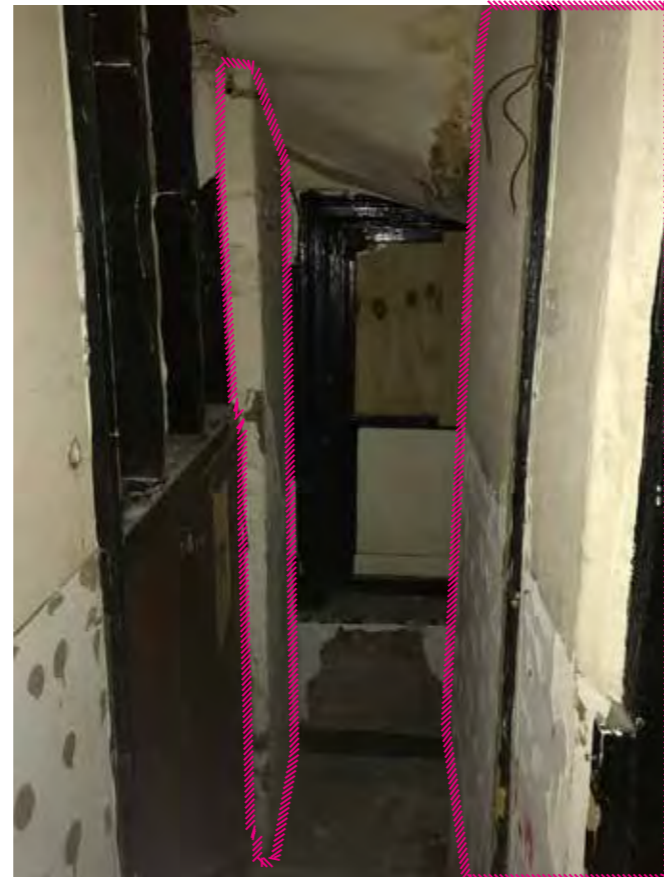
24 - Stair down to floor below. Original partition to secondary room visible on left-hand-side. Window on half landing boarded up

- Lining to boxing out on half landing removed to reveal contents.
- Enclosure of stair up to second floor to be carefully removed to expose extent of original balustrade.

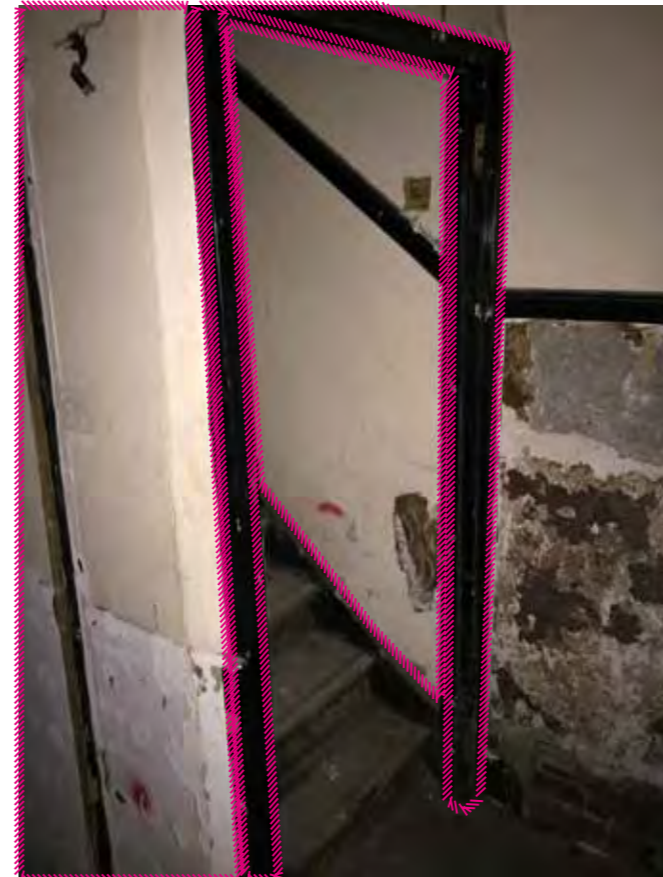
25 - Stair up to floor above.

- Lining removed to enclosing stair wall to reveal original balustrade and lining removed on party wall side to original plaster line behind.
- Door frame to stair removed .

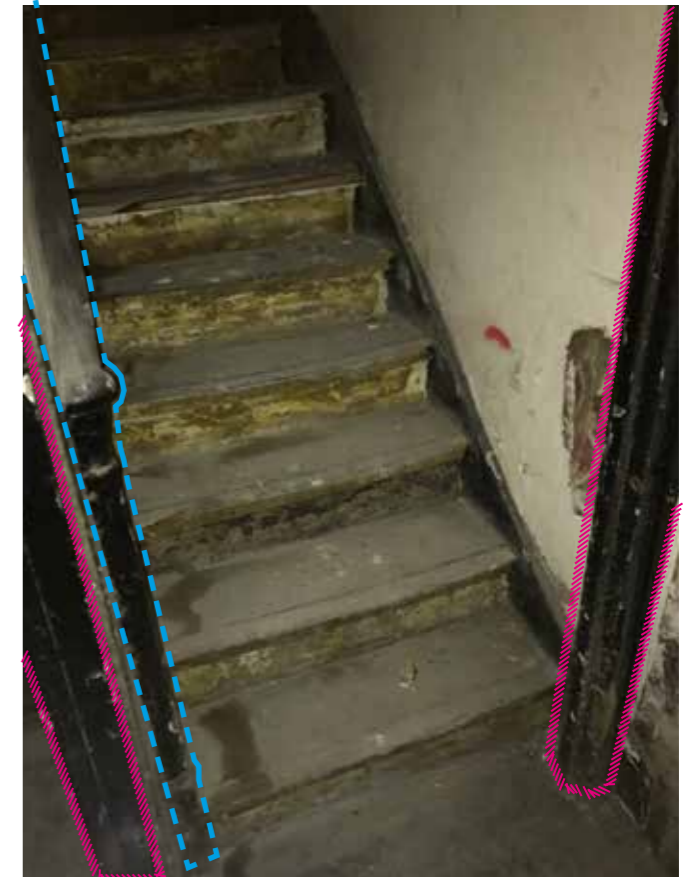
26 - Stair up to floor above. Possible original balustrade and knule post enclosed by partition?

- Lining removed to enclosing stair wall to reveal original balustrade and lining removed on party wall side to original plaster line behind. Door frame to stair removed.
- Linings to stair to be removed to reveal structural integrity and heritage value.

- Balustrade and handrail to be retained

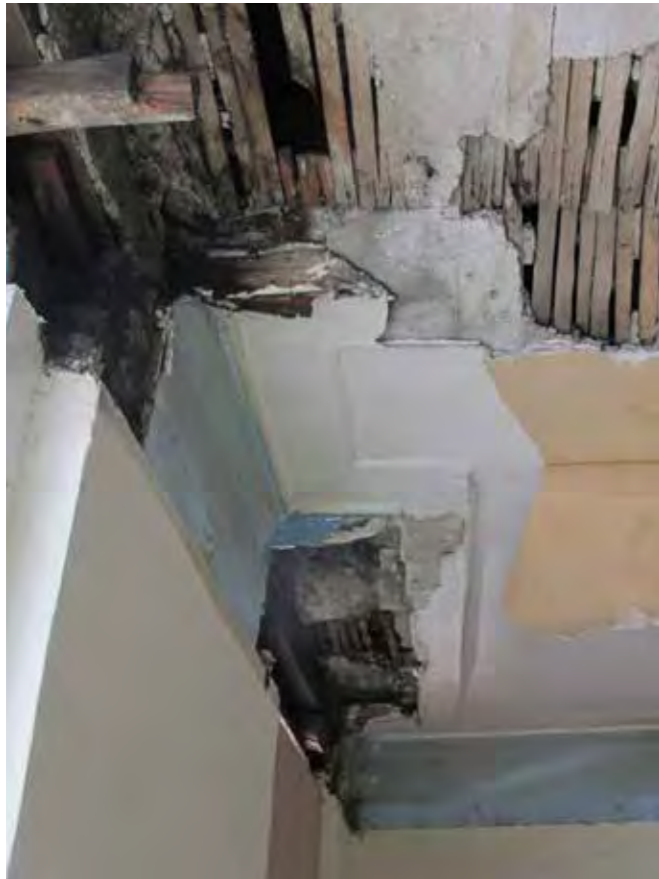
26.4 - Extent of remaining cornice line at first floor of 59 St Giles High Street . Also visible is the extent of the shutter box around the windows

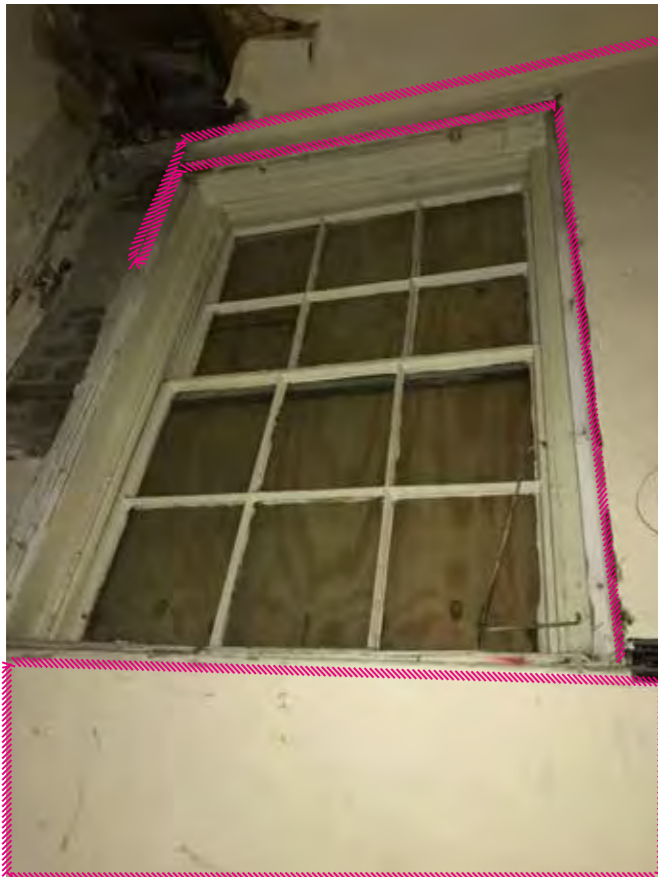
27 - Six over six sash window externally boarded up on half landing between first and second. Original architrave missing.

- Boxed out wall linings to be removed back to original plaster line.

- Original window architraves to be retained
 - Existing sash box surrounds carefully repaired and refurbished where possible. New sash boxes to match existing where necessary. Sash casements repaired where possible. New casements to match where necessary

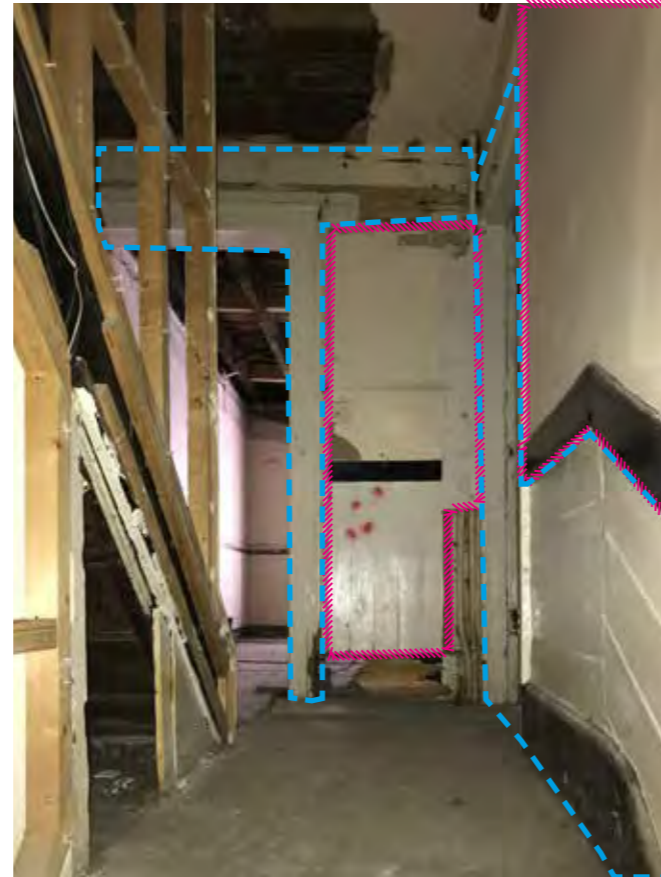
28 - Original matchboarding visible on large parts of the internal walls. Original door architraves

- Overboarding to be carefully removed to reveal original matchboarding behind.

- Original door architraves to be retained

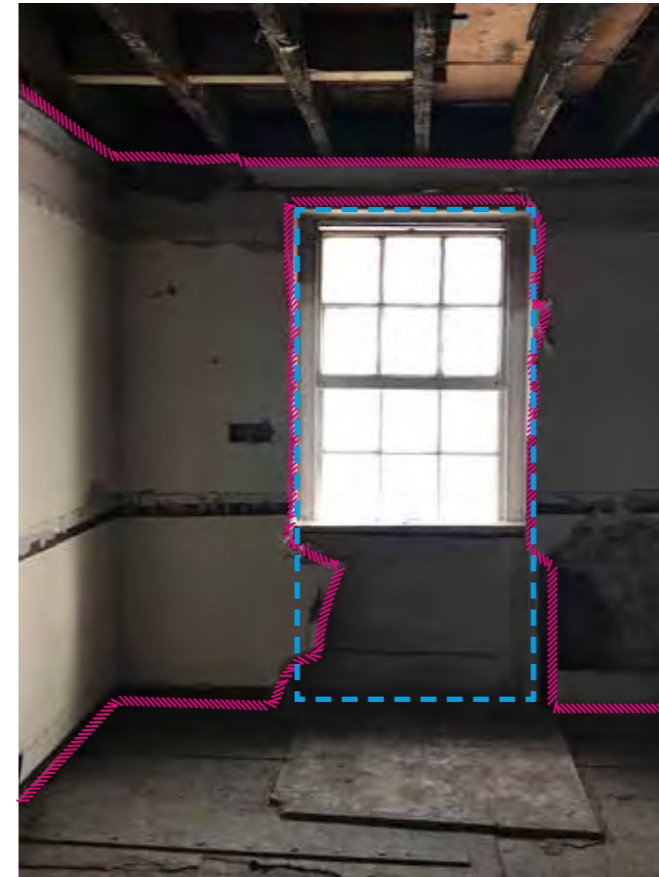
29 - Original six over six in primary room. Straps visible from party wall supports

- Boxed out wall linings to be removed back to original plaster line.

- Paneling below window to be retained
 - Existing sash box surrounds carefully repaired and refurbished where possible. New sash boxes to match existing where necessary. Sash casements repaired where possible. New casements to match where necessary

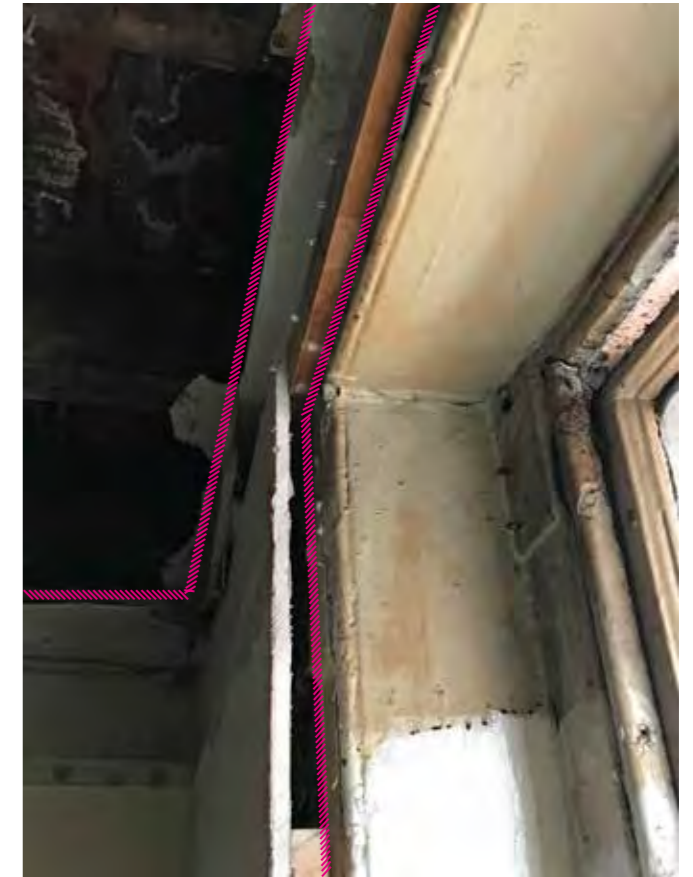
30 - Detail of layered faces of internal wall

- Boxed out wall linings to be removed back to original plaster line.

- Original window architraves to be retained

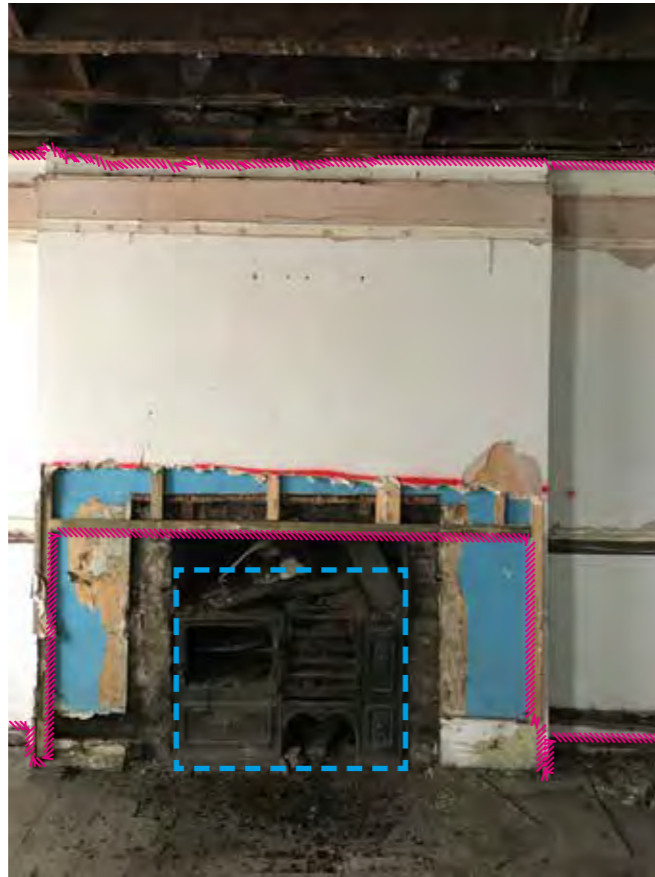
31 - Fireplace with cast iron stove in primary room

- Wall lining removed back to original lathe and plaster wall line

- Cast Iron Stove to be retained
- New appropriate fireplace surround

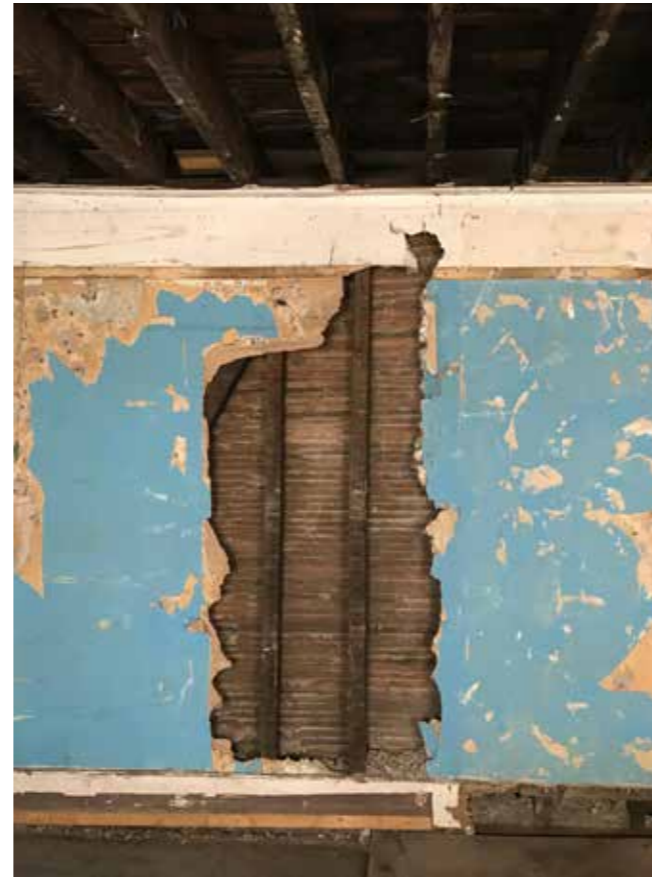
32 - Original partition
