BASEMENT PHOTO RECORD

GROUND FLOOR - EXISTING, STRIP OUT & PROPOSED

FIRST FLOOR - EXISTING, STRIP OUT & PROPOSED

SECOND FLOOR - EXISTING, STRIP OUT & PROPOSED

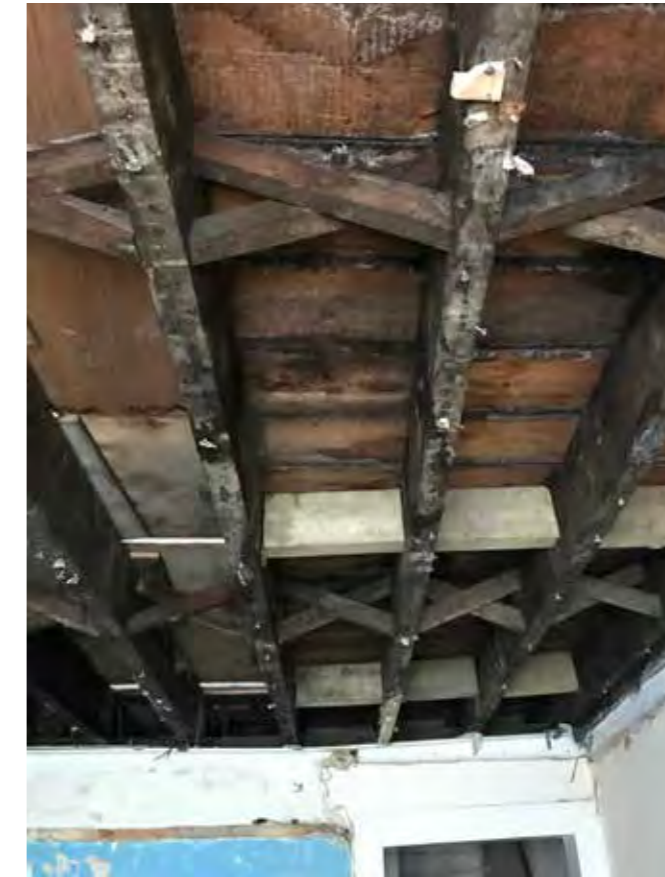
33 - floor joists at high level second floor primary room. New timber noggins visible to provide additional strength. Evidence of truncated floor boards on level above.

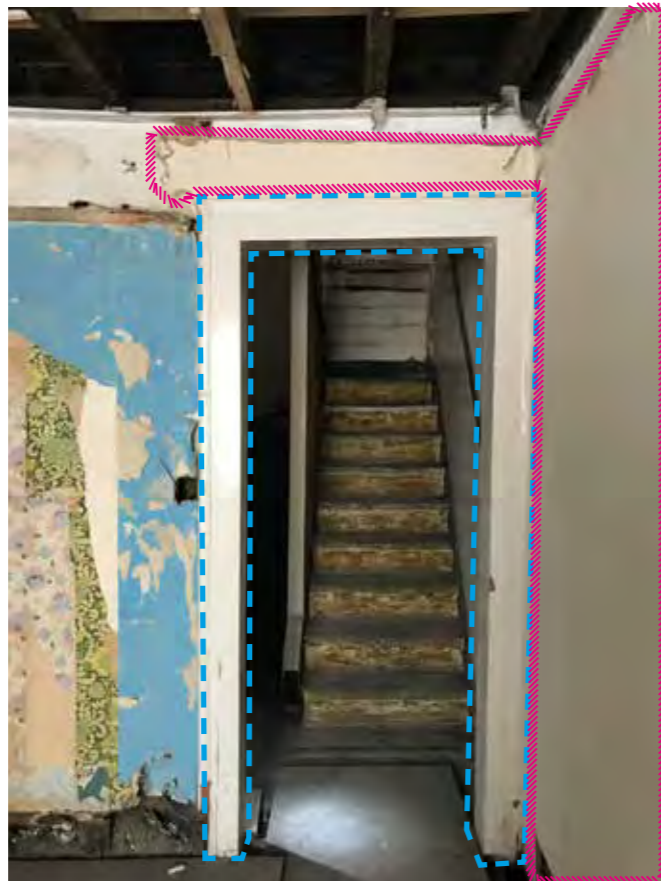
34 - Original opening and architrave between primary room and stair. Unoriginal osb / chipboard staircase visible. Multiple layers of patterned wallpaper

-Wall lining removed back to original lathe and plaster wall line

- Original door architraves to be retained

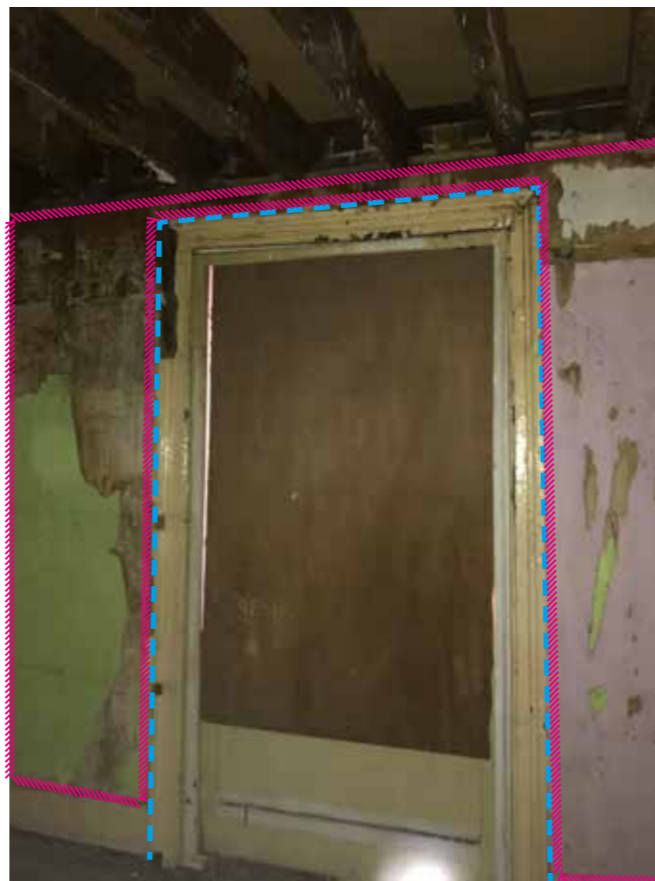
35 - Boarded up window and original architraves in secondary room. Exterior brick wall visible behind floor joists

- Wall lining removed back to original lathe and plaster wall line

- Original window architraves to be retained
- Existing sash box surrounds carefully repaired and refurbished where possible. New sash boxes to match existing where necessary. Sash casements repaired where possible. New casements to match where necessary

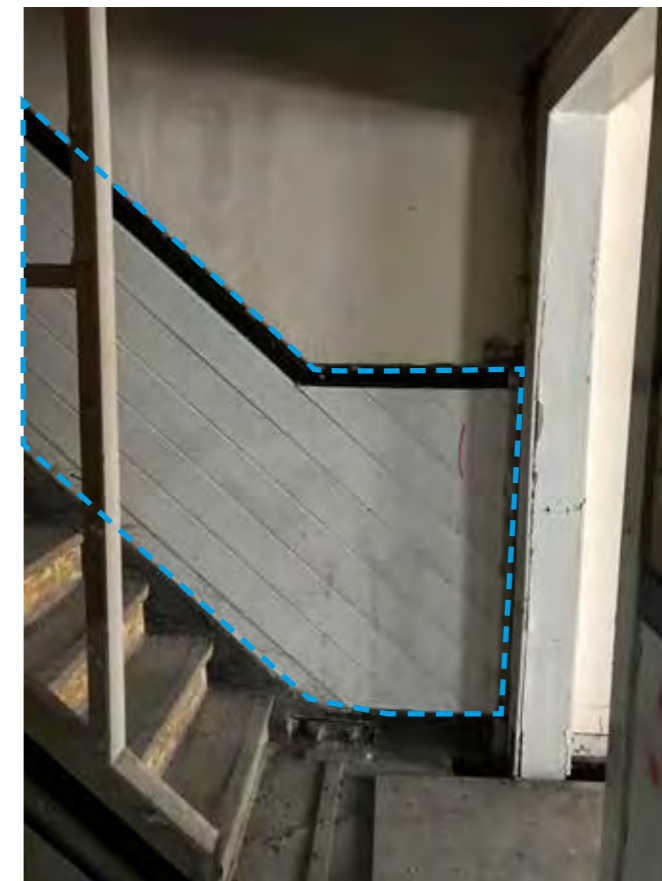
36 - Stair up to level above

- Original matchboarding to be retained
