THIRD FLOOR - EXISTING, STRIP OUT & PROPOSED

THIRD FLOOR PHOTO RECORD

ROOF - EXISTING, STRIP OUT & PROPOSED

ROOF PHOTO RECORD

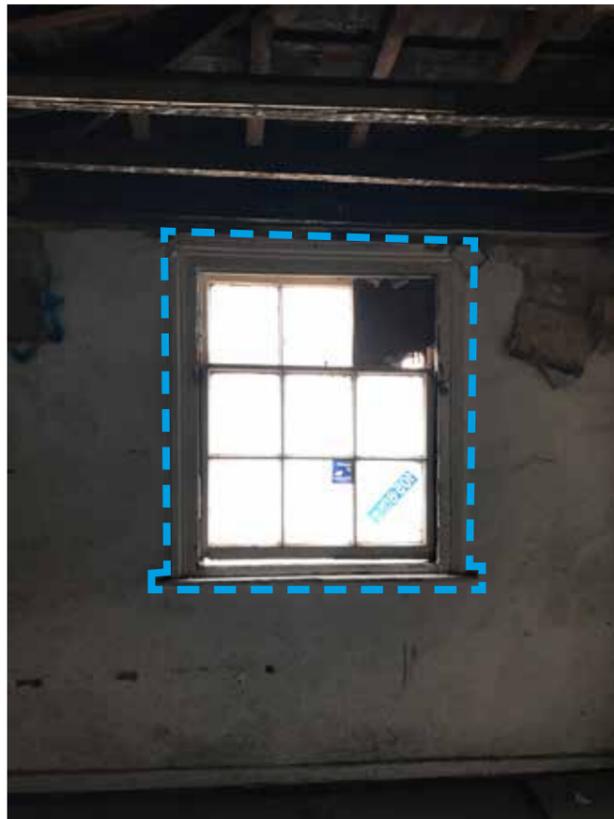
37 - Original three over six sash window with original architrave

- Existing sash box surrounds carefully repaired and refurbished where possible. New sash boxes to match existing where necessary. Sash casements repaired where possible. New casements to match where necessary

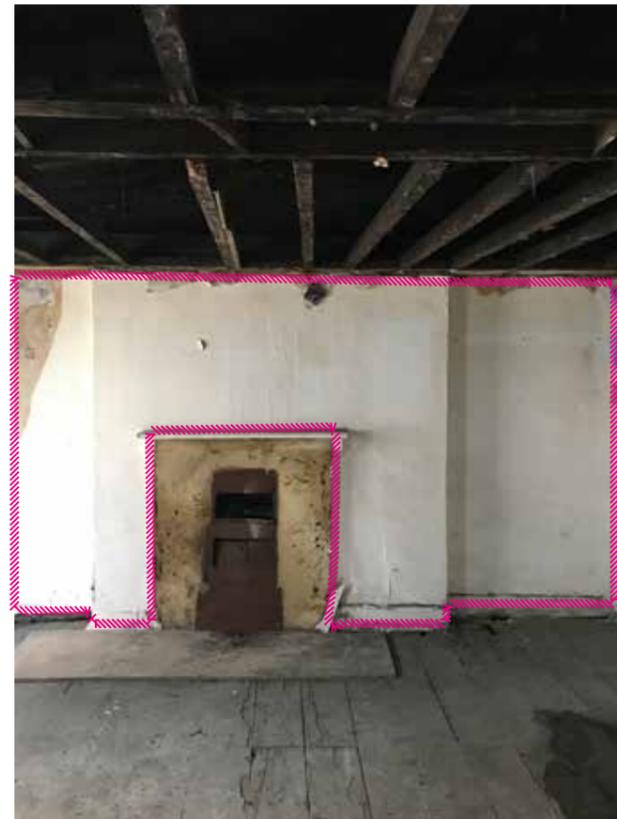
38 - Chimney breast with unoriginal fireplace. Assumed larger opening behind

- Wall linings to be stripped back to line of masonry

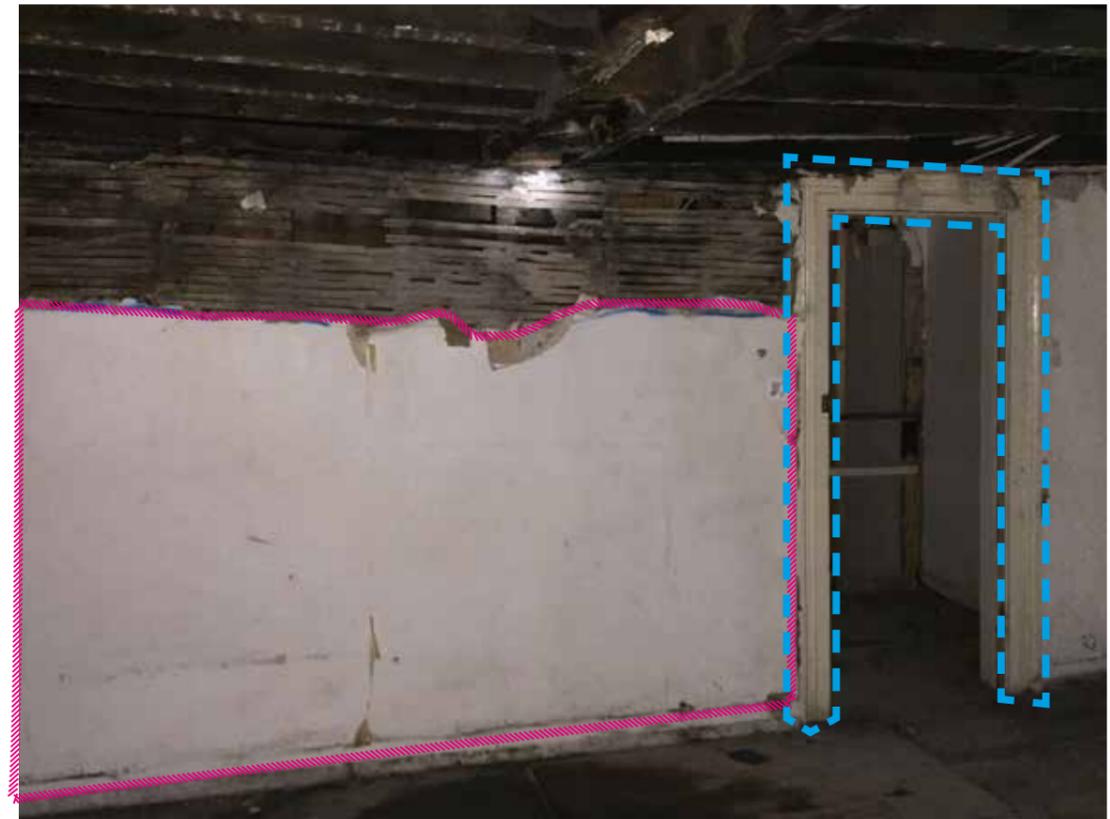
39 - Original architraves on door opening between stair and primary room. Evidence of structural failures in original partition resulting in roof subsidence, and water ingress causing rotting beams in roof structure.

- Wall linings to be stripped back to line of lathe

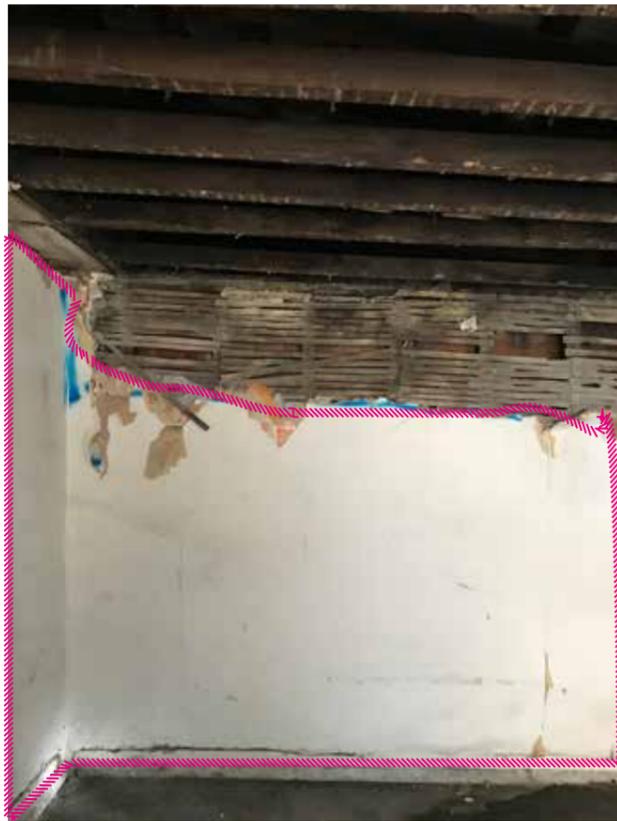
40 - joists of butterfly roof and central partition. Structural failure of partition clearly visible

Strip-Out Note:
 - Wall linings to be stripped back to line of lathe

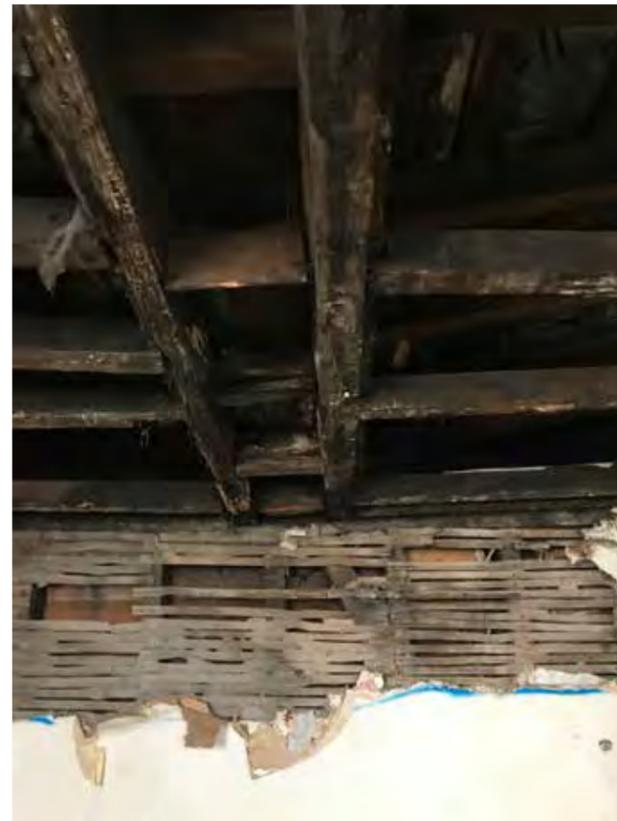
41 - Central joists of butterfly roof. Extensive water damage

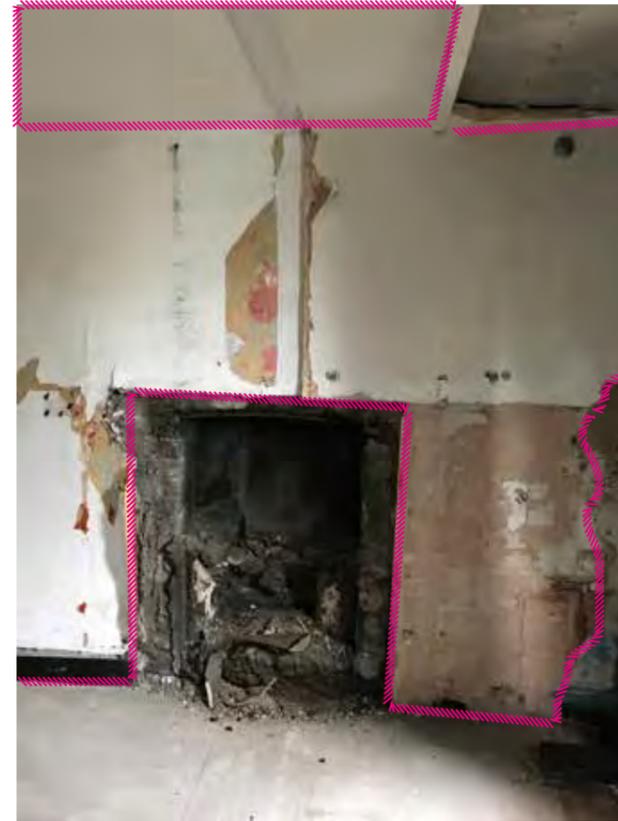
42 - Chimney breast boxed out in secondary room

Strip-Out Note:
 - Wall linings to be removed to exposed chimney stack boxing out
 - Lining to ceiling to be removed to show extent of damage to rafters above

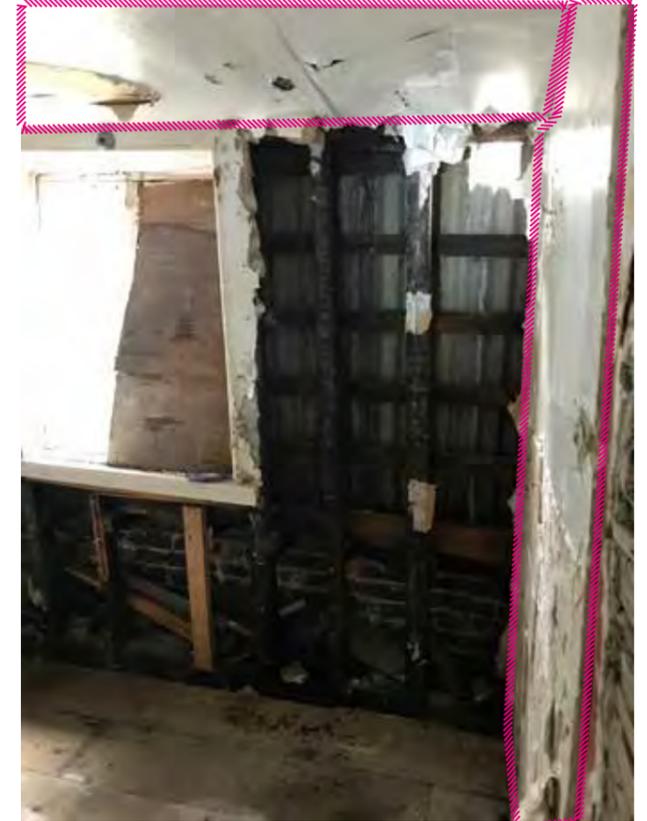
43 - Corrugated metal mansard roof in secondary room. External brick wall, external brick wall / parapet visible behind timber joists.

Strip-Out Note:
 - Lining to ceiling to be removed to show extent of damage to rafters above

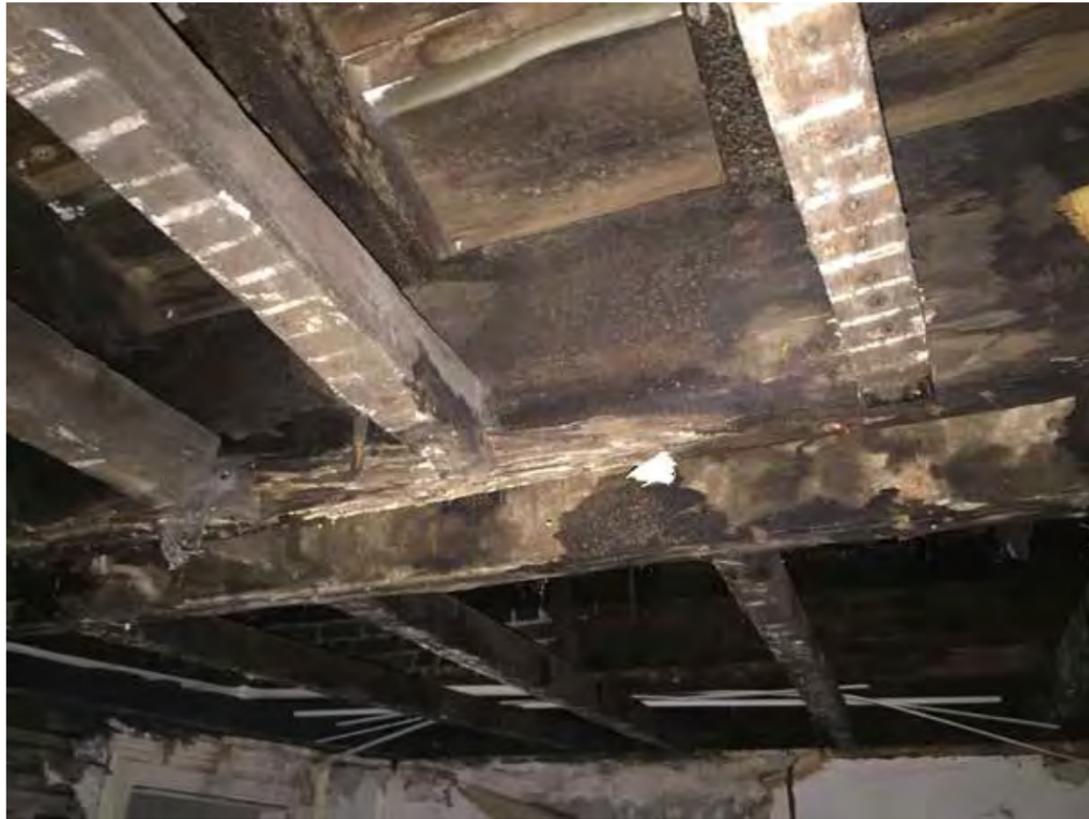
44 - Extensive and continuing water damage to central beams & joists. Roof visibly sagging. Underside of roof slates visible.

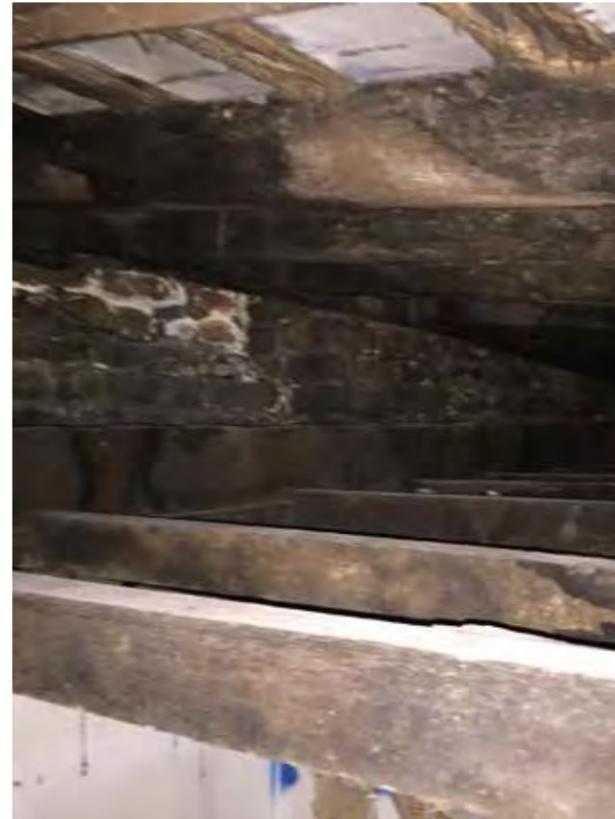
45 - Underside of slates visible. Roof area completely uninsulated. Brick party wall between to nos 28 Denmark Street in background. Tile batten's very damaged.

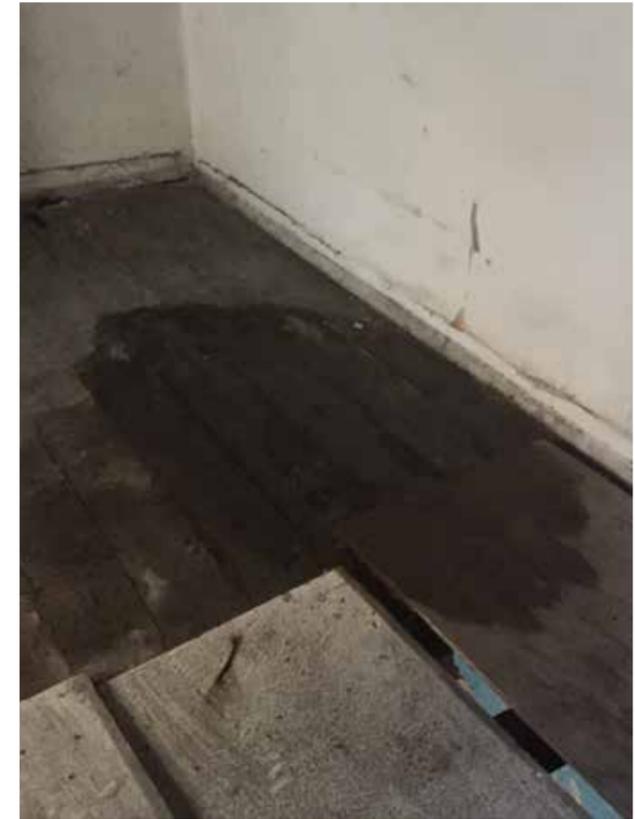
46 - Continuing water damage to floorboards beneath central beams of butterfly roof - spongy underfoot.

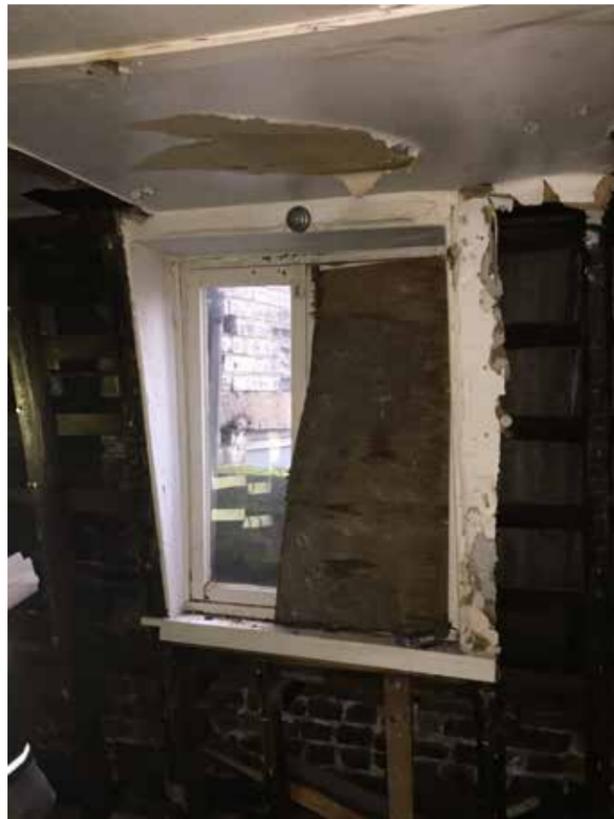
47 - Dormer window set within corrugated metal mansard roof in secondary room. External brick wall, external brick wall / parapet visible behind timber joists. Party wall of 28 Denmark Street accessible behind roof structure to the left hand side of dormer window

Strip-Out Note:
- All linings to ceiling to be removed

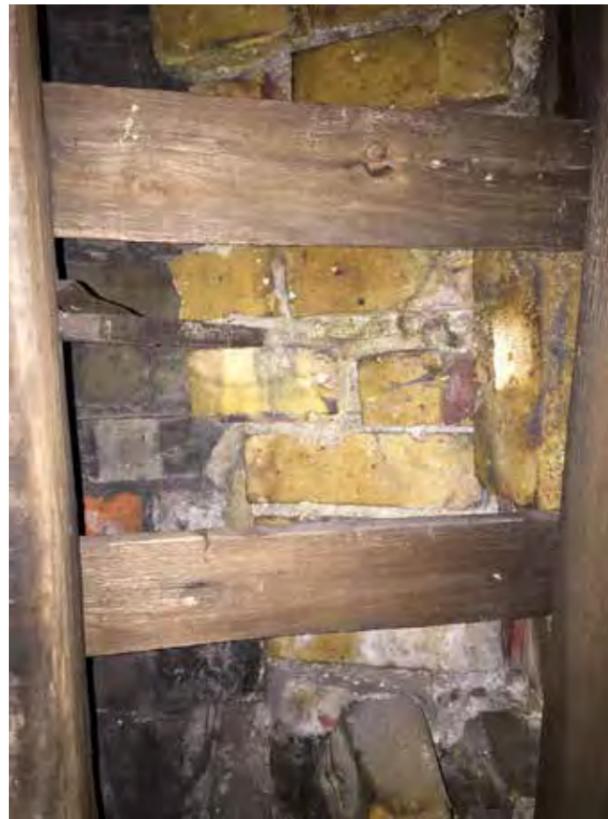
48 - Stock brick infill between mansard roof of 59 St Giles High Street and 28 Denmark Street. Party wall of 28 Denmark Street built off parapet of 59 St Giles High Street

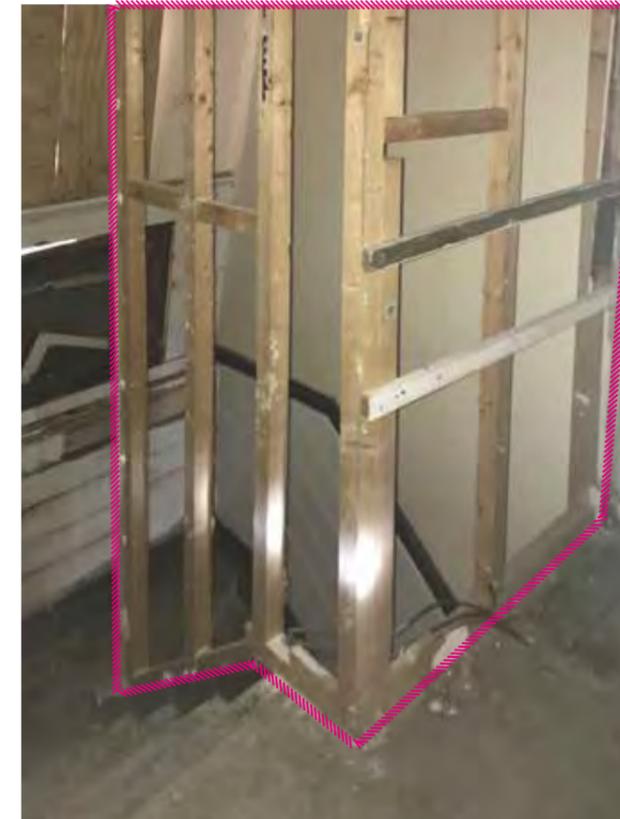
49 - Stair at third floor level. Truncated half landing within mansard roof in order to allow space for water tank behind.

Strip-Out Note:
- Timber studs to be removed

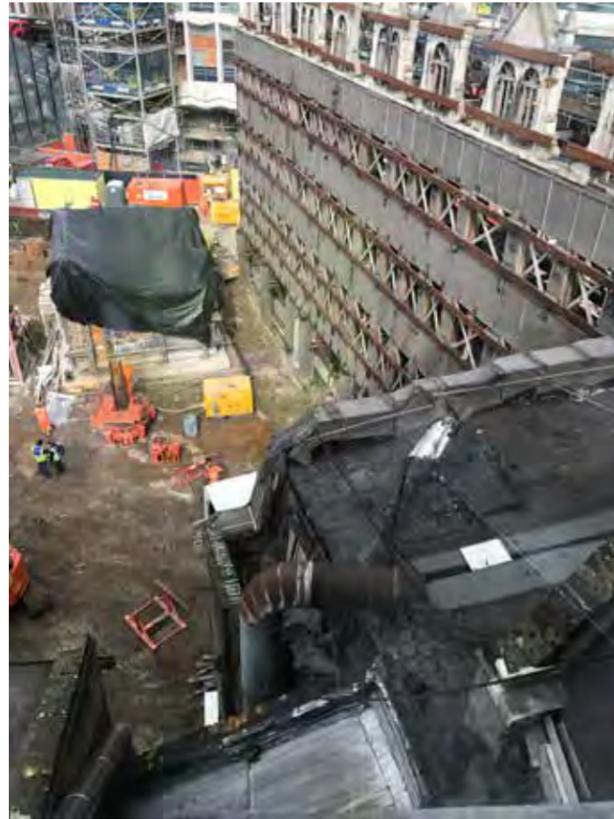
50 - Roof of 59 St Giles High Street from 28 Denmark Street stairwell. Corrugated steel mansard and dormer visible

- Existing dormers replaced with new timber dormer windows with lead copings. Extract duct to be removed.

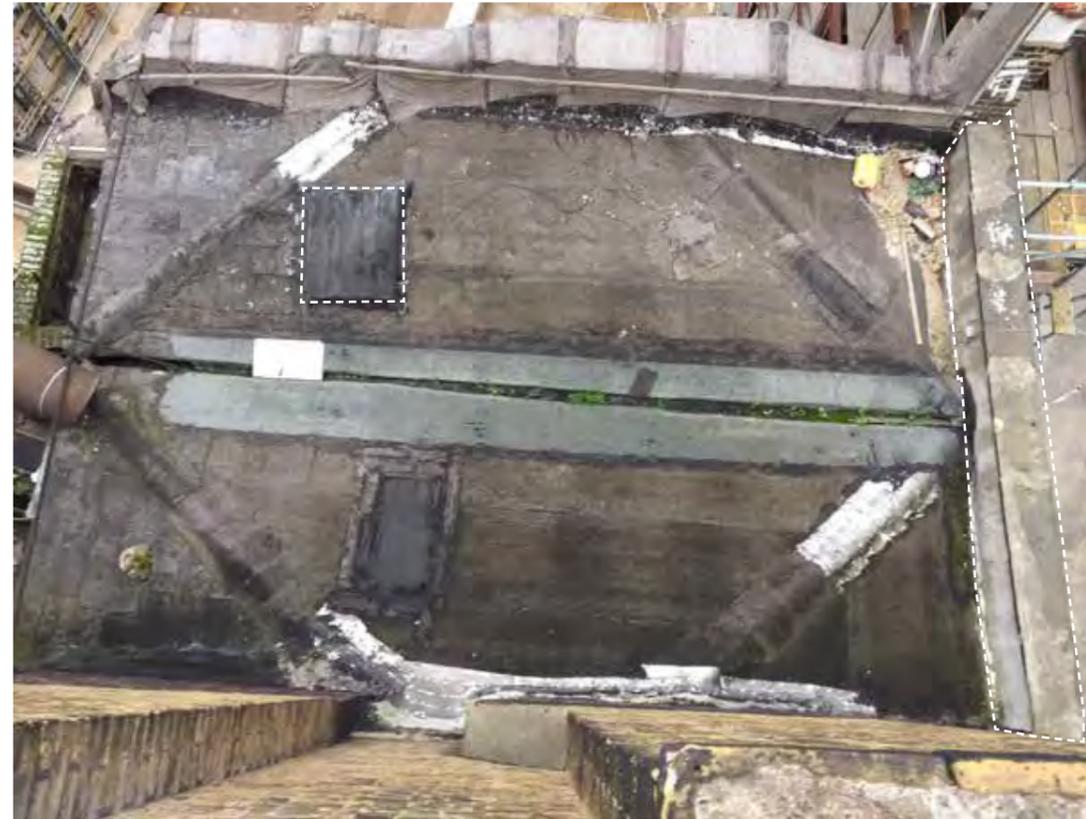
51 - Roof of 59 St Giles High Street from 28 Denmark Street roof

- New roof-light to replace existing hatch above staircase. All materials to roof carefully removed, trusses repaired and strengthened, and roof relined with reclaimed tiles, new lead ridge and flashings.

- Copings and parapet carefully cleaned and repaired, and replaced to match where necessary. New concealed box gutter behind.
