The Hope Project

Appendix H - Drainage Strategy Report

January 2018 (Rev.02)

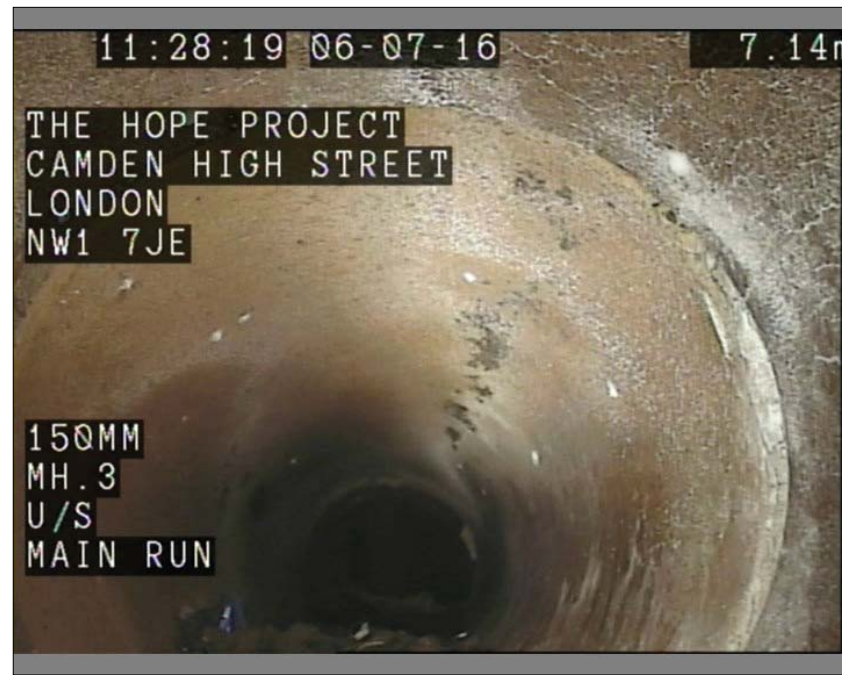
Photo: 13\_13\_70\_A.JPG  
7.14m, Settled deposits, coarse, 10% cross-sectional area loss

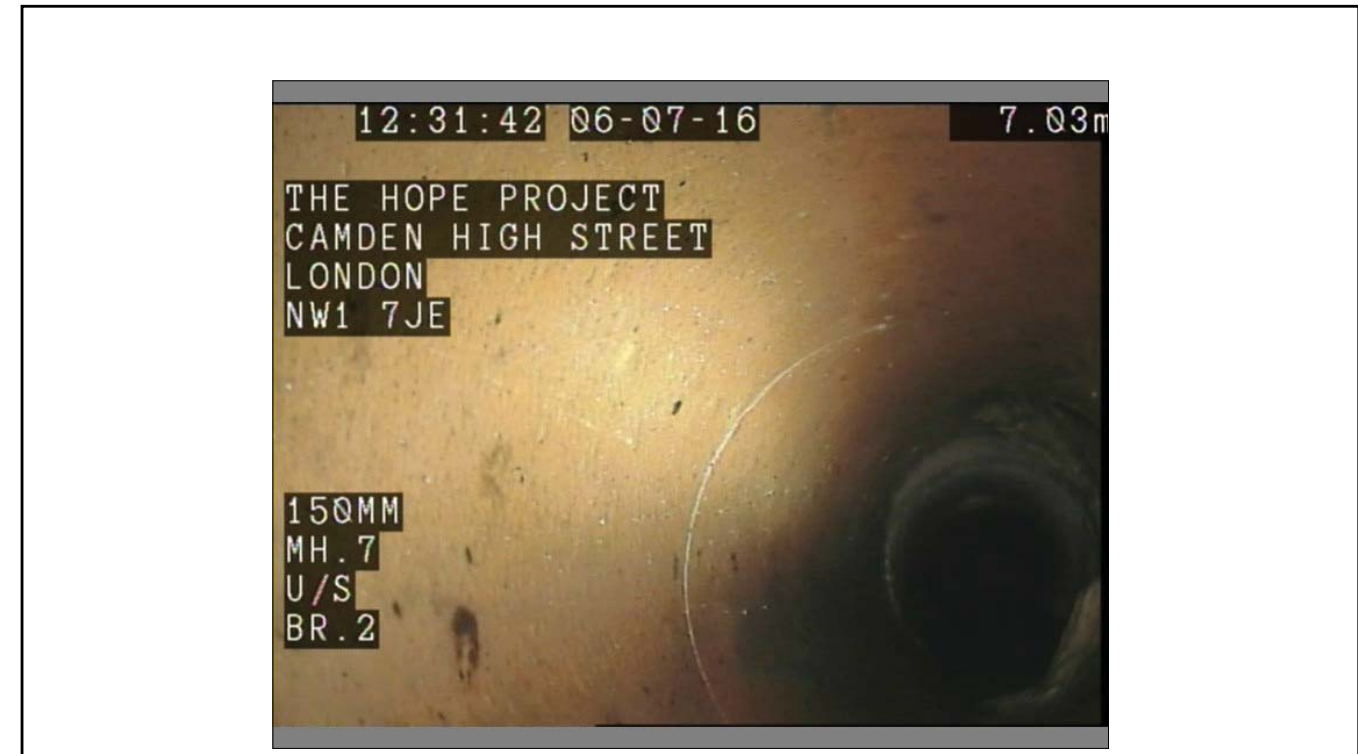
Photo: 20\_20\_129\_A.JPG  
7.03m, Crack, circumferential, from 7 to 11 o'clock

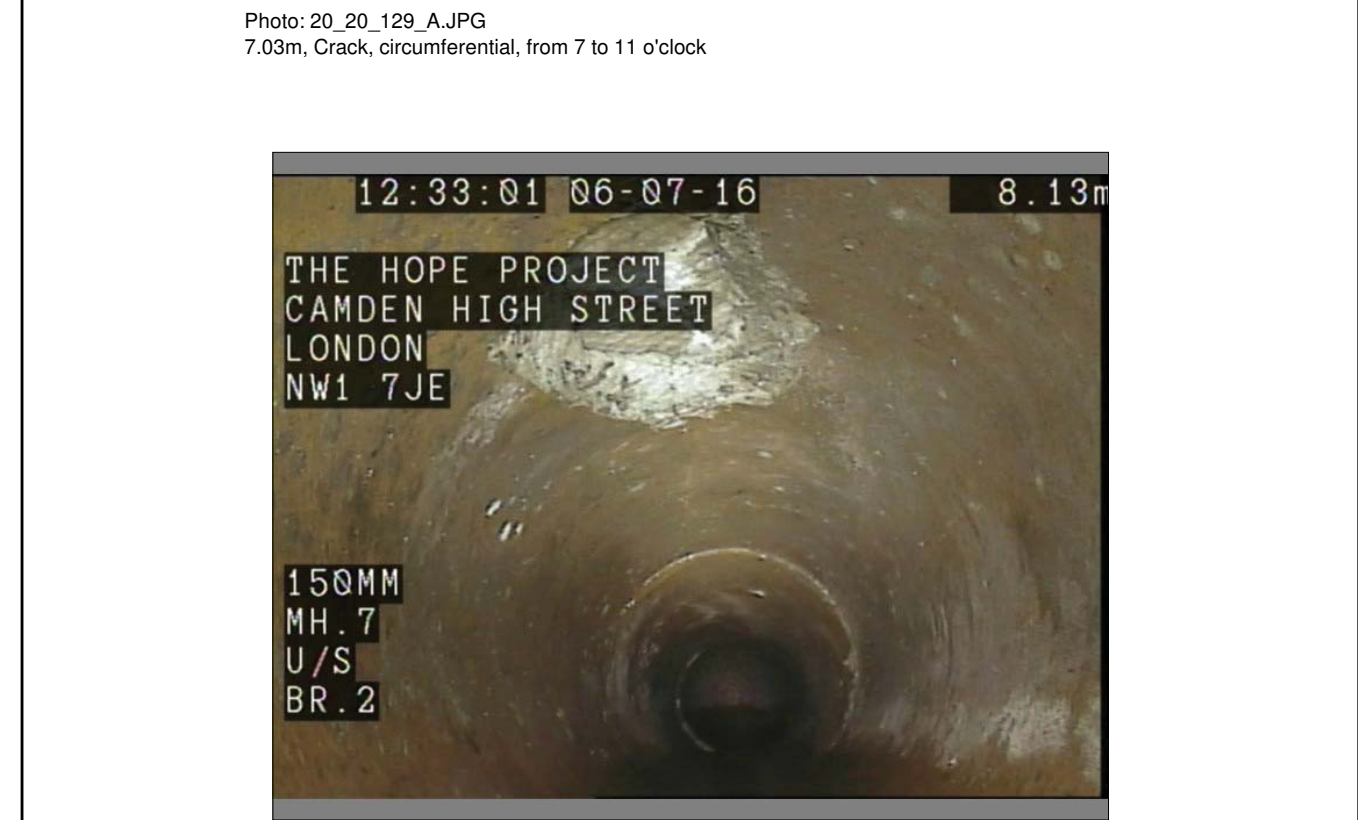
Photo: 20\_20\_131\_A.JPG  
8.13m, Broken pipe, from 10 to 12 o'clock

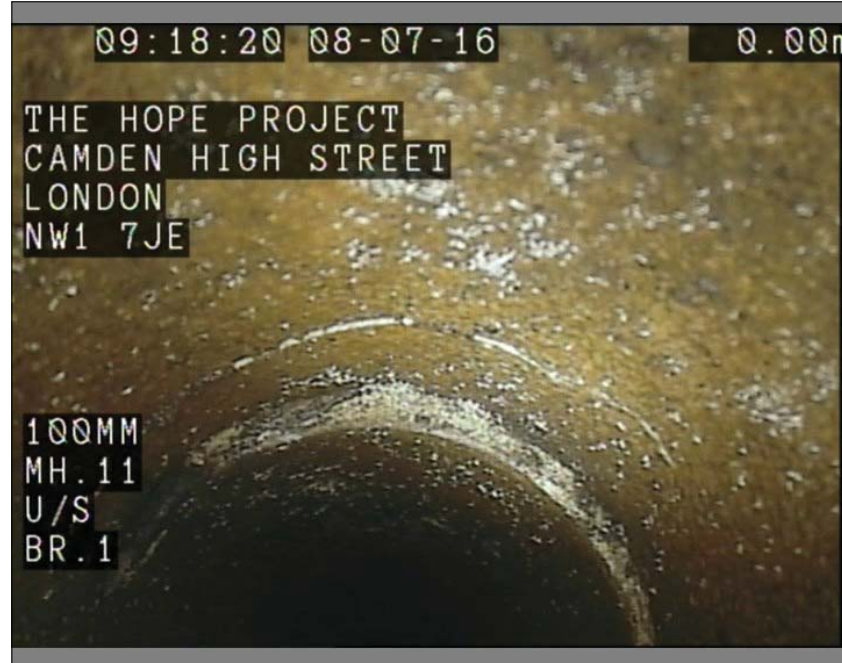
Photo: 25\_25\_155\_A.JPG  
0m, Crack, circumferential, from 10 to 2 o'clock

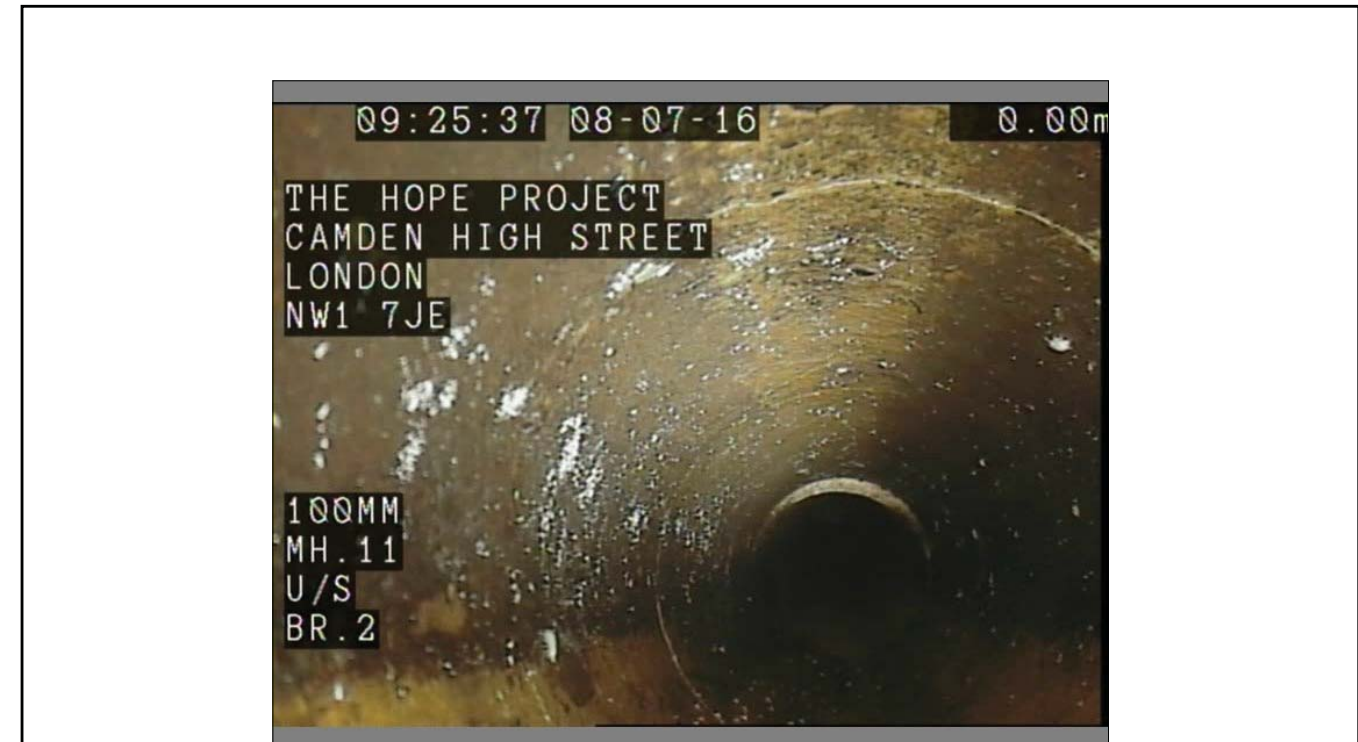
Photo: 26\_26\_161\_A.JPG  
0m, Crack, circumferential, from 7 to 4 o'clock

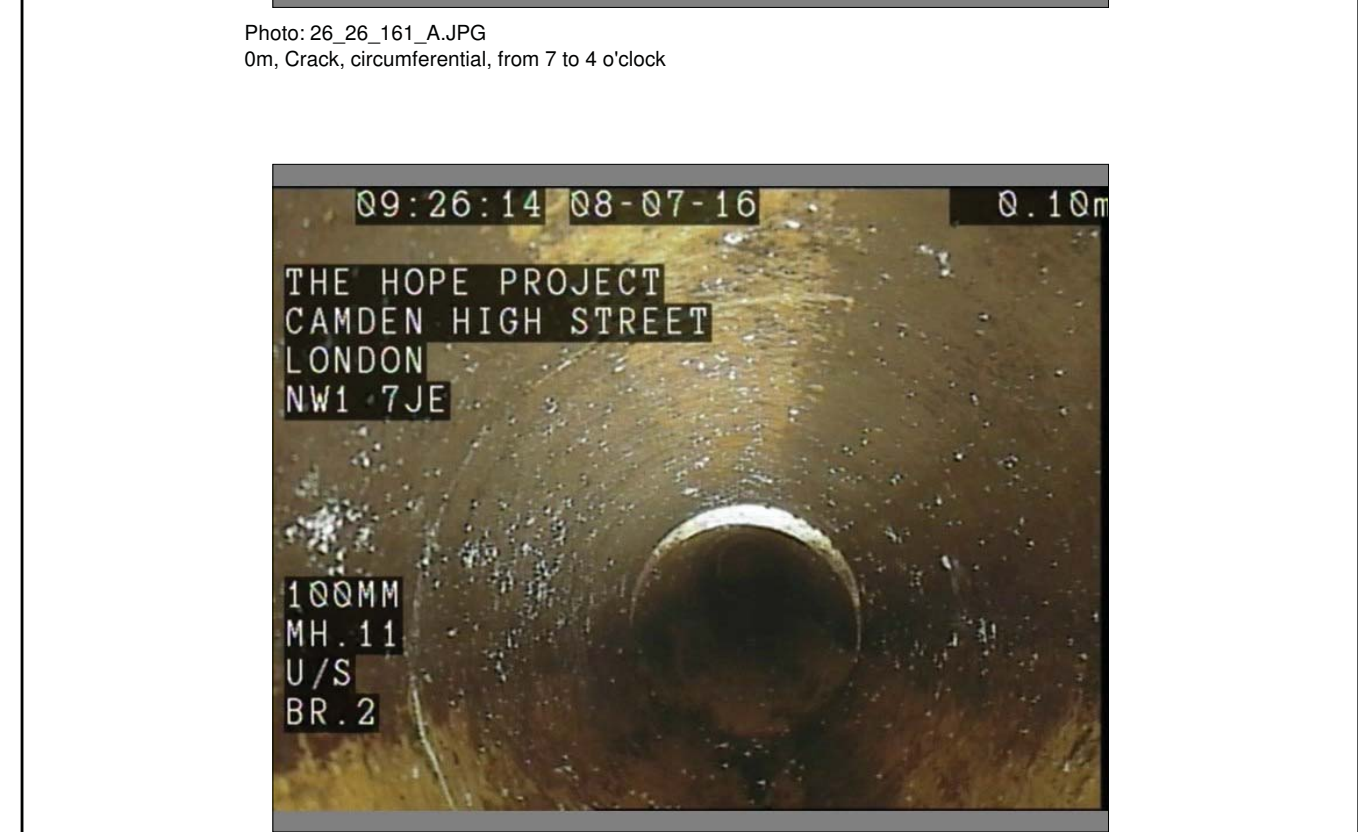
Photo: 26\_26\_162\_A.JPG  
0.1m, Crack, circumferential, from 7 to 12 o'clock

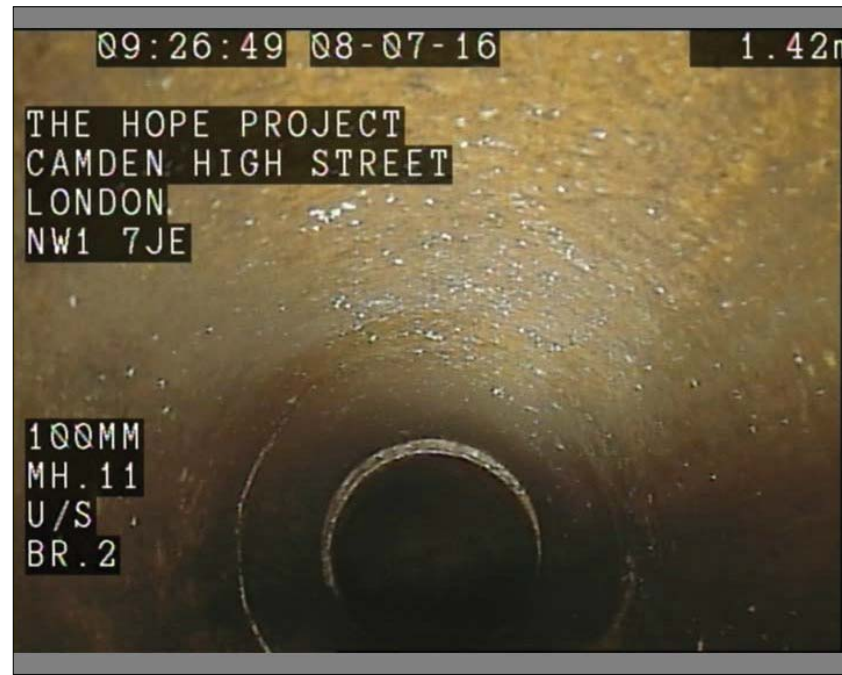
Photo: 26\_26\_163\_A.JPG  
1.42m, Crack, circumferential, from 7 to 5 o'clock

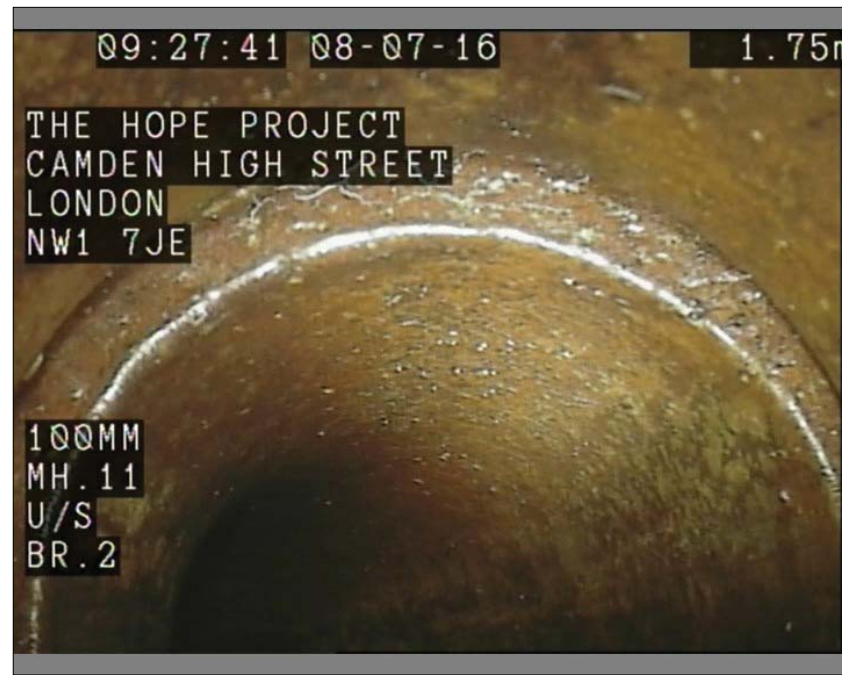
Photo: 26\_26\_164\_A.JPG  
1.75m, Crack, circumferential at joint, from 7 to 3 o'clock

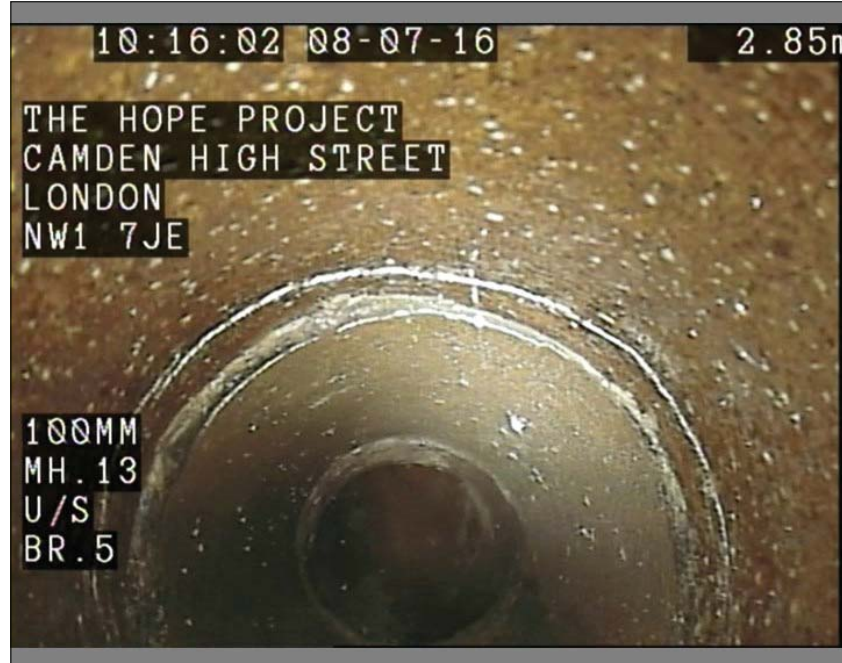
Photo: 32\_32\_211\_A.JPG  
2.85m, Crack, circumferential, from 9 to 3 o'clock

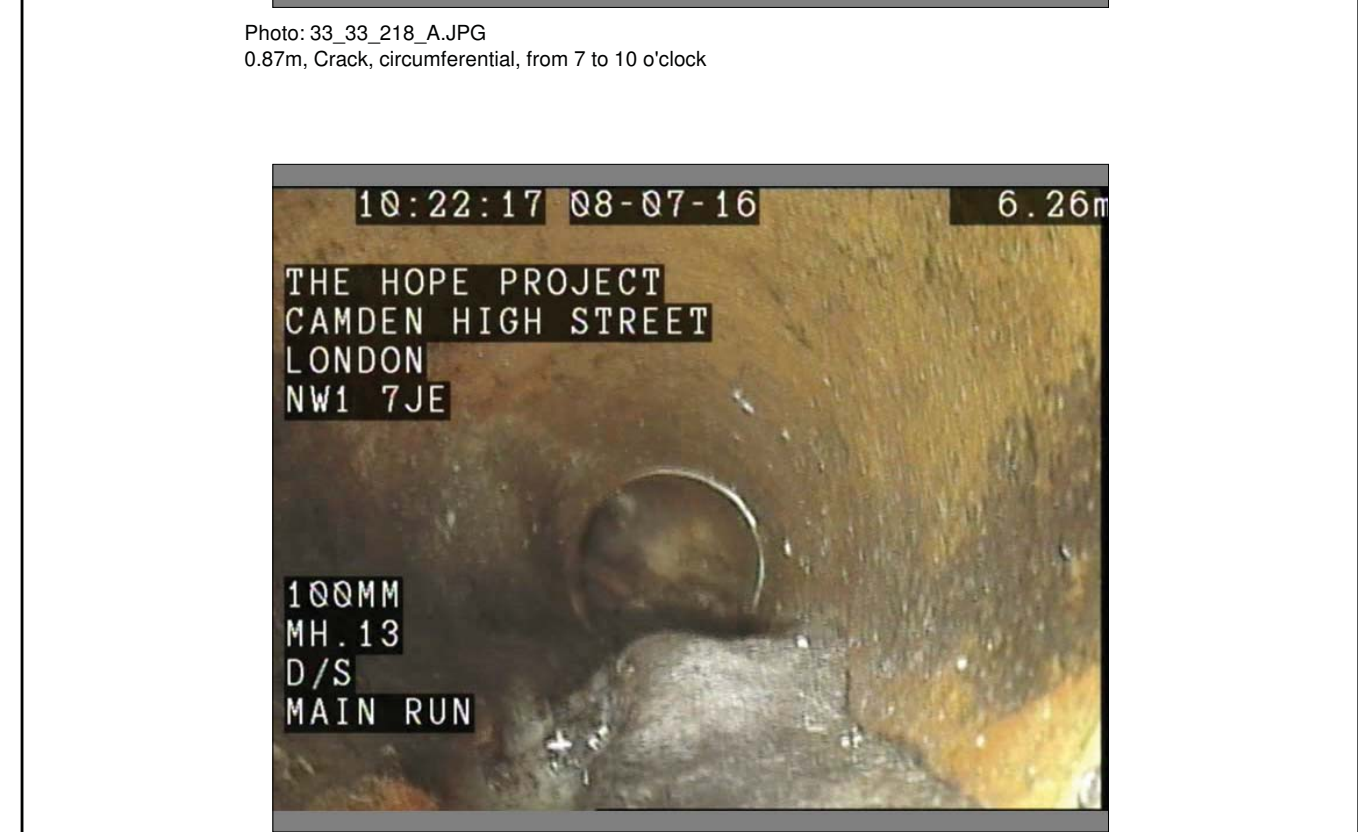
Photo: 33\_33\_227\_A.jpg  
 6.26m, Attached deposits, encrustation, from 4 to 6 o'clock, 20% cross-sectional area loss
