Claim Assessment Report

Our Reference: IFS-DLG-SUB-17-0072238

Risk Address: 9 Montpelier Grove, London, NW5 2XD

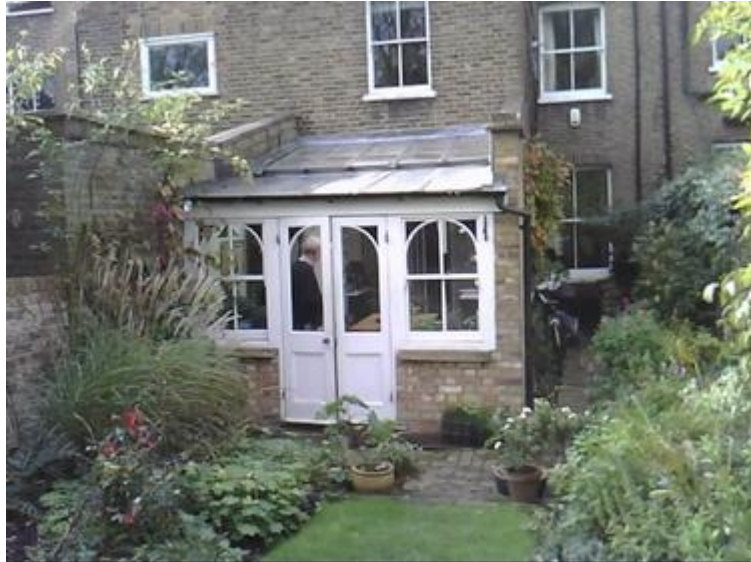
Extensive cracking and distortion of the brick work above the window at the junction of the left hand wall of the structure and rear wall of the main property.

The roof structure has moved from its original position.

FIGURE 03 Rear Elevation.

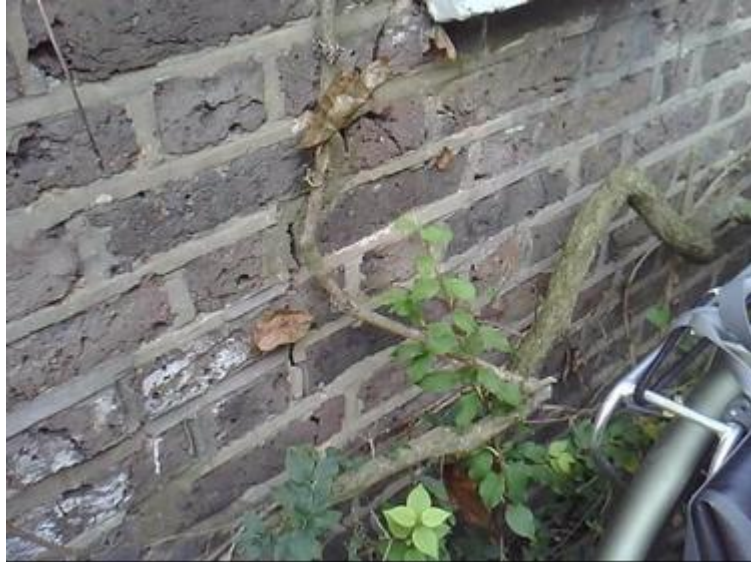
Further tapered cracking 10mm wide evident below the window located on the left hand elevation.

FIGURE 04 Left Hand Elevation - cracking below window.

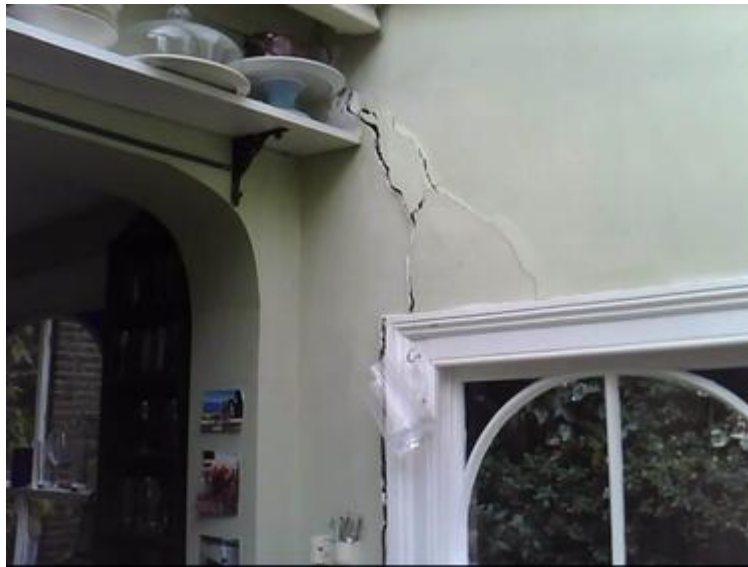
Extensive tapered cracking 20mm wide is evident at the junction of the rear of the property and left hand wall of the Summer Room above the window. Further cracking 10mm wide is evident below the window.

FIGURE 05 Summer Room - cracking above window.

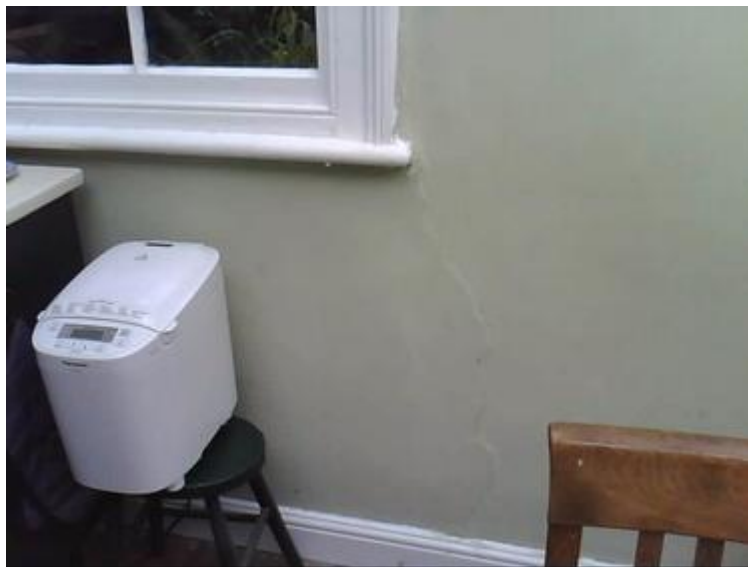
FIGURE 06 Summer Room - cracking below window
