# Kidderpore Summer House

Final Report December 2017

Report prepared for:  
Mount Anvil

**OBJECT:** Timber framed and clad. Cast, sectioned concrete columns. Terracotta tiled floor, all sited on a concrete base.

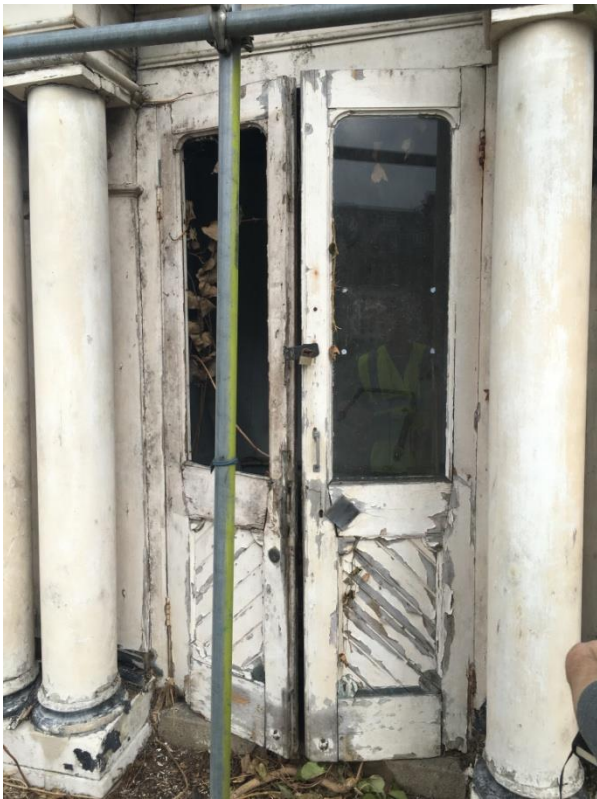
**Fig 2. Doors**

They featured squared, top, middle, bottom rails and gun-stock stiles (*fig 2*). All rebates and glazing beads were planted on (*fig 3&4*). Quarter circled and moulded corner blocks had also been planted onto the upper glazing panel (top only) and lower boarded panel. These lower panels to the doors TG&V with a beaded surround all set at an angle of 45 degrees (*fig 5*). This setting of the boarding ran as a common theme on the original, adjacent elevations containing the single casement windows. The rebate of the door was off-set to allow flush bolts to be set into it so as to be hidden when closed.

Over the years the doors have had numerous interventions to allow for different types of ironmongery leaving large areas weak and vulnerable.

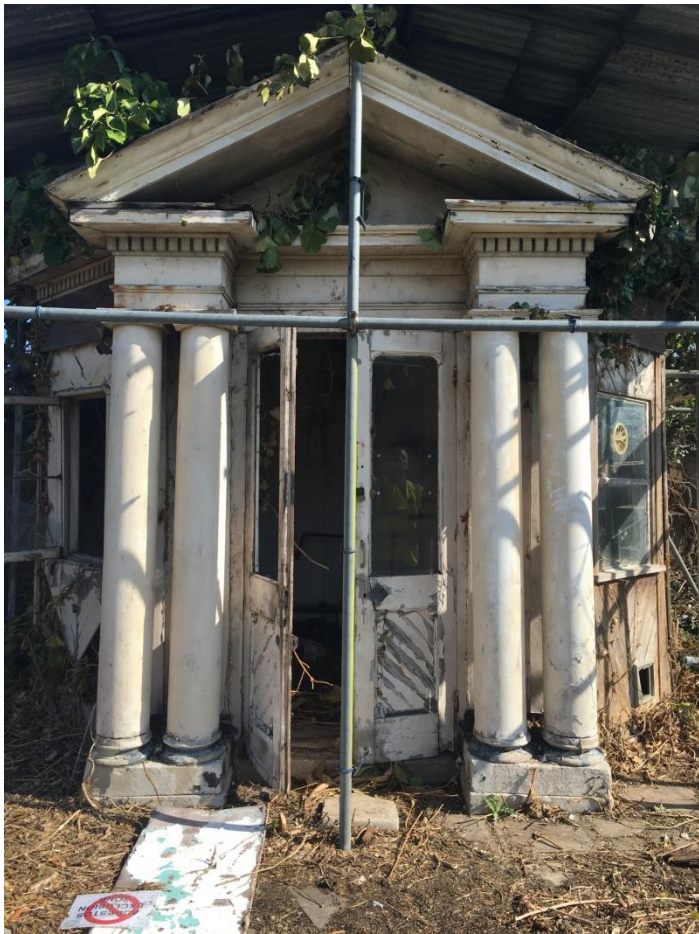
**Fig 6. Portico**

Adjacent to the doors were two pairs of SW pilasters fronted by corresponding cementitious, plain columns supporting a SW entablature under a recessed timber pediment (*fig 6*). The portico was decorated with dentil blocks extending around to the side elevations where repeated pairs of SW pilasters ended the extent of architectural detail.

3. It is fortunate that nearly all of the Portico has survived as this is the area of greatest aesthetic significance. As described previously, we propose to incorporate all of the surviving elements into the re-construction of the Portico with missing elements replaced/repared with joinery grade Redwood.

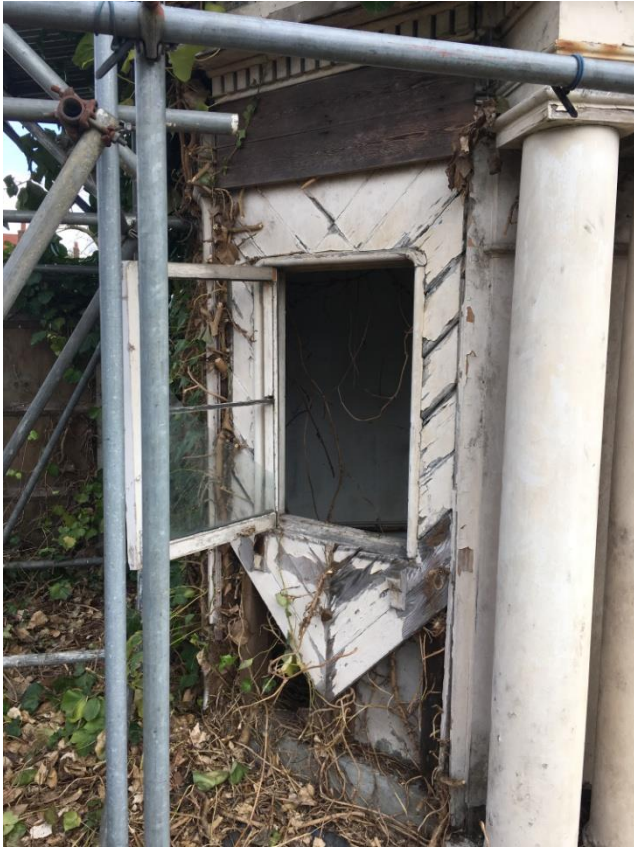
**Fig 7. Original Window**

The original window, in the left-hand panel to the portico, was a simple traditionally designed, single, opening casement window with one horizontal glazing bar (*fig 7*). The sill was extended and supported by brackets attached to the external boarding (*fig 8*). Rounded, planted-on mouldings were fixed to the front of the frame to extend it past the external cladding (*fig 9*). At the joint of these mouldings, between stiles and top rail, were quarter round blocks thus removing the sharp corner of the joint. The top rail of the casement had rounded corners corresponding to the rounded blocks (*fig 10*). The right window was clearly a crude, later replacement and had no redeeming features (*fig 11*).

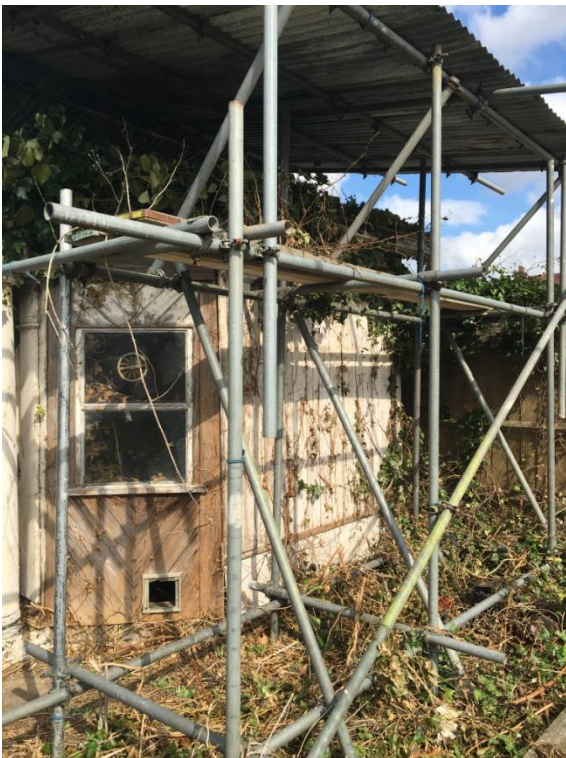
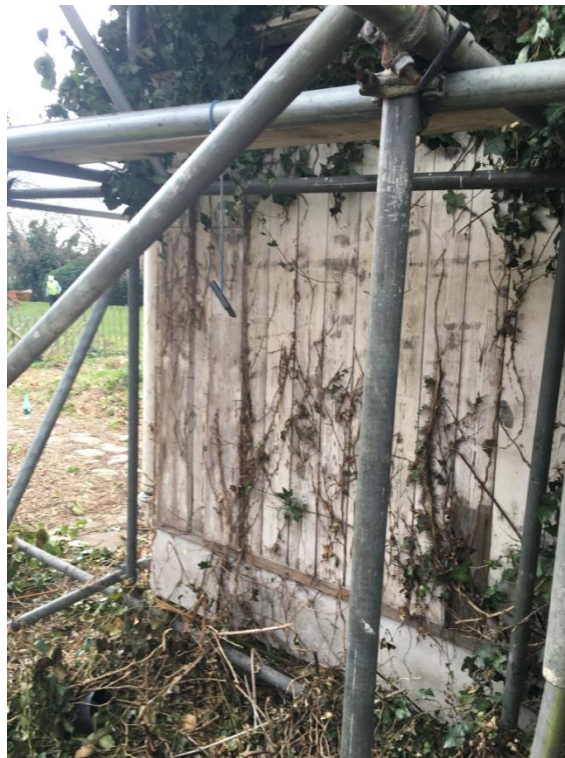
**Fig 12 & 13. Boarding**

These elevations were clad with three types of soft wood vertical boarding. TG&V, TG & beaded (TG&B) and plain tongued and grooved (T&G) boards (*fig 12&13*). The bulk of these elevations were clad with wide (6 inch) T&G boarding with the two rear, radiused corners clad in narrow (3 inch) TG&B boards. From the surveyed boards we were unable to conclude which style of boarding was original (if any) because of the sacrificial nature of timber cladding (*fig 14&15*). As stated before a pair of SW pilasters are the only significant feature on the front ends of the side panels.

4. It is difficult to conclude which would have been the original style of boarding as this is the most vulnerable area of the building and probably none that has been recorded is original. We therefore propose to use tongued and grooved vertical boards, nominally 6in. except the boards forming the radiused corners at the rear to be nom. 3in.

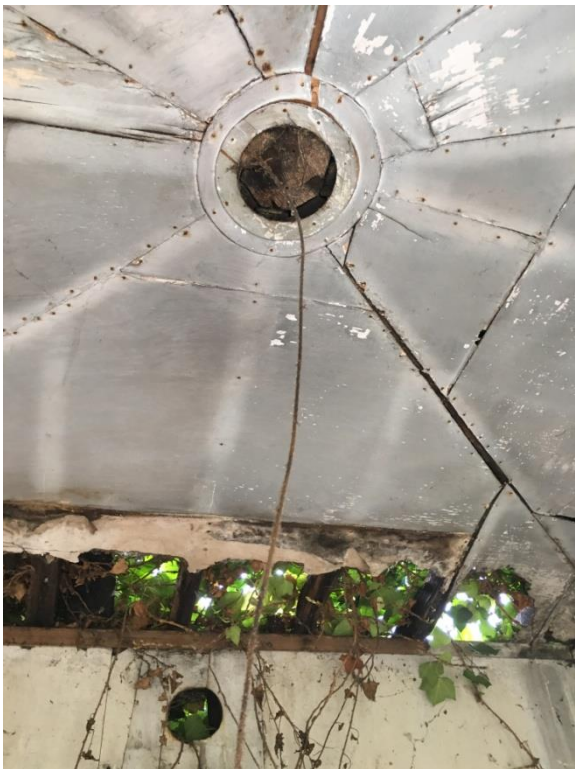
**Fig 16. Central timber boss**

Was constructed of SW timbers, forming a shallow pitched hipped roof. With the hips meeting in the centre against a solid timber boss at the apex (*fig 16*). The pediment roof extended from this boss with a ridge to its apex. No roof covering remained and the whole was in poor condition.

5. None of the roof timbers survive. We will construct a new roof to the same profile and proportions as the surveyed roof using construction standard 94mm x 47mm treated

timber. There was no evidence to suggest what material covered the original roof but because of the shallow pitch we can rule out tiles or slates. We would suggest a sheet metal material to be advised. The use of zinc is the most likely candidate in this instance and will be used.

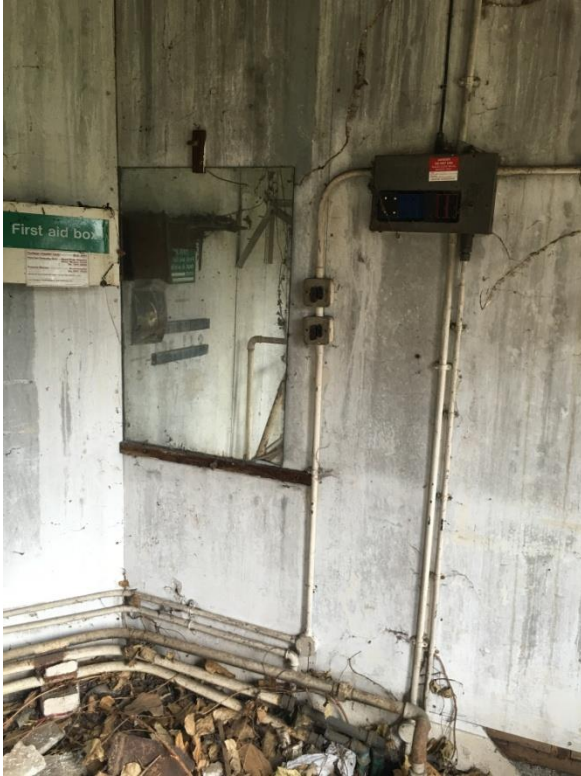
**Fig 17. Asbestos lining and services**

At some stage the pavilion has been re-sited, possibly more than once. The latest intervention to the building was to convert it into a boiler house, as a consequence, the internal walls were clad in asbestos sheeting and services were introduced to serve the heating system (*fig 17,18&19*). The walls immediately adjacent to the door architrave showed evidence of a traditional lath and plaster finish. The floor was finished with terracotta tiles and relatively modern. These were bedded with a strong cementitious adhesive making them impossible to remove without damage (*fig 20*).

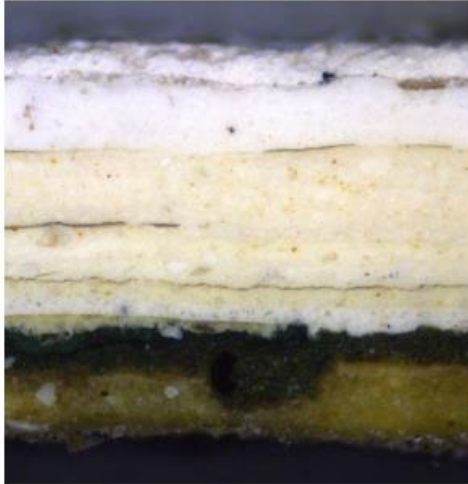
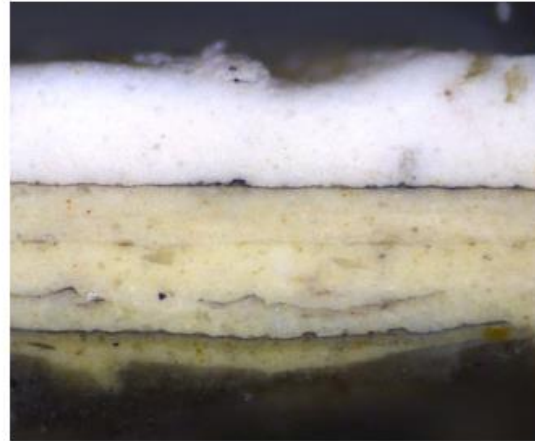
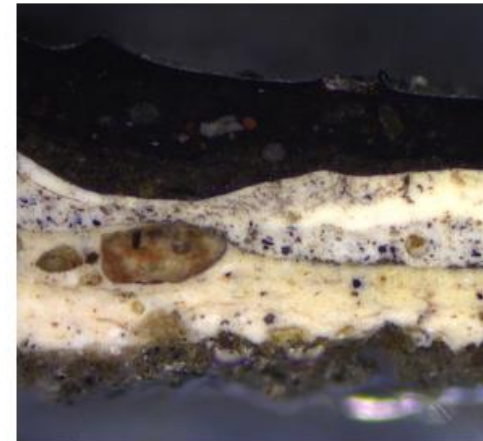
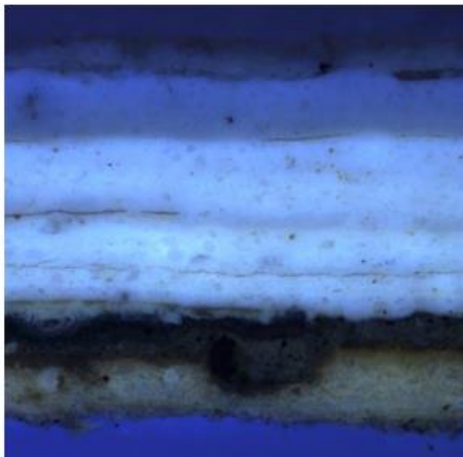
The three cross-section images above show the chronology of schemes applied over the three separate elements. The first image, sample 1 door, shows the full paint history back to the first two green oilpaint schemes. The subsequent 4 cream schemes are then clearly seen in sample 2.

A similar chronology to sample 2 is seen in sample 3 with the exception of the final schemes of black paint.

The image adjacent under UV fluorescence shows that all of the layers are lead paint or contain a significant percentage of lead.
