## SITE INVESTIGATION FACTUAL REPORT

Report No: 287264  
Client: Cunningham Lindsey - Maidstone  
Site: 54 Compayne Gardens, London  
Client Ref: XXXXXXXXXX  
Date of Visit: 20/10/2015

# Investigation Layout Plan

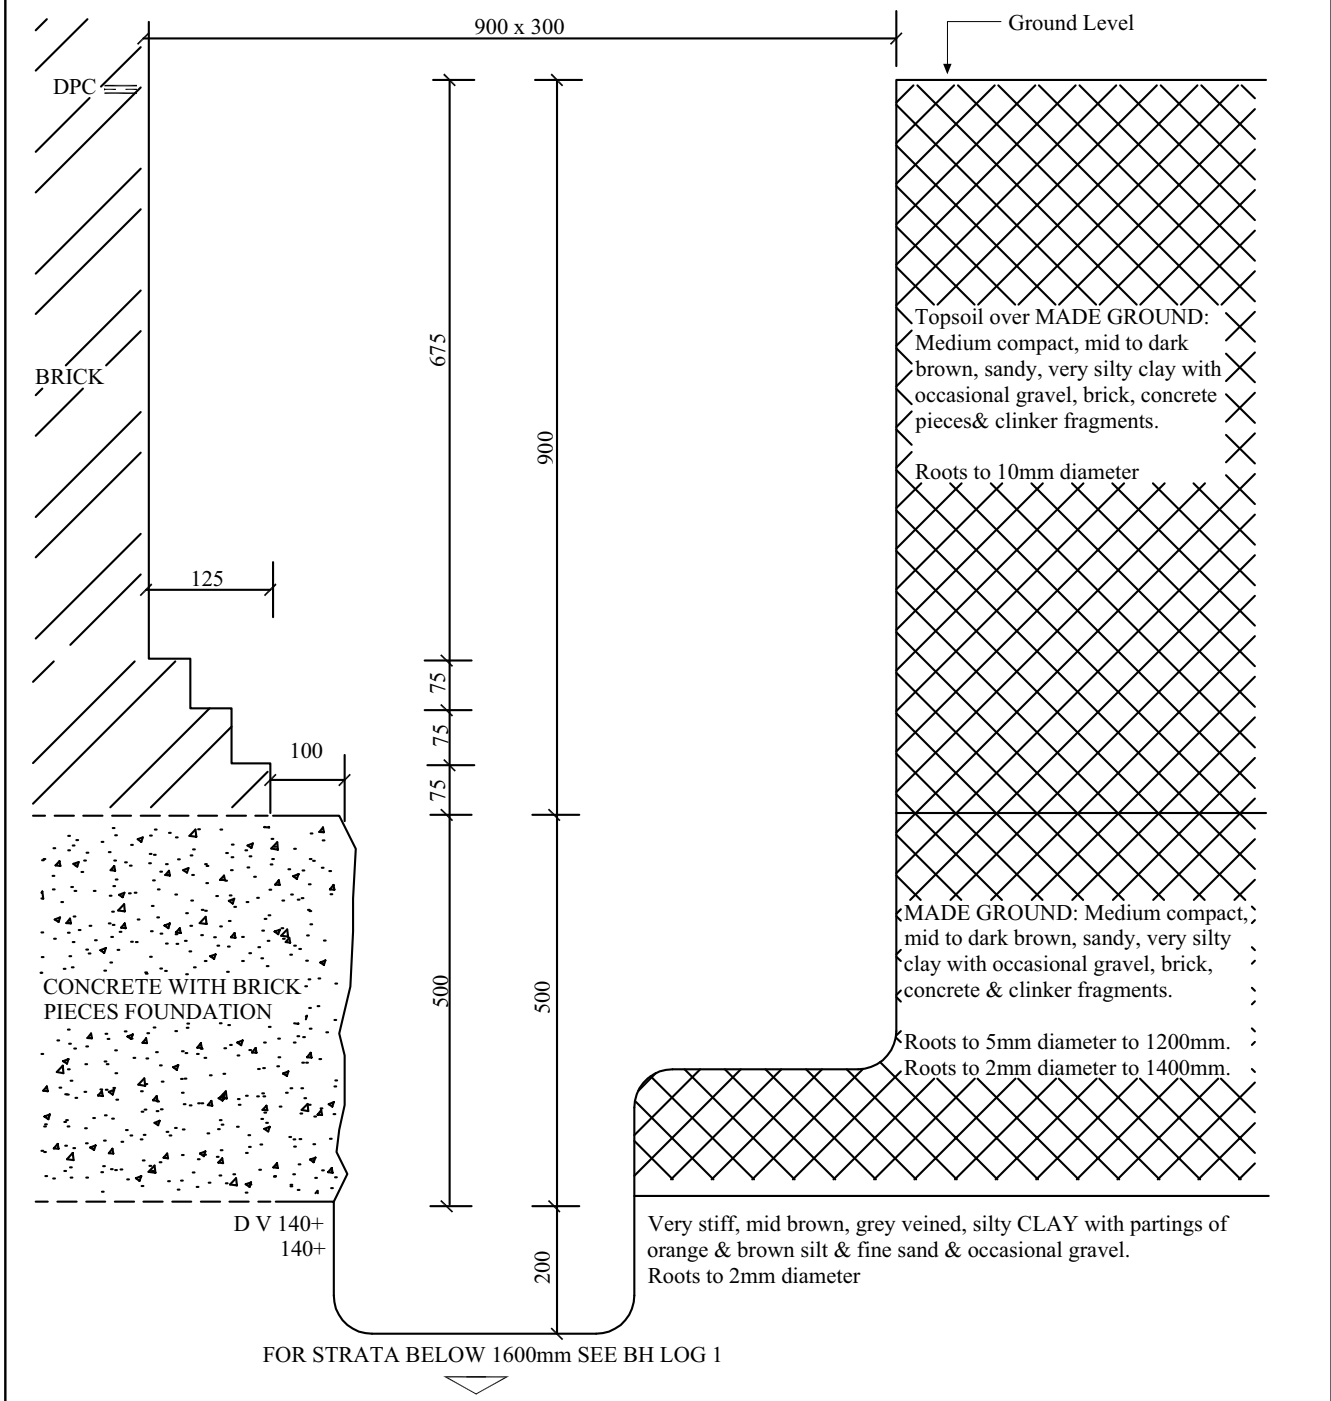
<b>Trial Pit No: 1</b>	Sheet: 1 of 1	Site: 54 Compayne Gardens
	Job No: 287264	
Excavation Method: Hand Tools	Date: 20.10.15	Work carried out for: Cunningham Lindsey
Weather: DRY	Drawn by: DVC	
	Ground Level mOD:

Remarks: All measurements in millimetres. Trial Pit excavated to 1200mm then extended with the aid of a hand auger to 1600mm.	Key:	
	D Small disturbed sample	J Jar sample
	B Bulk disturbed sample	V Pilcon Vane (kPa)
	W Water sample	M Mackintosh probe
	TDTD Too dense to drive	
Logged: MH	Checked: SA	Approved:
	Scale: N.T.S.

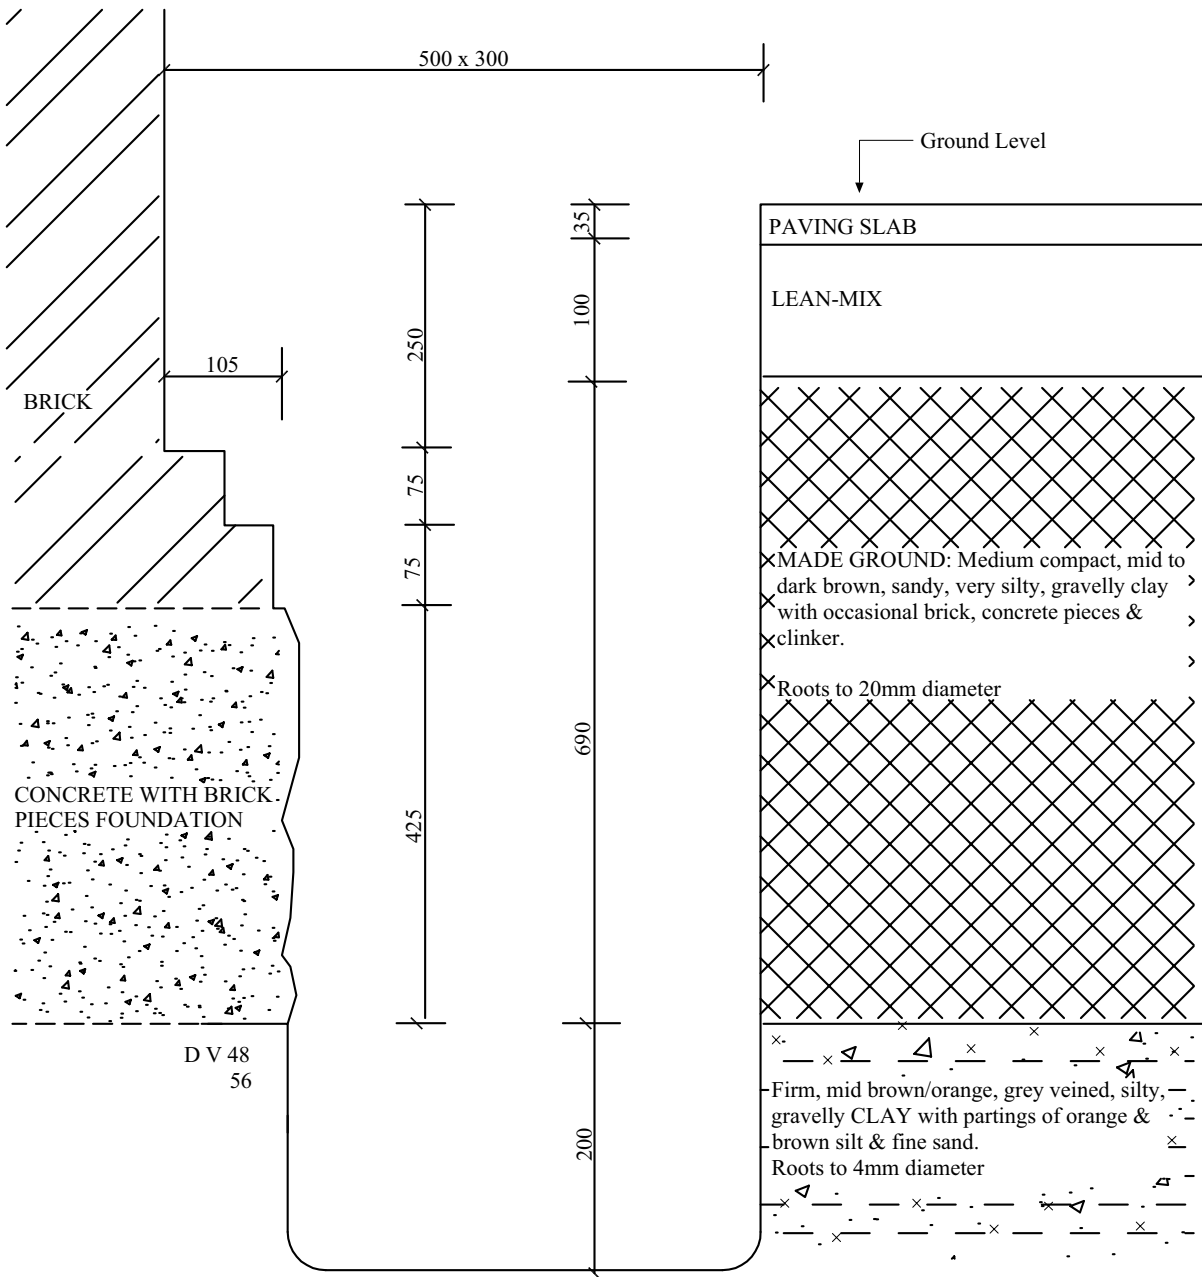
# Trial Pit No: 2

FOR STRATA BELOW 1025mm SEE BH LOG 2

Remarks: All measurements in millimetres.

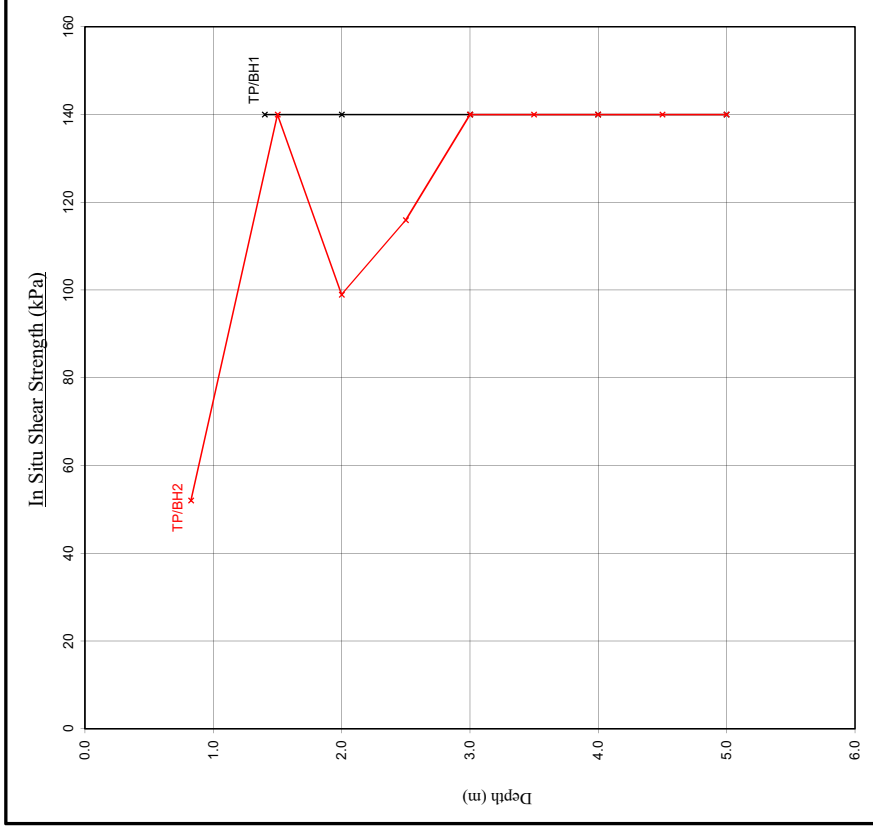
## Shear Strength Profiles

**Note**  
 1. Unless otherwise stated, values of Shear Strength were determined in situ by CET using a Picon Hand Vane the calibration of which is limited to a maximum reading of 140 kPa.  
 2. Unless specifically noted the profiles have not been related to a site datum.

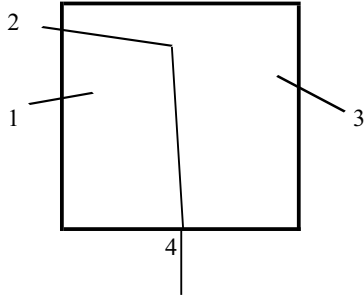
M/H: 1 Depth: 950mm

Manhole Condition

As built

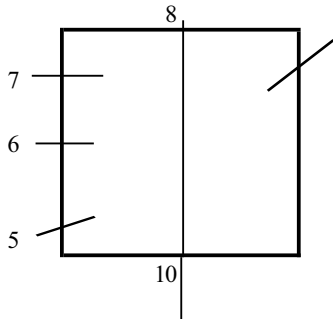
M/H: 4 Depth: 600mm

Chamber Dimension (mm): 650 X 450

Manhole Condition

As built
