Level Monitoring - Relative Movement Over Time

Our Ref: 00/30237 Date of Issue 08/01/18

Occupier:	[REDACTED]
Address:	54 Compayne Gardens
Address:	
Town:	London
County:	
Post Code:	NW6 3RY
Tel Day:	[REDACTED]
Tel Eve:	
Mobile:	
Other:	
Other:

Level Monitoring - Site Sketch

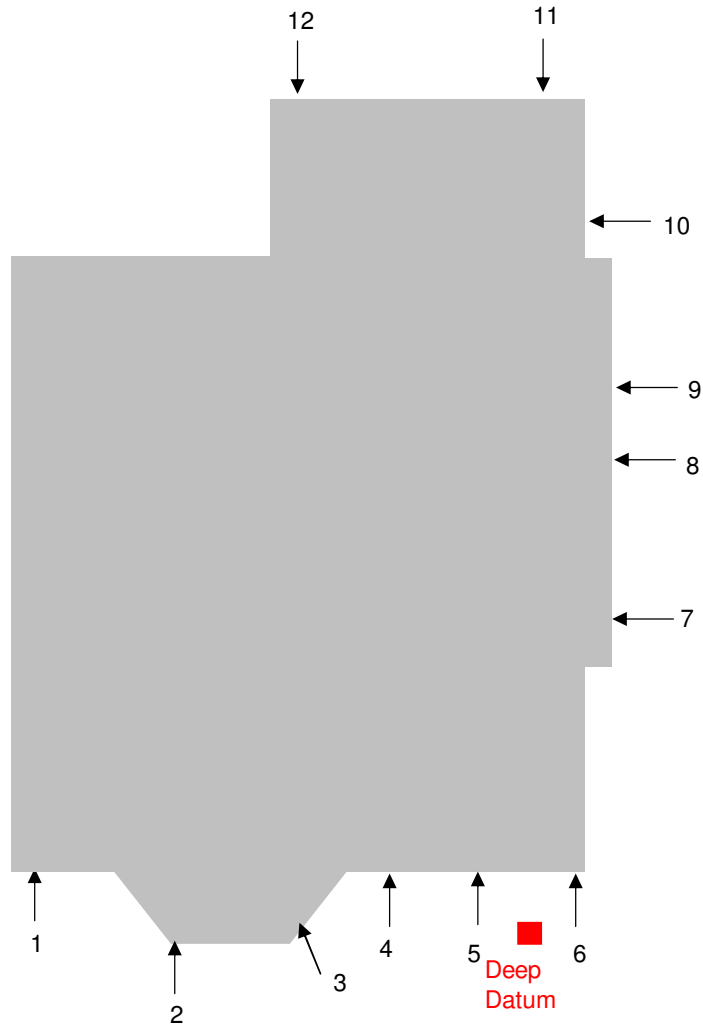
points 5,6 no access ther is cable in way
