ARBORICULTURAL ASSESSMENT REPORT

For:	Client:	Cunningham Lindsey (Maidstone)
	Insurer:	[REDACTED]
Site:	Policyholder:	[REDACTED]
	Risk Address:	54 Compayne Gardens, London, NW6 3RY
Refs:	OCA Ref:	63797
	Client Ref:	[REDACTED]
	Insurer Ref:	[REDACTED]

Arborist Name:	Thomas Peppiatt	Date:	25/07/2017
-----------------------	-----------------	--------------	------------

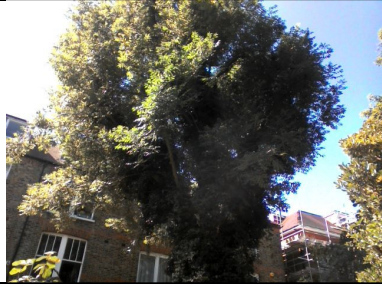
T6 - Ash

TP/BH1:	Tilia, 5 roots. 1.5mm diameter
TP/BH1:	Tilia, 4 roots. 1mm diameter
TP/BH2:	Fraxinus, 3 roots. 2mm diameter
TP/BH2:	Fraxinus, 3 roots. 2mm diameter
TP/BH2:	Clematis, 1mm diameter

T6	Ash	Mature	Fair	17	10	600	7	No significant recent management.	Fell and treat stump			54 Compayne Gardens, London, NW6 3RY	PH
SG1	Rose	Semi-Mature	Fair	3	1.50	30	0.3	Subject to past management.	No work required		X2 Rose.	54 Compayne Gardens, London, NW6 3RY	PH
SG2	Mixed Species shrubs	Mature	Fair	4	1.0	20	0.3	Managed Shrub group.	No work required		Including Rose and Wisteria.	54 Compayne Gardens, London, NW6 3RY	PH

Tree No:	Species	Works Required
C2	Clematis	Fell close to ground level (approx 50mm)
T1	Lime	Fell and treat stump
T2	Lime	Fell and treat stump
T3	Lime	Fell and treat stump
T4	Lime	Fell and treat stump
T6	Ash	Fell and treat stump
