CLIENT Venoru Ltd	
PROJECT 49 Marchmont Street, WC1N 2AN	
DRAWING CONDITION SURVEY REAR ELEVATION	
DRG. No 34	REVISION -
SCALE 1:50 @ A3 PAPER	DATE 11 Jan 2018

EXISTING REAR ELEVATION

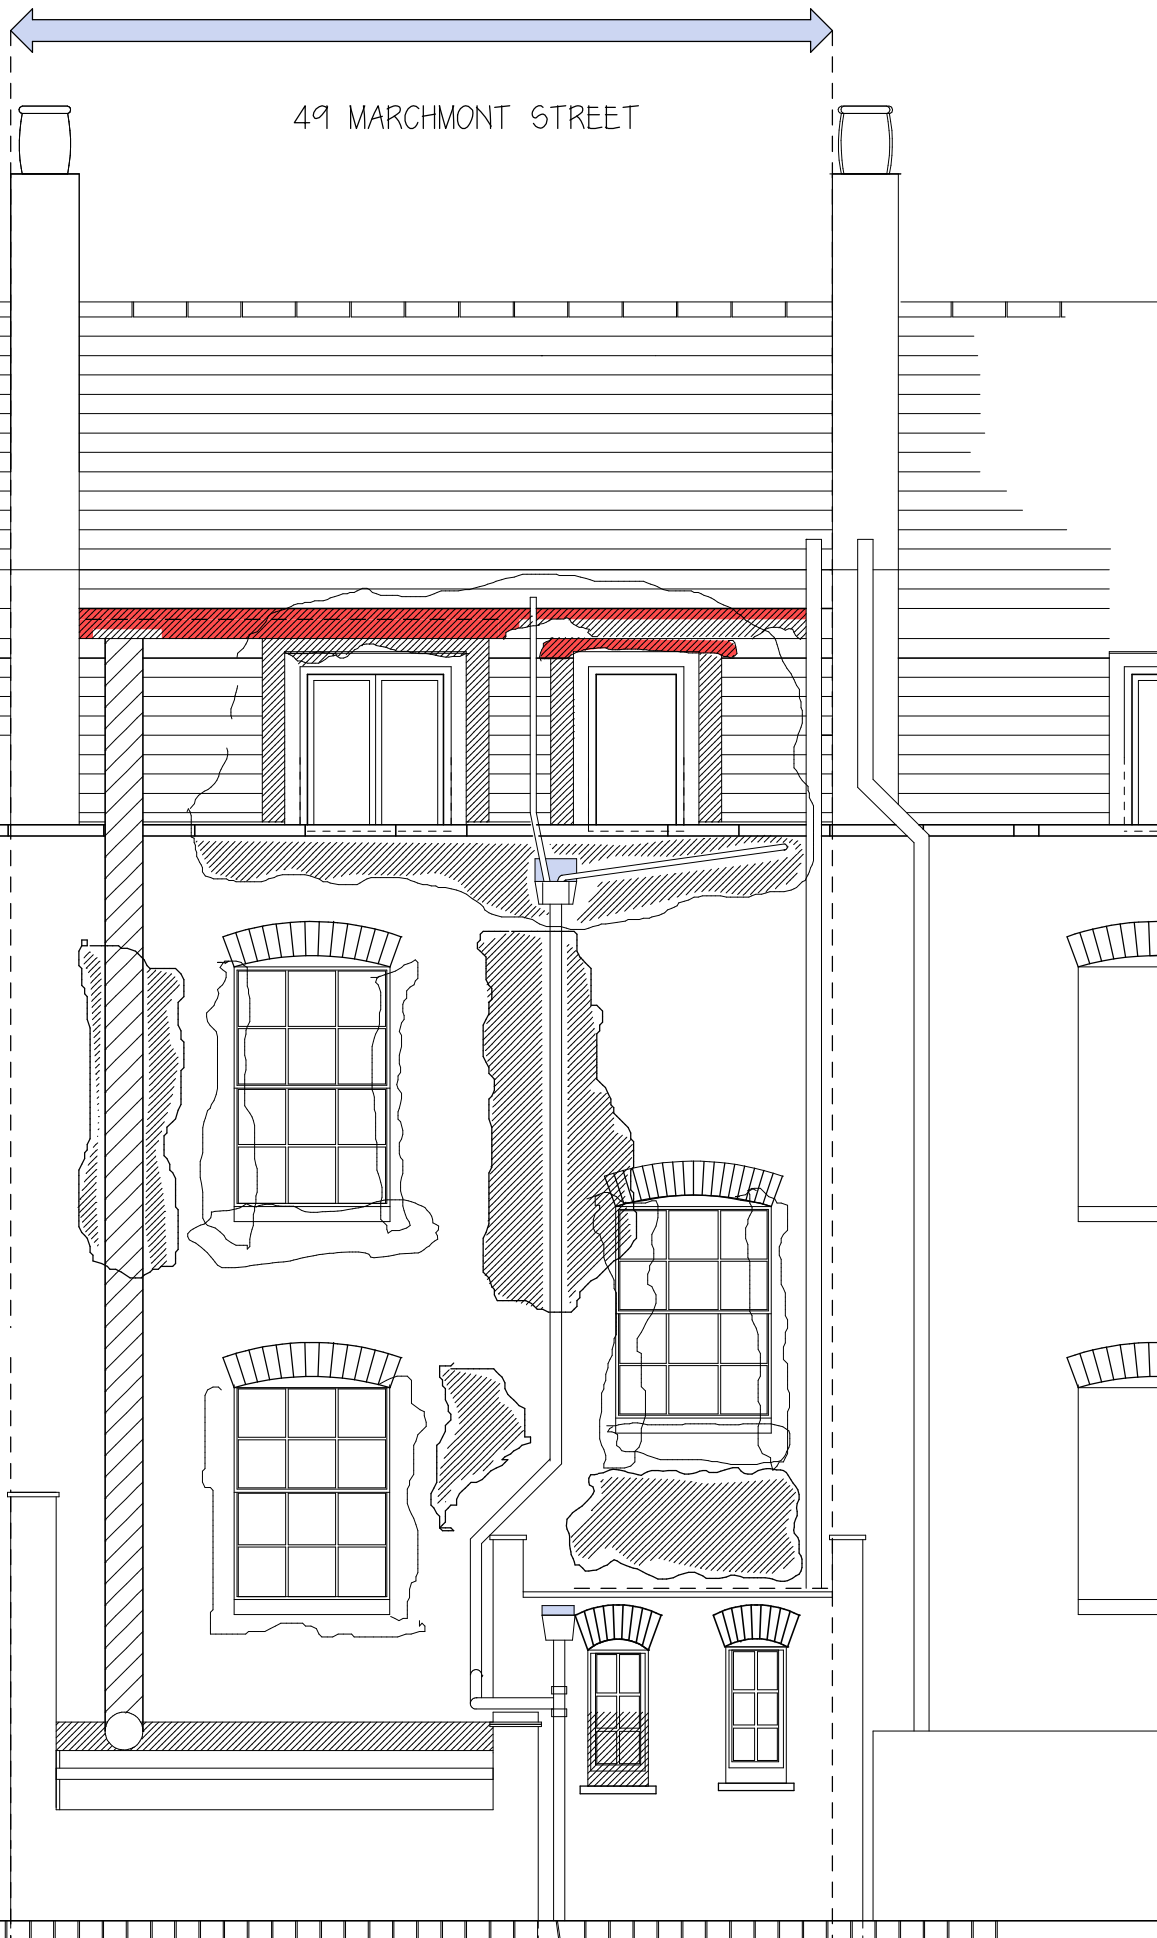
- brick pointing is poor in localised areas - brick vulnerable to leaks from pipes and poorly detailed weatherings - saturation stains visible
- some cementitious mortar repointing has caused brick decay and delamination - repointing recommended
- leadwork at roof and around mansard windows loose and failing
- parapet stones are decaying and loose masonry in evidence below parapet gutter (viewed from closed window) appears in very poor condition equires reconstruction and re-lining in lead
- 20th century extension in fair condition although roof finish has a short lifespan, falls are poor and lead upstands require closer investigation
- lead box over drainage runs on flat roof in poor condition and allowing localised water retention
