49 MARCHMONT STREET

PROJECT
 49 Marchmont Street, WC1N 2AN

DRAWING
 SURVEY OF SIGNIFICANCE
 REAR ELEVATION

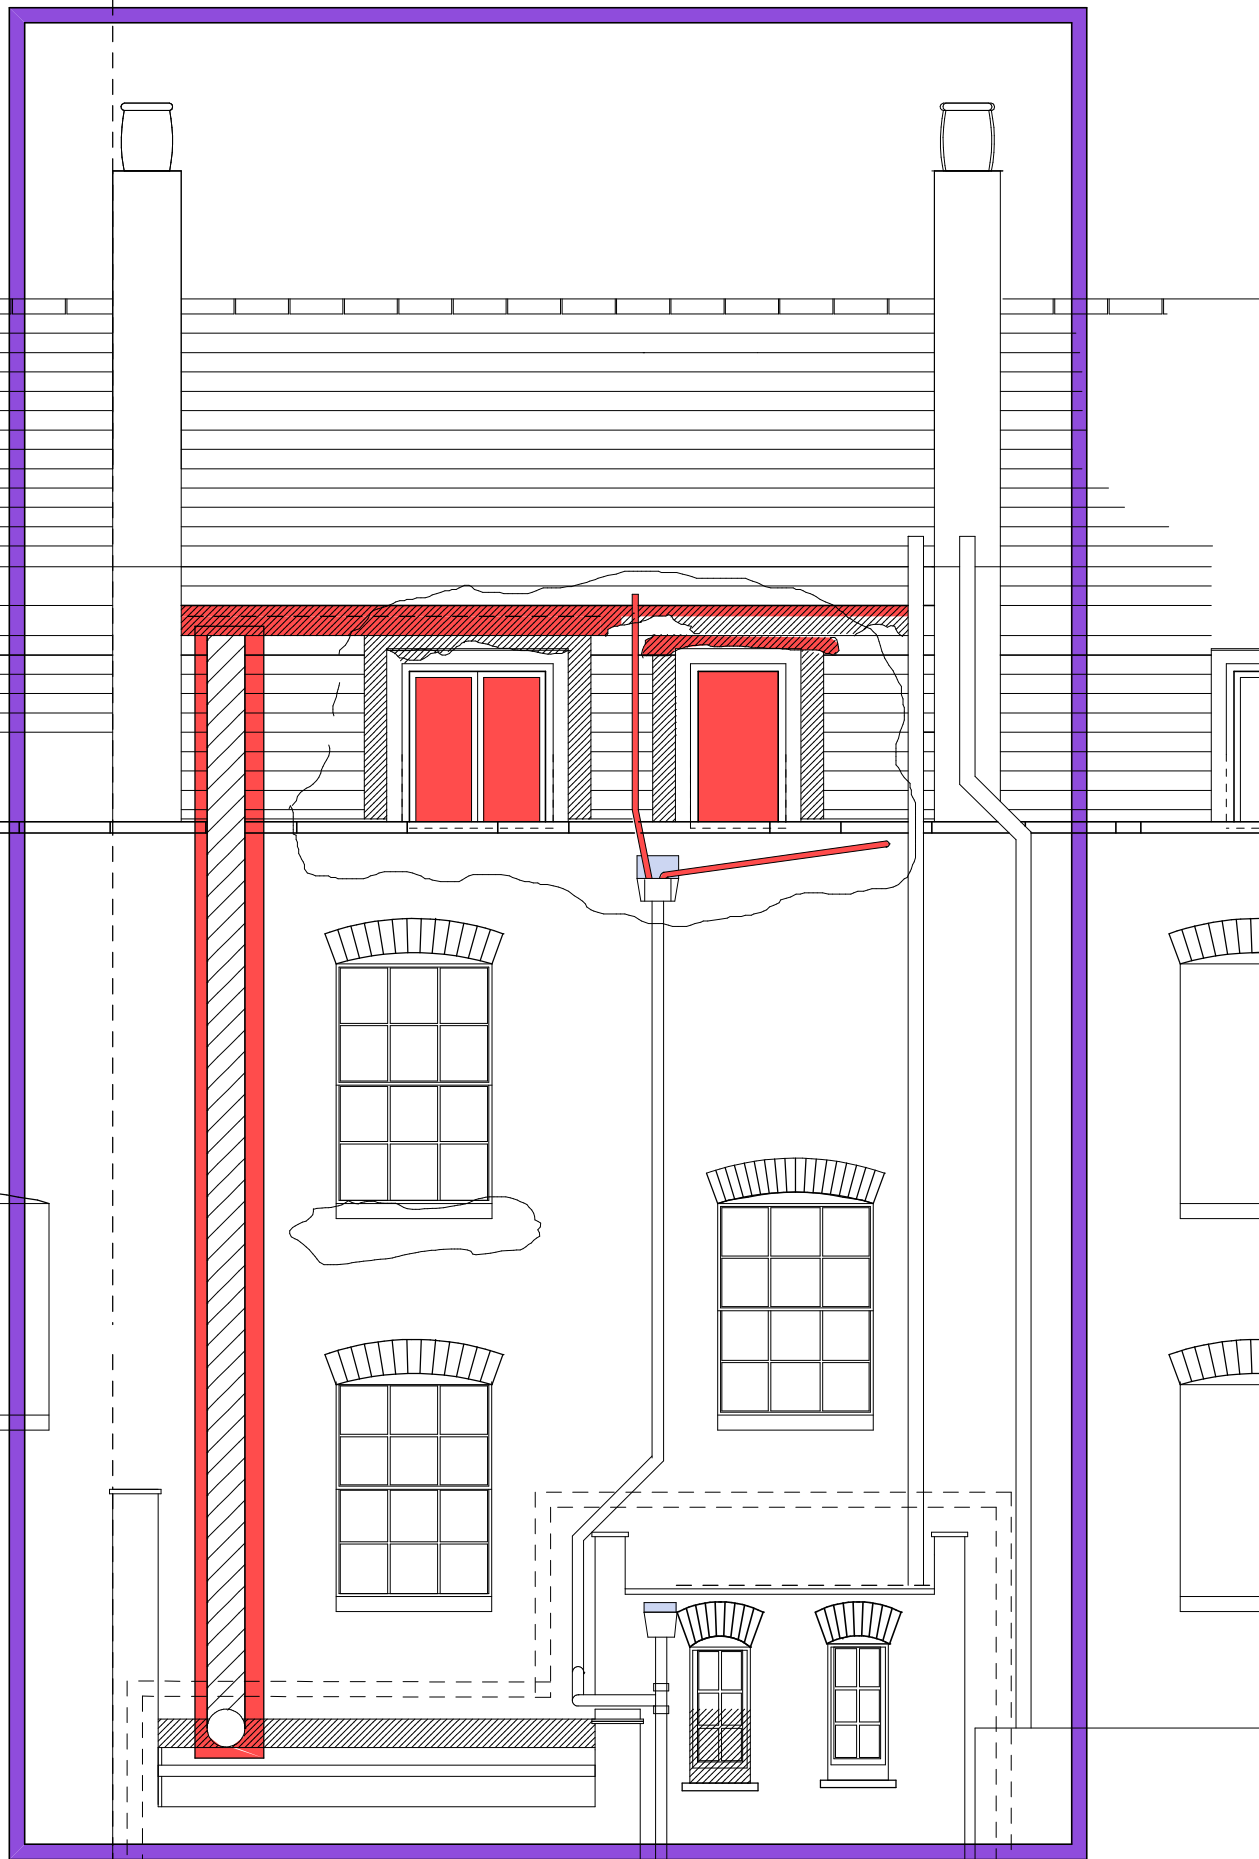
EXISTING REAR ELEVATION

Overall rear elevation - fair

rear extensions have altered the original form

ad hoc services and pipes create a cluttered appearance

poor maintenance of windows has led to loss of fabric at attic level

some leakage or saturation has harmed brickwork and stones
