SUMMARY - TIMBERS IN VERY POOR CONDITION IN FRONT AREA - ROOF EXPOSED TO WATER INGRESS

CLIENT Venoru Ltd.	
PROJECT 49 Marchmont Street, WC1N 1AP	
DRAWING CONDITION SURVEY fourth (attic)plan	
DRG. No 31	REVISION -
SCALE 1:50 @ A 3 paper	DATE 12 jan 2018

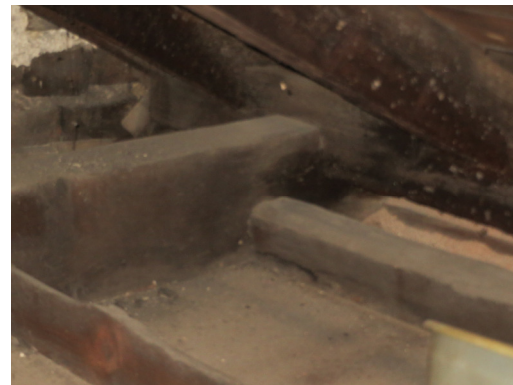
FRONT (EAST) PARAPET GUTTER PLATE IS IN A CRITICAL CONDITION - SATURATED AND ROTTEN - IT COULD BE AT THE POINT OF COLLAPSE - LONG TERM EXPOSURE TO WET IS SUSPECTED

PARAPET GUTTER BOARD IN CRITICAL CONDITION

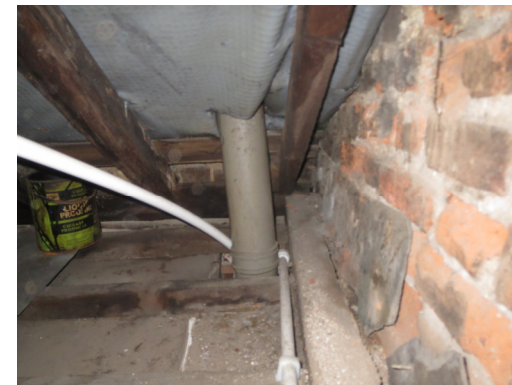
SEVERE DAMAGE TO CEILING JOISTS ON FRONT PART OF BUILDING (EAST) THEY APPEAR UNDERSIZED

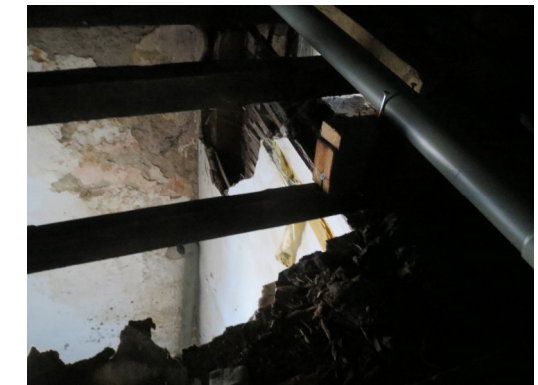
SURVIVING RAFTERS - SUFFERING FROM EXPOSURE TO WET AT EASTERN END

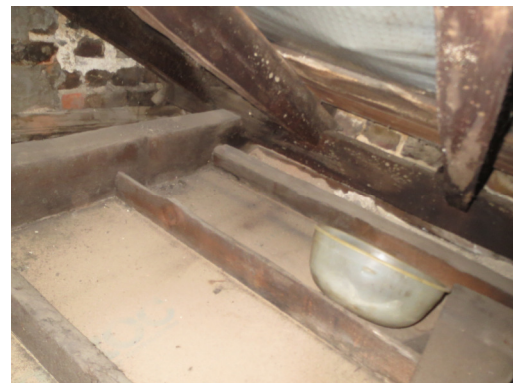
SIGNS OF PREVIOUS WATER INGRESS EVIDENCED BY BOWLS AND OTHER RECEPTICLES - A NEW ROOF MEMBRANE APPEARS TO HAVE BEEN PATCH-FITTED OVER PART OF THE ROOF - TYPE UNKNOWN SOME MEMBRANE IS LOOSE AND SOME PIECES HAVE FALLEN AWAY

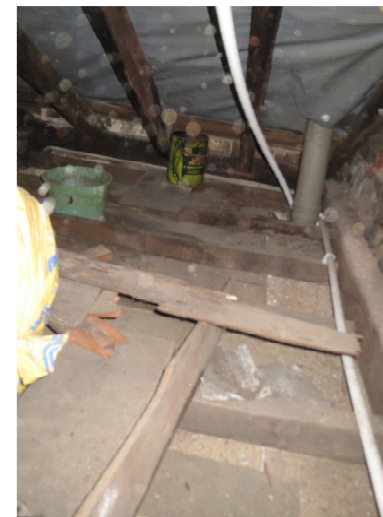
BRACES AND TIMBER BEARER PLATES SOUND IN CENTRAL PART OF ROOF AWAY FROM THE WATER DAMAGE AND PARAPET GUTTERS

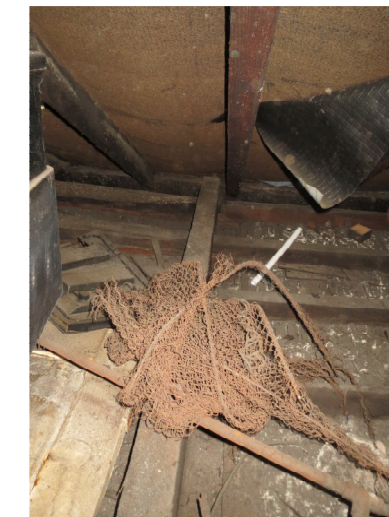
SOIL AND VENT PIPE AND OTHER ROOF PENETRATIONS HAVE NOT BE SLEEVED TO MODERN BUILDING STANDARDS
