SUMMARY very little surviving fabric - modernised interiors - external elements require repairs and redecoration

PROJECT
49 Marchmont Street

DRAWING
CONDITION SURVEY
FIRST floor plan

DRG. No 28	REVISION -
SCALE 1:50 @ A 3 paper	DATE 12 JAN 2018

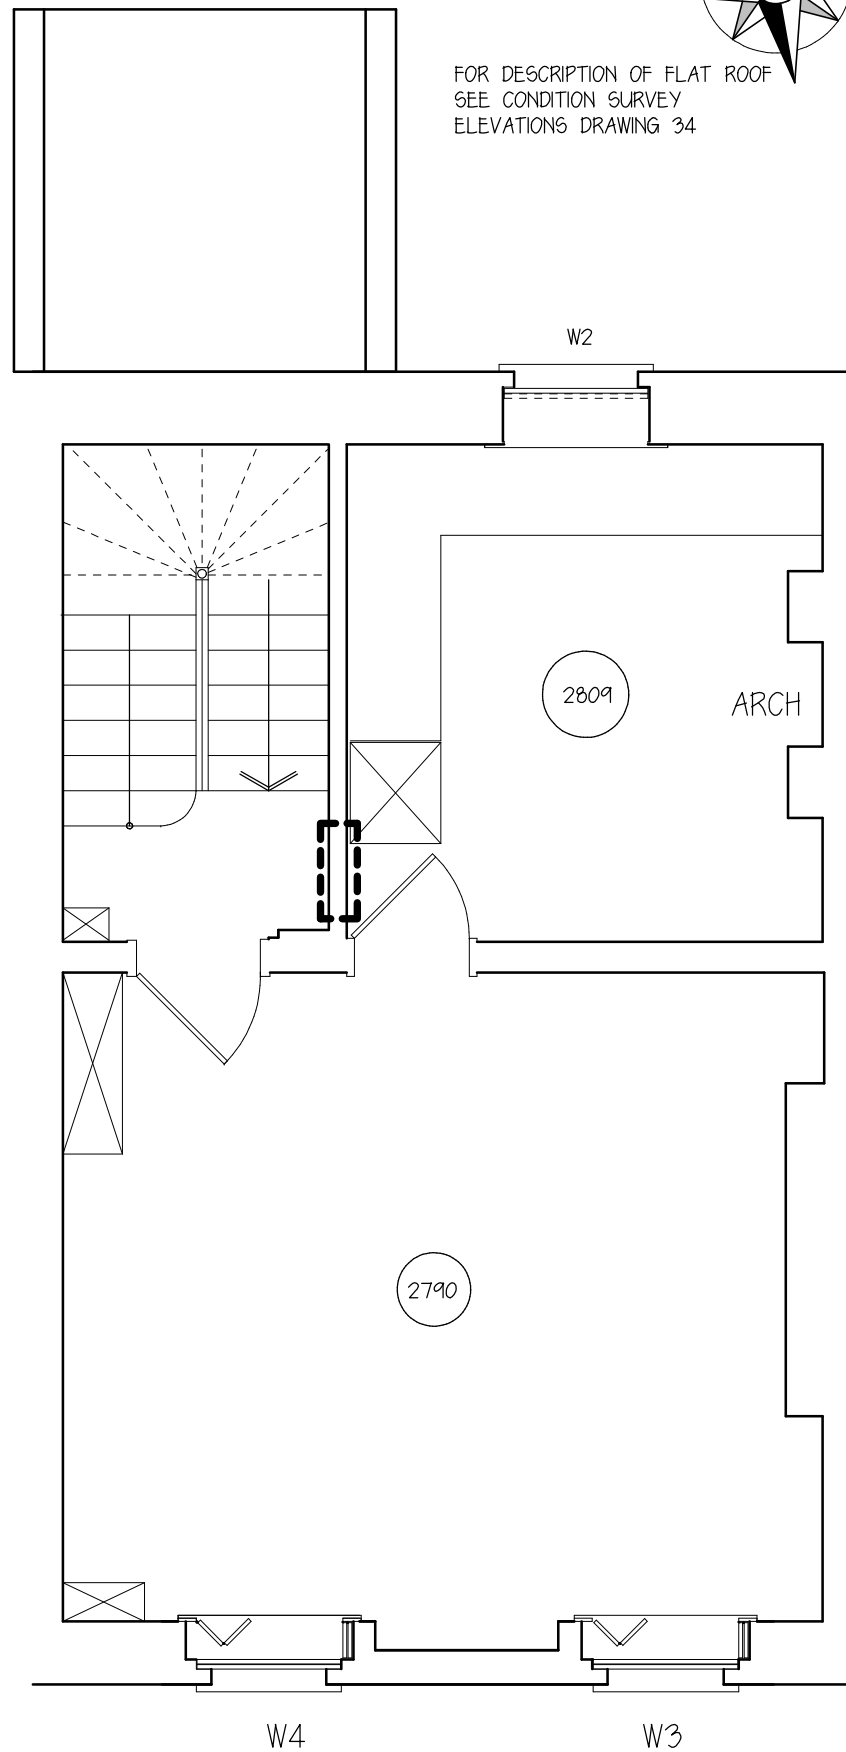
CONDITION SURVEY - FIRST FLOOR PLAN

CEILING - SOME CRACKS WEST TO EAST MID SPAN

WALLS - FAIR - NO HISTORIC LININGS IN EVIDENCE - SPINE WALL MAY BE A LATHE AND PLASTER BUT NEW OPENING MADE IN WALL - NO HISTORIC FABRIC SEEN

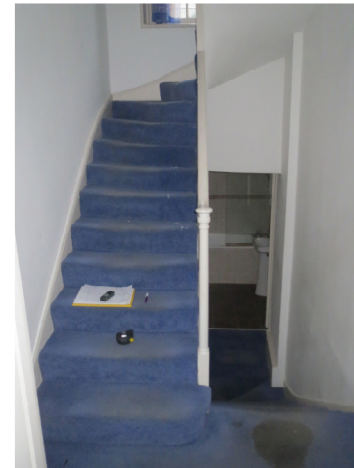
STAIRCASE - ORIGINAL ELEMENT CARPET VERY POOR - UNABLE TO SEE CONDITION OF TREADS

surviving staircase

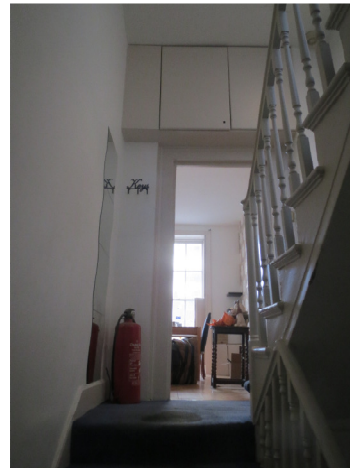
modern door

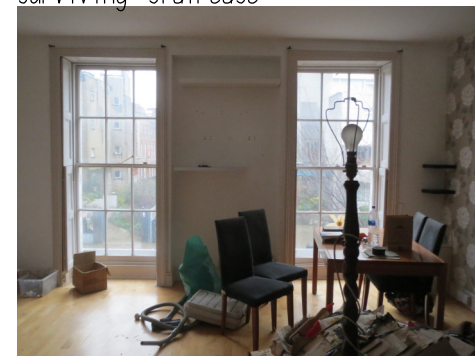
FRONT ROOM W3 & 4 SHUTTERS AND WINDOWS - GOOD CONDITION - ONE PANE OF GLASS MISSING - MODERN GLASS UNABLE TO OPEN TO CHECK SASH WEIGHTS
- GENERAL OVERHAUL SUGGESTED BY SPECIALIST JOINER
ORIGINAL ARCHITRAVE AND SHUTTER BOX SURROUND - JOINERY GOOD CONDITION

surviving shutters and windows

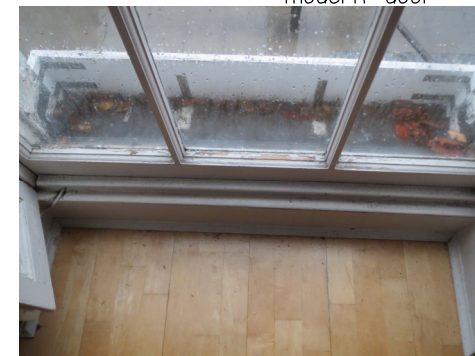
bottom rails require maintenance

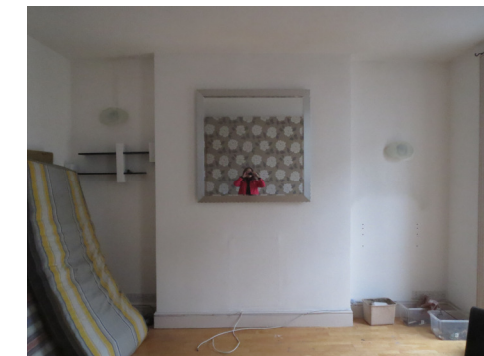
ALL FIREPLACES BLOCKED - NO SURVIVING HISTORIC FABRIC REAR FIREPLACE - ARCH MODERN LINING ALL FAIR CONDITION

fireplace blocked

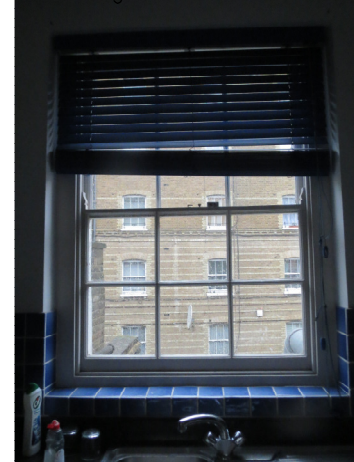
REAR ROOM WINDOW (W2) - PROB 20TH CENTURY REPLACEMENT - GILLS AND REVEALS ALL FLAKING AND SOME WEATHERING
REQUIRES OVERHAUL

modern replacement window

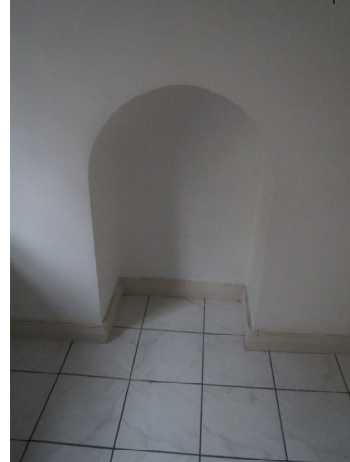
blocked fireplace with arch

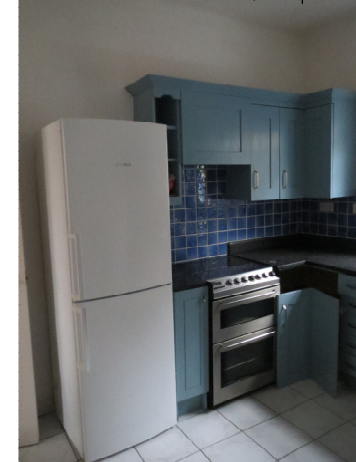
REAR ROOM ENTIRELY MODERN FINISHES NO ORIGINAL LININGS SEEN

modern linings in rear room
