EXISTING FRONT (EAST) ELEVATION

CLIENT Venoru Ltd	
PROJECT 49 Marchmont Street, WC1N 2AN	
DRAWING CONDITION SURVEY FRONT ELEVATION	
DRG. No 33	REVISION -
SCALE 1:50 @ A3 PAPER	DATE 12 JAN 2018

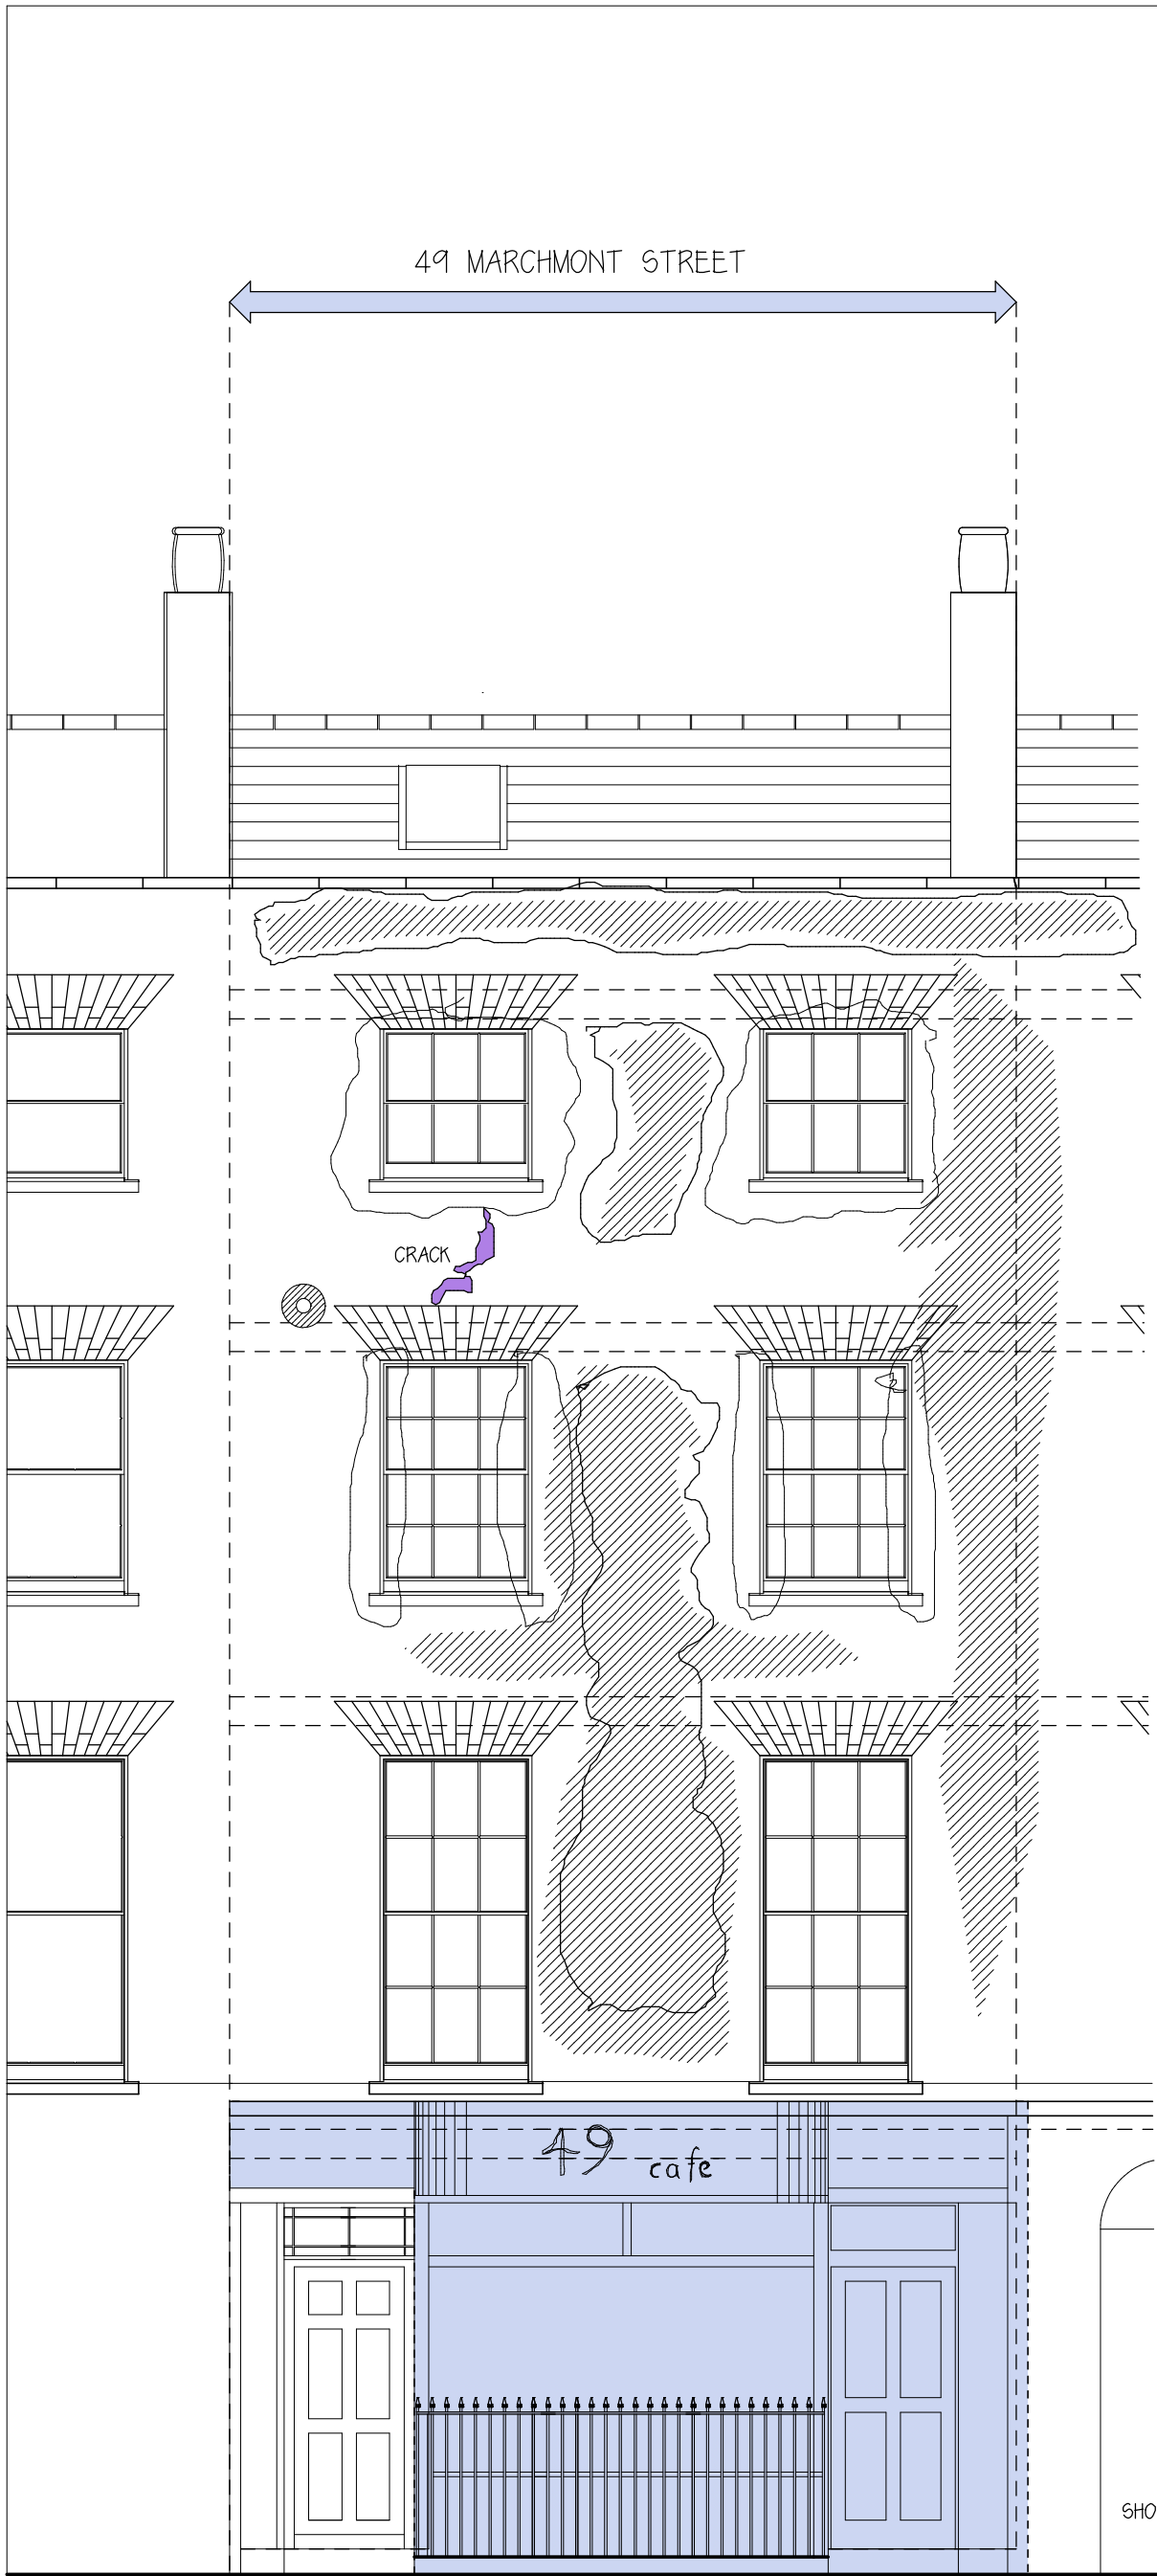
SUMMARY - BRICKWORK REQUIRES ATTENTION - VERY POOR AT PARAPET
SOME MORTAR LIES FORWARD OF THE BRICK FACE AND IS CAUSING HARM

PATCH REPAIRS AND REPOINTING GIVES THE FACADE AN UNTIDY APPEARANCE
CEMENTITIOUS MORTAR IS IN EVIDENCE - SOME BRICKS HAVE DELAMINATED
DUE TO INABILITY TO EVAPOURATE MOISTURE THROUGH THEIR ADJACENT JOINTS

THERE ARE RAKING CRACKS UNDER THE THIRD FLOOR WINDOW - STRUCTURAL
DEFECTS OCCUR INSIDE

FLAT GAUGED BRICK ARCH HAS BEEN PAINTED - THE PAINT MAY BE
HARMING THE BRICK

PARAPET STONES ARE BADLY WEATHERED AND DELAMINATING
BEDDING MORTAR NOT POSSIBLE TO INSPECT DURING SURVEY

6 - OVER - 6 SASHES IN VARIOUS FORMS ARE PRESENT ON THIS FACADE
THEY VARY IN TERMS OF GLAZING BAR MOULDINGS AND GLAZING BAR SIZES
SUGGESTING A NUMBER HAVE BEEN REPLACED WITH HISTORICALLY-REFERENCED
NEW SASHES
ALL WINDOWS REQUIRE RECEDORATION TO ENSURE A WEATHERTIGHT FINISH

CLOSE INSPECTION OF SILLS AND REVEAL AND WINDOW SURROUNDS WHEN VIEWED
FROM INSIDE SHOW FLAKY PAINT AND OPEN CRACKS ALLOWING WATER INGRESS
