↑  
CONDITION SURVEY - GROUND FLOOR PLAN - entrance level

CLIENT Venoru Ltd.	
PROJECT 49 Marchmont Street, WC1N 1AP	
DRAWING CONDITION SURVEY ground floor plan	
DRG. No 27	REVISION -
SCALE 1:50 @ A 3 paper	DATE 12 jan 2018

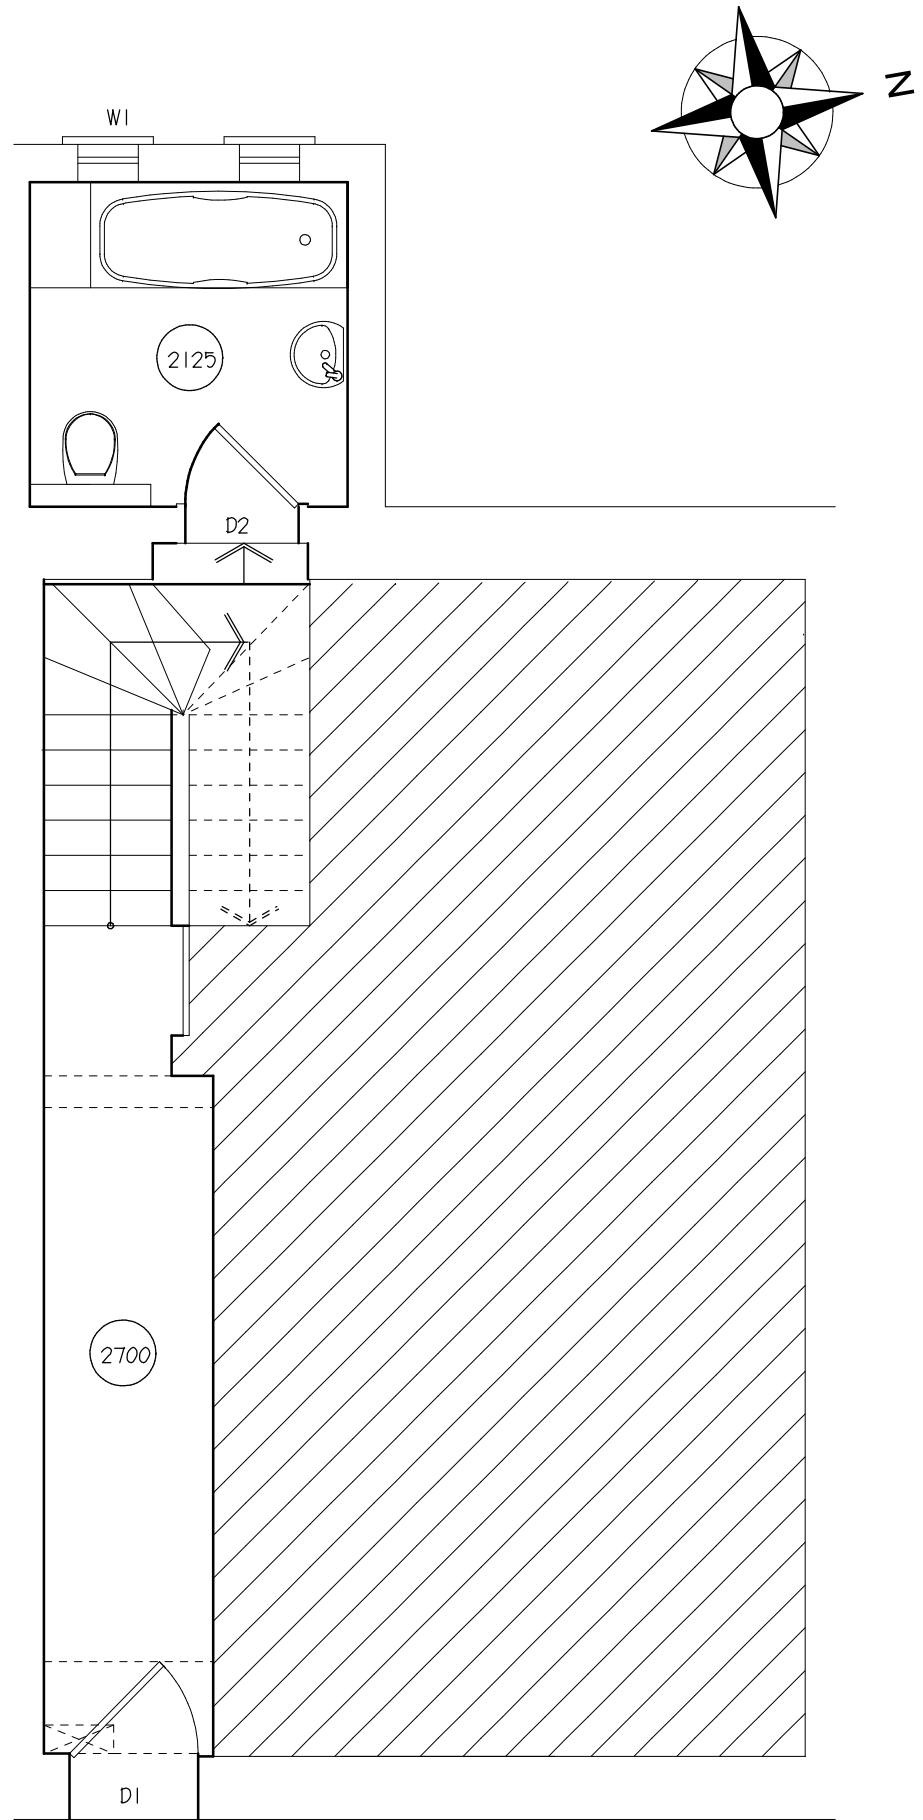
FRONT DOOR - ORIGINAL ELEMENT BUT MANY ALTERATIONS SUCH AS SECURITY LOCKS HAVE LEFT IT COMPROMISED

STAIRCASE - ORIGINAL ELEMENT - STRINGS WORN & PARTLY CONCEALED BEHIND WALL FINISH

UNABLE TO SEE CONDITION OF TREADS DUE TO CARPET ONCE CARPET REMOVED CONDITION TO BE ASSESSED APPEARS VERY WORN EVIDENCED BY DIP IN CENTRE

SPINDLES FAIR

HANDRAIL FAIR

NO ORIGINAL SKIRTINGS IN HALLWAY

WALLS PAINTED AND PAPERED - CONDITION WORN

MEZZANINE ROOM ENTIRELY TILED  
UNABLE TO DETERMINE CONDITION OF FABRIC
