CONDITION SURVEY - ROOF PLAN

CLIENT
Venoru Ltd.

PROJECT
49 Marchmont Street, WC1N 1AP

DRAWING
CONDITION SURVEY
ROOF plan

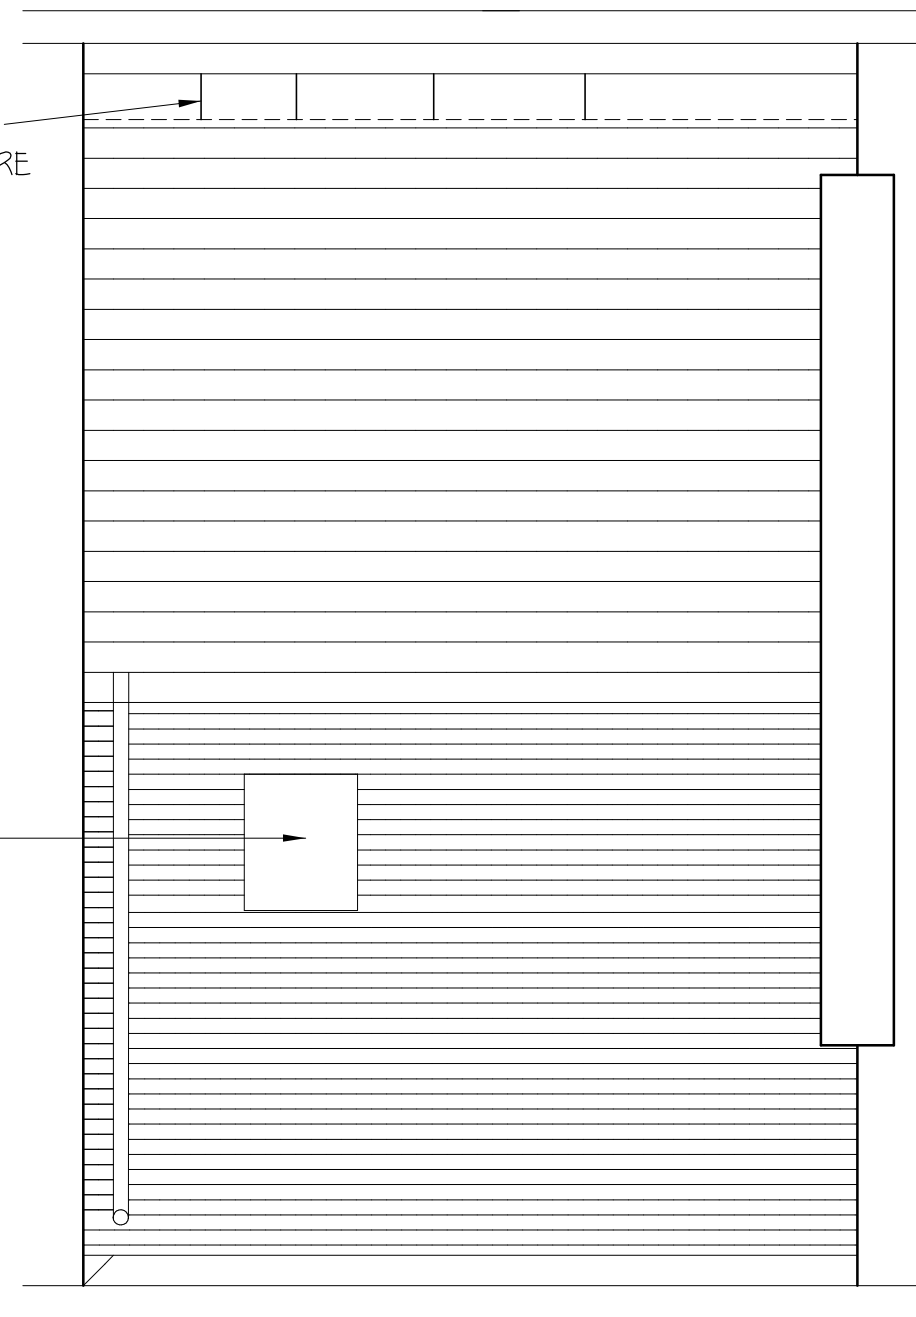
SUMMARY - SURVIVING HISTORIC ELEMENTS BUT CONDITION POOR

ORIGINAL SLATES HAVE NOT BEEN CLOSELY INSPECTED FOR CONDITION BUT SOME HAVE SLIPPED OR ARE MISSING

ORIGINAL BRICKWORK TO CHIMNEYS PARTY WALLS AND PARAPET IN POOR CONDITION
- MANY JOINTS ARE LACKING MORTAR

PATCH REPOINTING HAS BEEN DONE IN CEMENTITIOUS MORTAR - FACE OF BRICK IS DELAMINATING

RENDER AT PARTY WALL APPEARS TO BE A HARD CEMENTITIOUS MATERIAL THAT HAS LOST ITS KEY TO THE BRICK SUBSTRATE

A CEMENT FILLET APPEARS TO HAVE BEEN USED AS A WEATHERING AND FILLING MATERIAL
- IT HAS CRACKED AND IS LIFTING AWAY FROM THE BASE OF THE WALL

LEAD FLASHING WHERE IT IS USED IS NOT PROPERLY BONDED INTO THE WALL
- NOR IS THERE A DOUBLE LAYER ON THE UPSTAND TO PREVENT CAPILLARY ACTION OF WATER

SUSPECT WATER PENETRATION IN ATTIC ARISES FROM THE POOR CONDITION OF POINTING AND INADEQUATE WEATHERINGS

PARAPET GUTTER IN VERY POOR CONDITION AND ALLOWING WATER INGRESS
- CLOSE INSPECTION OF GUTTER AND CONDITION OF LEAD COULD NOT BE CONDUCTED DUE TO WEATHER AND CRITICAL CONDITION OF GUTTER PLATE

DROP AT GUTTER VERY SHORT - AN IDEAL DROP OF 100 - 150 MM IS REQUIRED
- TO PREVENT WIND DRIVEN RAIN TO ENTER ROOF

DORMER
STRUCTURE
ORIGINAL

LEAD
COVERED
ACCESS
HATCH

SUGGEST A SPROCKETED EAVES BOARD TO TILT SLATES UP FOR BETTER DROP WHEN PARAPET GUTTER REPAIRED

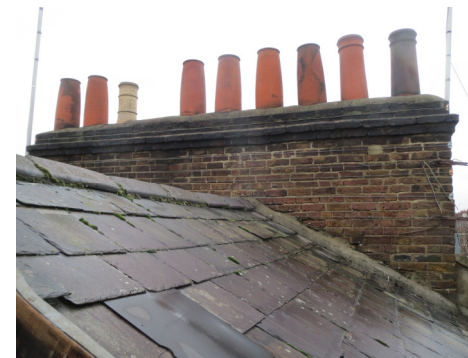
ORIGINAL SLATES and ridge tiles

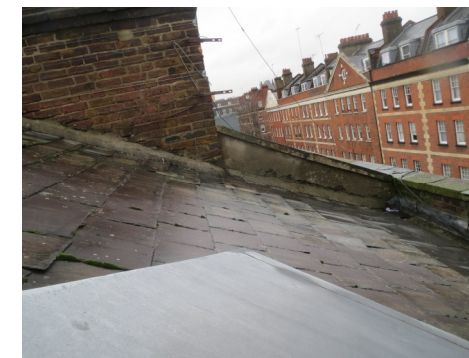
missing slates and intrusive services

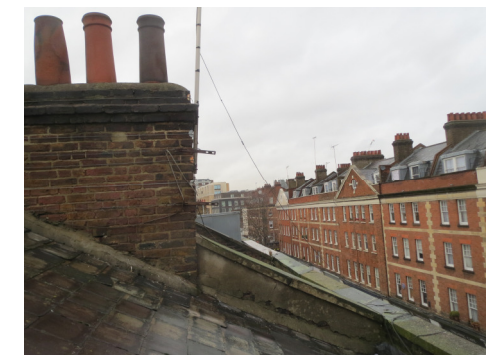
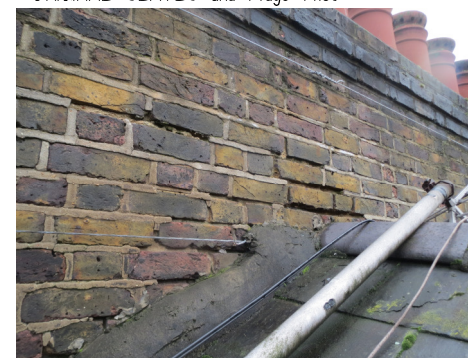
repointed brickwork harmful

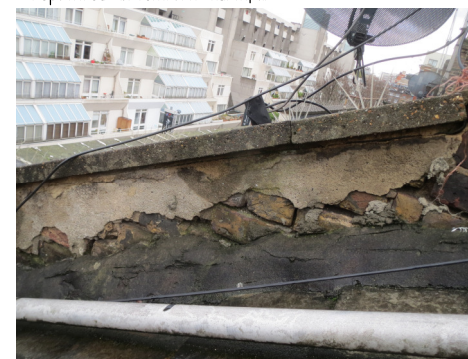
party wall - poor
