CONDITION SURVEY - SECOND FLOOR PLAN

CLIENT Venoru Ltd.	
PROJECT 49 Marchmont Street, WC1N 1AP	
DRAWING CONDITION SURVEY second floor plan	
DRG. No 29	REVISION -
SCALE 1:50 @ A 3 paper	DATE 12 JAN 2018

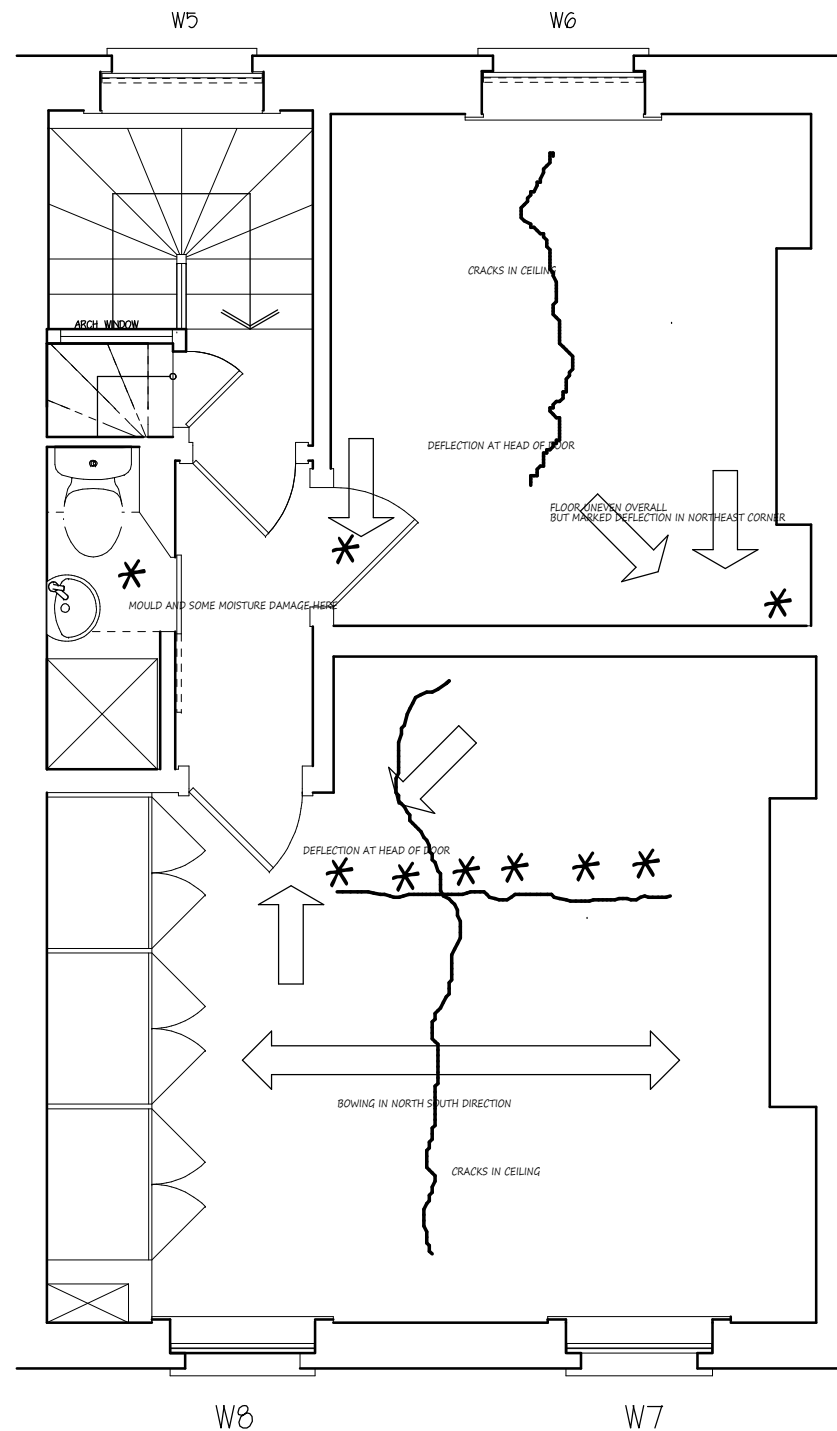
MODERN LININGS PREVENTED DETAILED INSPECTION

STAIRCASES ORIGINAL - DECORATION OF SPINDLES GOOD - CARPET POOR UNABLE TO SEE CONDITION OF TREADS

ARCH WINDOW OVER ATTIC STAIRS BLOCKED GLASS IN FRAME BUT COVERED OVER

REAR ROOM - DOOR D6 ORIGINAL BUT DEFLECTED - ARCHITRAVE COMPROMISED

PRONOUNCED DEFLECTION OF FLOOR TOWARDS NORTHEAST CORNER - REST OF FLOOR UNEVEN

CRACKS TO CEILING WEST TO EAST

FRONT ROOM

DEFLECTION OVER DOOR - CEILING DEFLECTS NORTH TO SOUTH DIPPING IN CENTRE OF ROOM
