PROJECT
49 Marchmont Street, WC1N 1AP

DRAWING
CONDITION SURVEY
third floor plan

DRG. No 30	REVISION -
SCALE 1:50 @ A 3 paper	DATE 12 jan 2018

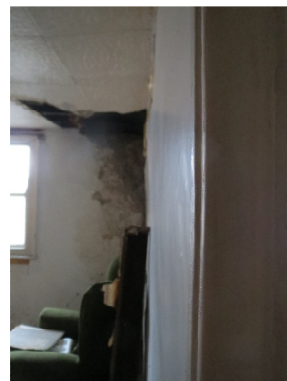
LATHER AND PLASTER PARTITION (RUNNING EAST TO WEST) DEFLECTING CRITICALLY AND TWISTING LATERALLY

twisting to partition

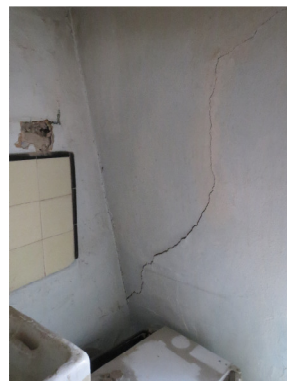
raking crack to mansard roof at rear

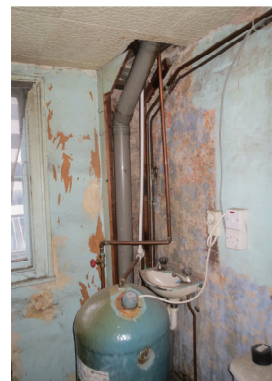
WATER ENTERED THE BUILDING DURING THE SURVEY - WALLS ARE SATURATED ON EASTERN SIDE
PARTICULARLY WET UNDER SOIL AND VENT PIPE

water ingress

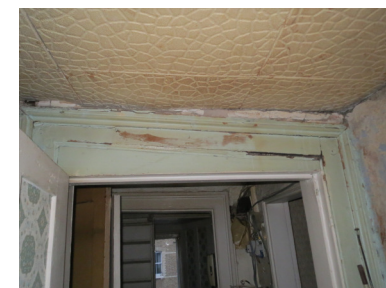
DOORS ORIGINAL BUT SEVERELY COMPROMISED BY FLOOR DEFLECTIONS

door fitted with infill panel due to deflection
