SURVEY OF SIGNIFICANCE ATTIC (4th) FLOOR PLAN

CLIENT Venoru Ltd.	
PROJECT 49 Marchmont Street	
DRAWING SURVEY OF SIGNIFICANCE FOURTH (ATTIC) floor plan	
DRG. No 23	REVISION -
SCALE 1:50 @ A 3 paper	DATE 29 Dec 2017

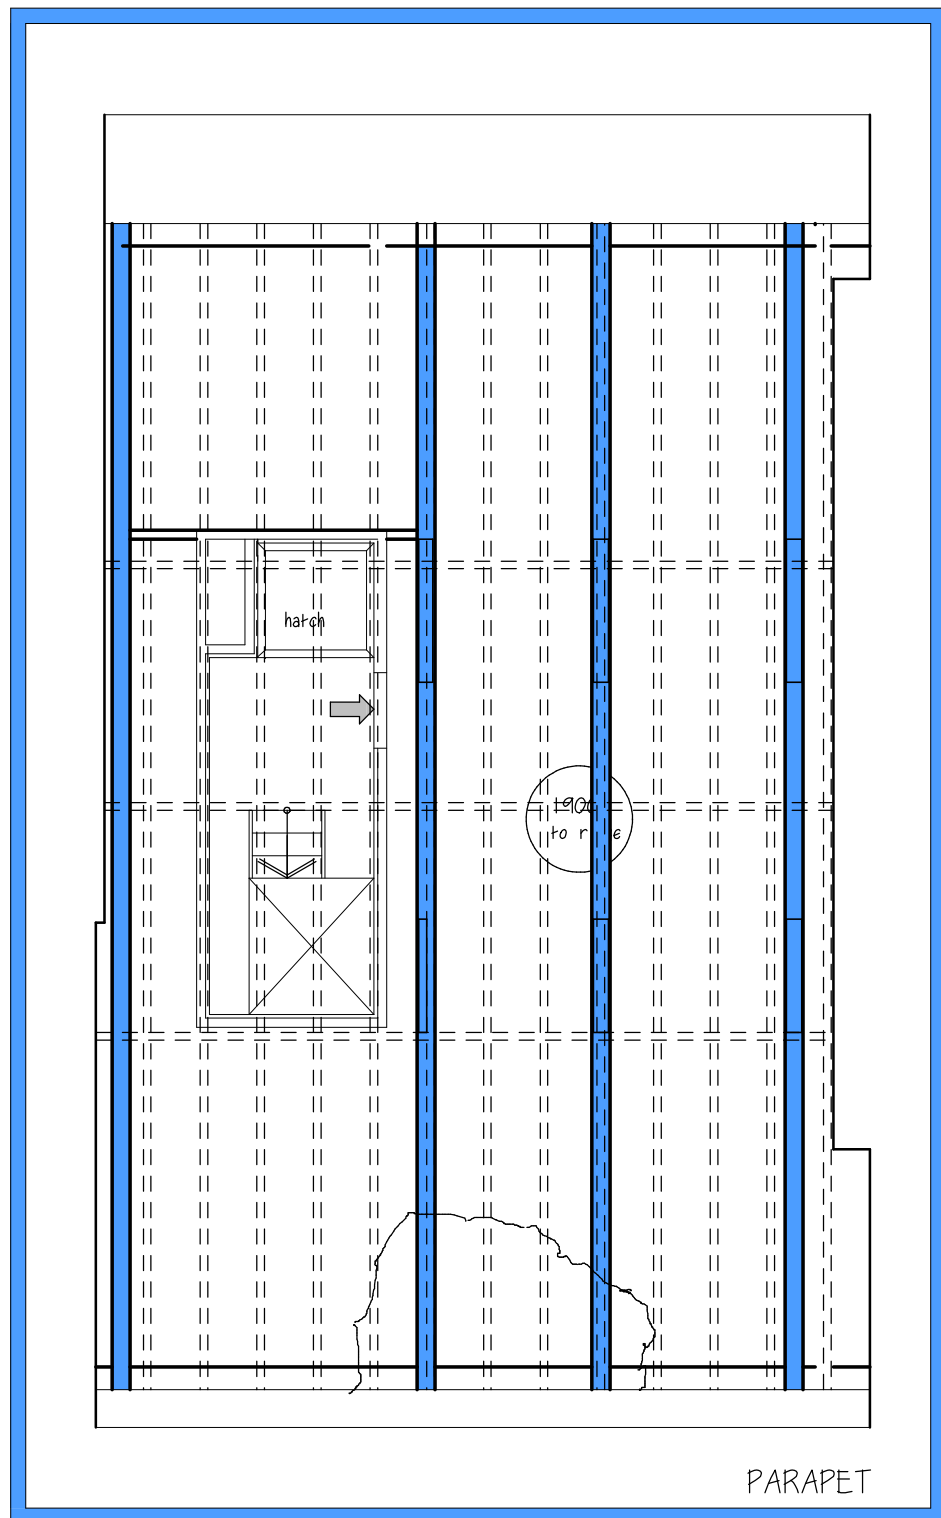
SURVIVING RAFTERS - UNPLANNED  
CEILING JOISTS ORIGINAL

TONGUE AND GROOVE LININGS TO LOFT ACCESS MAY BE EARLY JOINERY

LOFT HATCH NON-ORIGINAL

SEVERE DAMAGE TO CEILING JOISTS AT FRONT ELEVATION

BRACES AND TRUSSES ORIGINAL

NEW ROOF FELT

SEVERE WATER INGRESS TO FRONT AREA - PARTIAL COLLAPSE

ORIGINAL WALL PLATE SATURATED AND ROTTEN - SEE CONDITION SURVEY

OVERALL CONDITION FAIR - BUT AREA OF SEVERE DAMAGE
