SURVEY OF SIGNIFICANCE - ROOF PLAN

CLIENT Venoru Ltd.	
PROJECT 49 Marchmont Street, WC1N 1AP	
DRAWING SURVEY OF SIGNIFICANCE ROOF plan	
DRG. No 24	REVISION -
SCALE 1:50 @ A 3 paper	DATE 29 Dec 2017

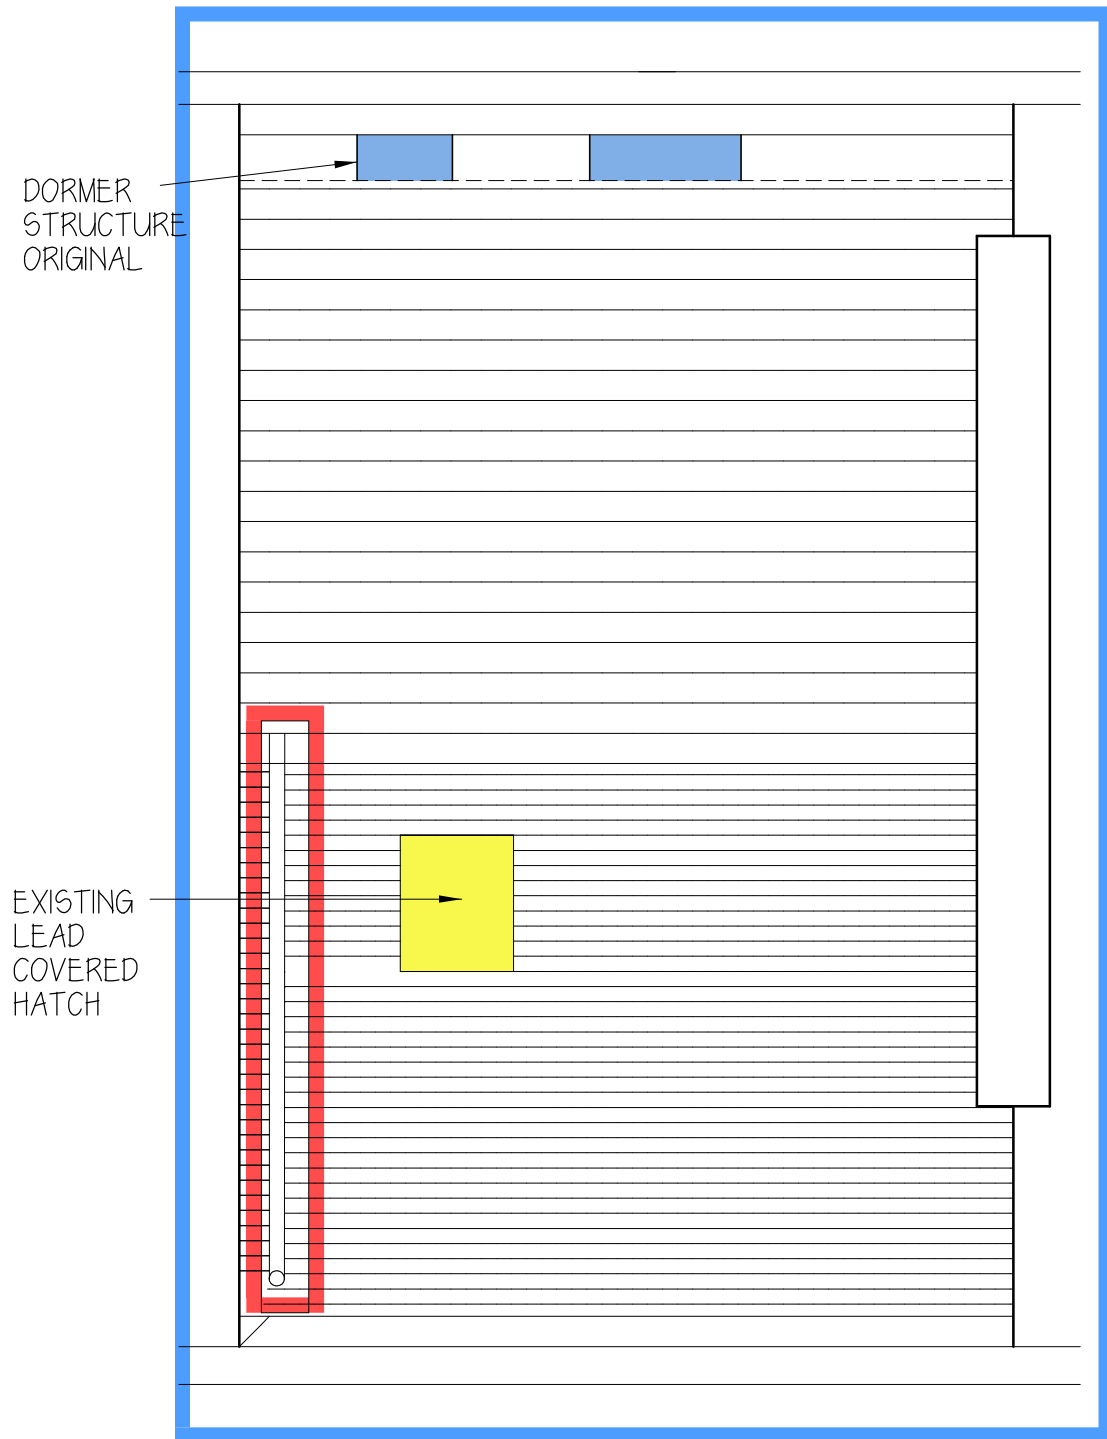
ROOF FORM ORIGINAL

ORIGINAL SLATES

ORIGINAL BRICKWORK

HISTORIC POTS AND ORIGINAL CHIMNEYS

ORIGINAL PARAPET

OVERALL - SURVIVING HISTORIC ELEMENTS BUT CONDITION POOR

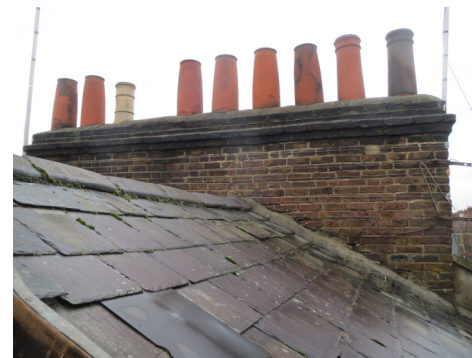
ORIGINAL SLATES and ridge tiles

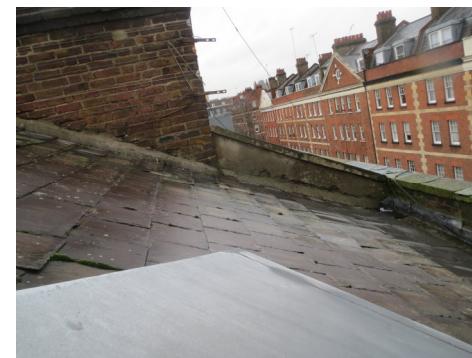
missing slates and intrusive services

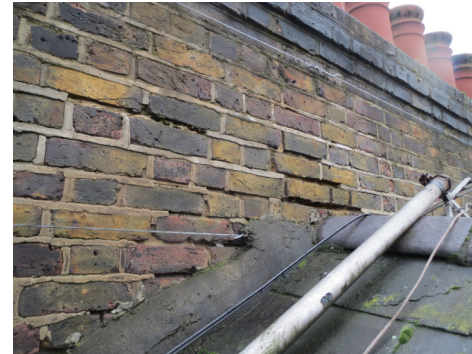
repointed brickwork harmful

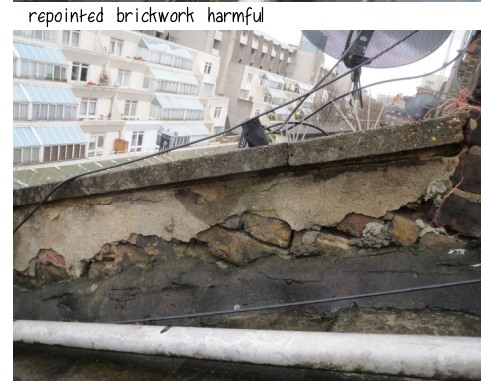
party wall - poor
