Appendix G

Photographic Schedule

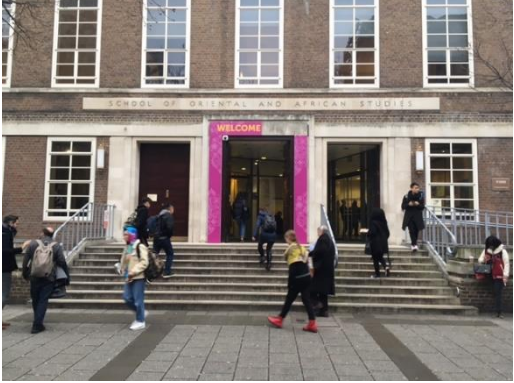
1. Front Elevation College Building	2. Front Elevation Area

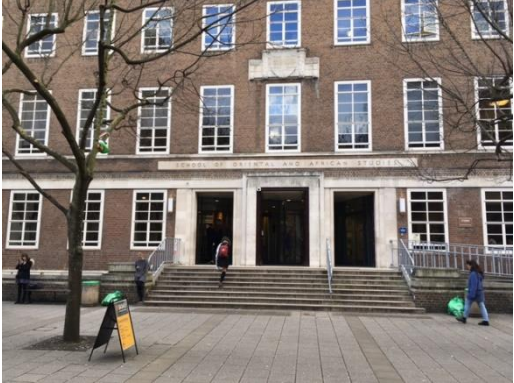
3. Front Elevation, 3 External Entrance Doors Open	4. Inside Existing Entrance Lobby Looking Outwards, Original Doors Fixed Open

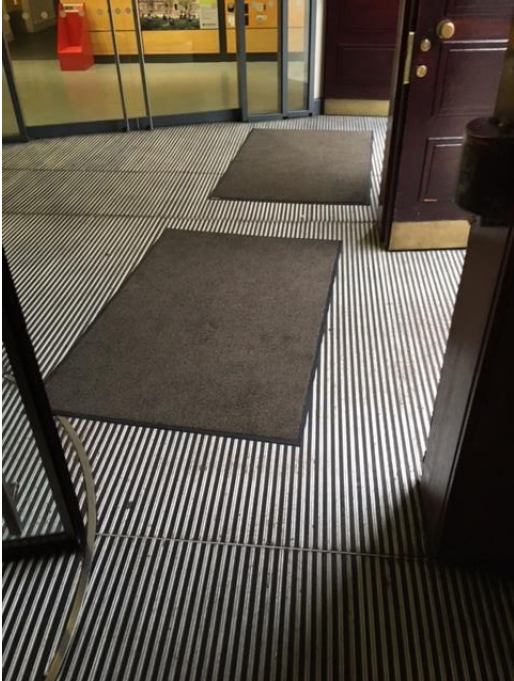
<p>5. Existing Entrance Lobby Matting System</p>	<p>6. Ceiling Area As Existing Within Lobby</p>

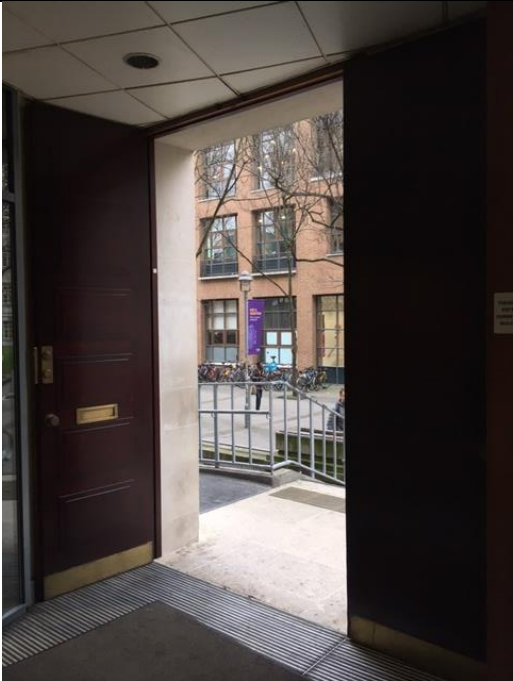
<p>7. Threshold to Entrance Door Through to Lobby</p>	<p>8. Original Timber Panelled External Door</p>

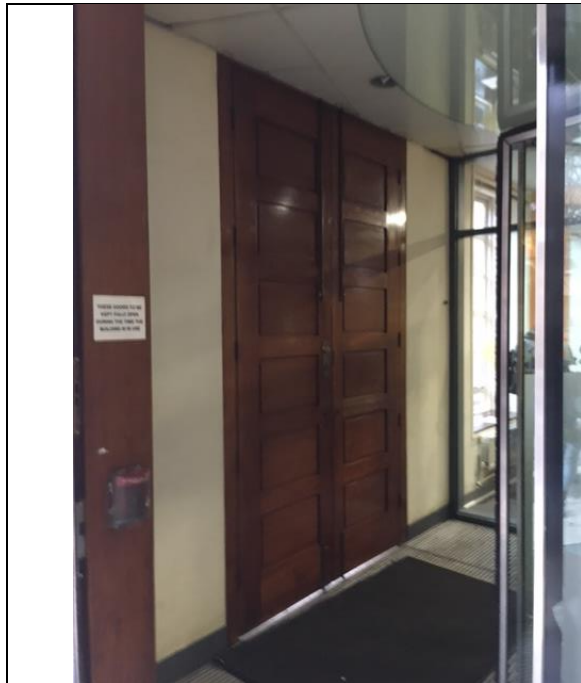
9. Original Panelled Entrance Door In Shut Position

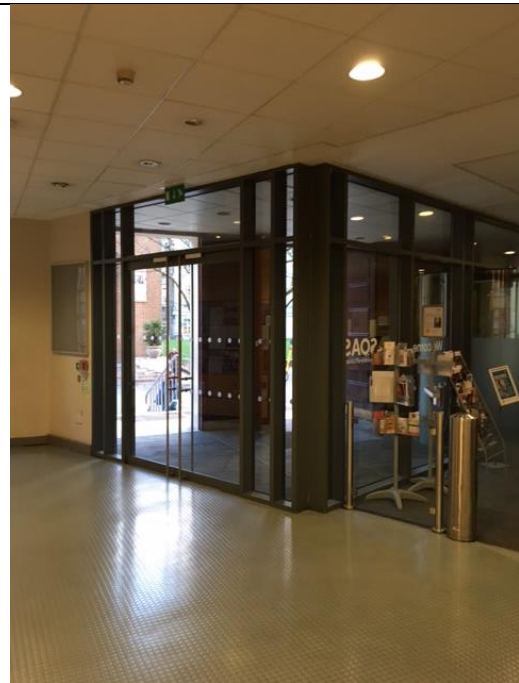
10. Entrance Lobby Double Doors Used for Escape Purposes Only

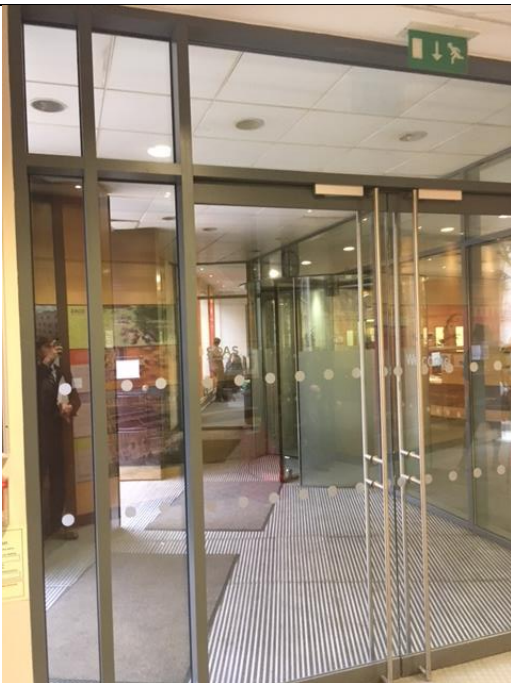
11. View Into Existing Entrance Lobby Through Double Doors

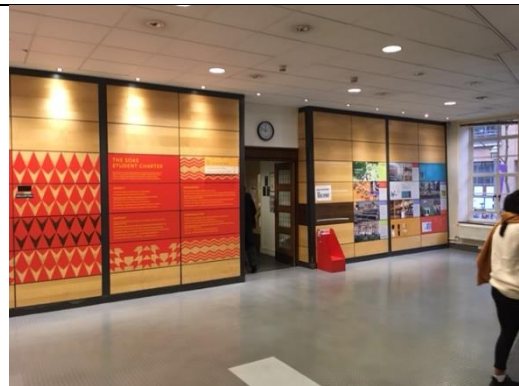
12. Existing Inbuilt Cupboards with Pine Clad Panels RHS Area As Enter Building

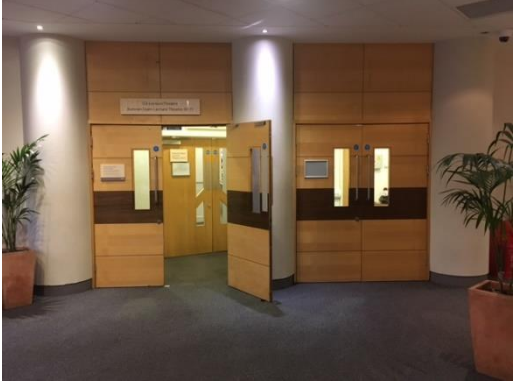
<p>13. Doors and Door Head Finished In Pine Cladding to LHS Area as Enter Reception Area</p>	<p>14. Existing Reception Desk, Structural Columns Behind With Oversized GRP Cladding</p>

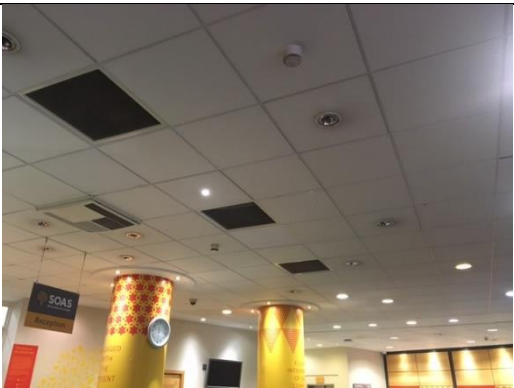
<p>15. Existing Ceiling With Surface Mounted Fixtures</p>	<p>16. View from RHS Area of Reception as Enter Looking Across Reception Area. Existing Carpet Finish and Grey Vinyl Shown</p>

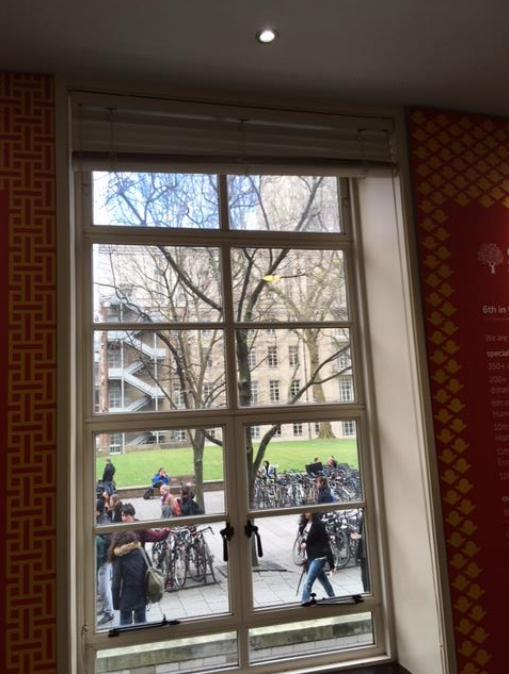
<p>17. Existing Metal Venetian Blinds Fitted to Window Reveal</p>	<p>18. View Into Existing Suspended Ceiling Void</p>

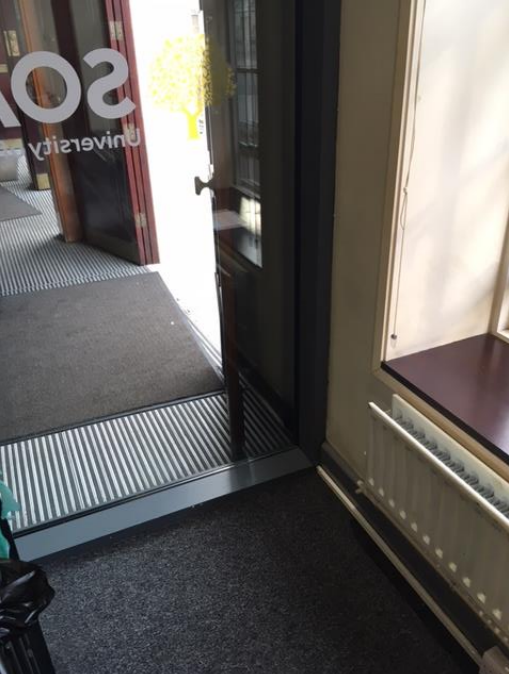
<p>19. Abutment Detail of Existing Curtain Walling to Wall</p>	<p>20. Existing Soffit to Structural Ceiling Above Suspended Ceiling. Structure Appears to be Hollow Clay Pot and Beam Construction, Underside Plastered and Painted Black</p>

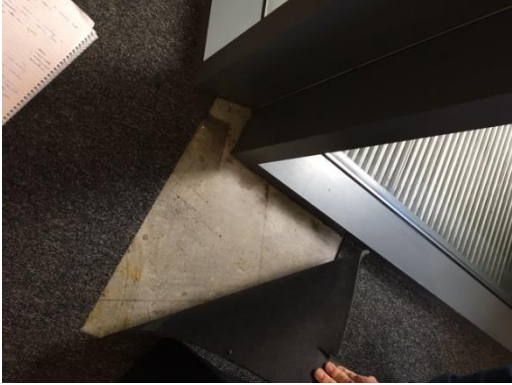
<p>21. Underside of Existing Floor Covering, Screed Finish</p>
