Project
Goodenough College, Repair to Facade

Drawing Title
Existing & Proposed Plan, Sections & Elevations

Drawing number 17104-A-0001 Revision P01

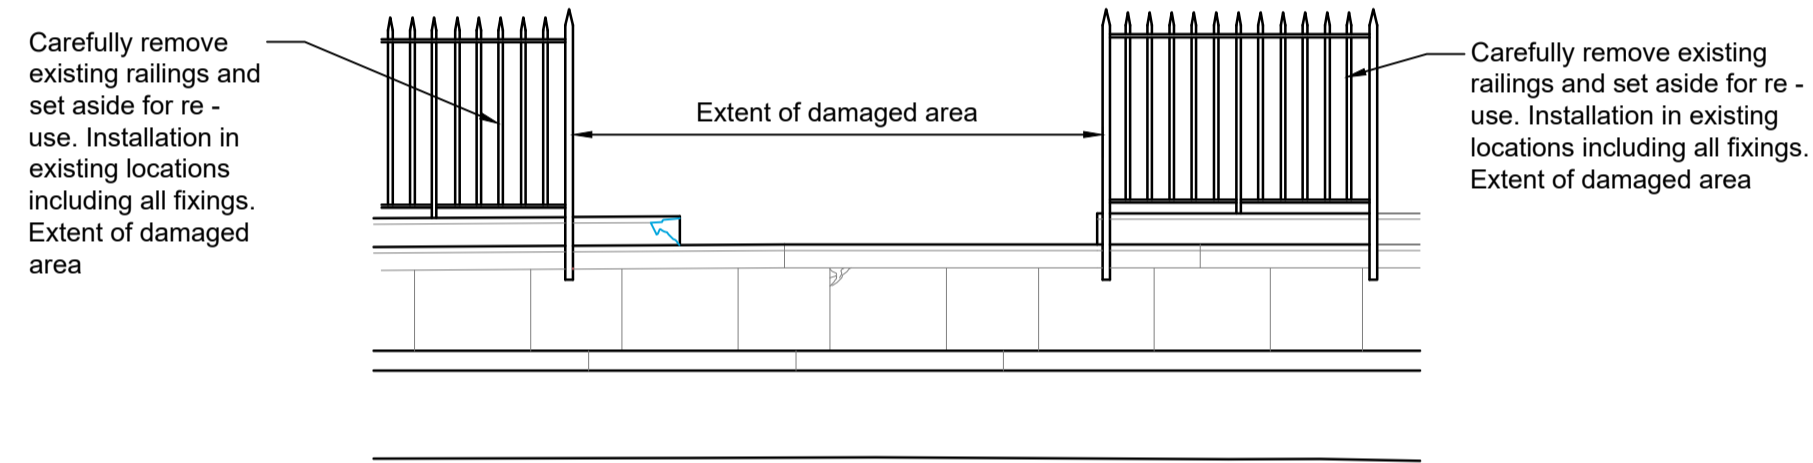
Existing Elevations of Damaged Areas

Elevation 2. Existing internal elevations to lightwell showing localised damage to stone
Datum: 19.00m.

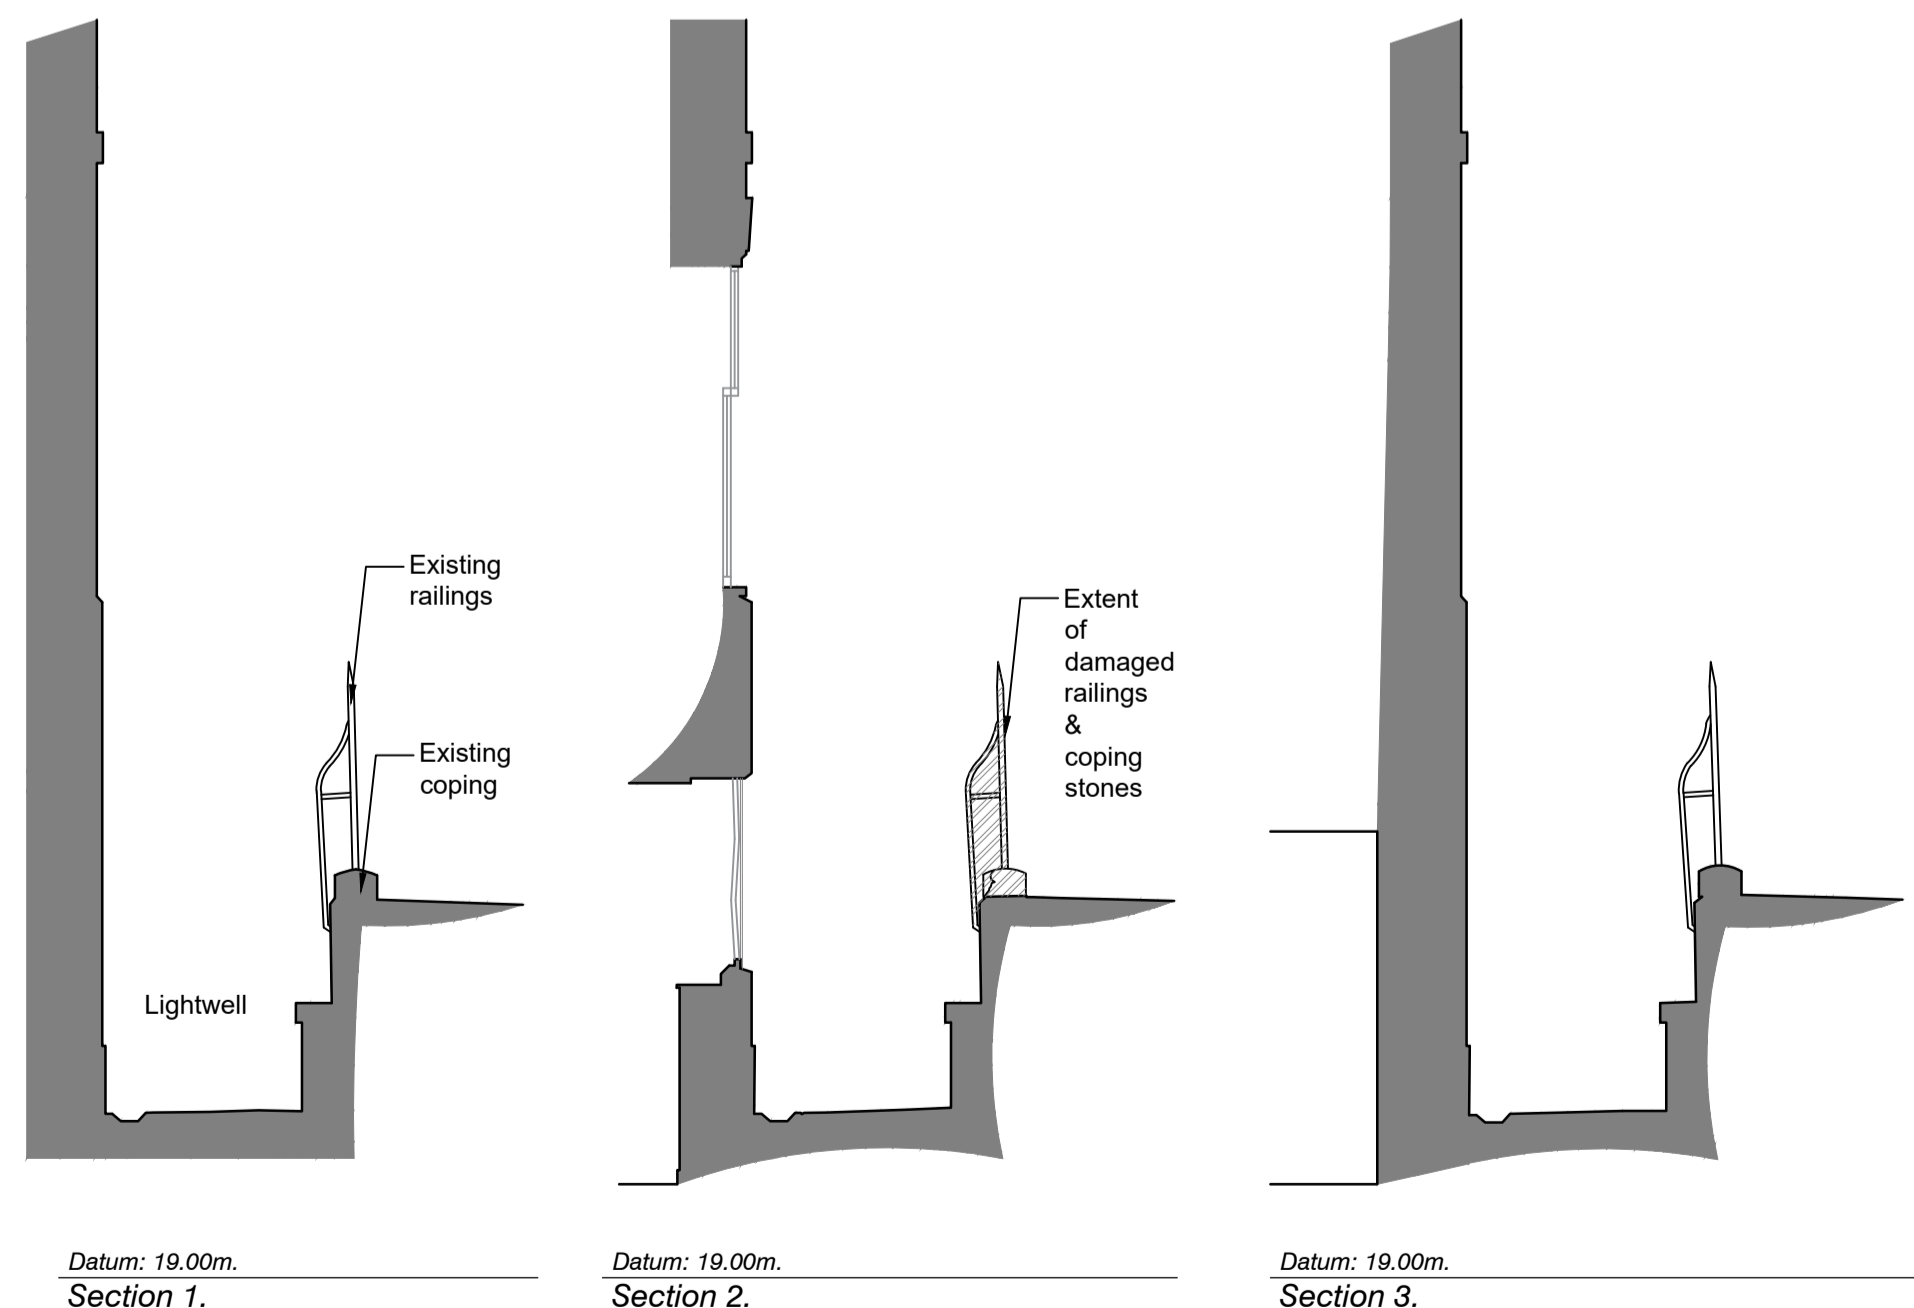
Existing Sections of Damaged Areas

Existing Extent of Damaged Areas
