LONDON HOUSE
GOODENOUGH COLLEGE

Mecklenburgh Square,
London, WC1N 2AB

Report on Structural Inspection
of Vehicular Damage

October 2017
Rev A – November 2017

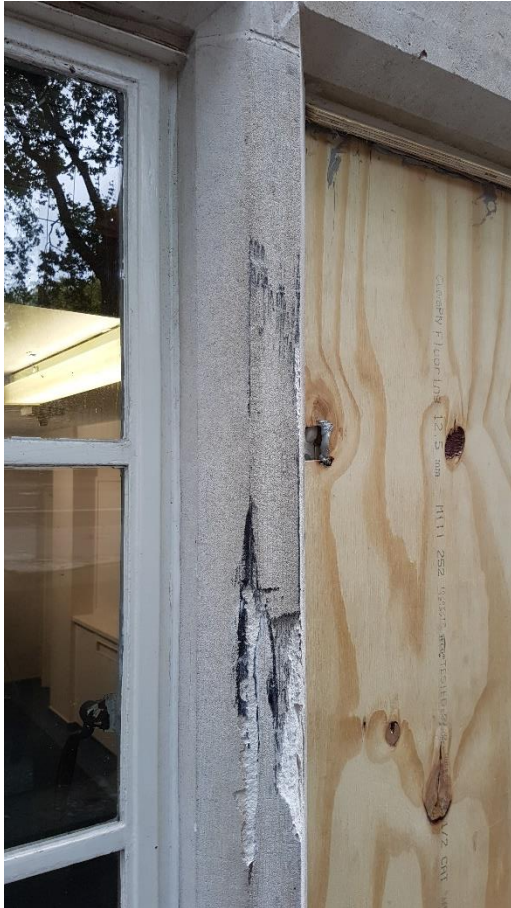
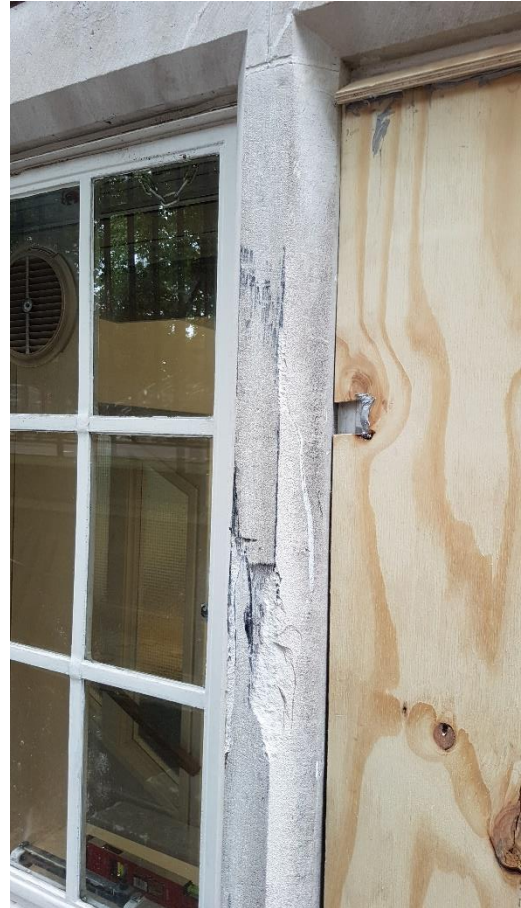
- The left hand mullion reveal has suffered direct impact damage with spalling of stone from the face and paint staining from the vehicle bodywork.

Left Hand Mullion. Spalled Stone and Staining

- c. Where the Portland stone reveal and mullion are damaged, cut the damaged areas back so that a minimum of 20mm repair mortar can be applied, install support pins or mesh as required and build the profile back to the original using lime based stone repair mortar with Portland stone dust incorporated into the mix.

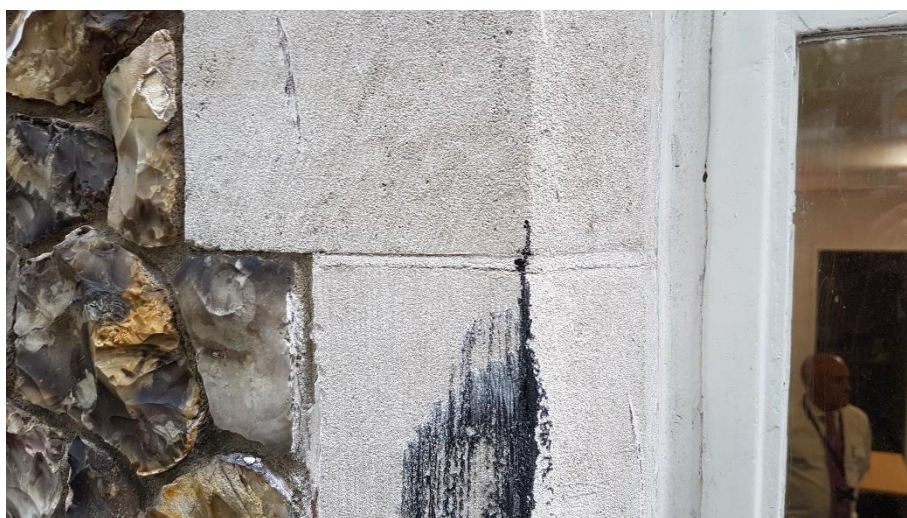
Left Hand Reveal. Paint Staining

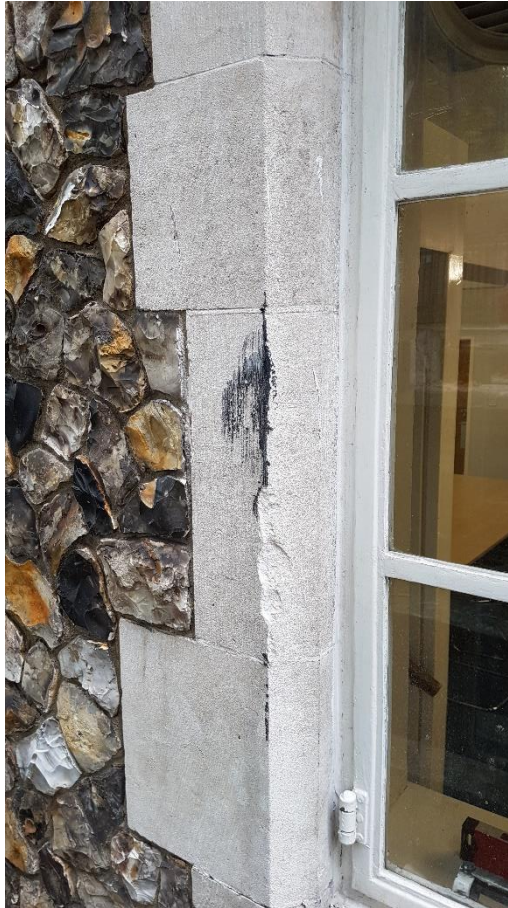
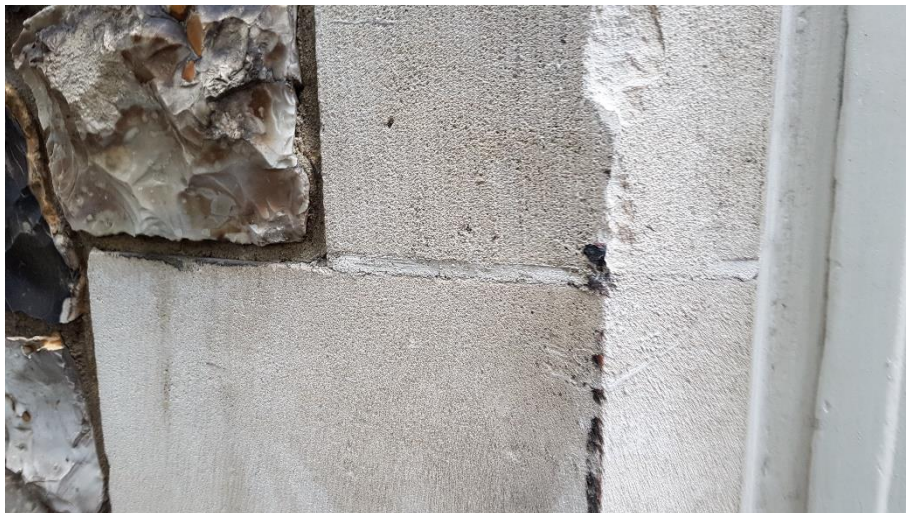
Left Hand Reveal. Spalled Stone and Paint Staining

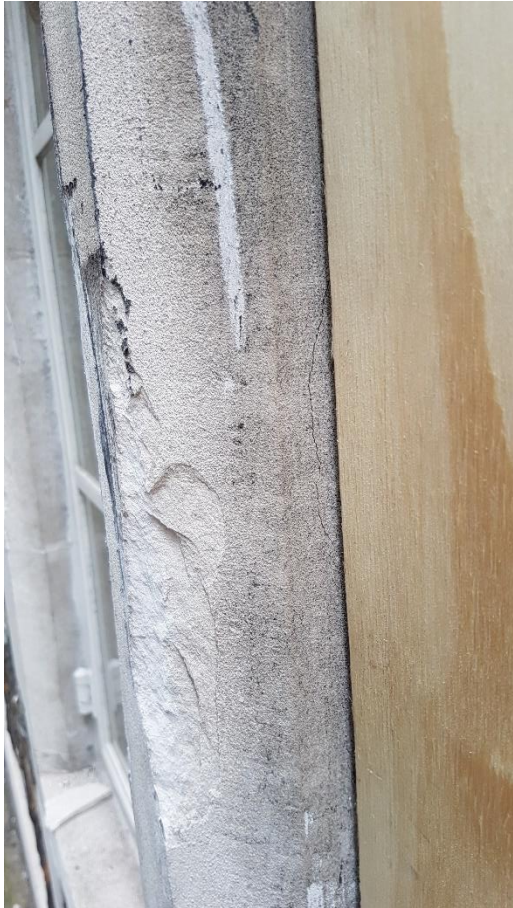
- There is both internal and external fine cracking to the left hand mullion.

Crack to RHS of Mullion - External

- d. Where the mullion has cracked, drill and install 4mm diameter stainless steel pins either horizontally or diagonally across the crack using a high strength resin bonding agent.

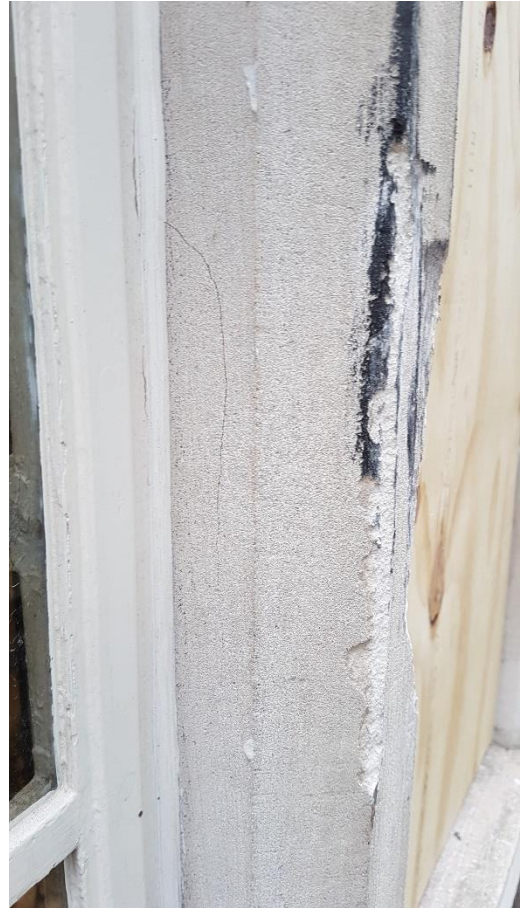
Crack to LHS of Mullion – External

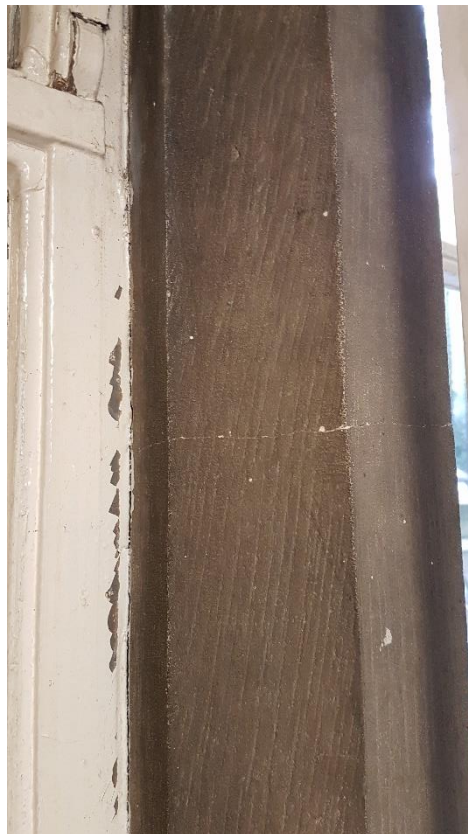
Crack to Mullion - Internal

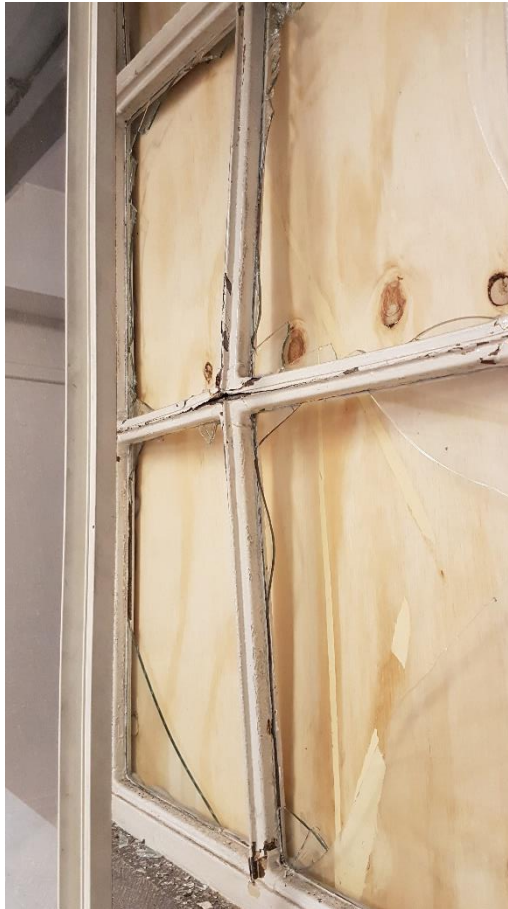
- The left hand steel casement window has been bent inwards over the lower third.

Steel Casement Window Bent Inwards

- a. Clear out all debris from the light well. Retain sections of the coping and railings to act as a template for their replacement.
- b. Remove the damaged steel casement window and temporarily secure the opening. Either repair the existing casement off-site or manufacture a new casement to match the existing. Replace the casement in the opening, once repaired.

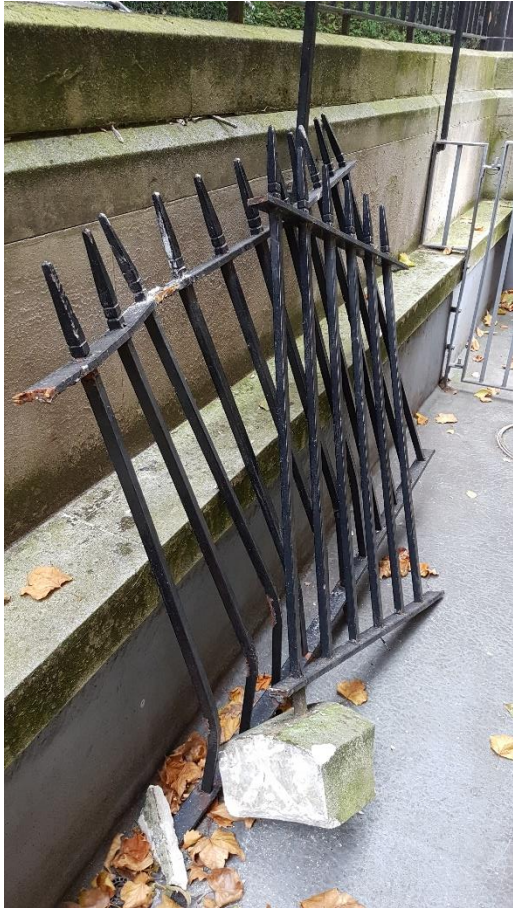
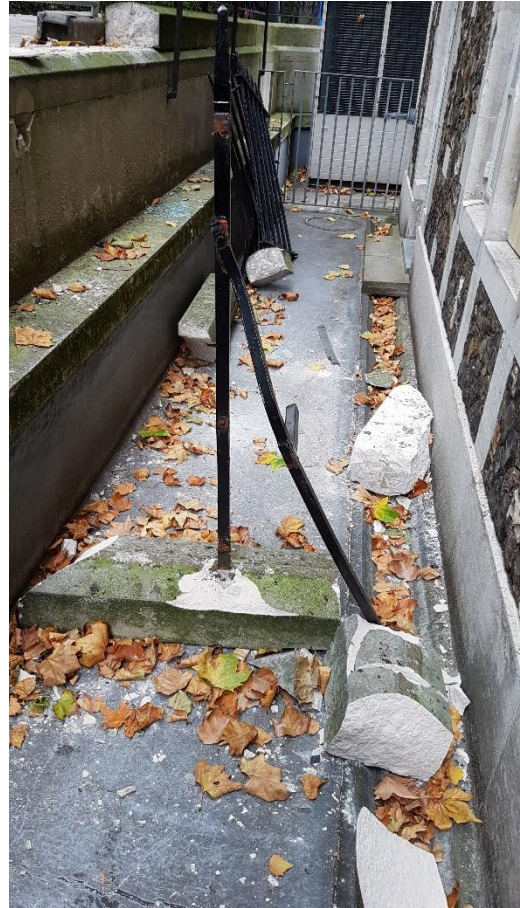
- A section of the black painted wrought iron railings on the boundary have been severely damaged. The cantilever arm that was embedded in the rear of the stone retaining wall has pulled out, pulling the localised stonework away also.

Damaged Railings

- g. Repair the pocket in the rear of the retaining wall where the railing fixing post was pulled out. Use the repair method noted in c. above.
- h. Manufacture and install new iron railings to a size and profile to match the existing. Note there are posts to be grouted onto the top of the coping stone as well as the main posts that fix into the rear of the wall.

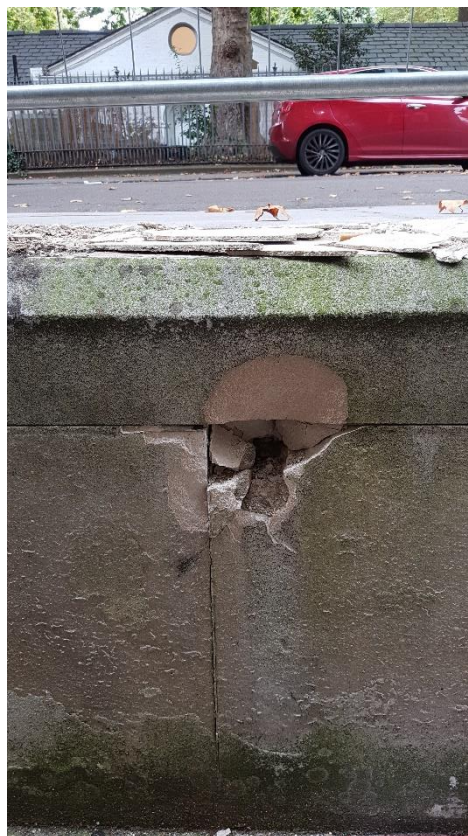
Damaged Wall Where Post Has Pulled Out

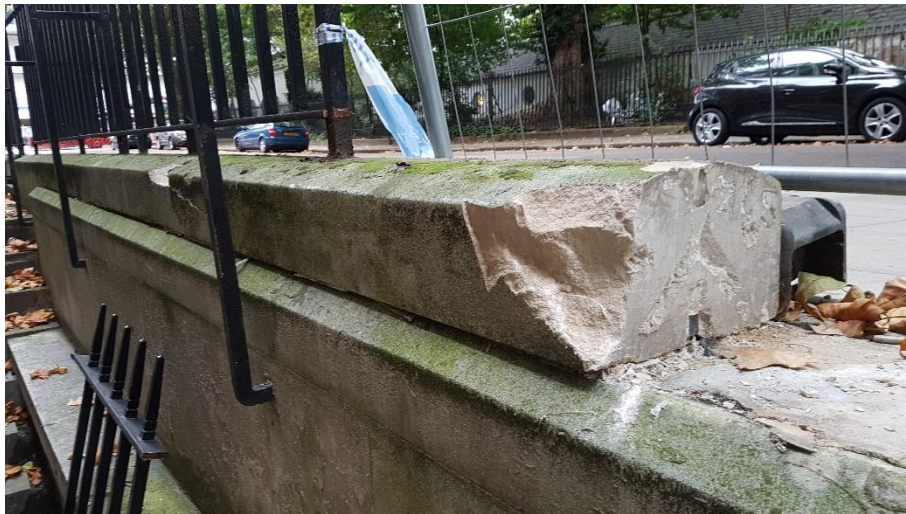
- A section of the retaining wall coping has been either completely dislodged or severely damaged by the impact.

Damaged Coping – Note the Support Dowel in the Lower Wall

- e. Where existing coping stones can be repaired, undertake the repair in the same way as c. and d. above.
- f. Where coping stones cannot be re-used due to the extent of damage, manufacture and install new Portland stone copings to the same profile as existing, ensuring they are adequately fixed down to the top of the retaining wall.

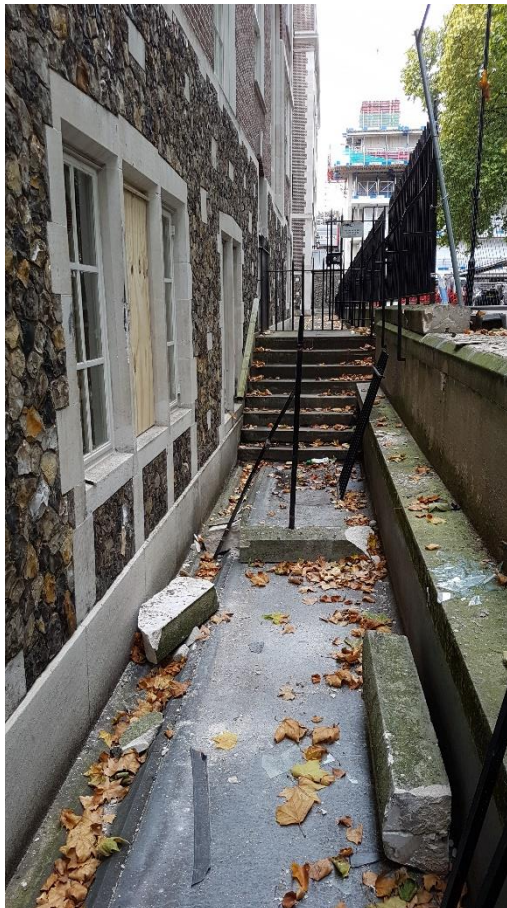
Dislodged Coping Stones

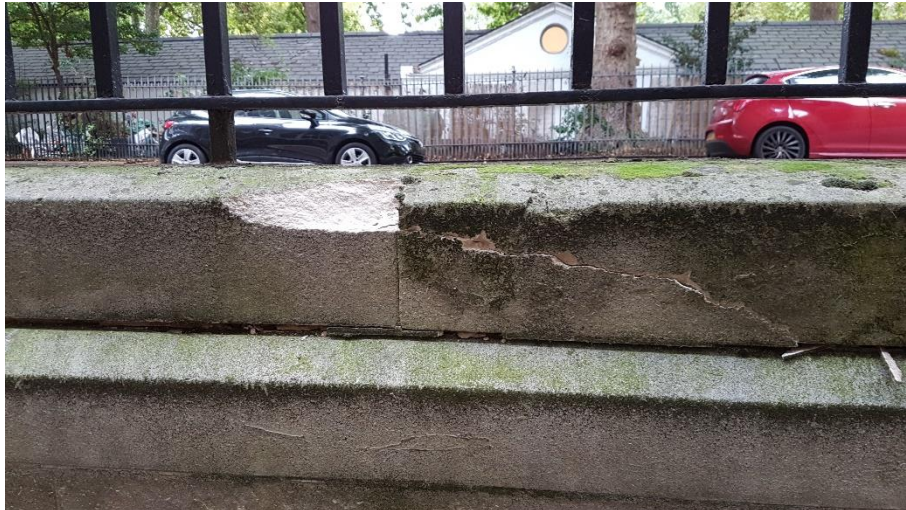
Cracked and Damaged Coping

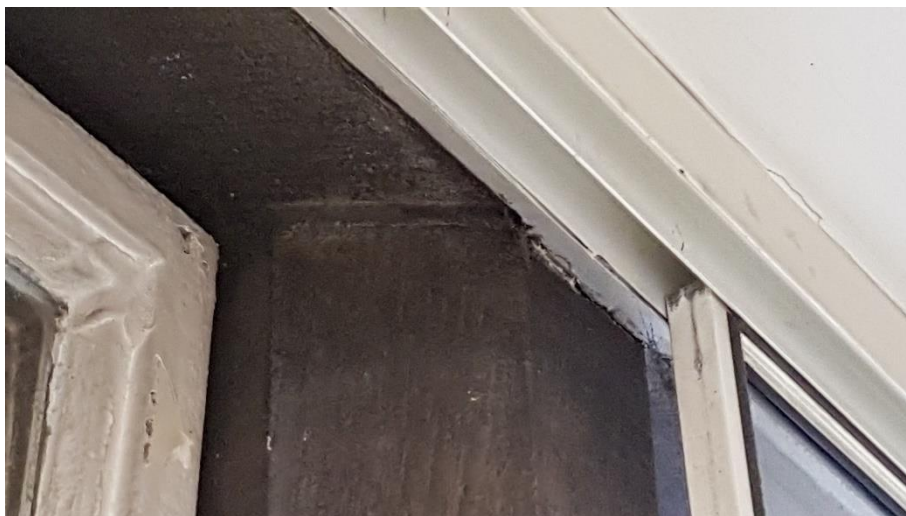
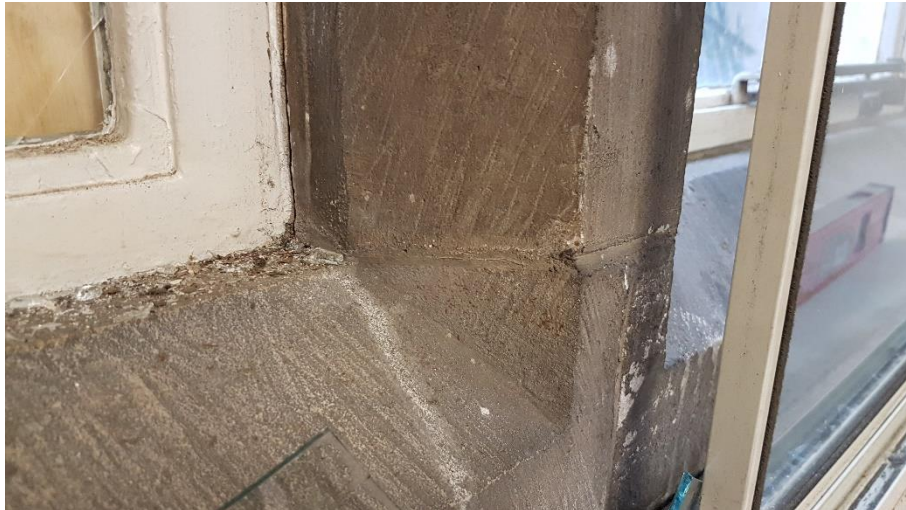
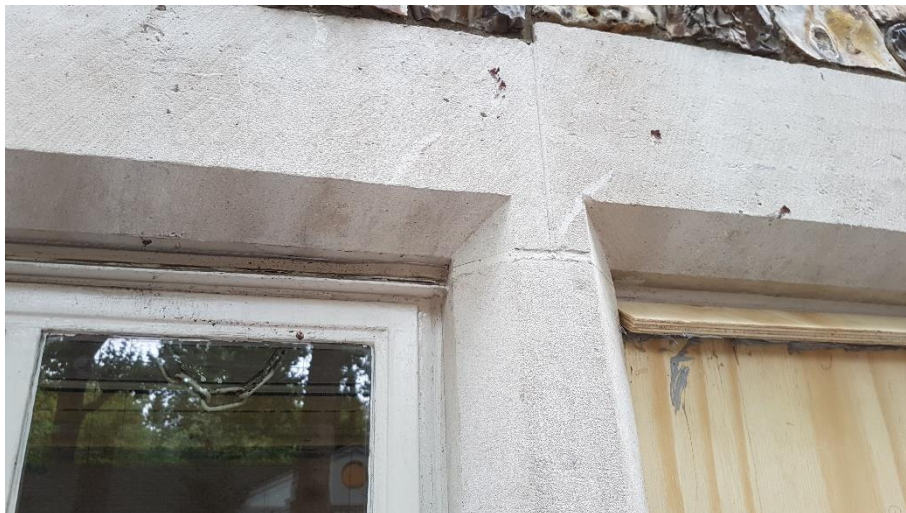
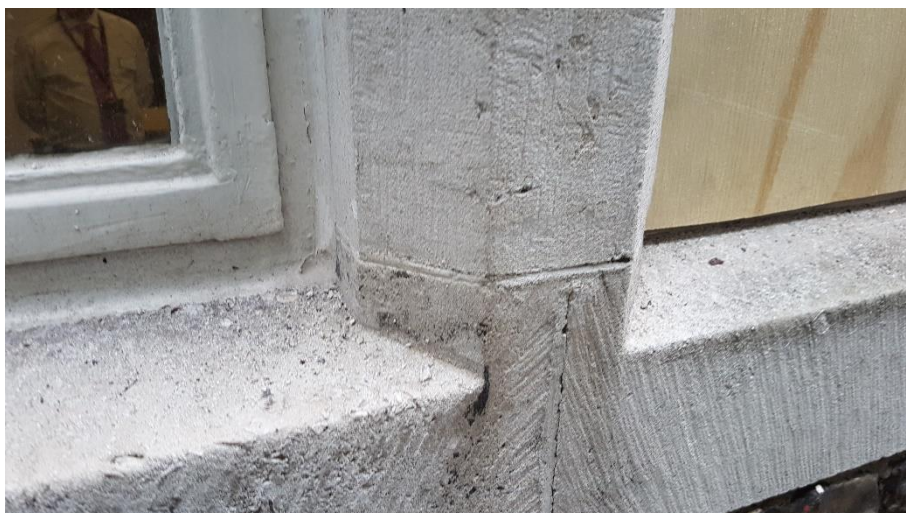
In terms of the overall level of damage and the structural assessment of the front wall, one item of significant note is the fact that the joints at the top of the damaged mullion where it fixes to the lintel and the bottom joint where it connects to the sill are not cracked and show no sign of distress.
