# Claim Assessment Report

On behalf of **Halifax Home Insurance**

**Our Reference:** IFS-LBG-SUB-17-0073205

**Risk Address:** 13 Lawford Road, London, NW5 2LH

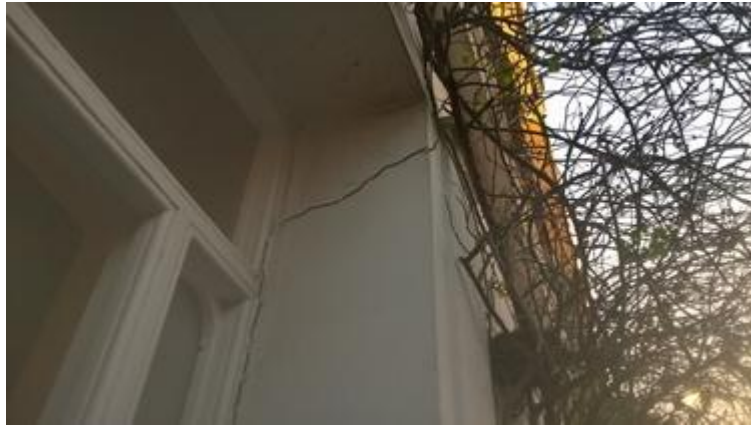
FIGURE 03 External Damage

Externally, diagonal cracks, wider at the top is due to seasonal foundation movement. There are a few small trees and bushes in the front garden and also a much larger street tree in the pavement.

The diagonal aspect of the cracks, together with the fact that they increase in width with height is indicative of subsidence as a result of shrinkage of the clay subsoil due to the moisture extracting influence of nearby vegetation.

Generally cracks 1mm wide or less will be filled (internal) or re-pointed (external). Internally, where the cracks are wider than 1mm, but less than 5mm the underlying brickwork or blockwork will be exposed and prior to making good the plaster finishes the cracking will be covered with expanded metal lath. Where cracks are 5mm across or wider, some form of bed joint reinforcement will be introduced.

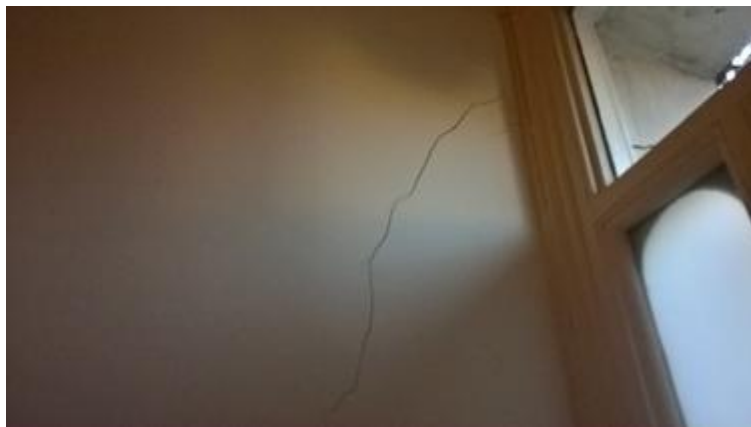
FIGURE 04 Hallway

Similar cracks are also evident in the front section of the hall and toward the front door.

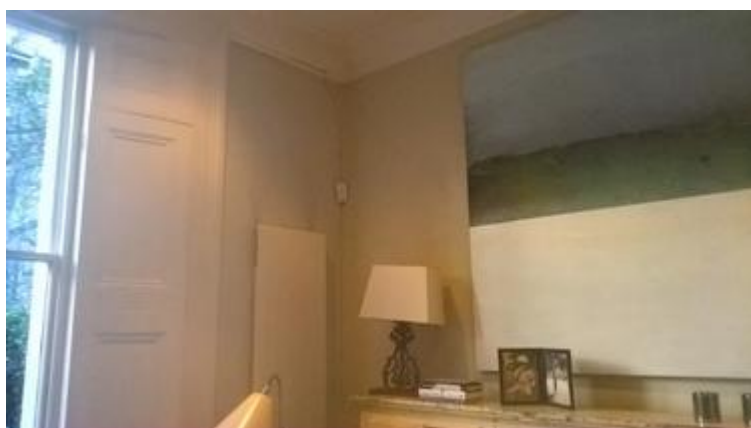
FIGURE 05 Living Room

The internal cracks are to be found in the front living room towards the left side of the bay area with the cracks following a diagonal pattern, being wider at the top. This type of crack pattern is indicative of foundation related movement of a seasonal nature.
