Supplementary Engineer's Report

Our Reference	IFS-COV-SUB-17-0068212
Claim Reference	C017106730
Prepared for	Cov�a Insurance

Report Date	30th November 2017
Policyholder	16 Goldhurst Terrace Limited
Address	16 Goldhurst Terrace, London, NW6 3HU

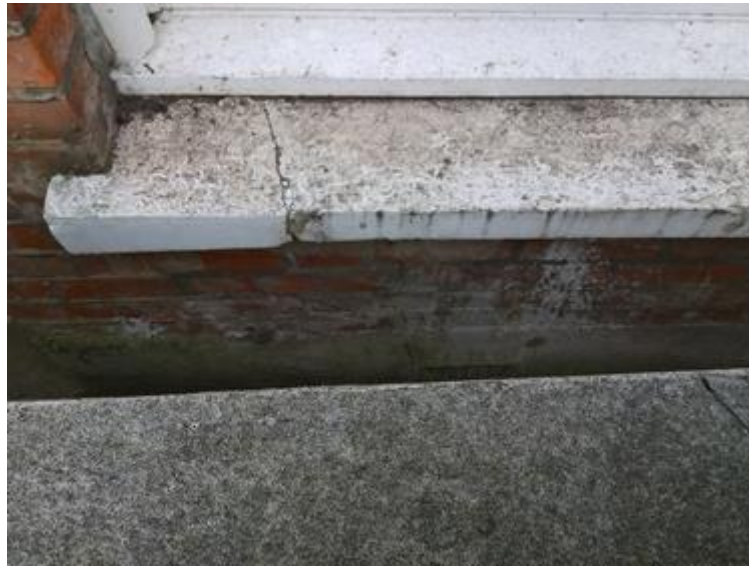
Fig 01 – Below front bay

- Cracking below the front bay at lower ground floor level, dropped brick arch and 2mm cracking above the lower ground floor centre window.

The indicated mechanism of movement is a seasonal, downward movement of the front of the property.

It is common practice to categorise the structural significance of the damage in this instance, the damage falls into Category 1 (Very Slight).

Where it is possible to mitigate further movement by removal of the implicated vegetation, we consider that superstructure repairs alone will suffice. The current estimated cost of this work is £3986.68. Where it is not possible to prevent further damage caused by seasonal movement induced by the effects of the implicated vegetation, it will be necessary to stabilise the building by foundation augmentation.
